VEHICLE INSPECTION REPORT

GV12WOA

Seat Ibiza 1.2 TSI FR 5dr

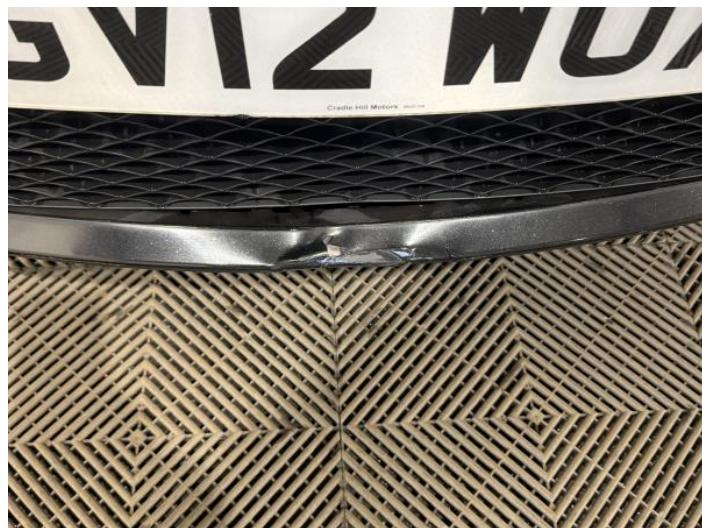
1: Bumper Front
Dented
With Paint Damage

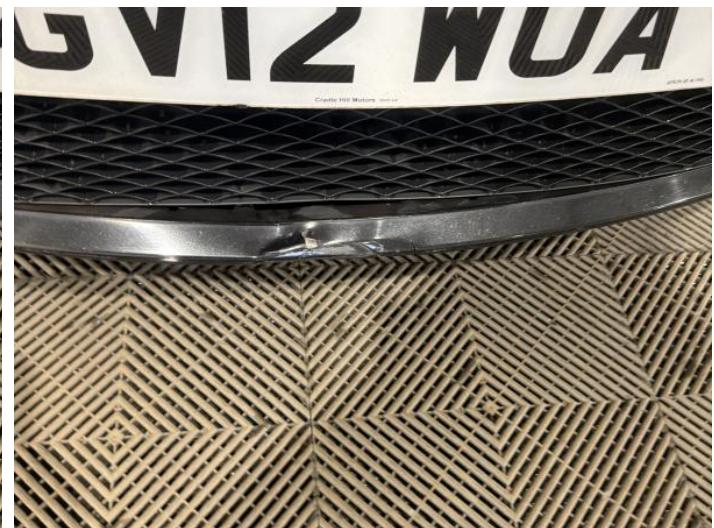
2: Bumper Front Moulding
Broken
Replace

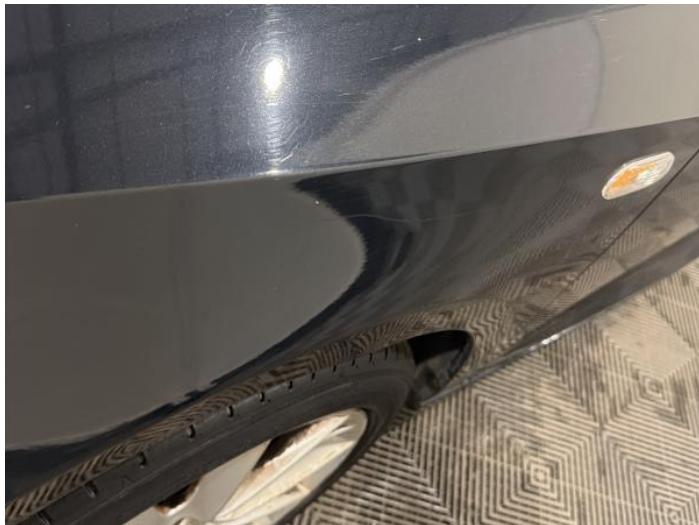
3: Wing nsf
Dented
With Paint Damage

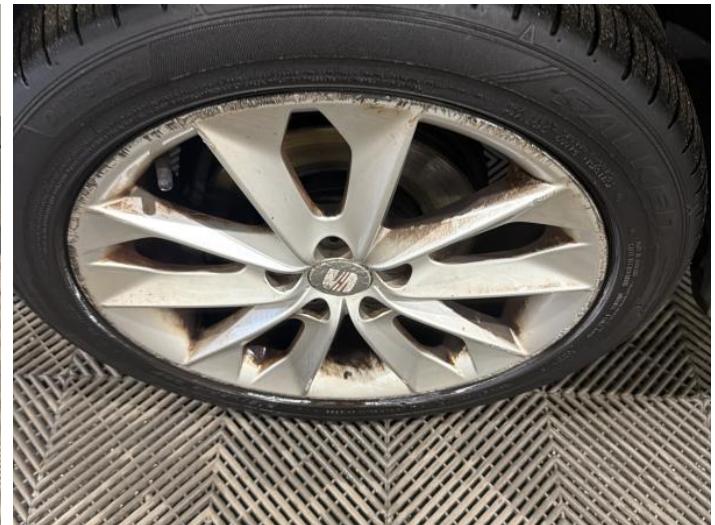
4: Wheel nsf
Scratched
Over 50mm

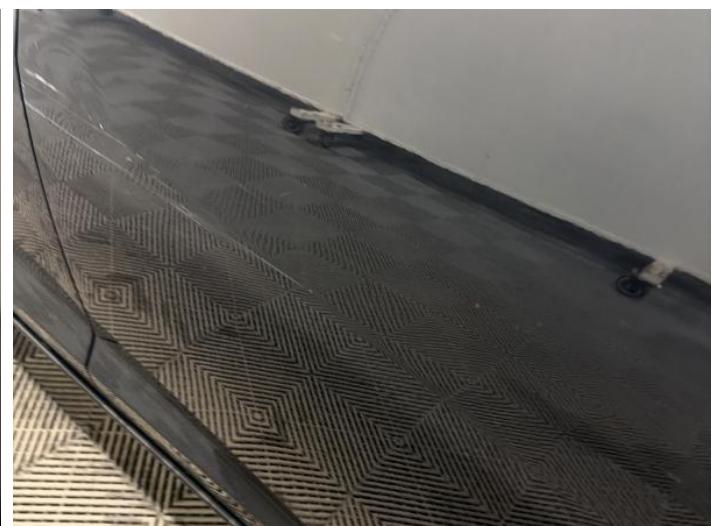
6: Door nsr
Dented
With Paint Damage

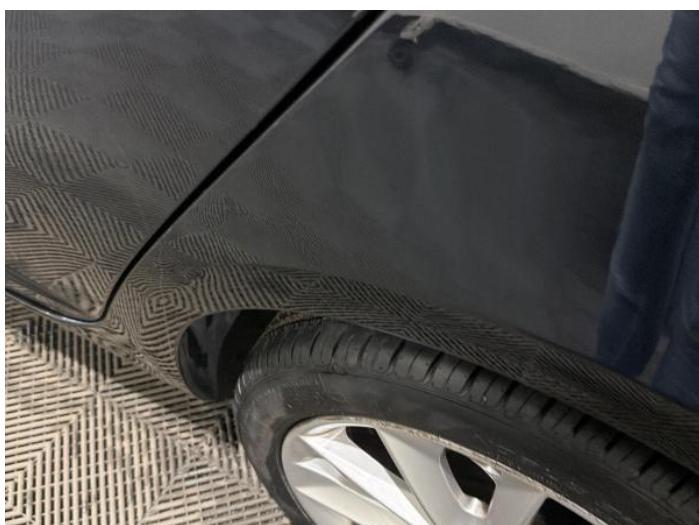
7: Qtr Panel nsr
Dented
With Paint Damage

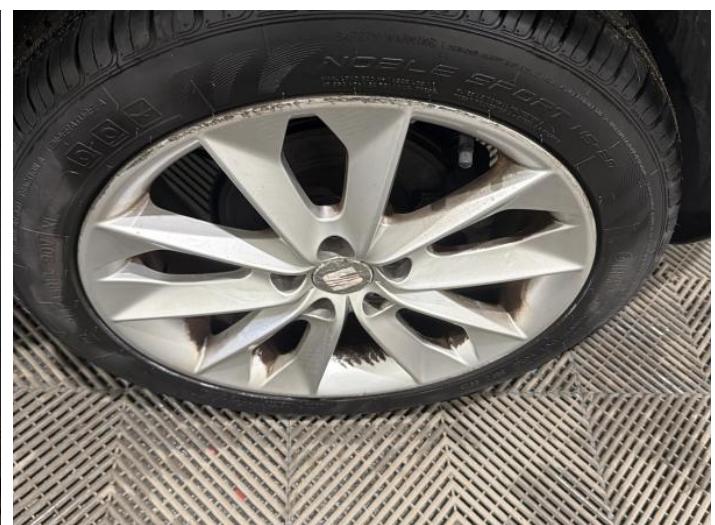
8: Wheel nsr
Scratched
Over 50mm

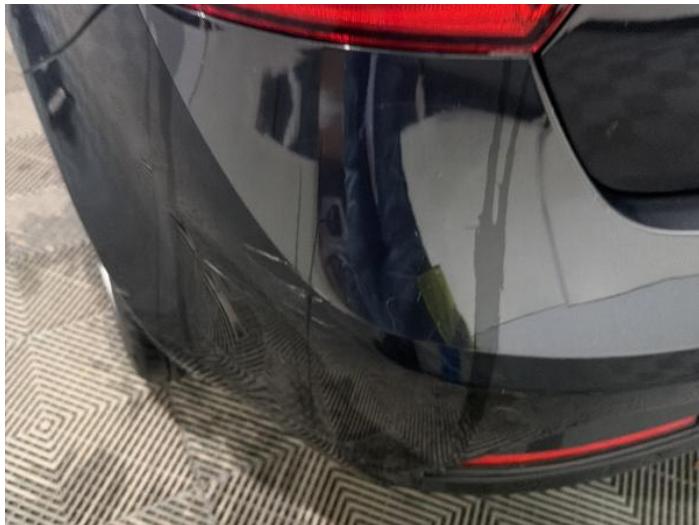
9: Bumper Rear
Scratched
Over 100mm Thru Paint

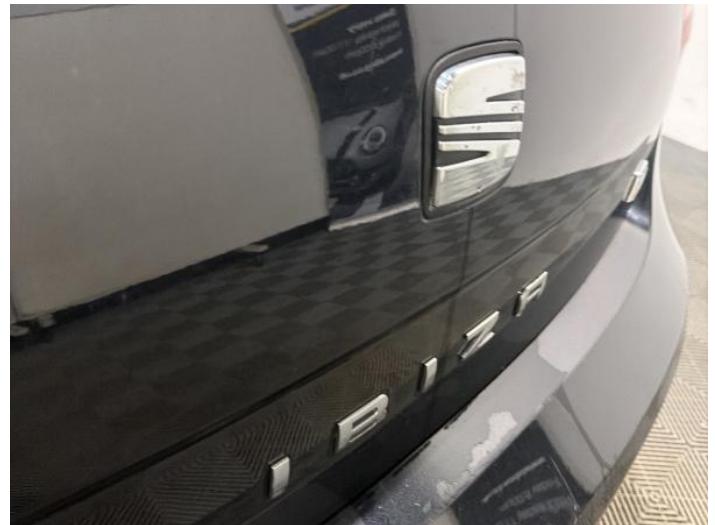
10: Boot Lid
Chipped
1 To 5

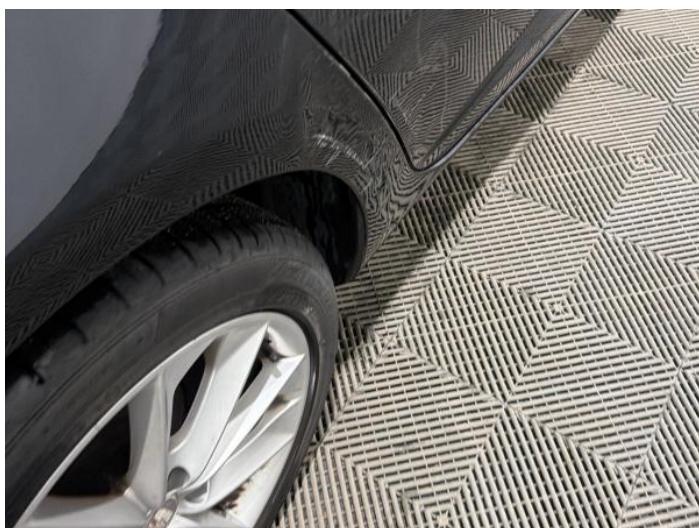
11: Qtr Panel osr
Dented
With Paint Damage

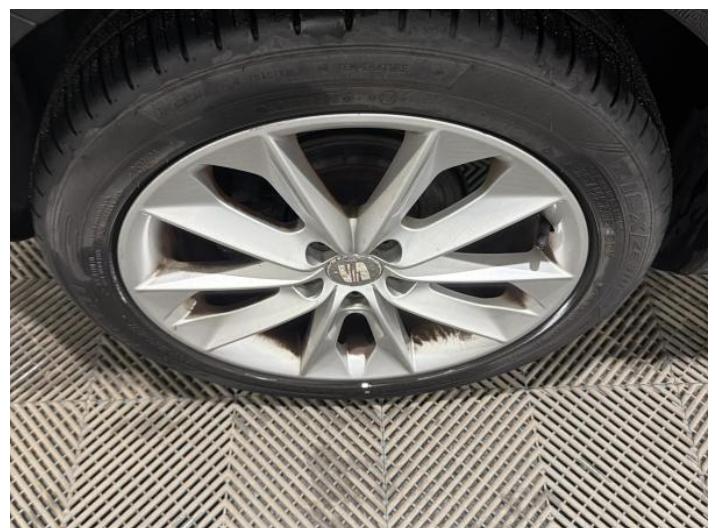
12: Wheel osr
Scratched
Up To 50mm

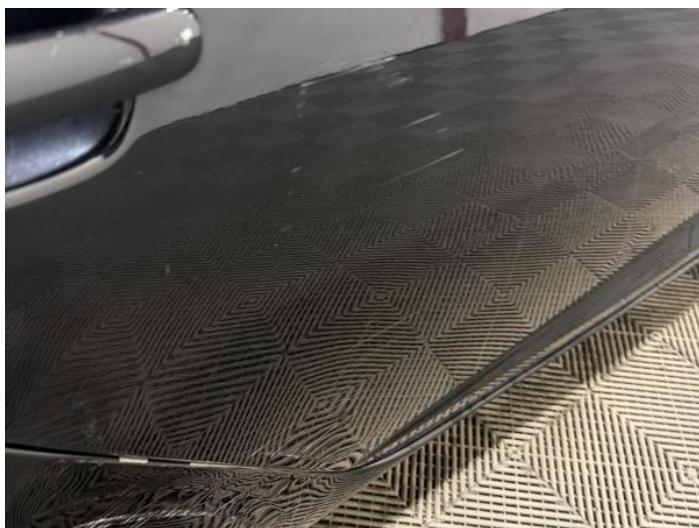
13: Door osr
Dented
With Paint Damage

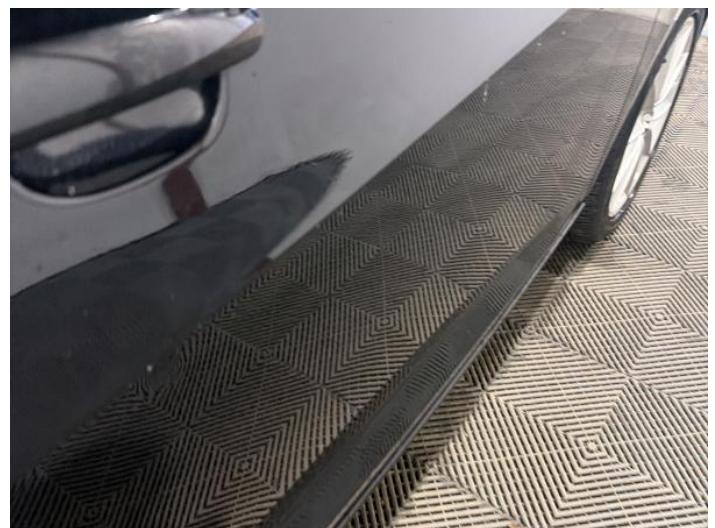
14: Door osf
Dented
With Paint Damage

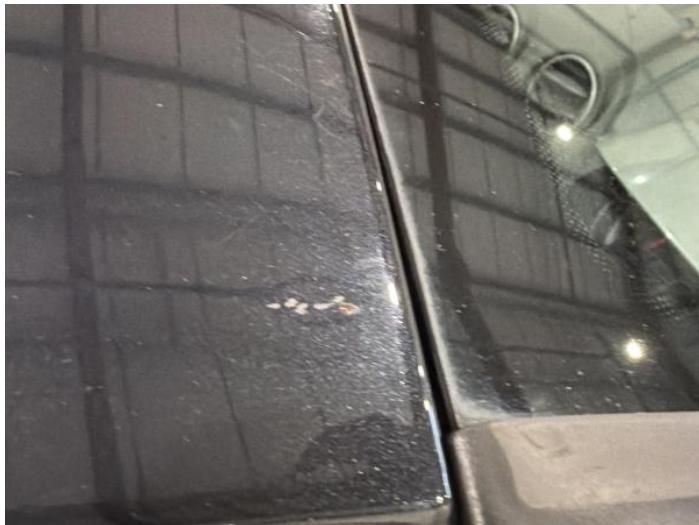
15: Roof
Dented
With Paint Damage

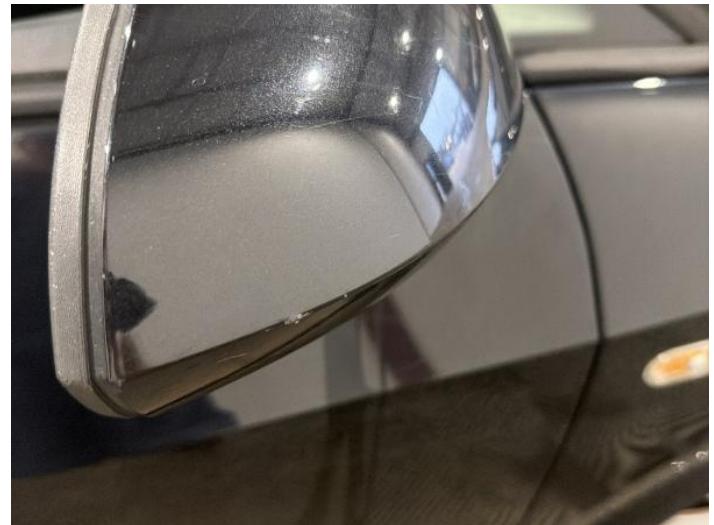
16: Door Mirror Assy osf
Scratched (Painted)
UpTo 25mm Thru Paint

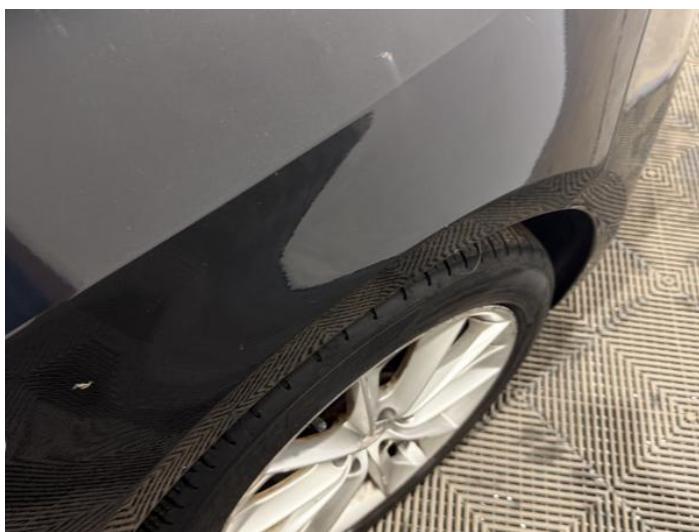
17: Wing osf
Chipped
Multiple Chips

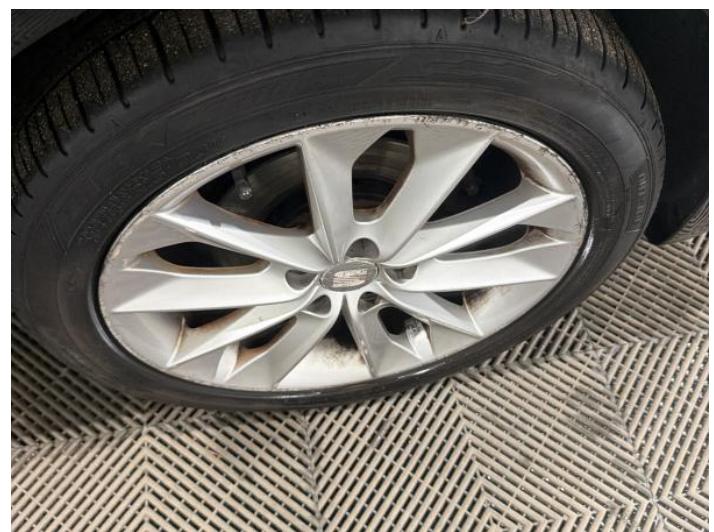
18: Wheel osf
Scratched
Over 50mm

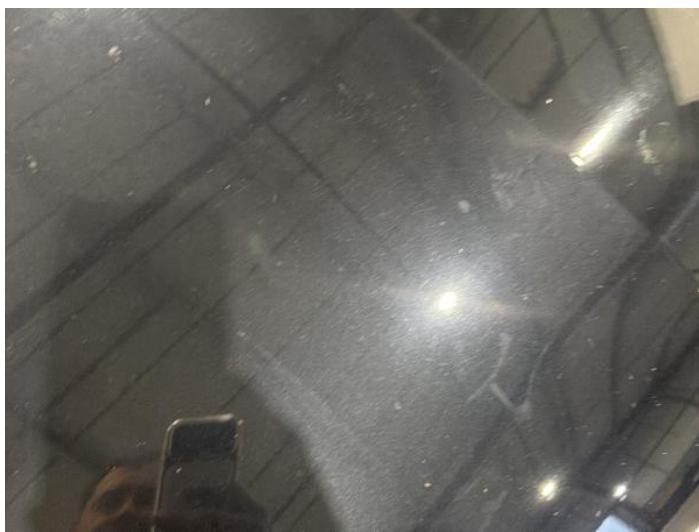
19: Bonnet
Chipped
Multiple Chips

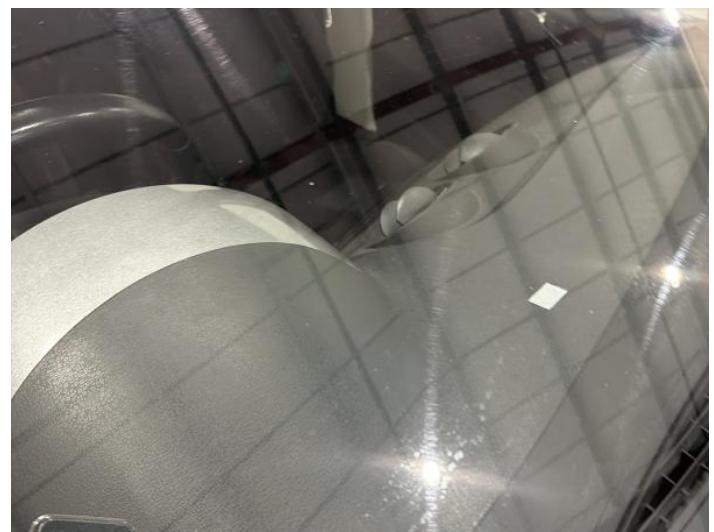
20: Screen Front
Chipped
UpTo 10mm

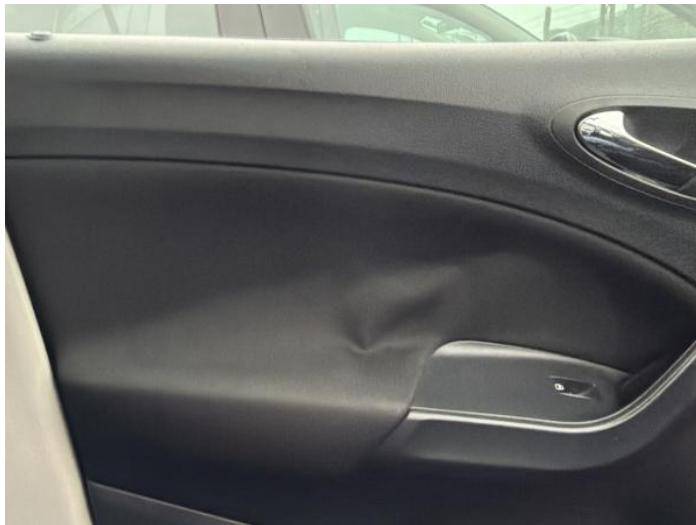
21: Door Pad nsf
Scuffed
Over 25mm

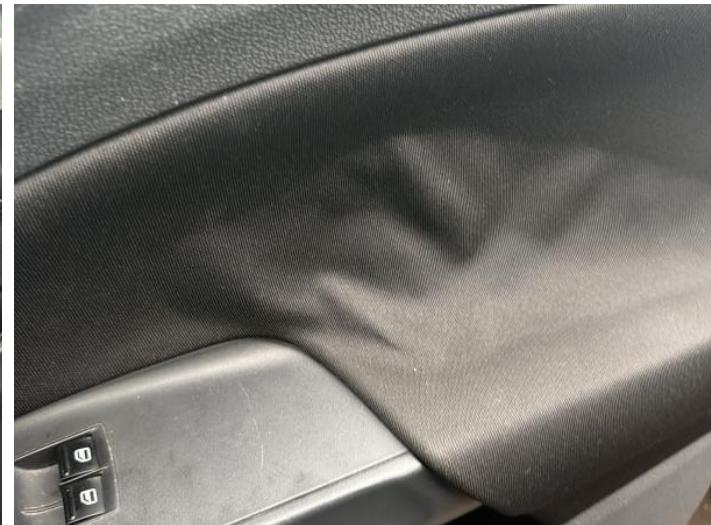
22: Door Pad osf
Scuffed
UpTo 25mm

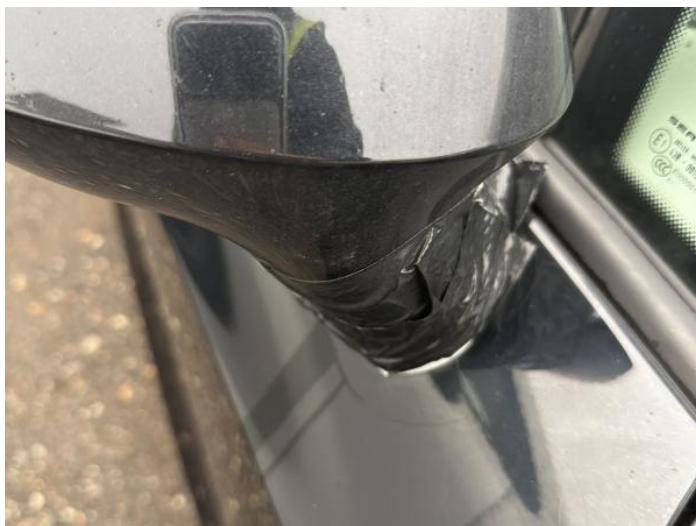
23: Door Mirror Assy osf
Broken
Replace
