VEHICLE INSPECTION REPORT

AF16UUL

Fiat 500 1.2 Pop 3dr

Cat: S

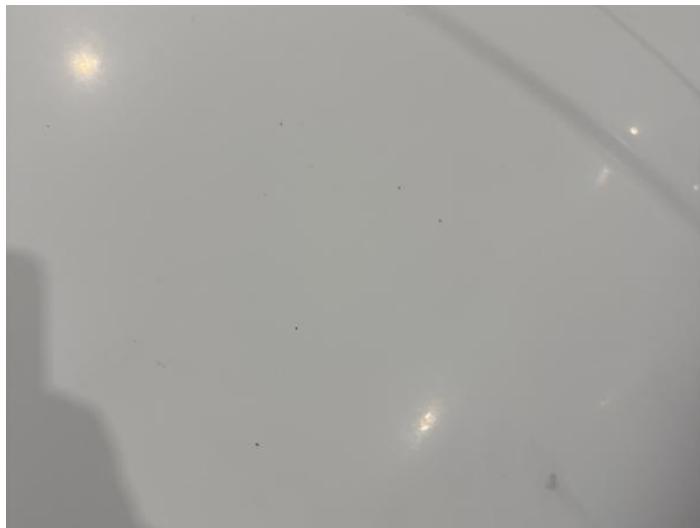
1: Bonnet
Chipped
Multiple Chips

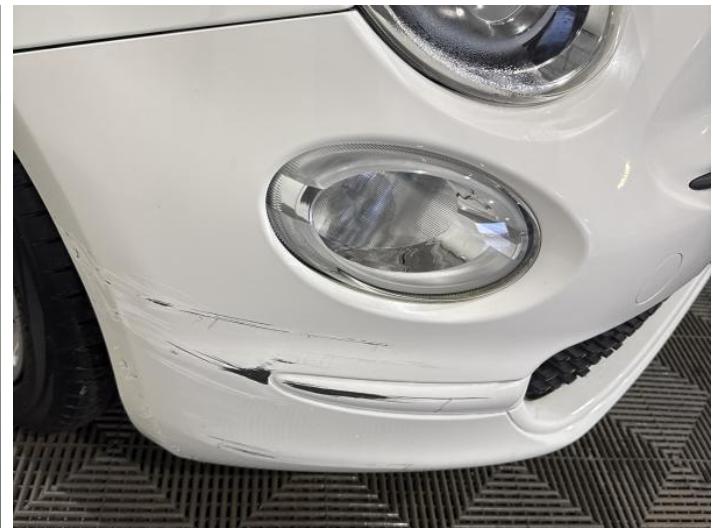
2: Bumper Front
Scratched
Over 100mm Thru Paint

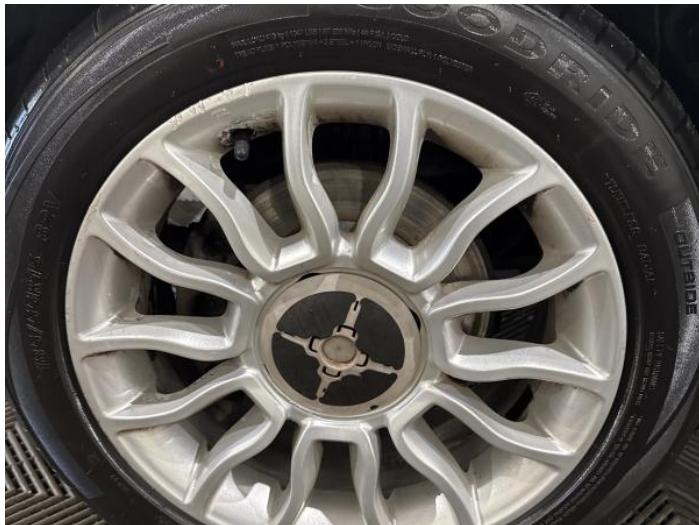
3: Wheel nsf
Scratched
Over 50mm

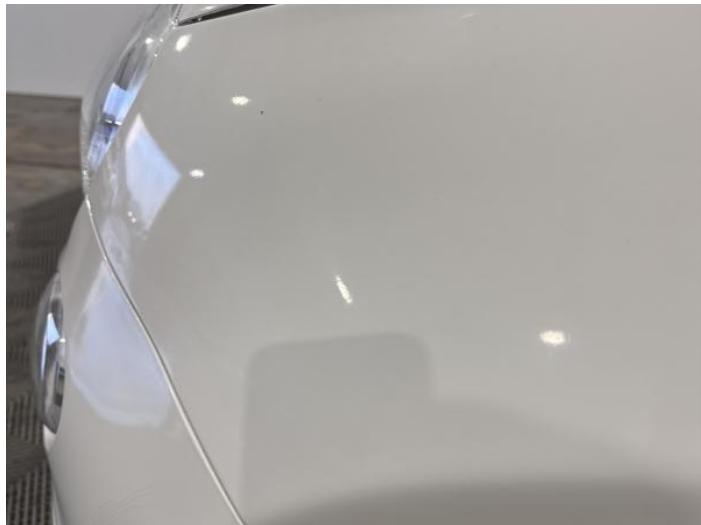
4: Wing nsf
Poor Previous Repair
Poor Paint

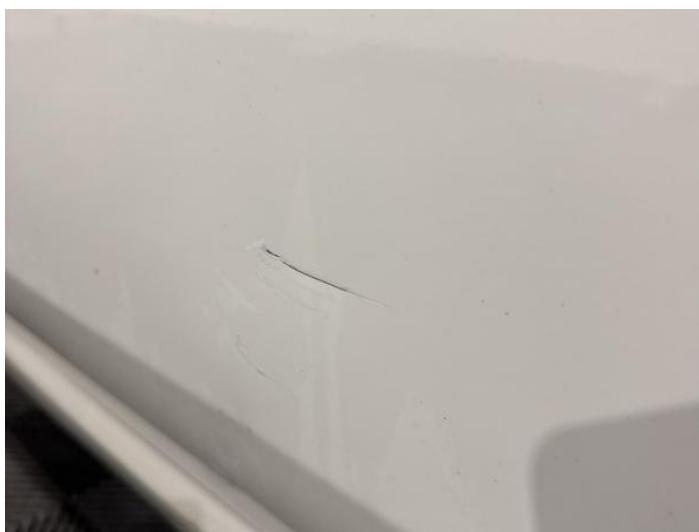
5: Door nsf
Scratched
Over 25mm Thru Paint

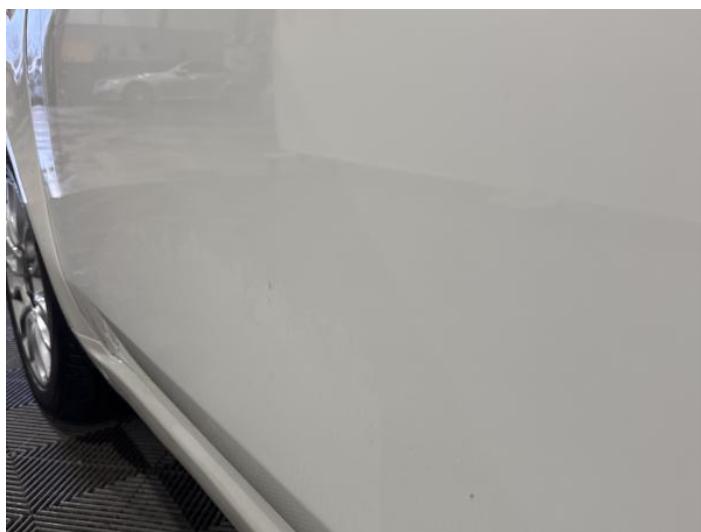
6: Door nsf
Dented
Over 30mm

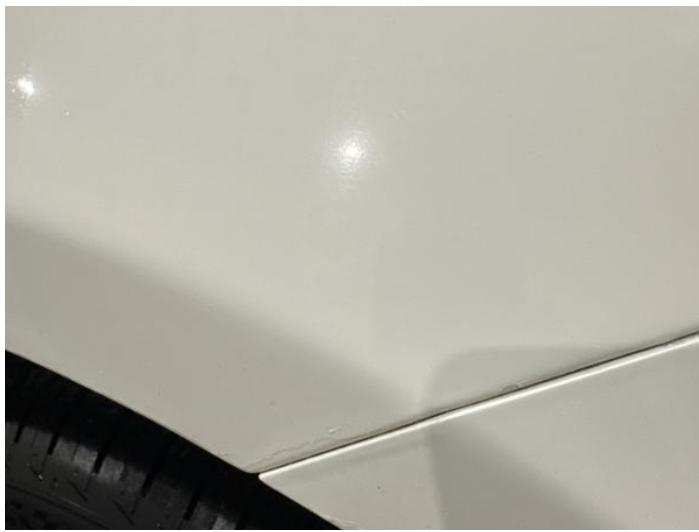
7: Qtr Panel nsr
Scratched
Over 25mm Thru Paint

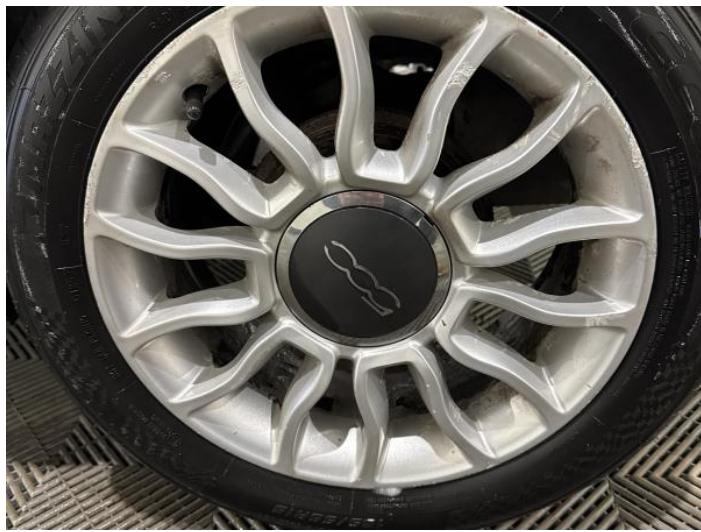
8: Wheel nsr
Scratched
Over 50mm

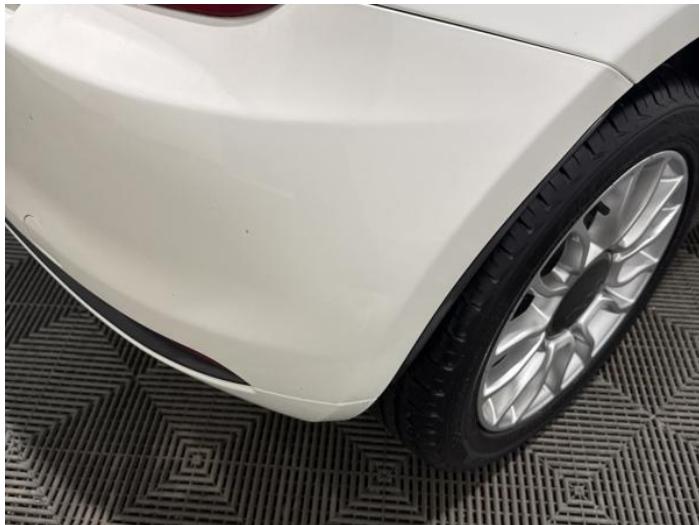
9: Bumper Rear
Scratched
Over 100mm Thru Paint

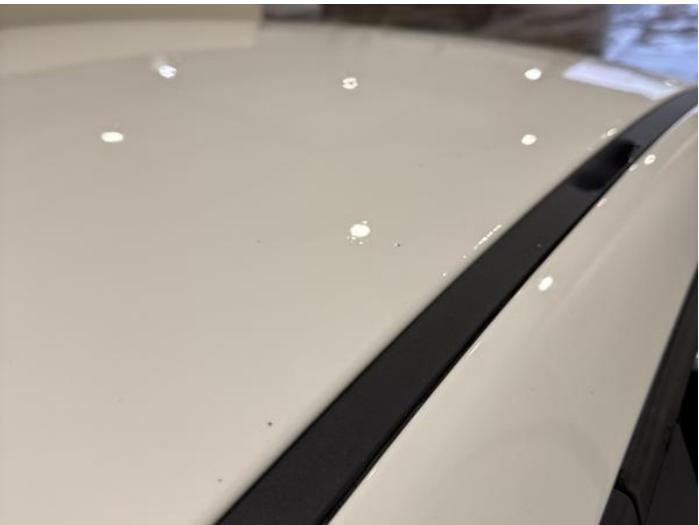
10: Roof
Dented
Over 30mm

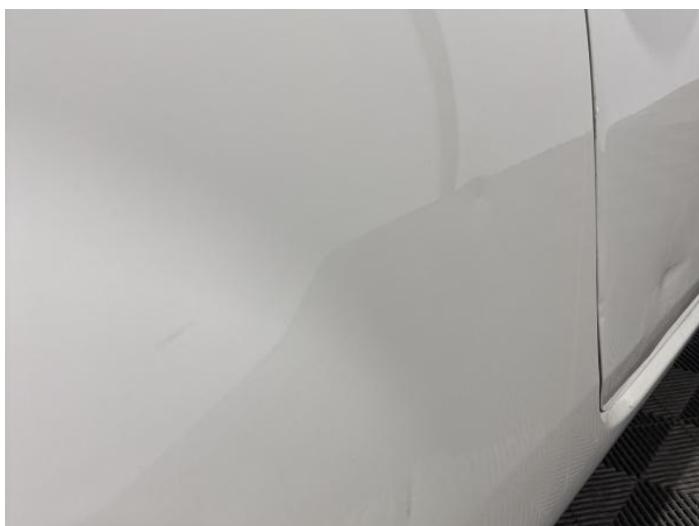
11: Qtr Panel osr
Dented
Between 10mm + 30mm

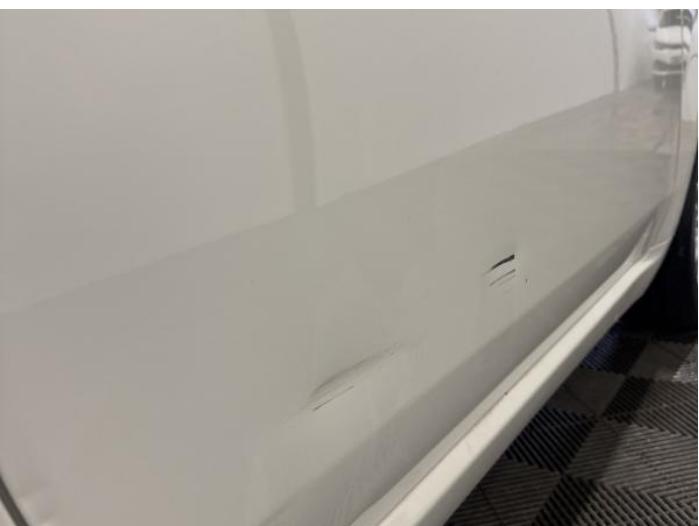
12: Door osr
Dented
With Paint Damage

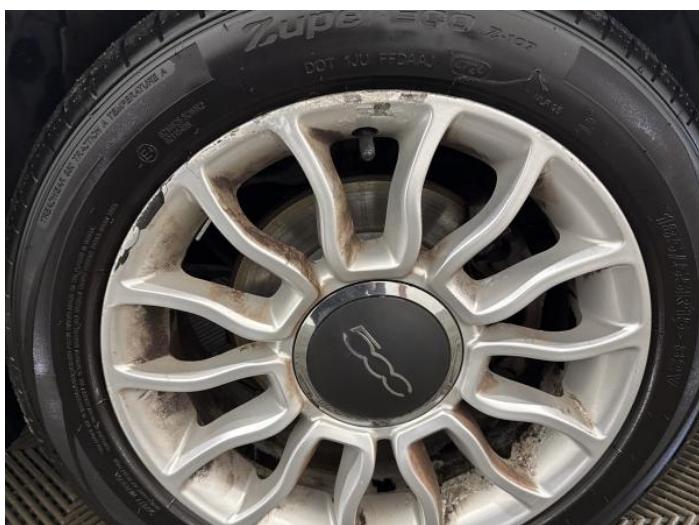
13: Wheel osr
Scratched
Over 50mm

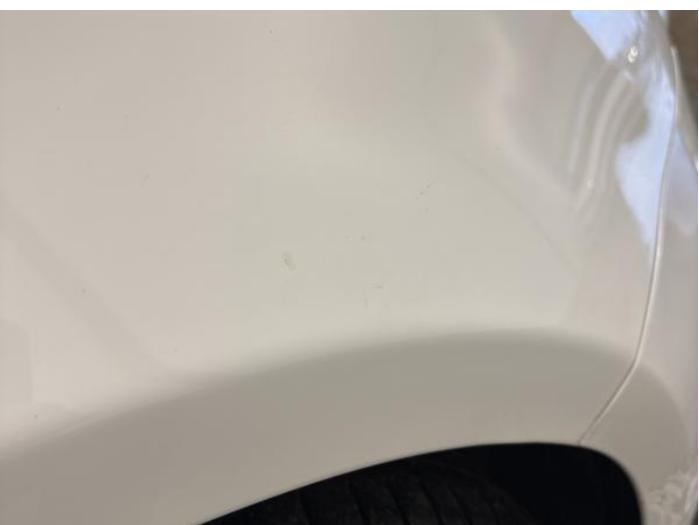
14: Wing osr
Scratched
UpTo 25mm Thru Paint

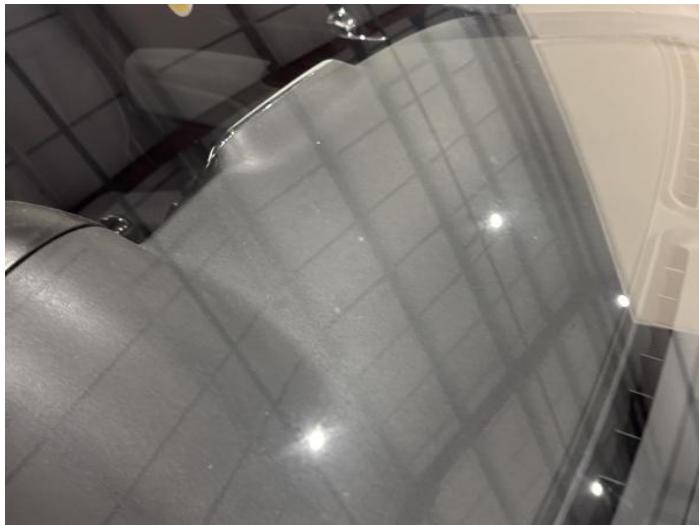
15: Screen Front
Chipped
UpTo 10mm
