# VEHICLE INSPECTION REPORT

**GX65UNL**

## Toyota Auris 1.2T Icon 5dr

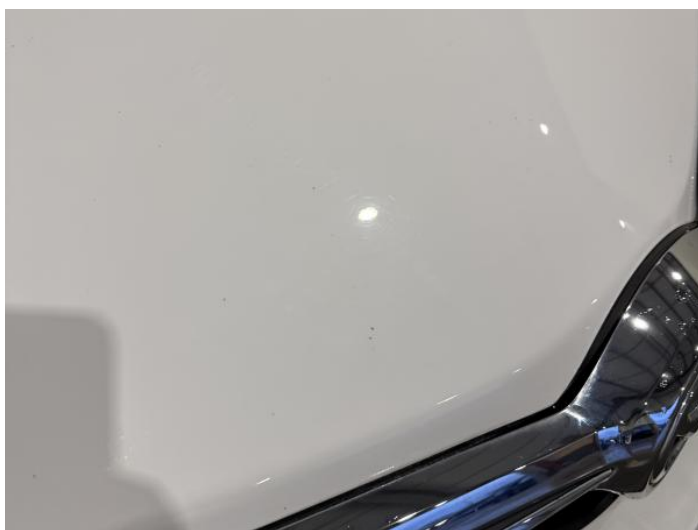
1: Bonnet  
Chipped  
Multiple Chips

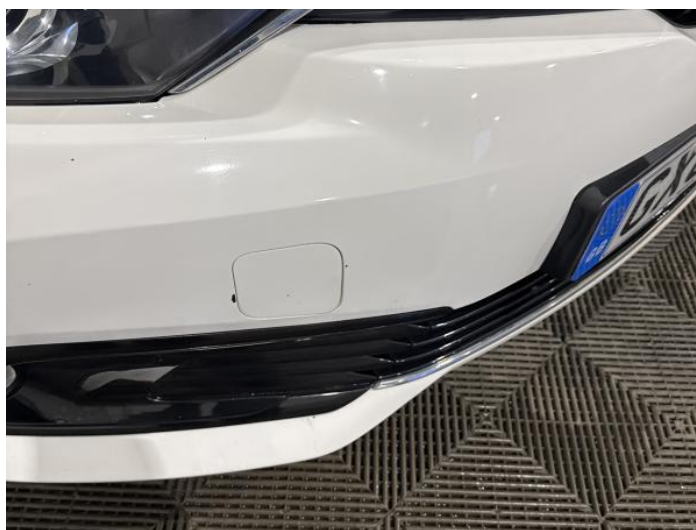
2: Bumper Front  
Chipped  
Multiple Chips

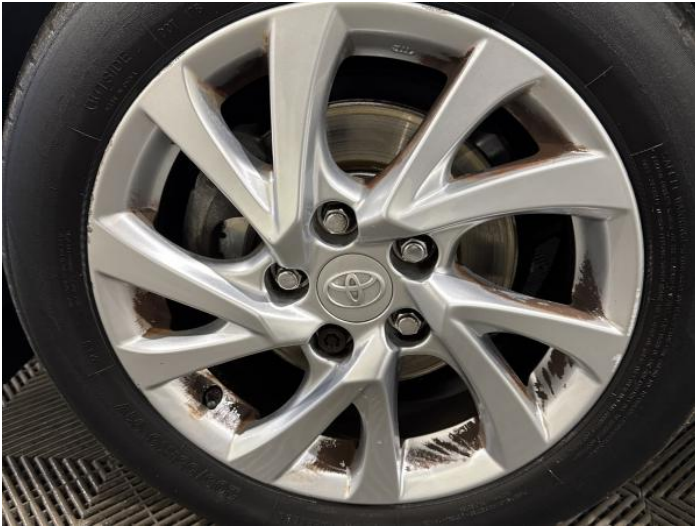
3: Wheel nsf  
Scratched  
Over 50mm

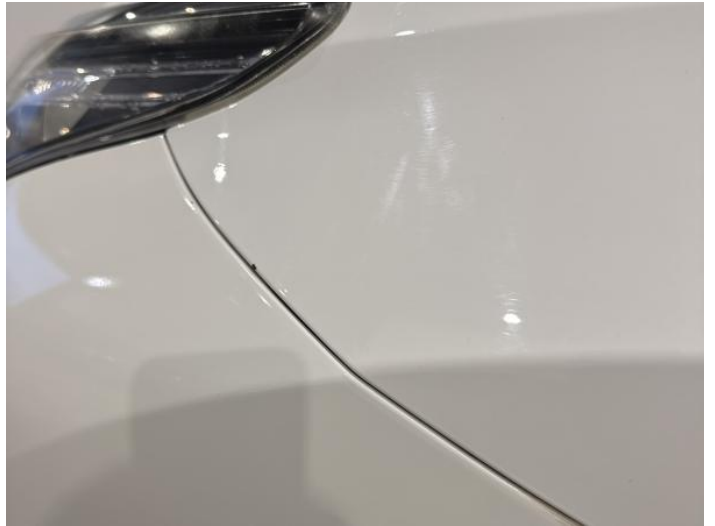
4: Wing nsf  
Chipped  
1 To 5

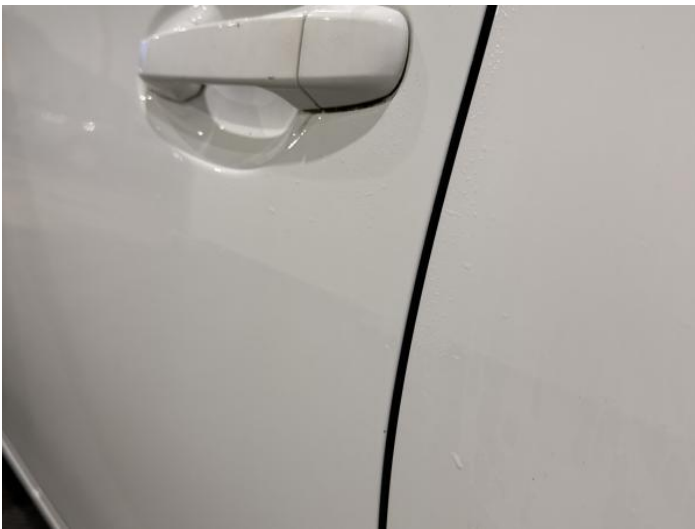
5: Door nsf  
Chipped  
Edge Chip

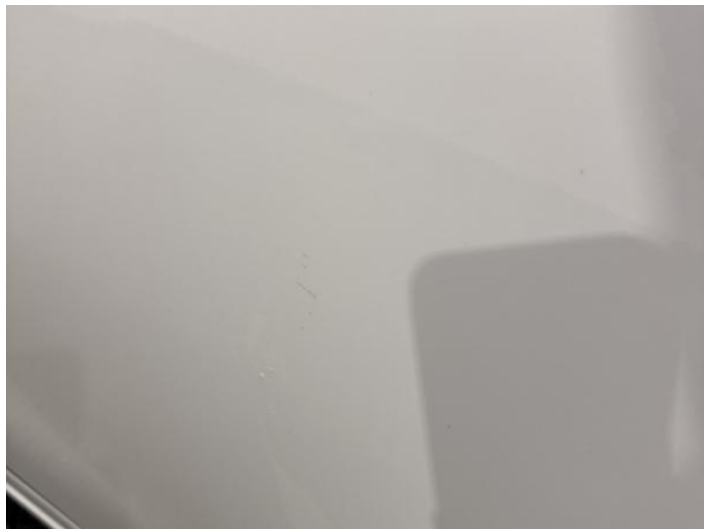
6: Door nsr  
Scratched  
Up To 25mm Thru Paint

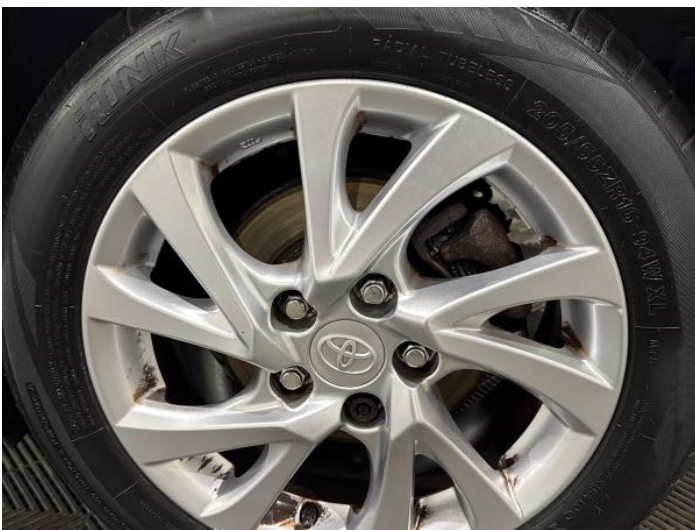
7: Wheel nsr  
Scratched  
Up To 50mm

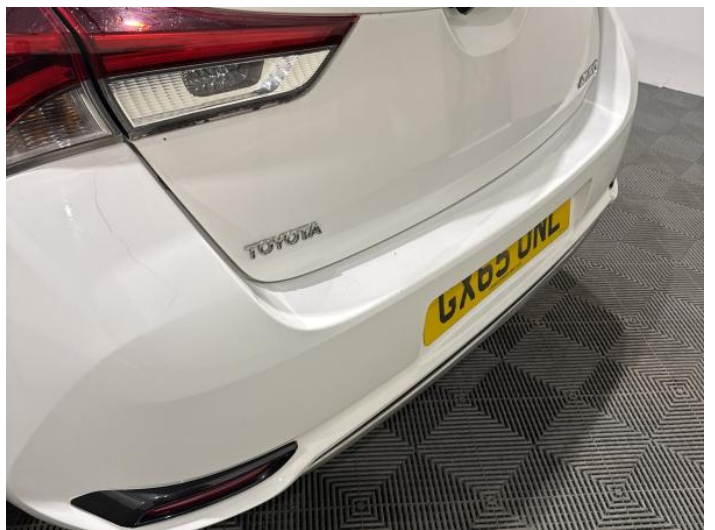
8: Bumper Rear  
Scratched  
25 to 100mm Thru Paint

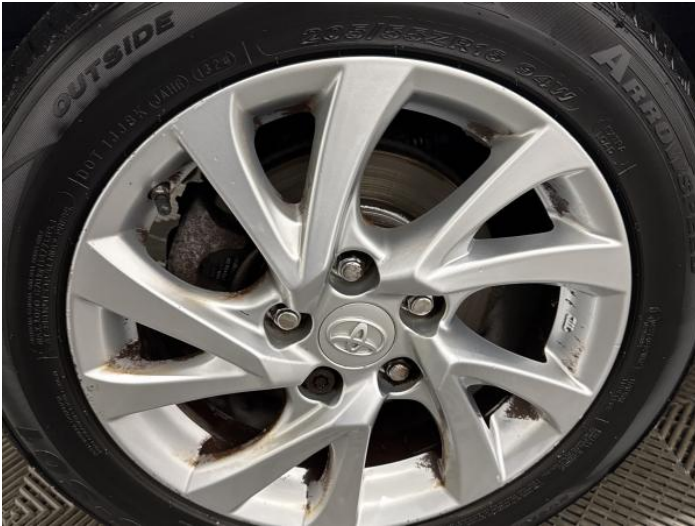
9: Wheel osr  
Scratched  
Over 50mm

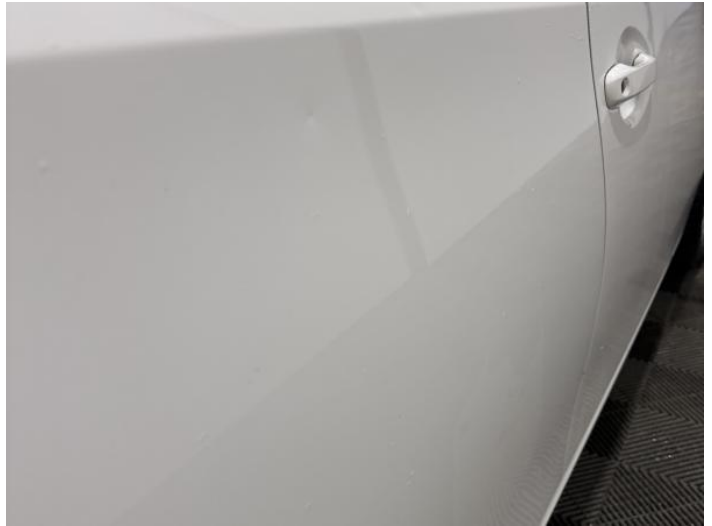
10: Door osr  
Dented  
Between 10mm + 30mm

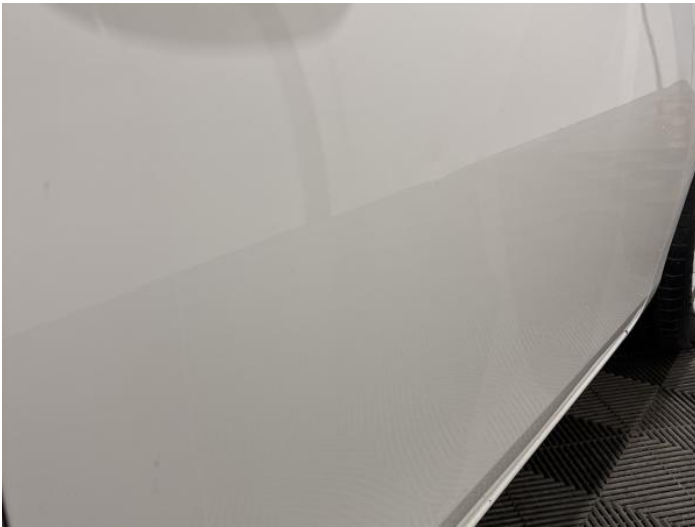
11: Door osf  
Dented  
Between 10mm + 30mm

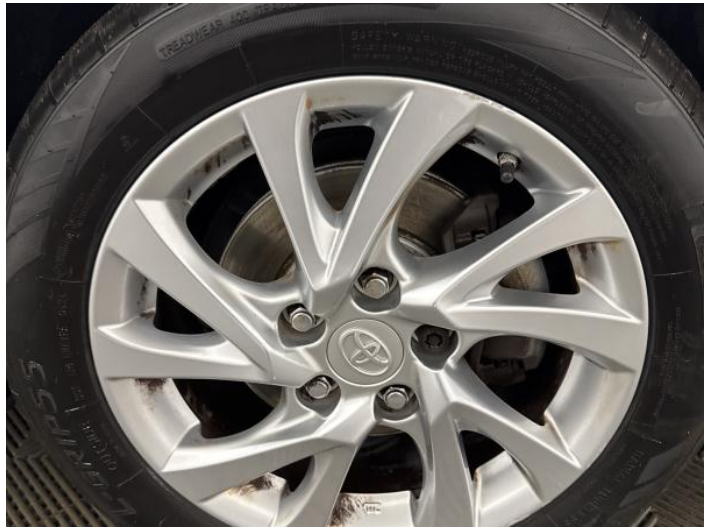
12: Wheel osf  
Scratched  
Over 50mm

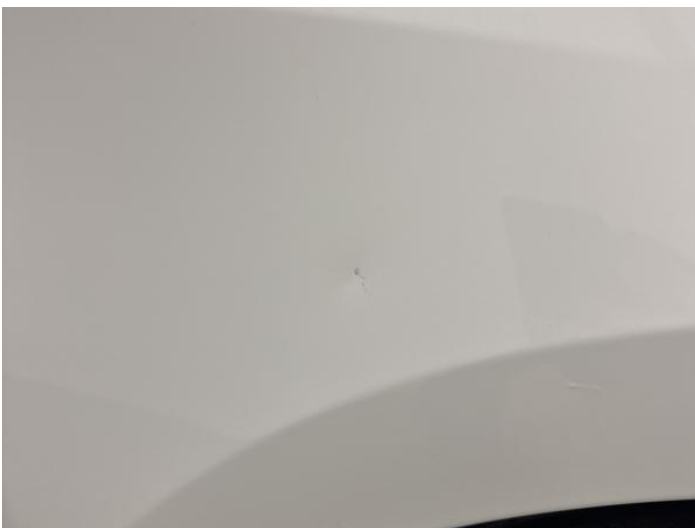
13: Wing osf  
Scratched  
UpTo 25mm Thru Paint
