# VEHICLE INSPECTION REPORT

DG70EPF

## Audi A3 35 TFSI S Line 5dr

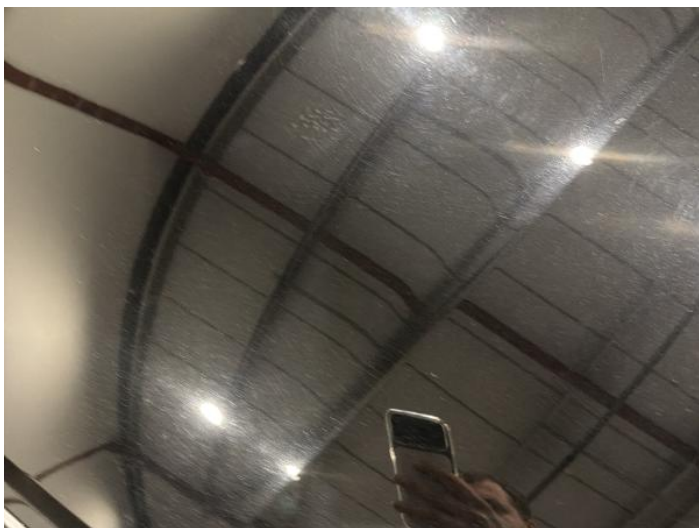
1: Bonnet  
Chipped  
1 To 5

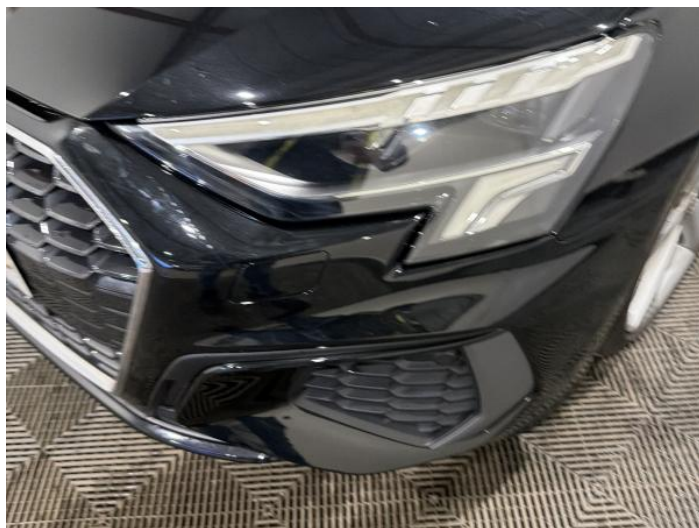
2: Bumper Front  
Chipped  
Multiple Chips

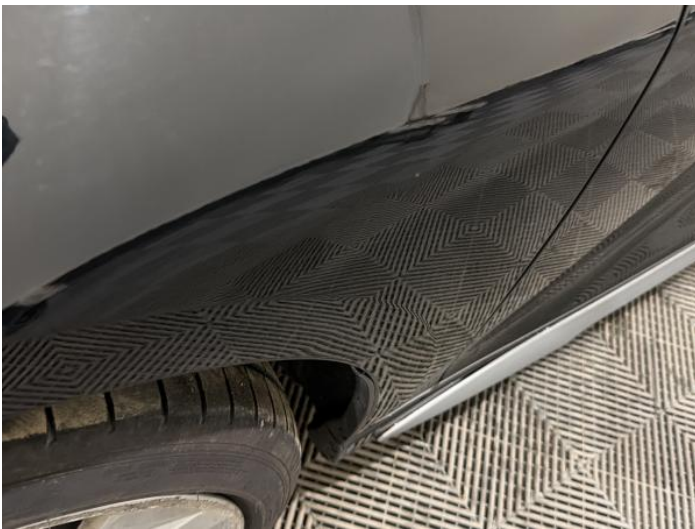
5: Wing nsf  
Dented  
Over 2 UpTo 10mm

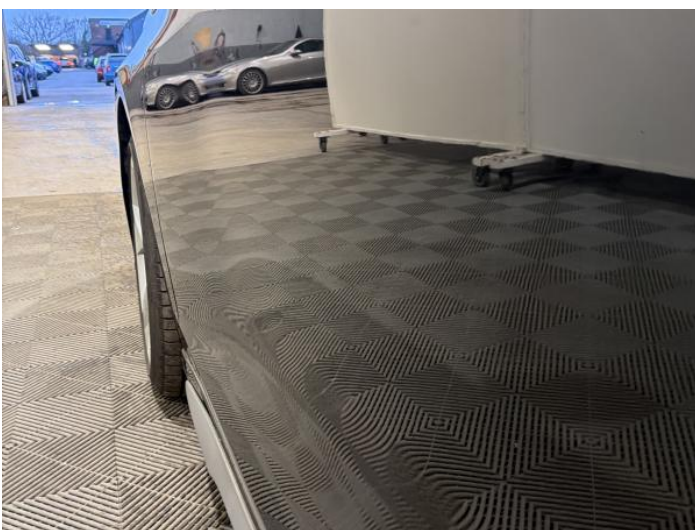
7: Door nsf  
Dented  
2 Or Less UpTo 10mm

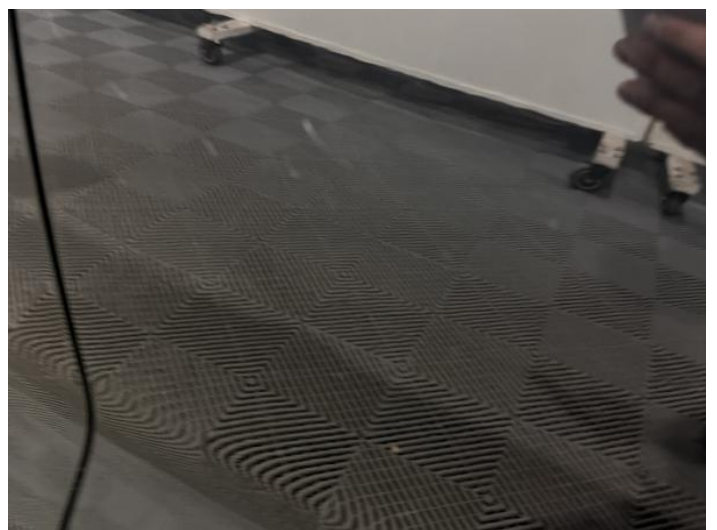
8: Door nsr  
Chipped  
1 To 5

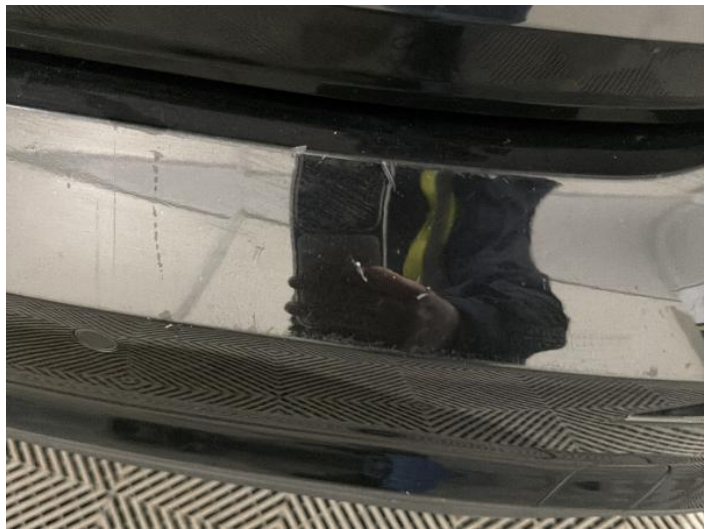
11: Qtr Panel nsr  
Scratched  
Over 25mm Not Thru Paint

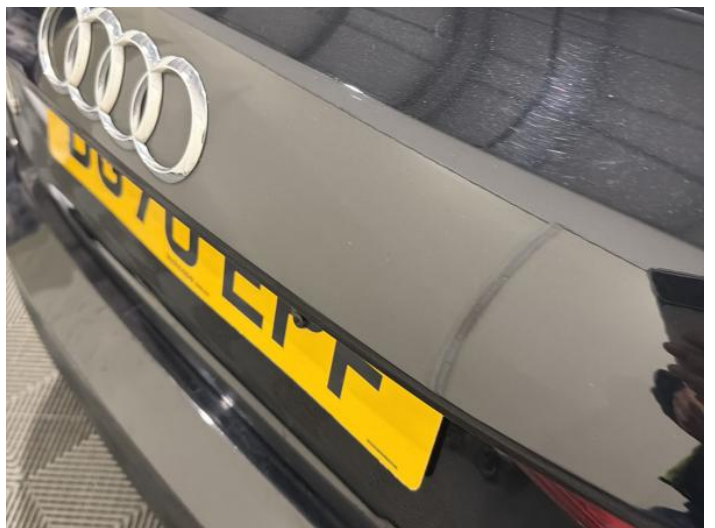
13: Bumper Rear  
Scratched  
Over 25mm Not Thru Paint

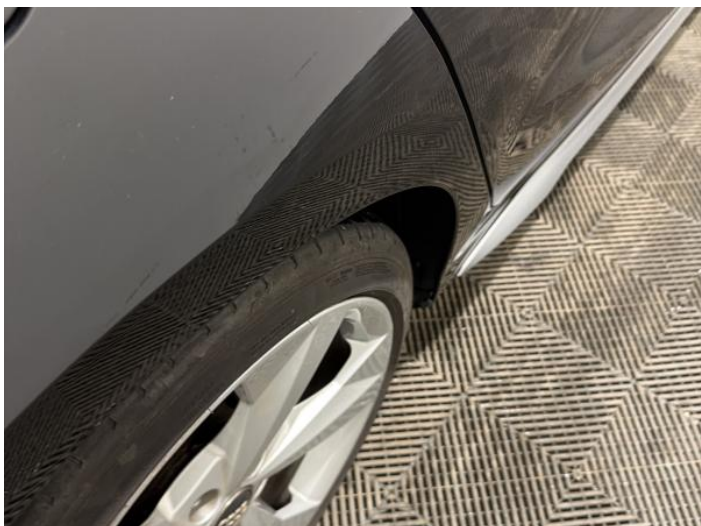
15: Qtr Panel osr  
Dented  
2 Or Less UpTo 10mm

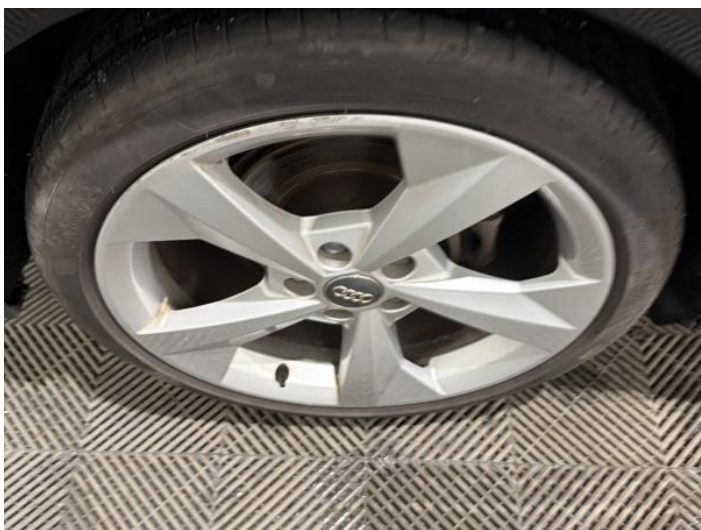
17: Wheel osr  
Scratched  
Over 50mm

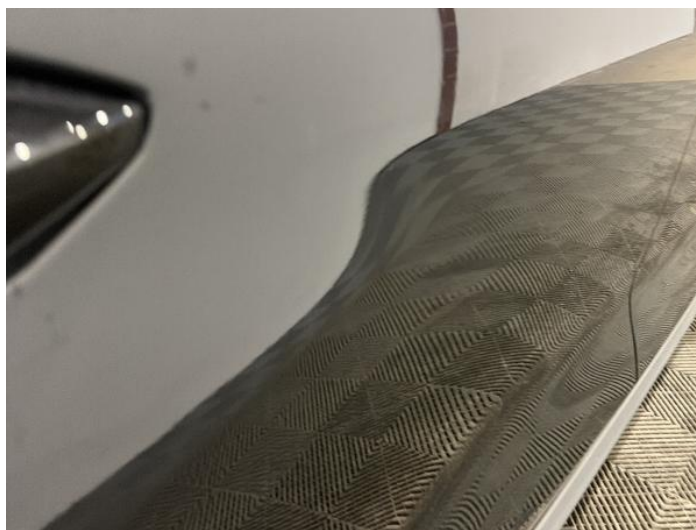
18: Door osr  
Poor Previous Repair  
Poor Paint

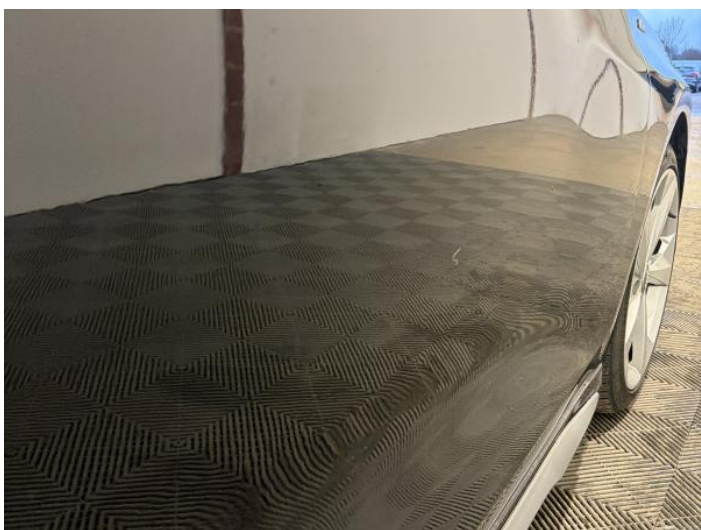
19: Door osf  
Poor Previous Repair  
Poor Paint

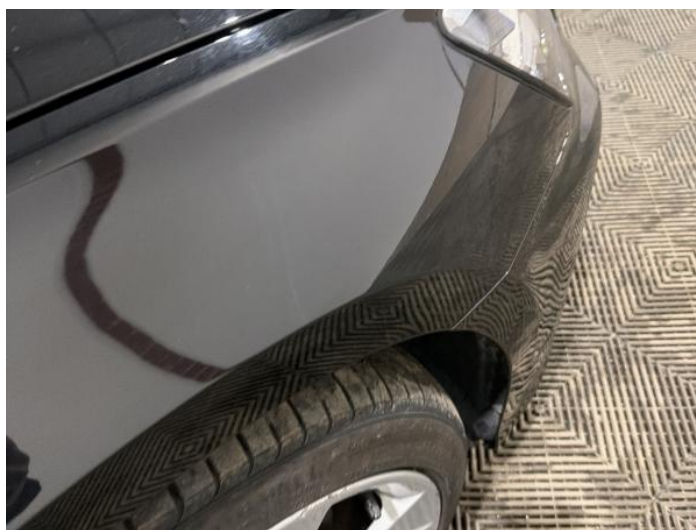
20: Wing osf  
Chipped  
1 To 5
