VEHICLE INSPECTION REPORT

GD17SFU

Land Rover Range Rover Evoque 2.0 eD4 SE Tech 5dr 2WD

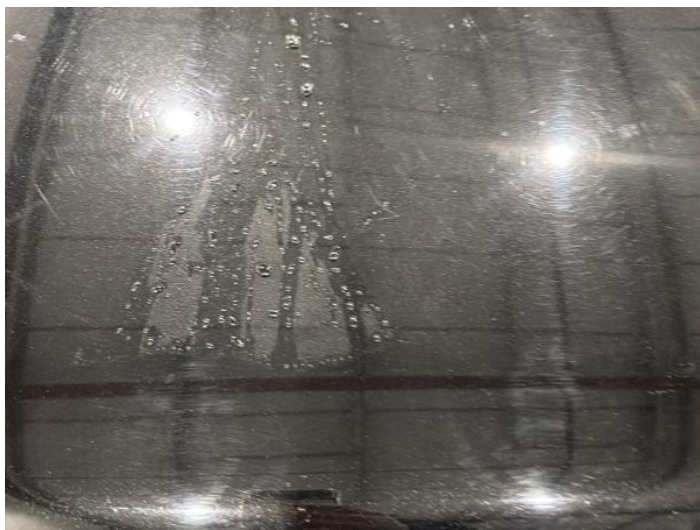
1: Bonnet
Chipped
1 To 5

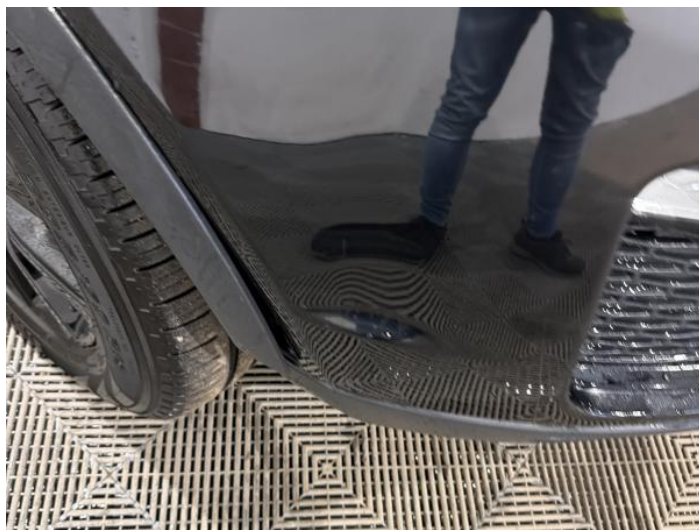
2: Wing Front Arch Extension os
Broken
Replace

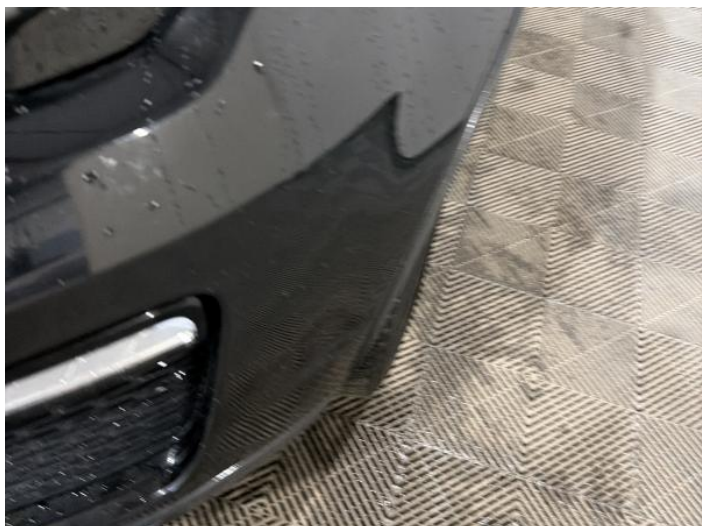
3: Bumper Front
Chipped
Multiple Chips

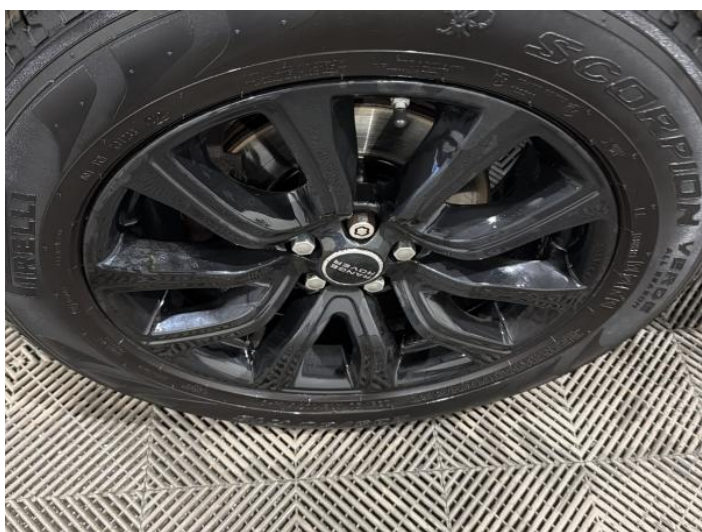
5: Wheel nsf
Scratched
Up To 50mm

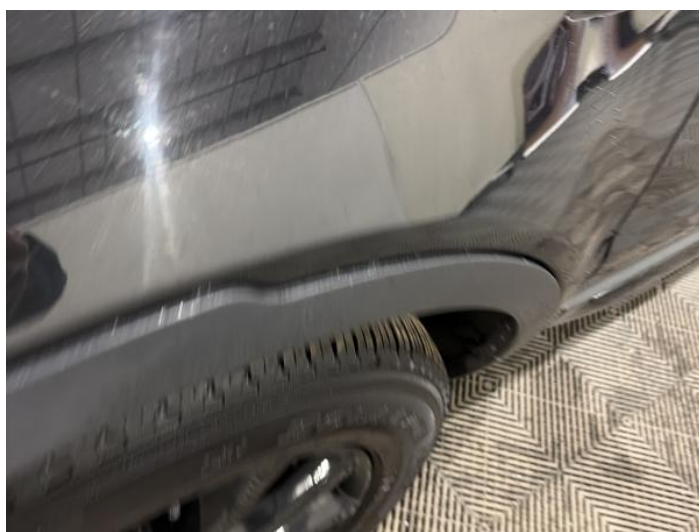
6: Wing nsf
Chipped
1 To 5

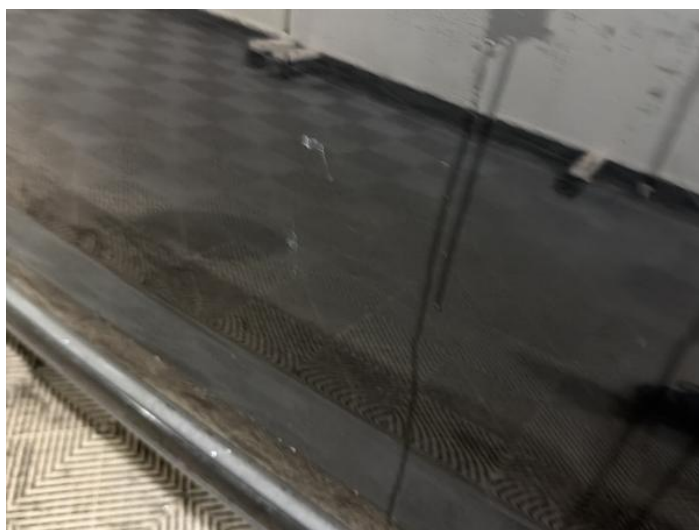
8: Door nsf
Chipped
Multiple Chips

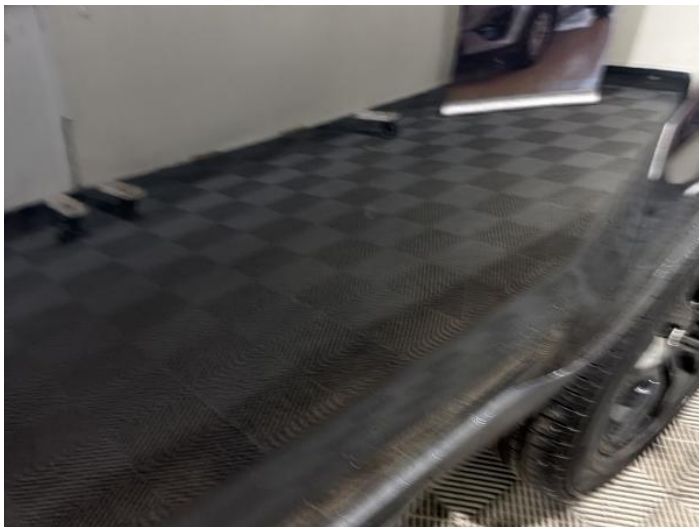
9: Door nsr
Poor Previous Repair
Poor Paint

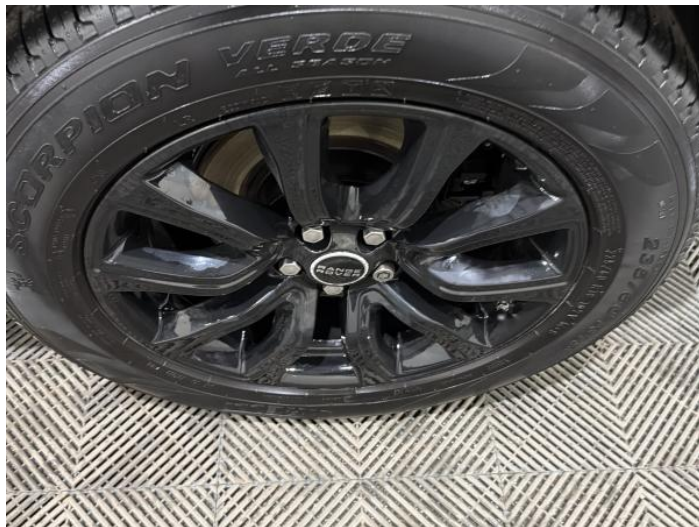
10: Wheel nsr
Scratched
Up To 50mm

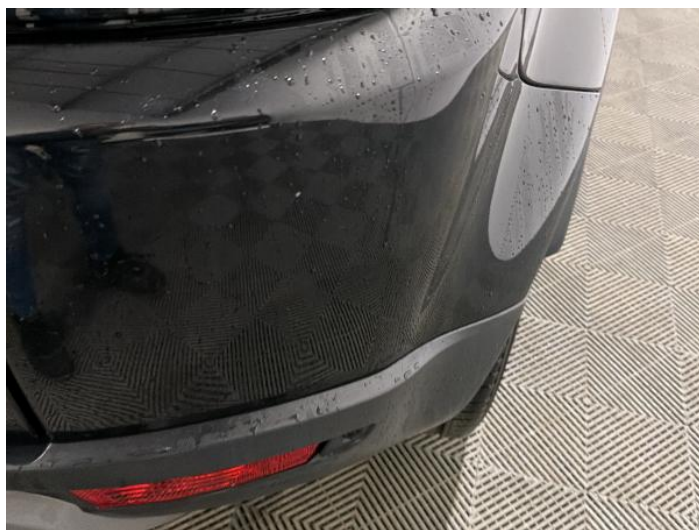
12: Bumper Rear
Chipped
Multiple Chips

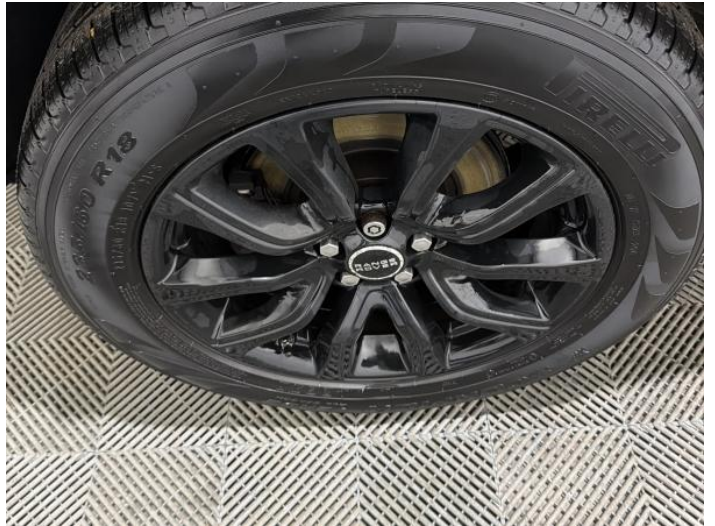
15: Qtr Panel osr
Scratched
Over 25mm Not Thru Paint

16: Wheel osr
Scratched
Up To 50mm

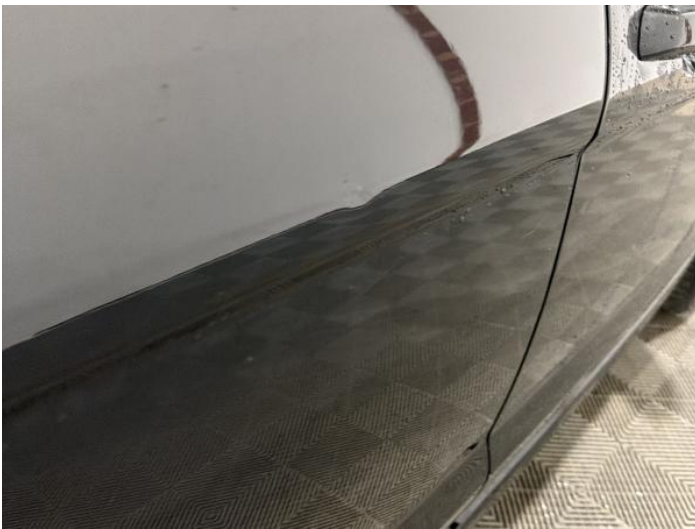
17: Door osr
Dented
Between 10mm + 30mm

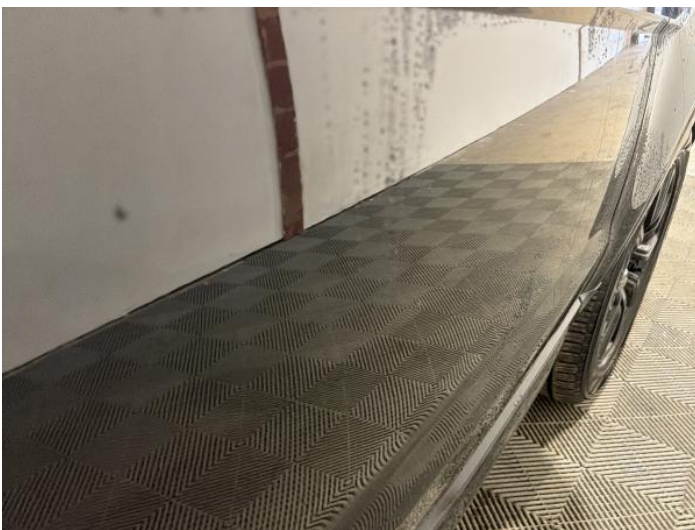
19: Door osf
Chipped
1 To 5

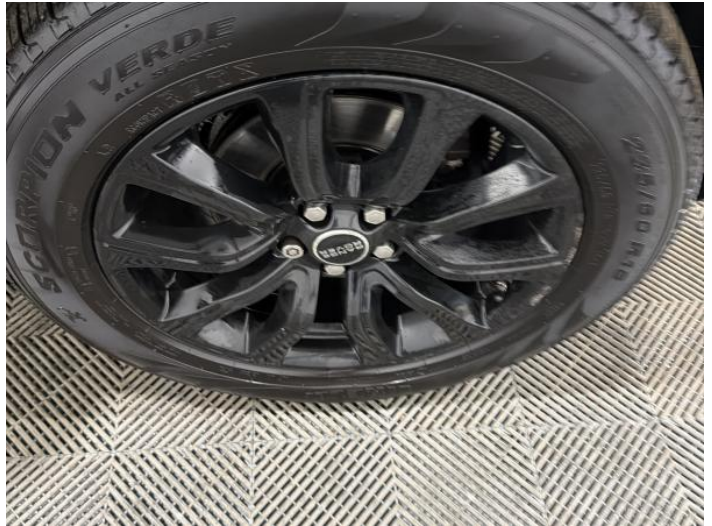
21: Wing osf
Scratched
Over 25mm Not Thru Paint

22: Wheel osf
Scratched
Over 50mm

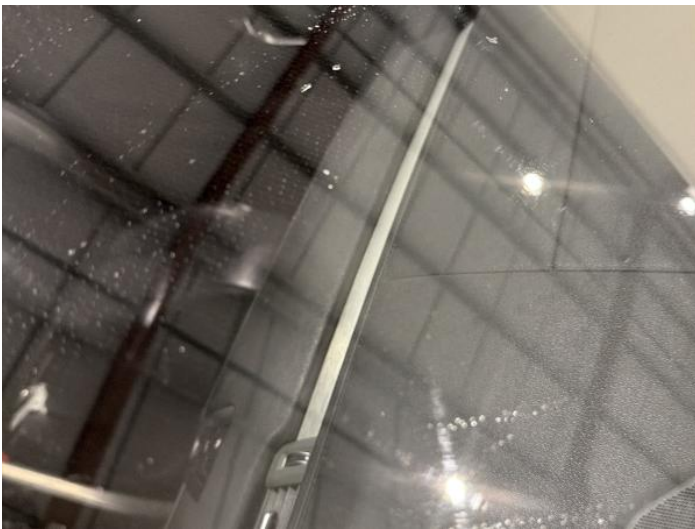
23: Screen Front
Chipped
UpTo 10mm
