VEHICLE INSPECTION REPORT

KT16NUW

Peugeot 308 2.0 BlueHDi 150 GT Line 5dr EAT6

nama
GRADE
3

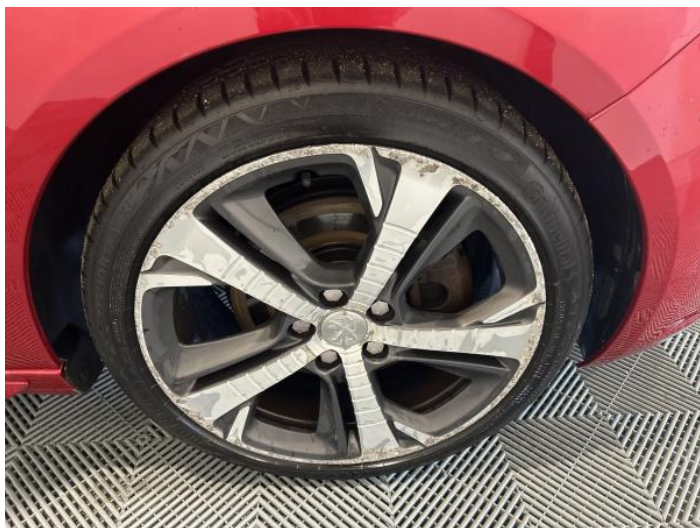
1: Wheel osf
Scratched
Over 50mm

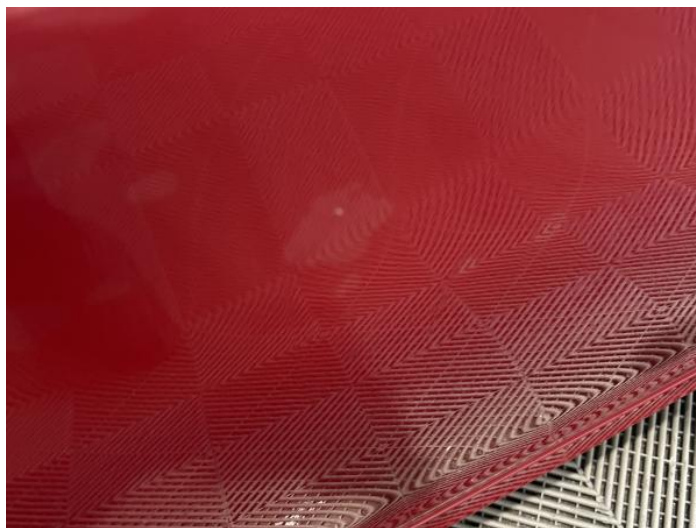
2: Door osf
Chipped
1 To 5

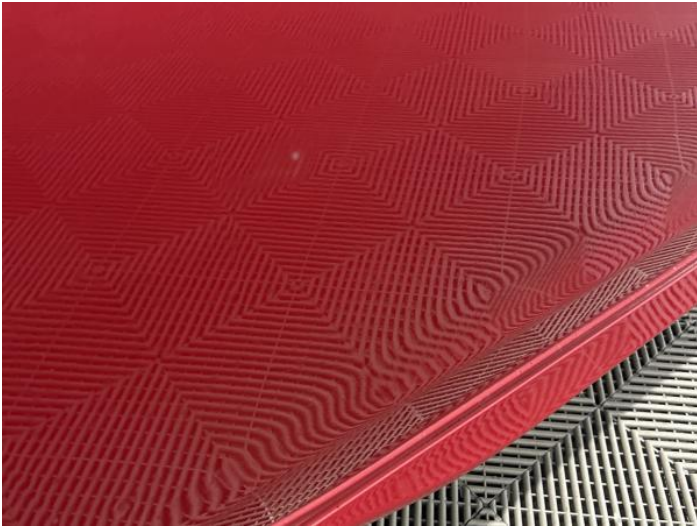
3: Door osr
Chipped
1 To 5

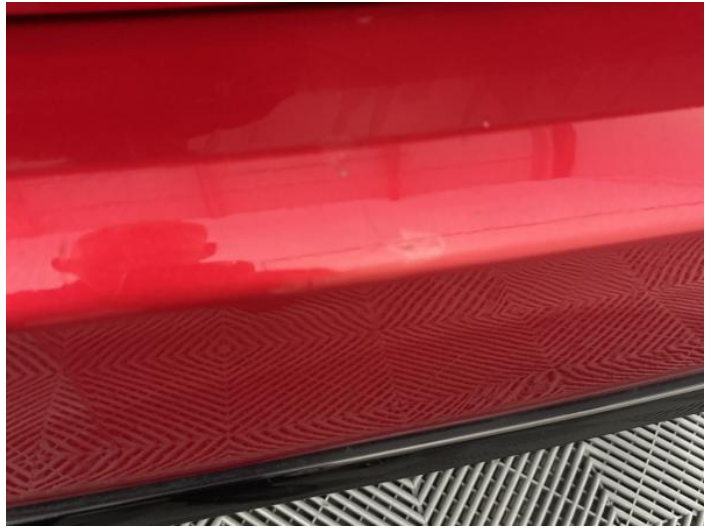
4: Bumper Rear
Chipped
1 To 5

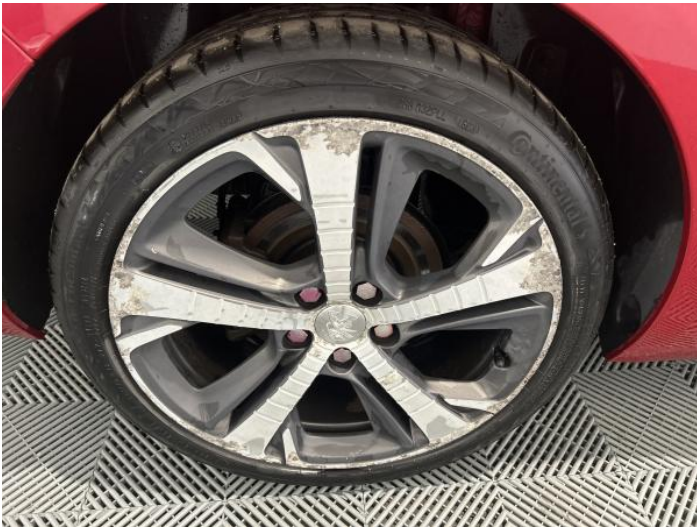
5: Wheel osr
Scratched
Over 50mm

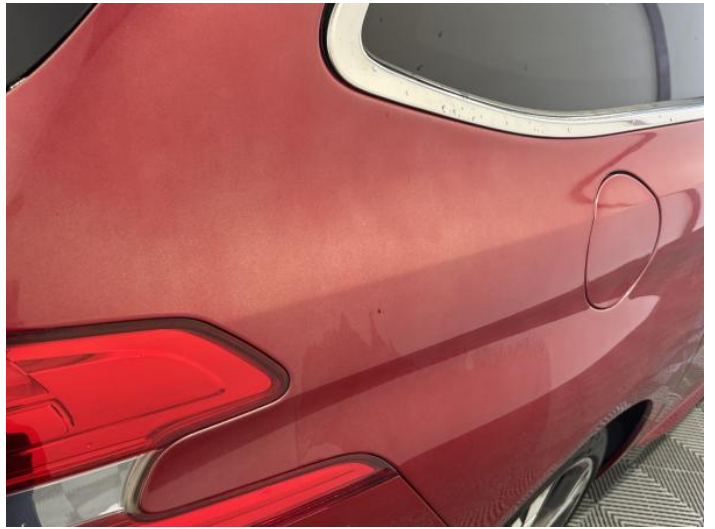
6: Qtr Panel osr
Poor Previous Repair
Poor Colour

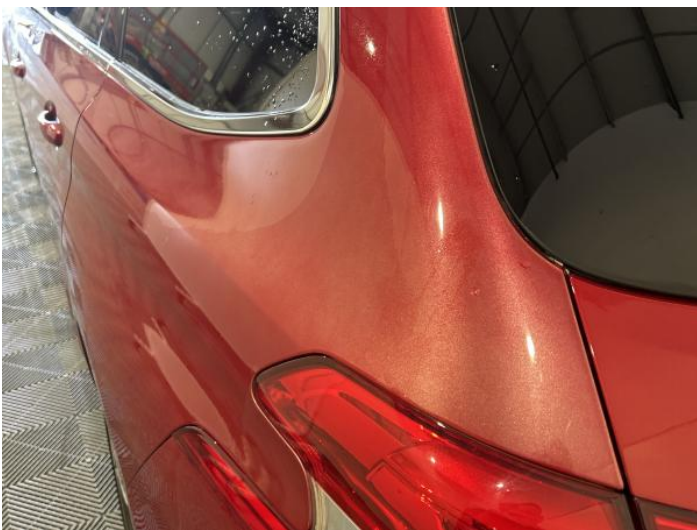
7: Qtr Panel nsr
Poor Previous Repair
Poor Colour

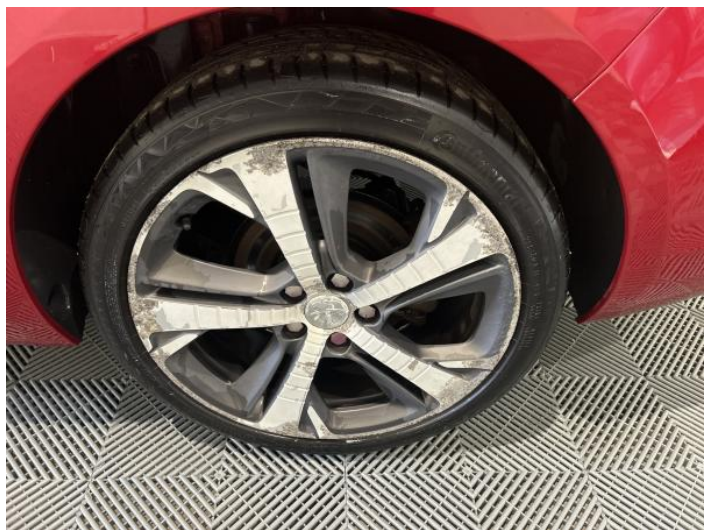
8: Wheel nsr
Scratched
Over 50mm

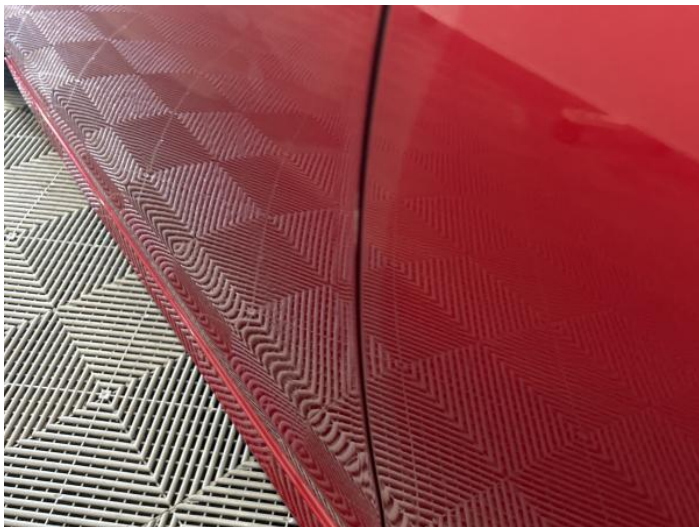
9: Door nsf
Chipped
Edge Chip

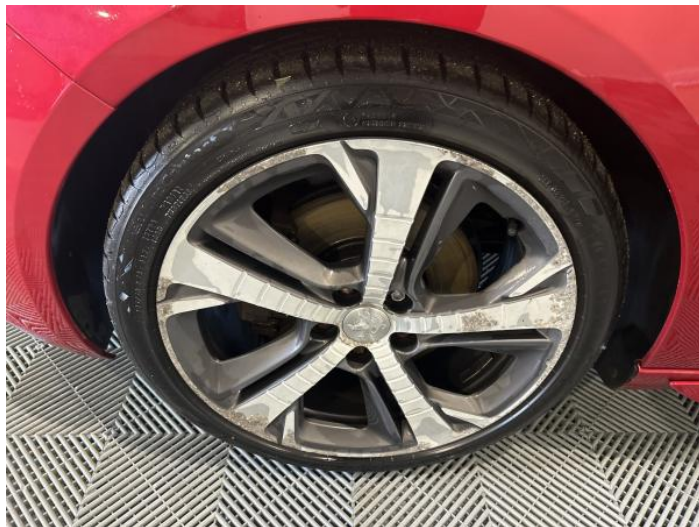
10: Wheel nsf
Scratched
Over 50mm

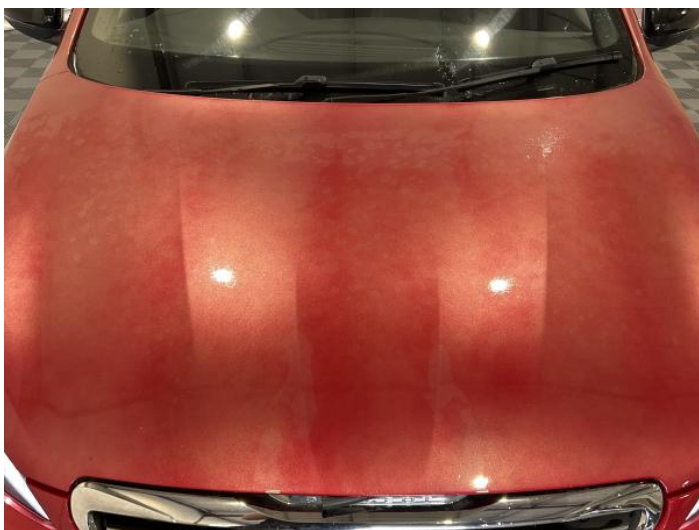
11: Bonnet
Poor Previous Repair
Poor Paint

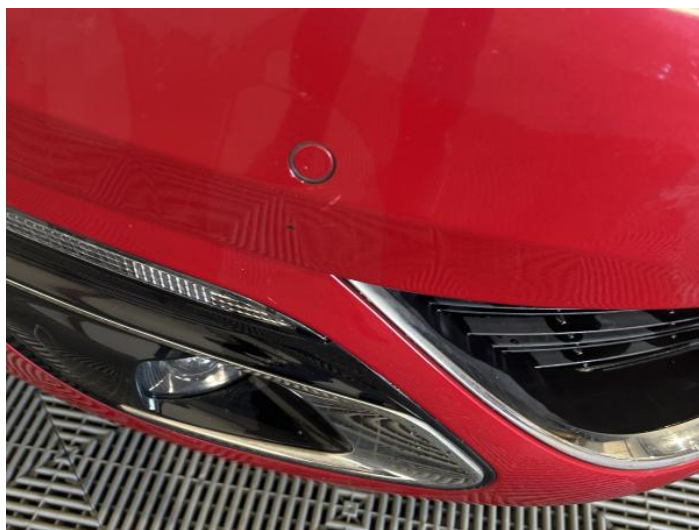
12: Bumper Front
Chipped
1 To 5

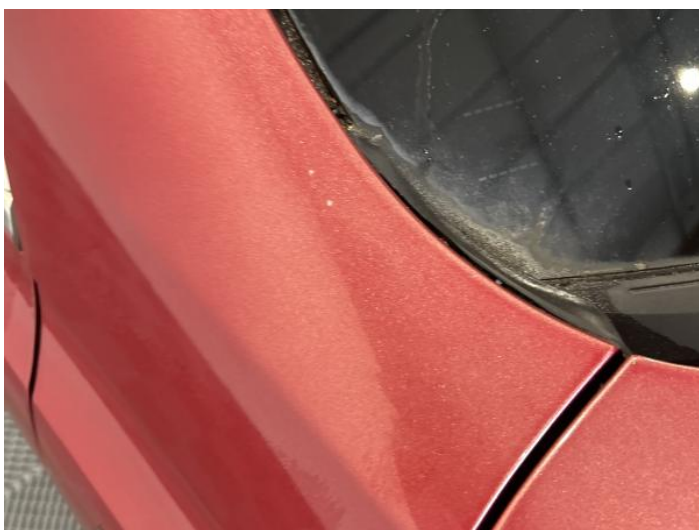
13: A Post os
Chipped
1 To 5
