VEHICLE INSPECTION REPORT

HX15XGB

Toyota Prius 1.8 VVTi Plug-in 5dr CVT Auto

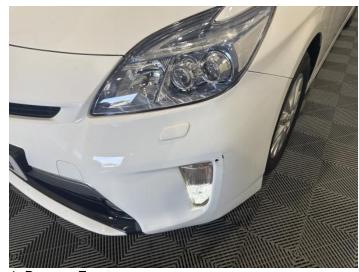
1: Bumper Front Scratched Over 100mm Thru Paint

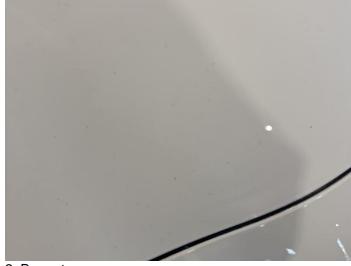
2: Bonnet Chipped Multiple Chips

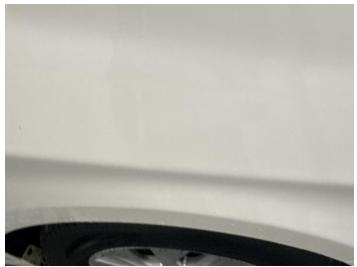
3: Wing osf Chipped 1 To 5

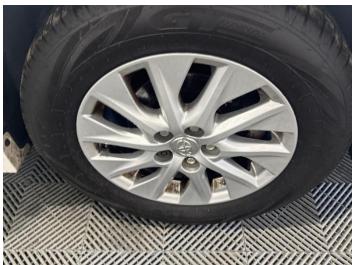
4: Wheel osf Scratched Over 50mm

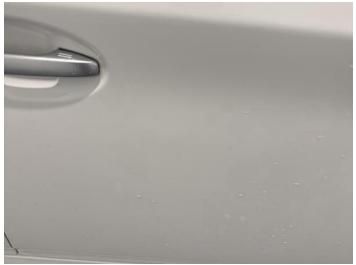
5: Door osf Chipped 1 To 5

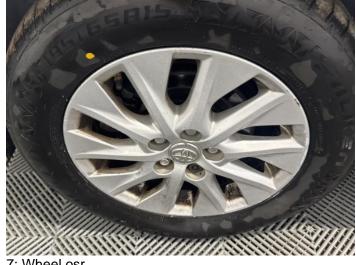
7: Wheel osr Scratched Over 50mm

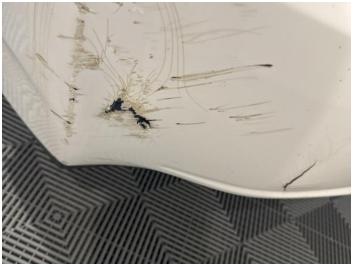
9: Bumper Rear Cracked UpTo 25mm

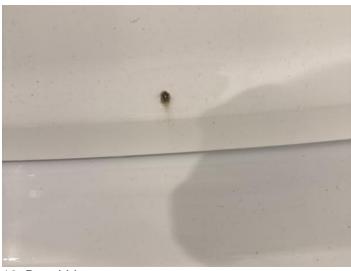
10: Boot Lid Chipped Over 5mm

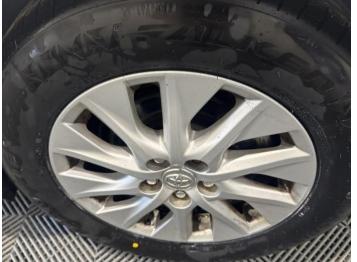
11: Wheel nsr Scratched Up To 50mm

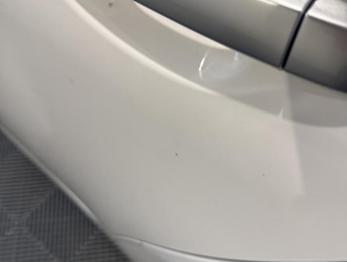
12: Door nsr Chipped 1 To 5

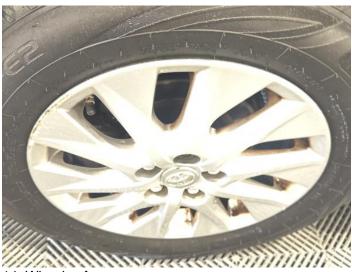
14: Wheel nsf Scratched Over 50mm
