VEHICLE INSPECTION REPORT

GY14UGA

Peugeot 308 1.6 HDi 92 Active 5dr

nama
GRADE
4

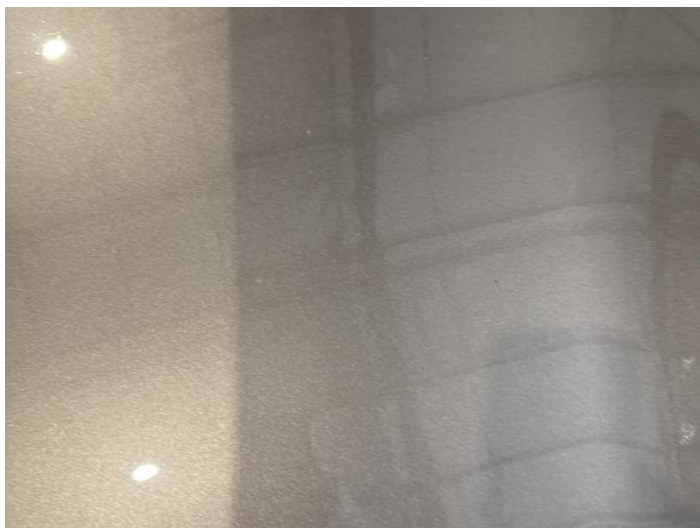
1: Bonnet
Chipped
1 To 5

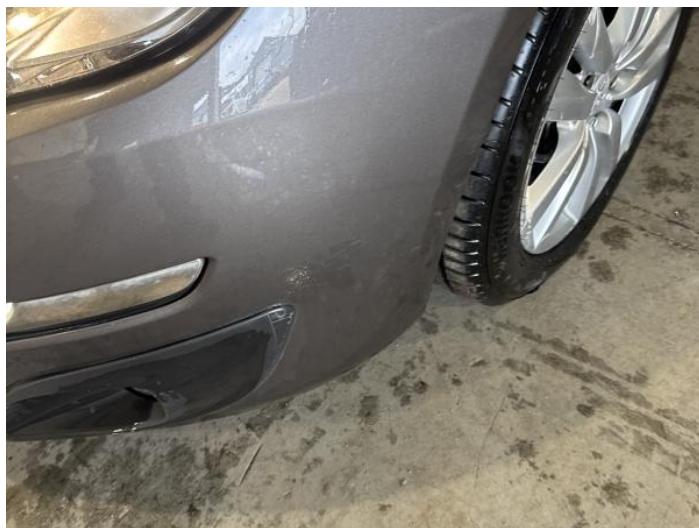
2: Bumper Front
Scratched
Over 100mm Thru Paint

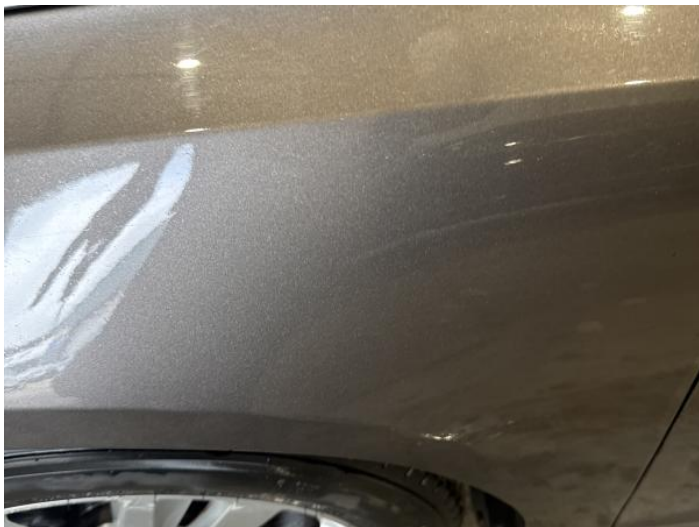
3: Wing nsf
Scratched
Over 25mm Not Thru Paint

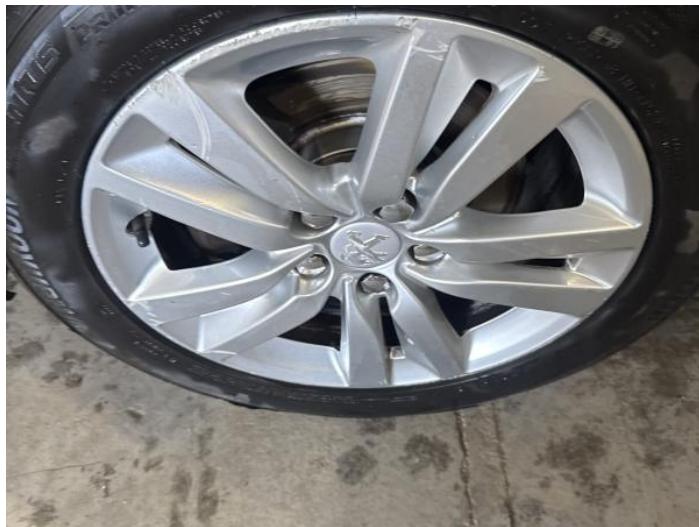
4: Wheel nsf
Scratched
Over 50mm

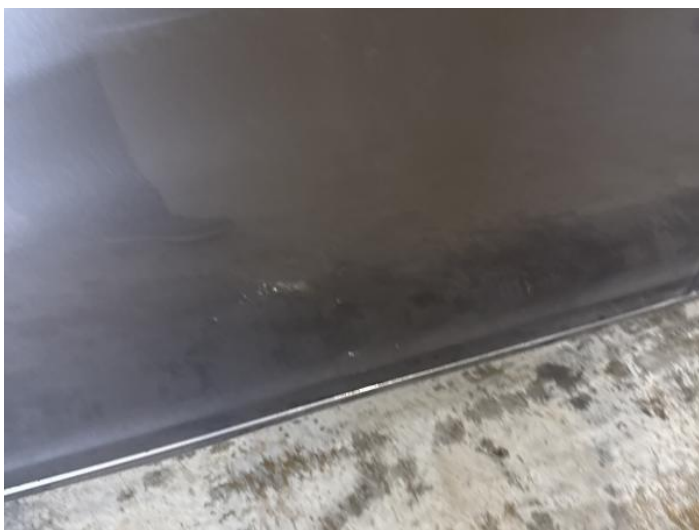
5: Door nsf
Scratched
UpTo 25mm Not Thru Paint

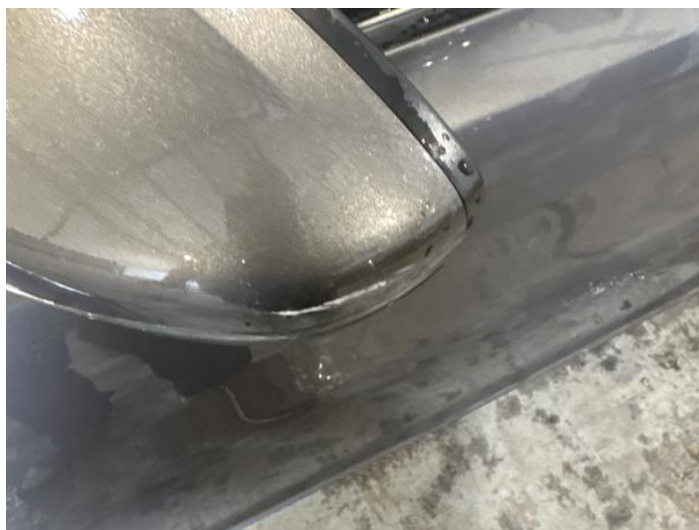
6: Door Mirror Assy nsf
Scratched (Painted)
Over 25mm Thru Paint

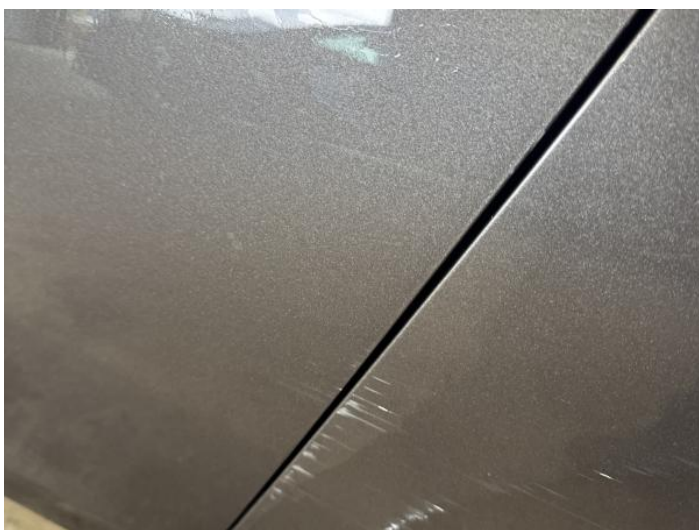
7: Door nsr
Scratched
Over 25mm Thru Paint

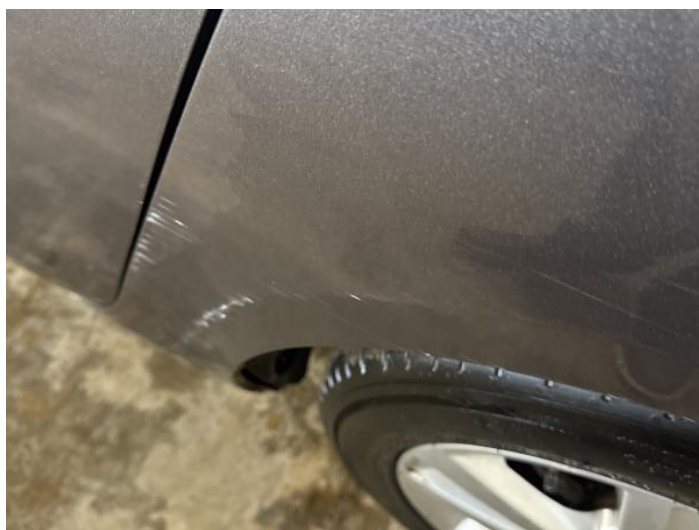
8: Qtr Panel nsr
Dented
With Paint Damage

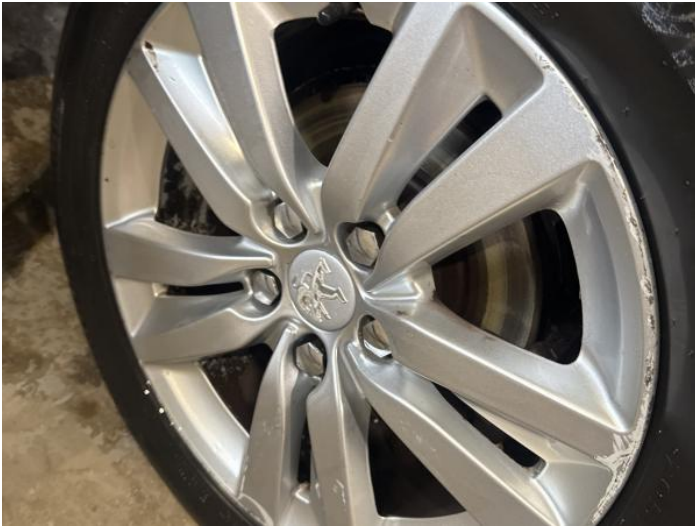
9: Wheel nsr
Scratched
Over 50mm

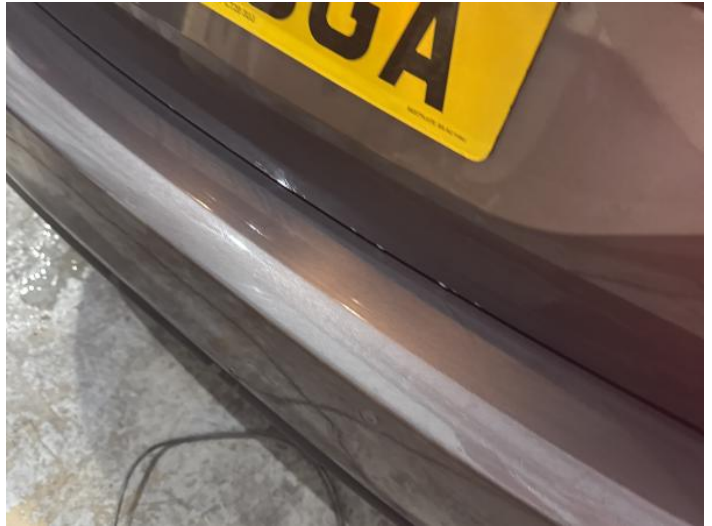
10: Bumper Rear
Scratched
25 to 100mm Thru Paint

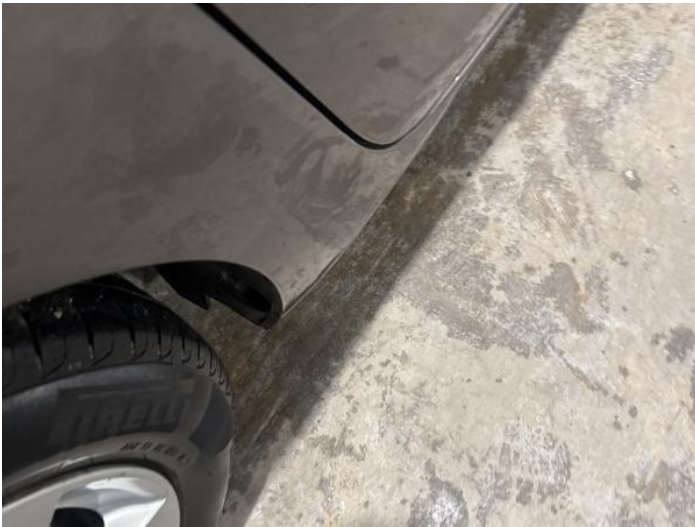
11: Qtr Panel osr
Dented
Over 30mm

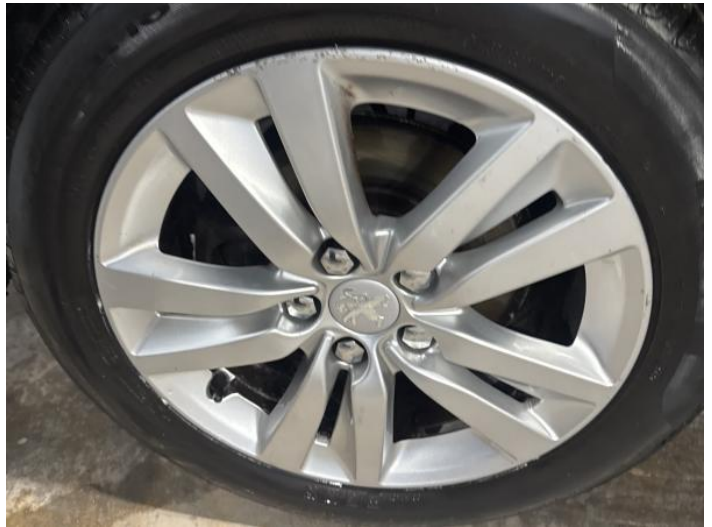
12: Wheel osr
Scratched
Up To 50mm

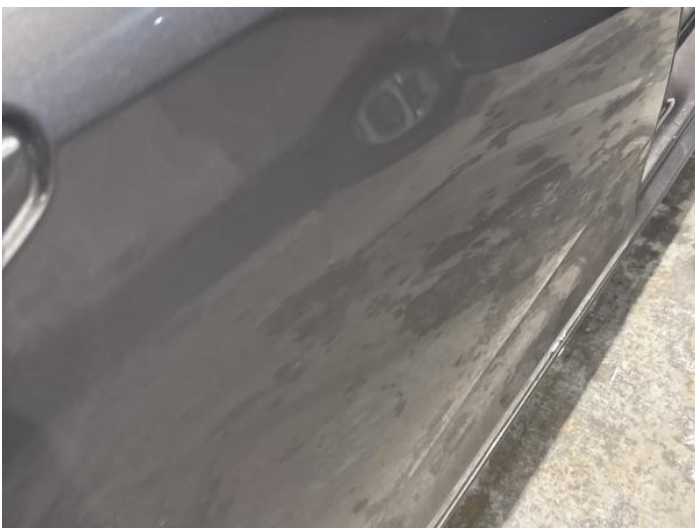
13: Door osr
Chipped
1 To 5

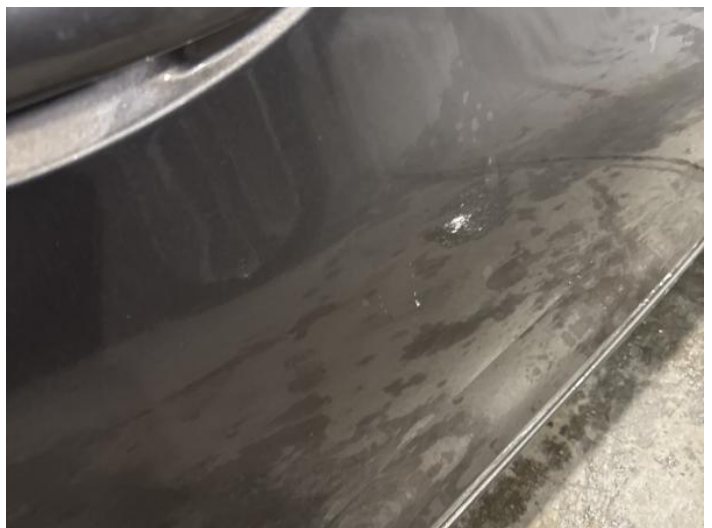
14: Door osf
Chipped
1 To 5

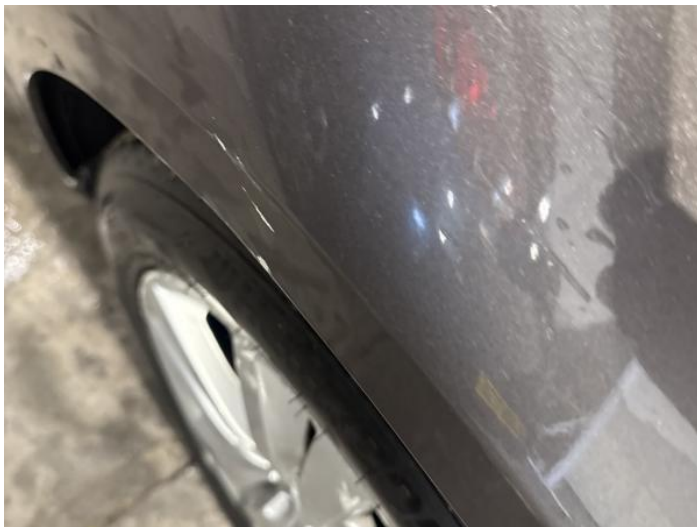
15: Wing osf
Dented
With Paint Damage

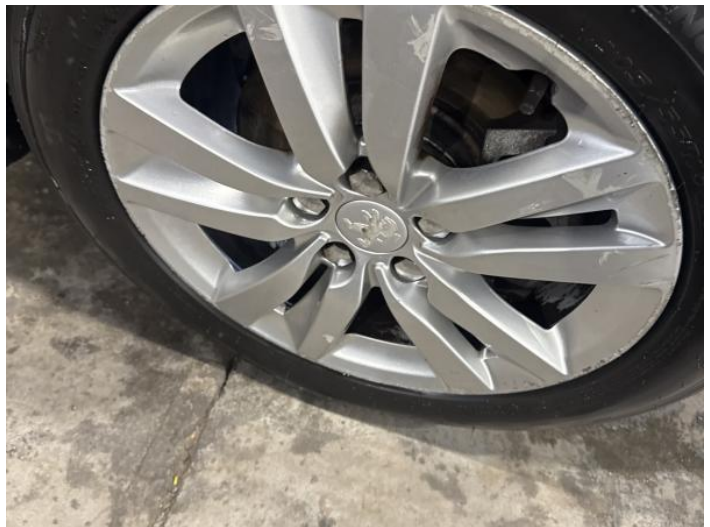
16: Wheel osf
Scratched
Over 50mm

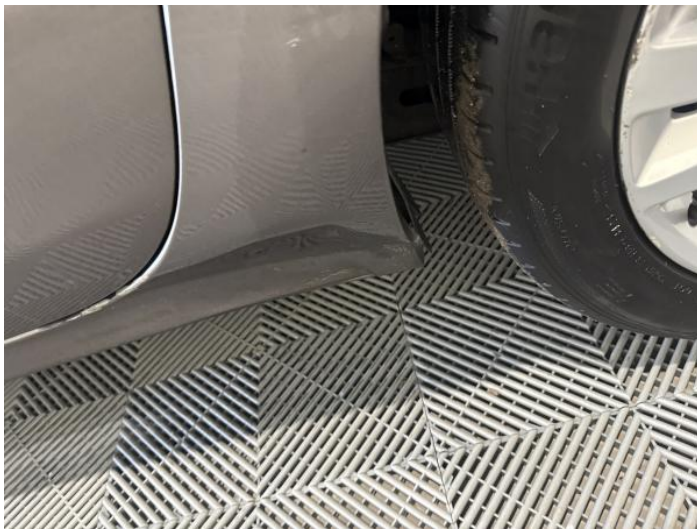
17: Sill ns
Dented
Over 30mm
