## VEHICLE INSPECTION REPORT

EU18UBB

### Nissan Juke 1.6 Tekna 5dr Xtronic [Bose]

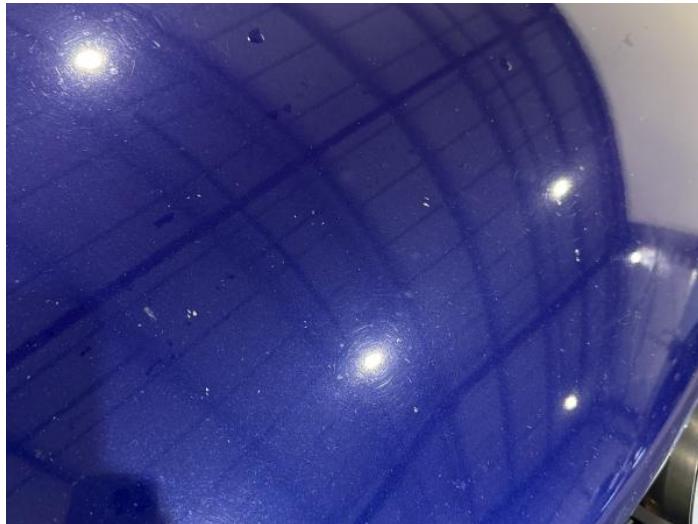
1: Bonnet  
Chipped  
Multiple Chips

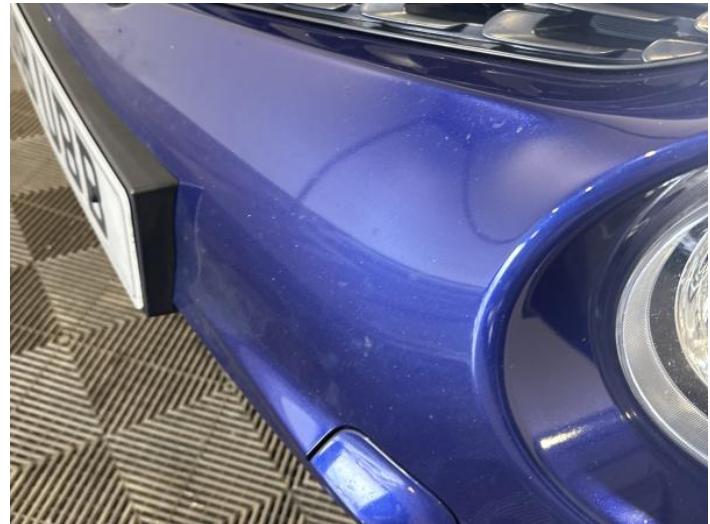
2: Bumper Front  
Chipped  
Multiple Chips

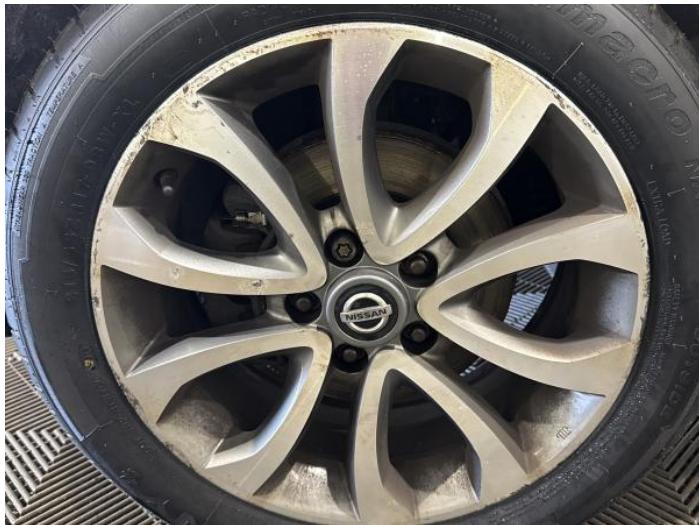
3: Wheel nsf  
Scratched  
Over 50mm

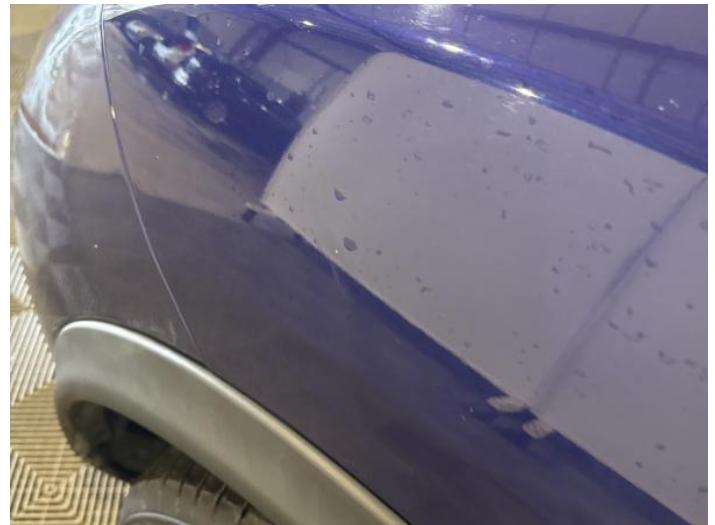
4: Wing osf  
Chipped  
1 To 5

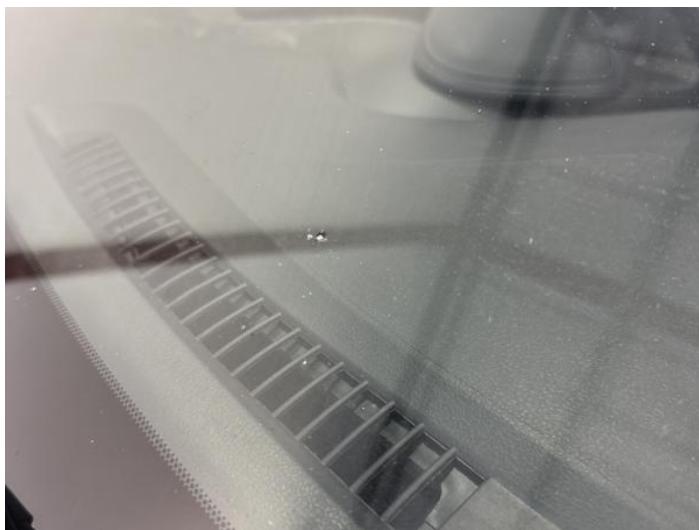
5: Screen Front  
Chipped  
UpTo 10mm

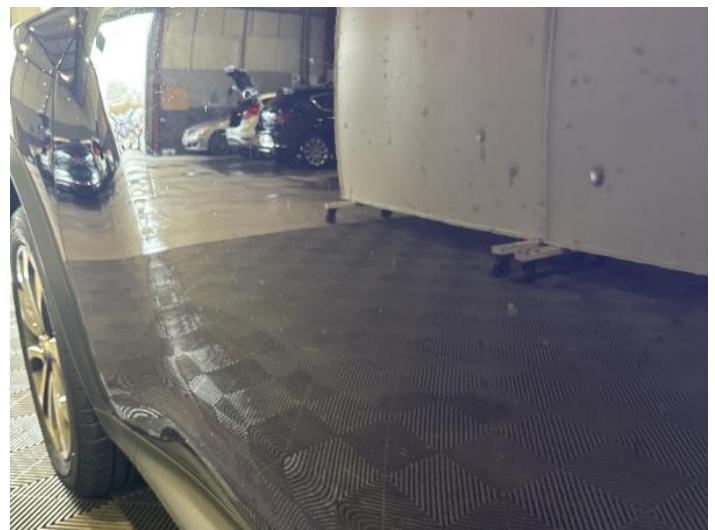
6: Door nsf  
Dented  
Over 30mm

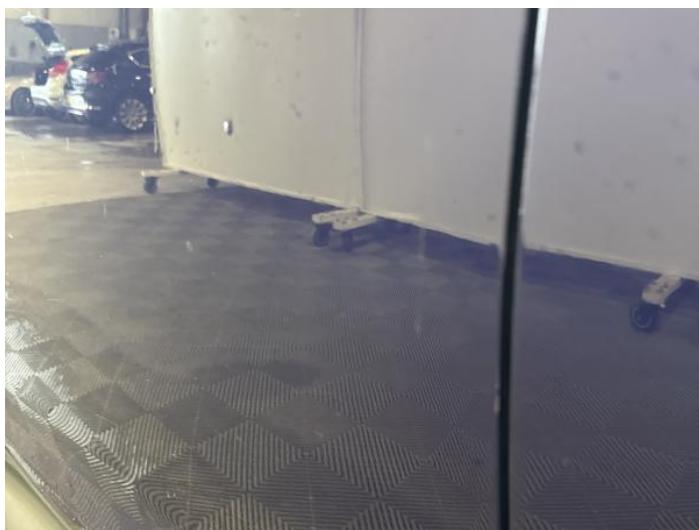
7: Door nsf  
Scratched  
UpTo 25mm Thru Paint

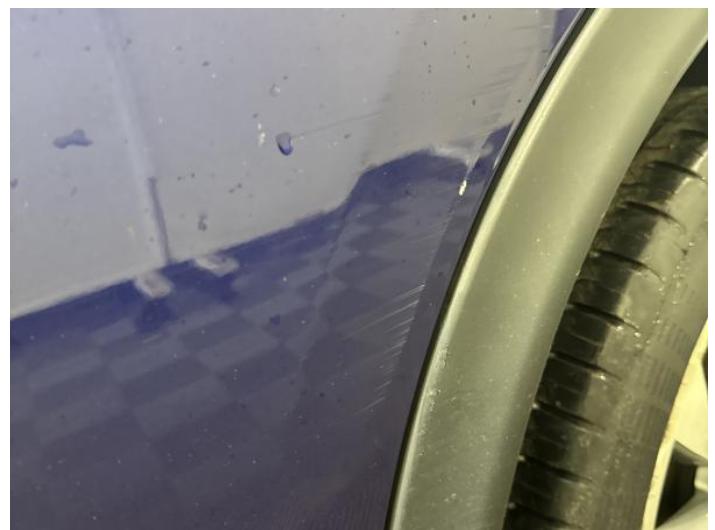
8: Door nsr  
Scratched  
Over 25mm Thru Paint

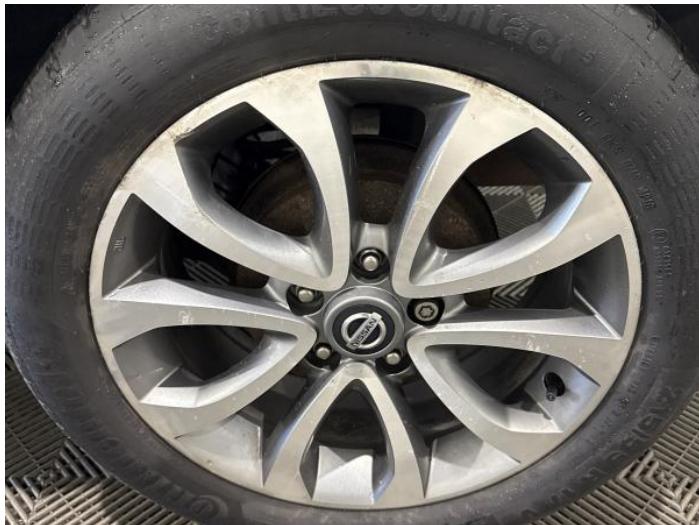
9: Wheel nsr  
Scratched  
Over 50mm

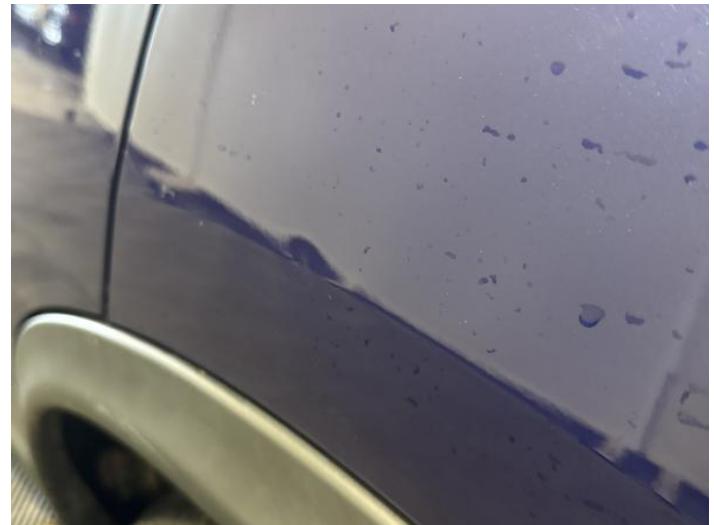
10: Qtr Panel nsr  
Dented  
Between 10mm + 30mm

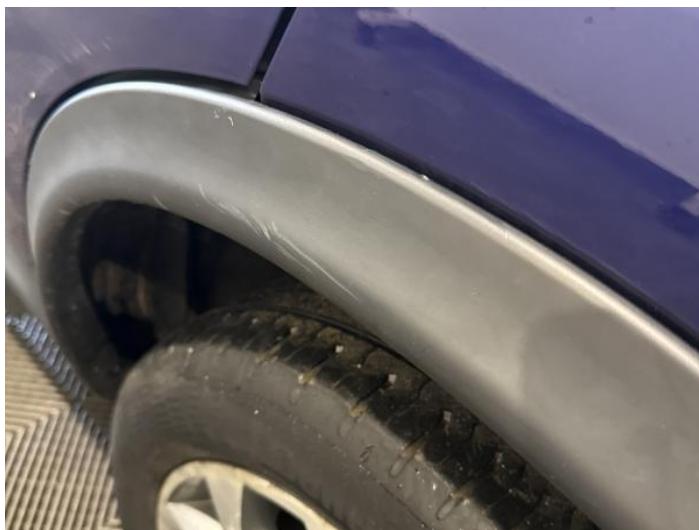
11: Qtr Panel Arch Extension ns  
Scuffed (Unpainted)  
UpTo 100mm

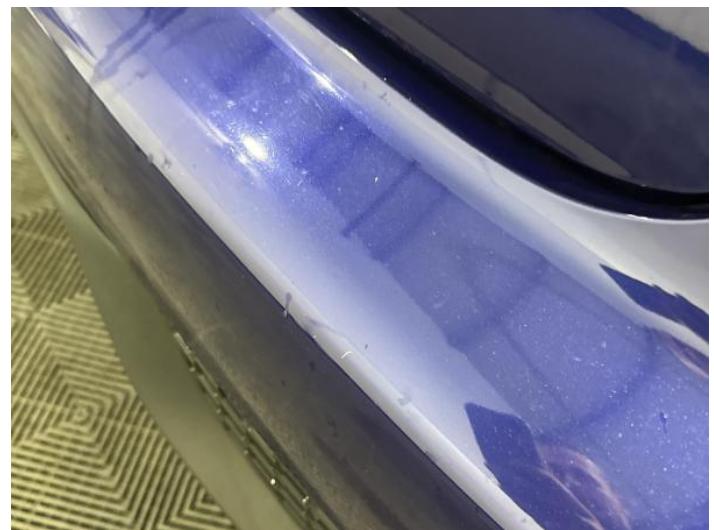
12: Bumper Rear  
Scratched  
Up To 25mm Thru Paint

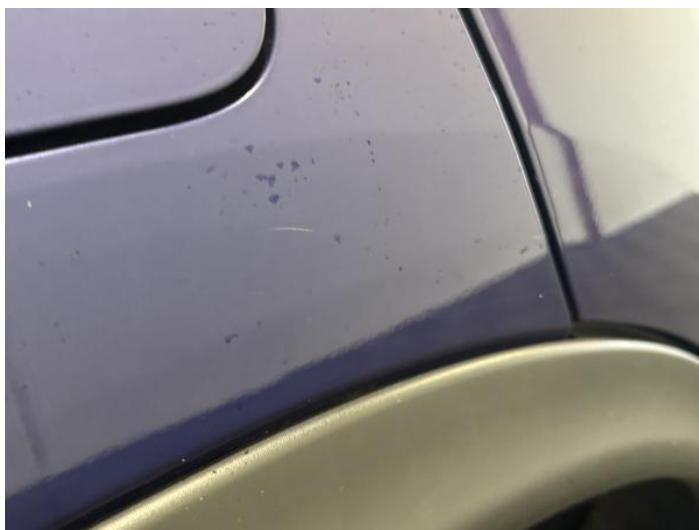
13: Qtr Panel osr  
Scratched  
UpTo 25mm Thru Paint

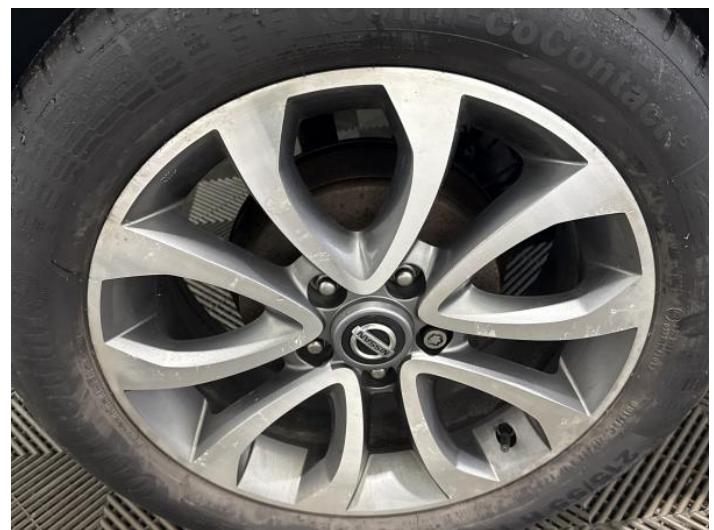
14: Wheel nsr  
Scratched  
Over 50mm

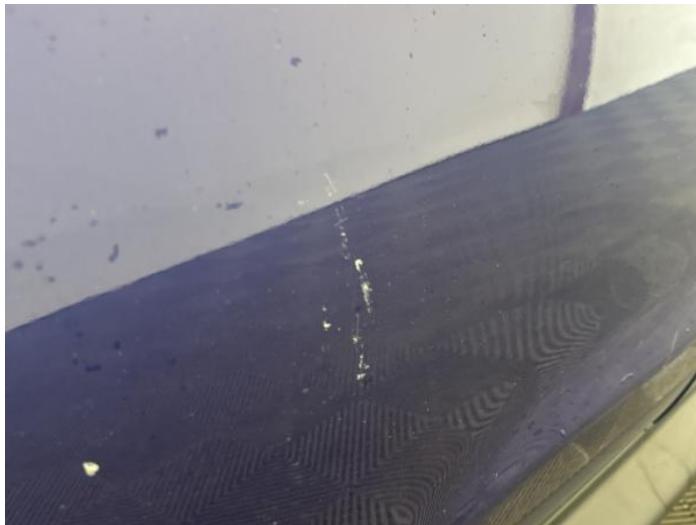
15: Door osr  
Scratched  
Over 25mm Thru Paint

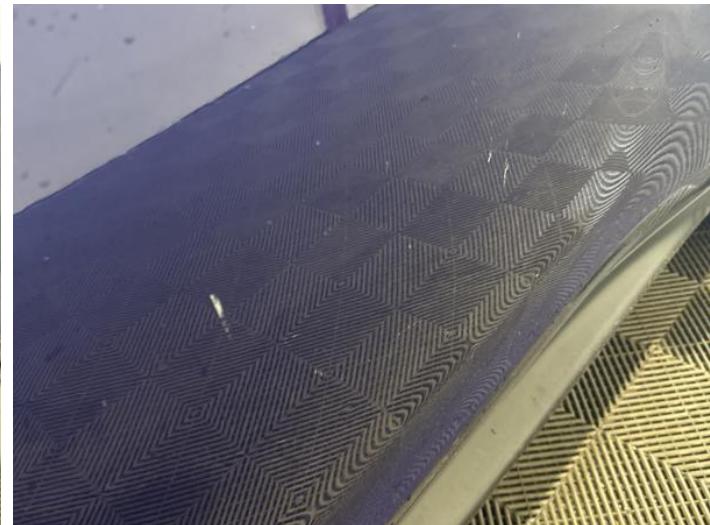
16: Door osf  
Scratched  
Over 25mm Thru Paint

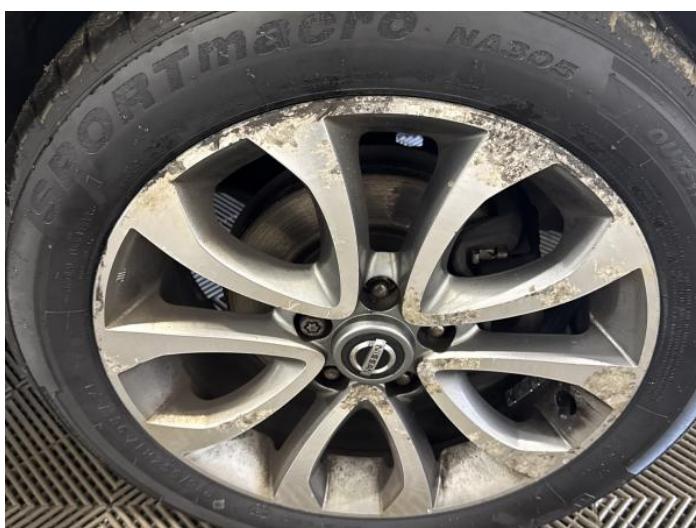
17: Wheel osf  
Scratched  
Over 50mm

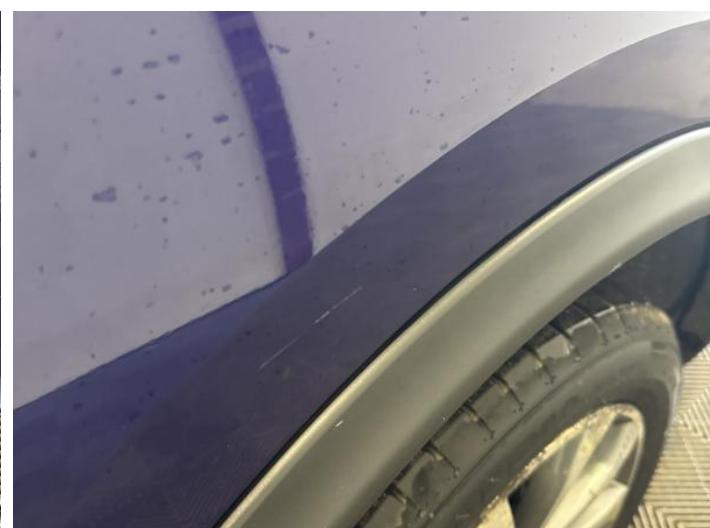
18: Wing osf  
Scratched  
Over 25mm Thru Paint
