VEHICLE INSPECTION REPORT

EF65RVN

Ford Transit Connect 1.6 TDCi 115ps Limited Van

Inspection	Vehicle		nama GRADE 3
Serious Damage?	VAT	Margin	
No	V5	Present

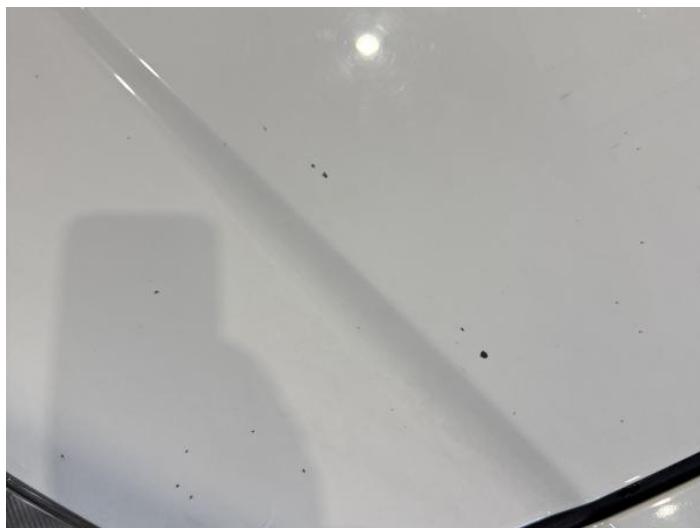
1: Bonnet
Chipped
Multiple Chips

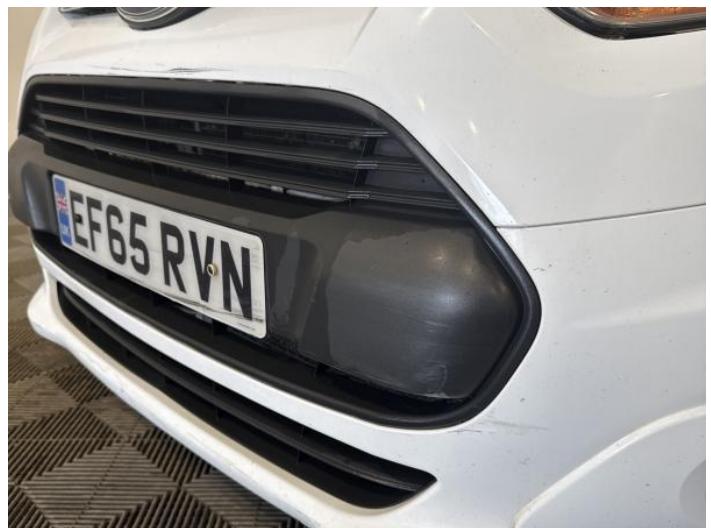
2: Bumper Front
Scratched
Over 100mm Thru Paint

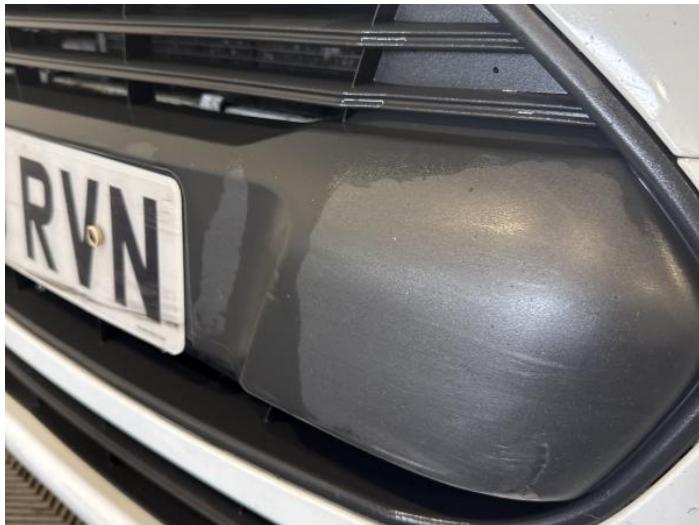
3: Bumper Front Moulding
Scuffed (Unpainted)
Over 100mm

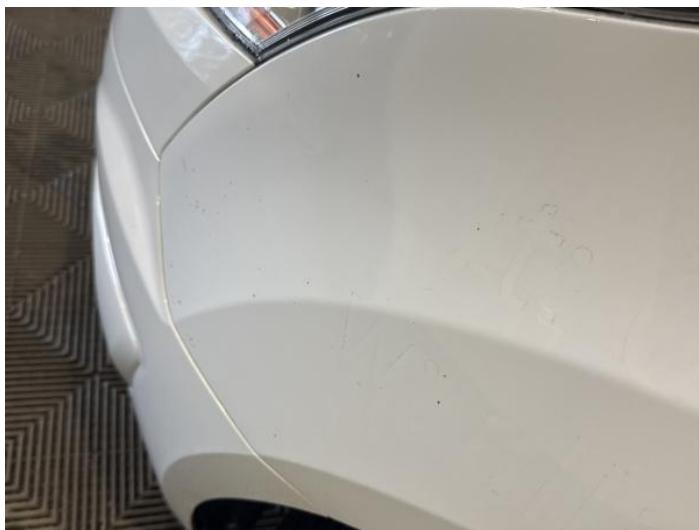
5: Wing nsf
Chipped
Multiple Chips

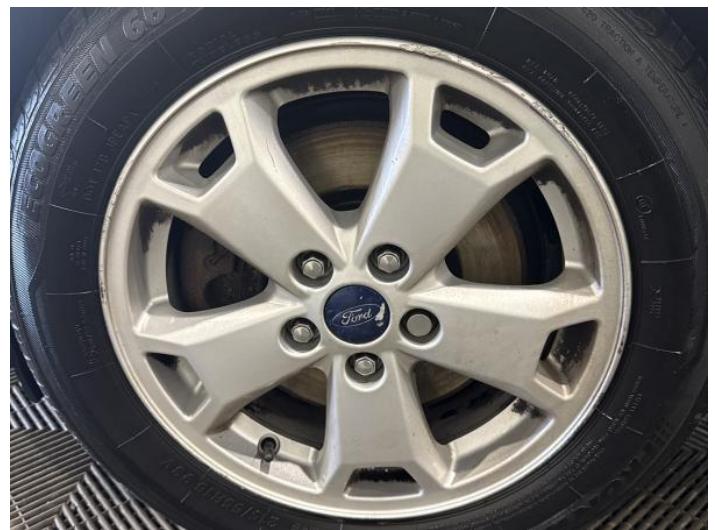
6: Wheel nsf
Scratched
Over 50mm

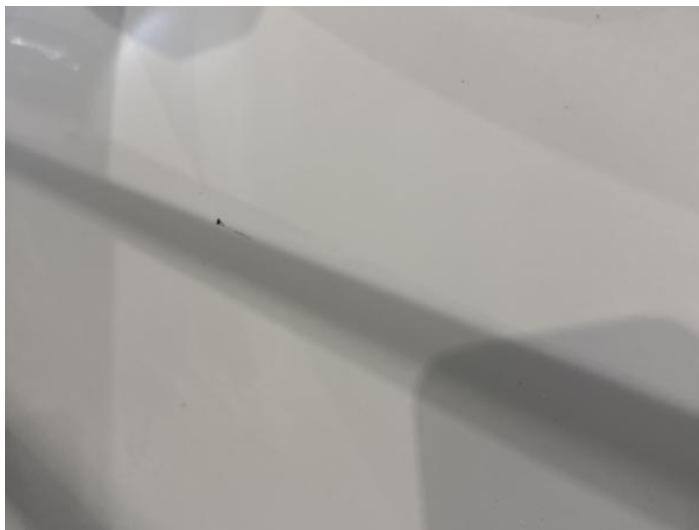
7: Door nsf
Scratched
UpTo 25mm Thru Paint

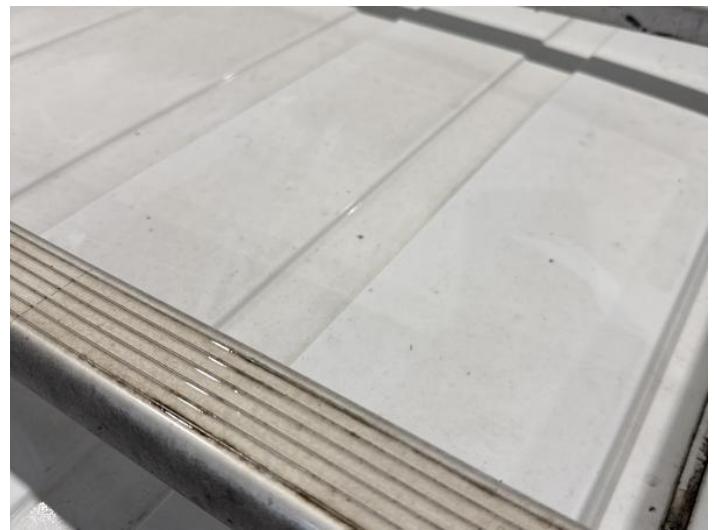
8: Roof
Dented
Over 30mm

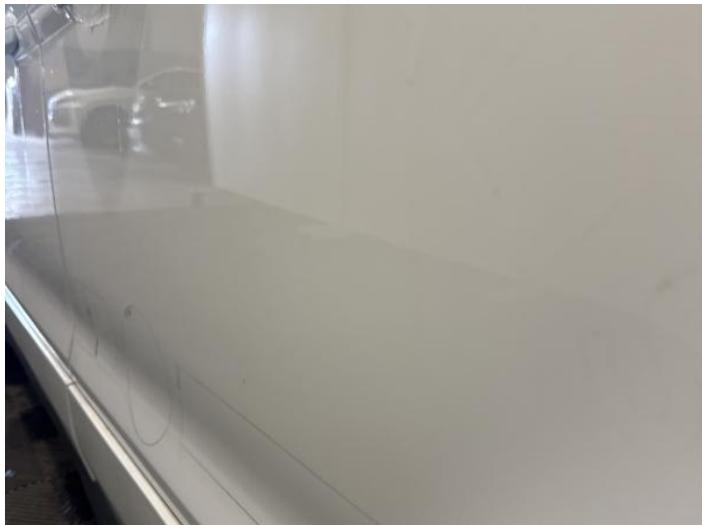
9: Door nsr
Dented
Between 10mm + 30mm

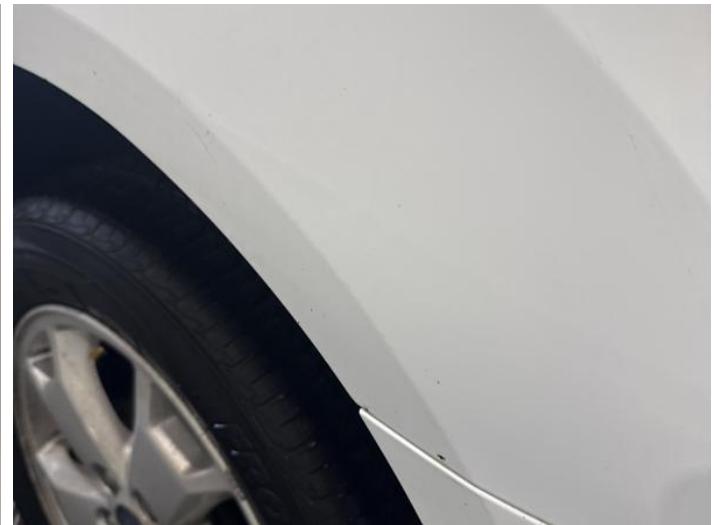
10: Qtr Panel nsr
Scratched
Rusted

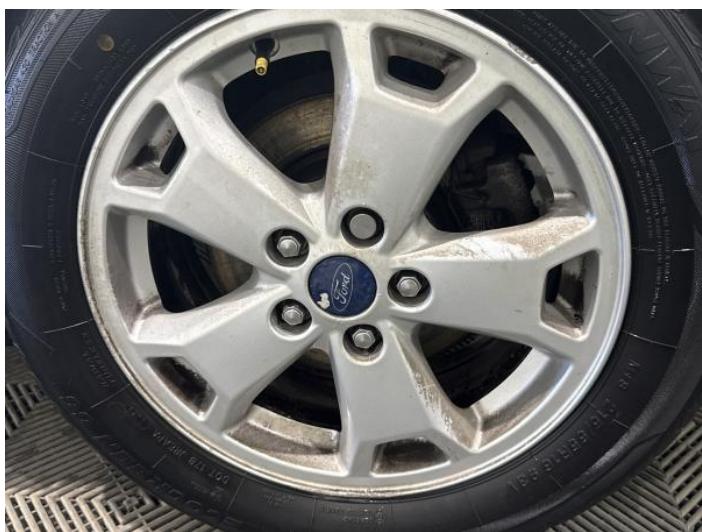
11: Wheel nsr
Scratched
Over 50mm

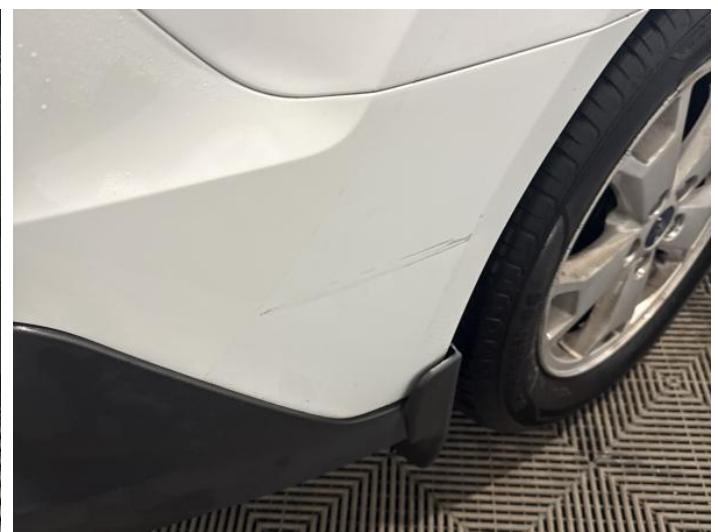
12: Bumper Rear
Scratched
25 to 100mm Thru Paint

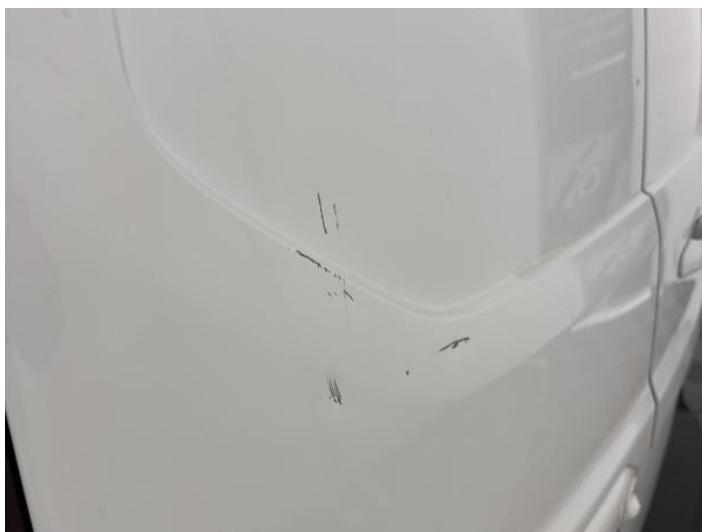
13: Tailgate
Dented
With Paint Damage

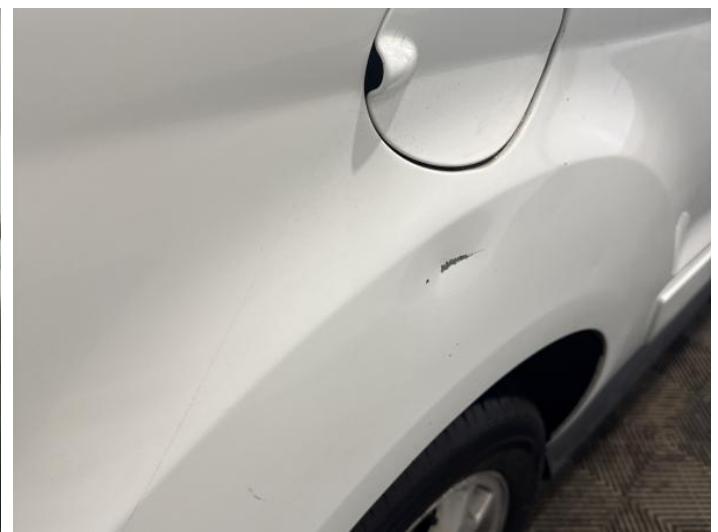
14: Qtr Panel osr
Dented
With Paint Damage

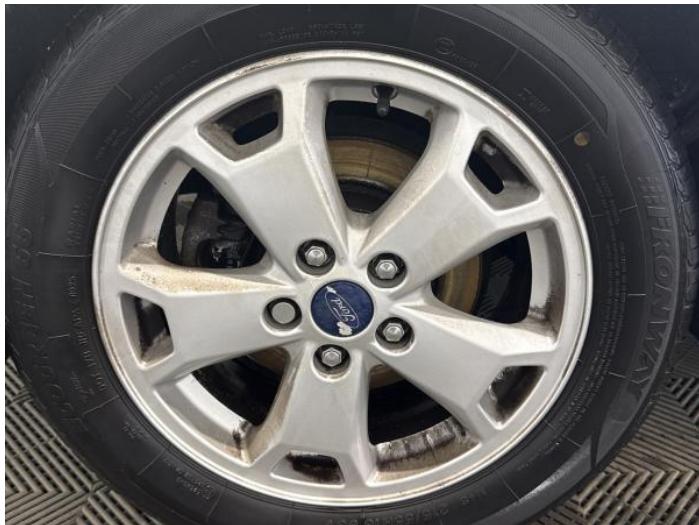
15: Wheel osf
Scratched
Up To 50mm

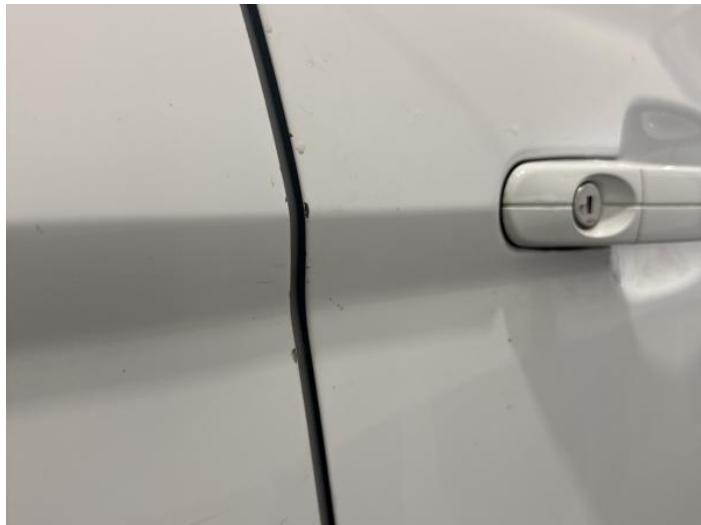
16: Door osf
Chipped
Edge Chip

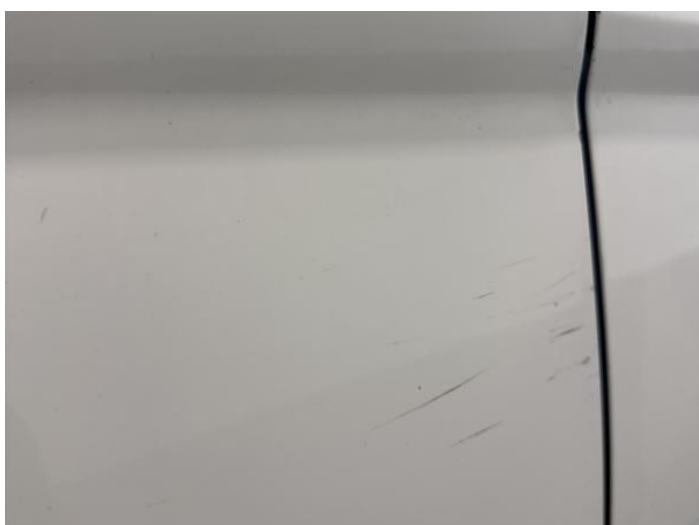
17: Panel Front
Scratched
Over 25mm Thru Paint

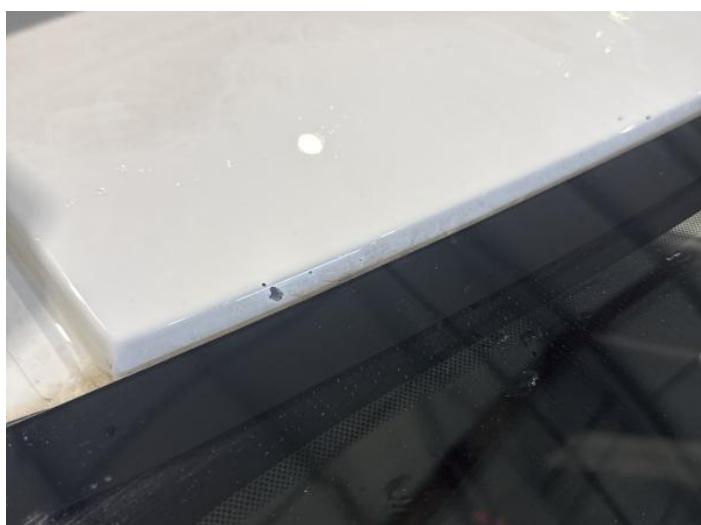
18: Roof
Chipped
Edge Chip

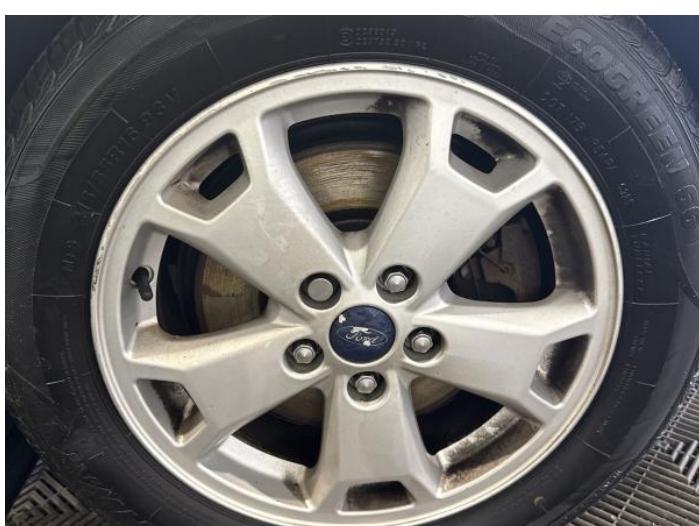
19: Wheel osf
Scratched
Over 50mm

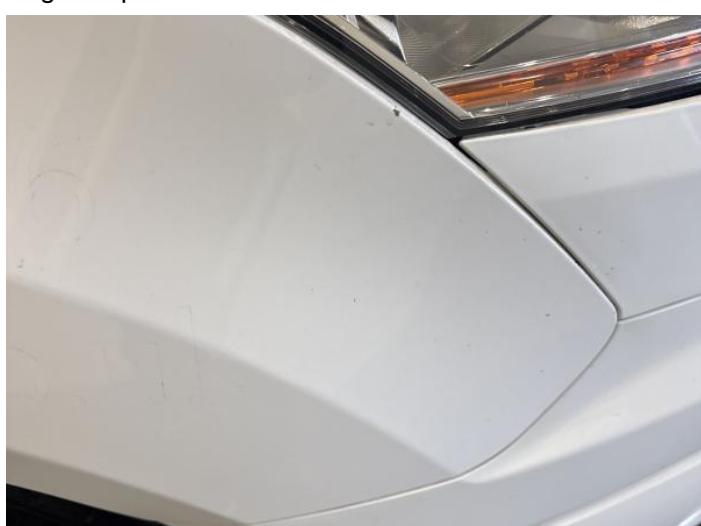
20: Wing osf
Chipped
Multiple Chips
