VEHICLE INSPECTION REPORT

GF22EOO

MG Mg Hs EXCLUSIVE DCT

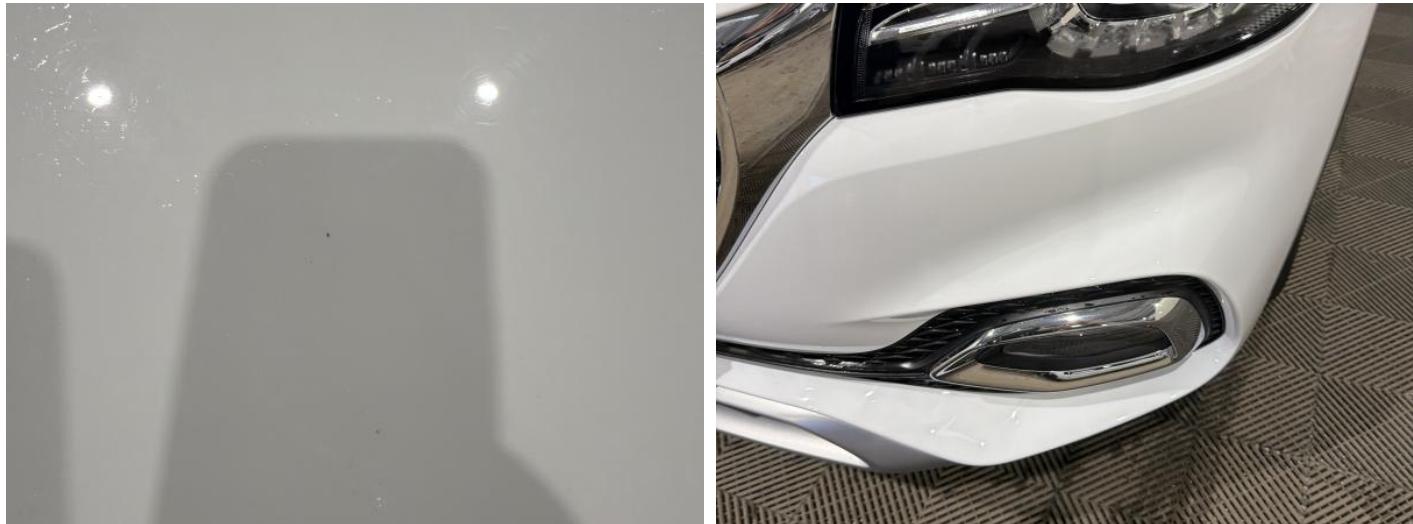
1: Bonnet
Chipped
1 To 5

2: Bumper Front
Scratched
25 to 100mm Thru Paint

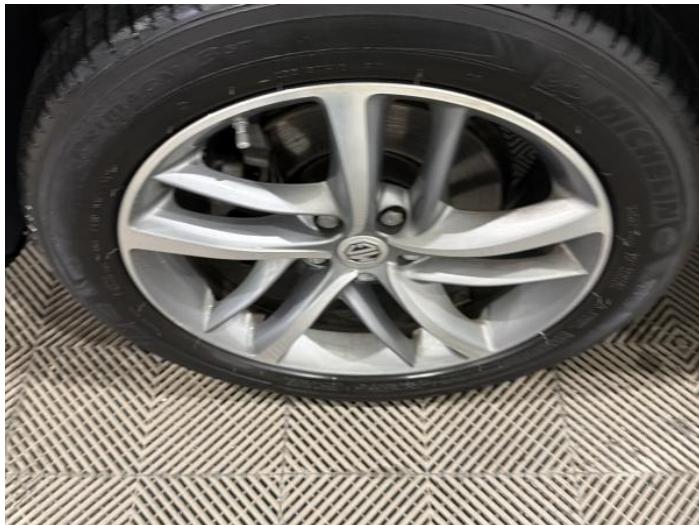
3: Wheel nsf
Scratched
Up To 50mm

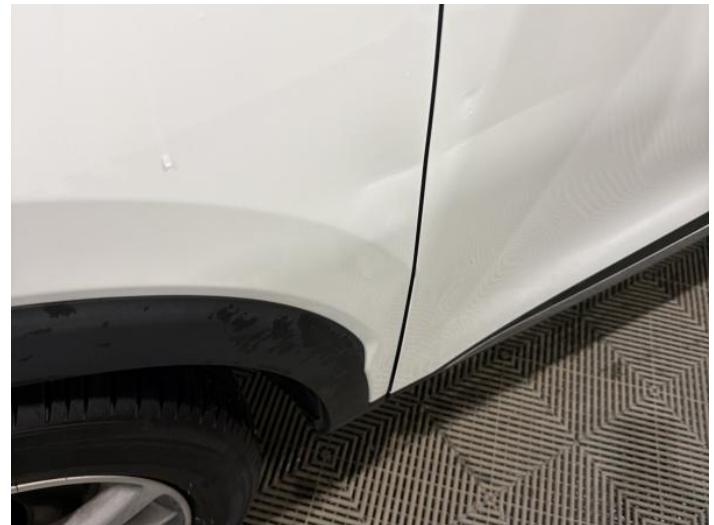
4: Wing nsf
Dented
Over 30mm

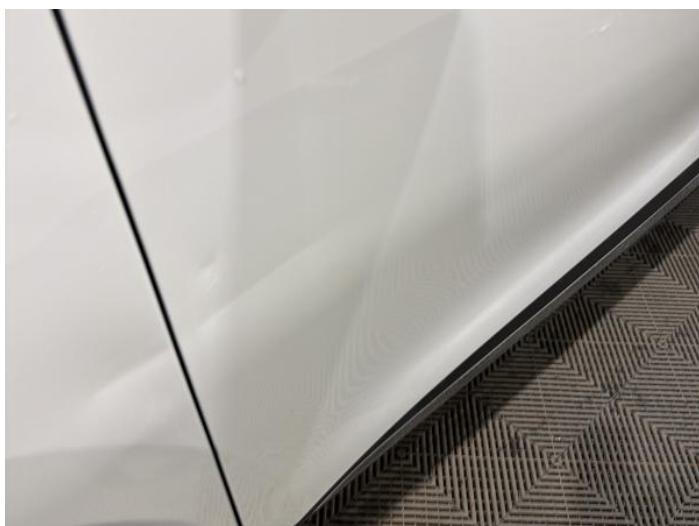
5: Door nsf
Dented
Over 30mm

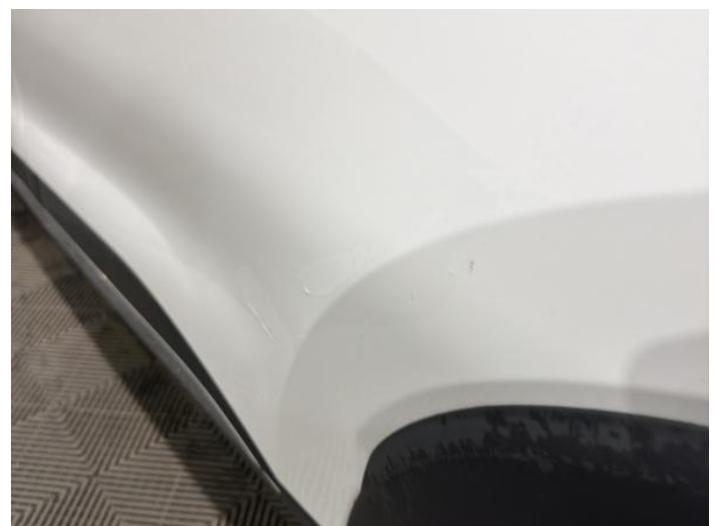
6: Door nsr
Chipped
1 To 5

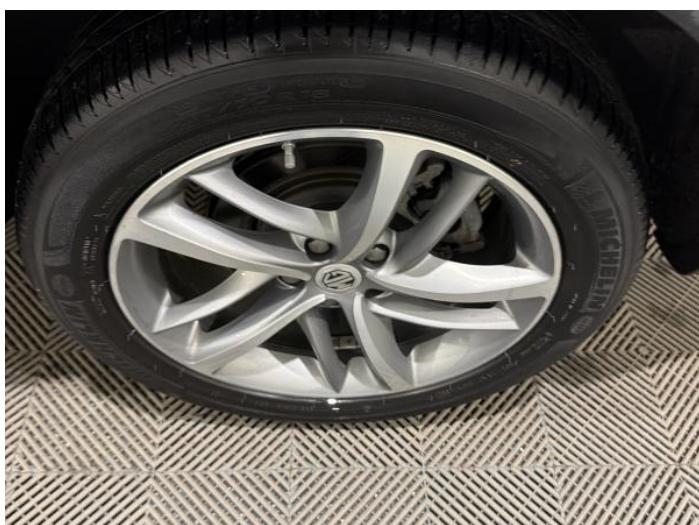
7: Wheel nsr
Scratched
Up To 50mm

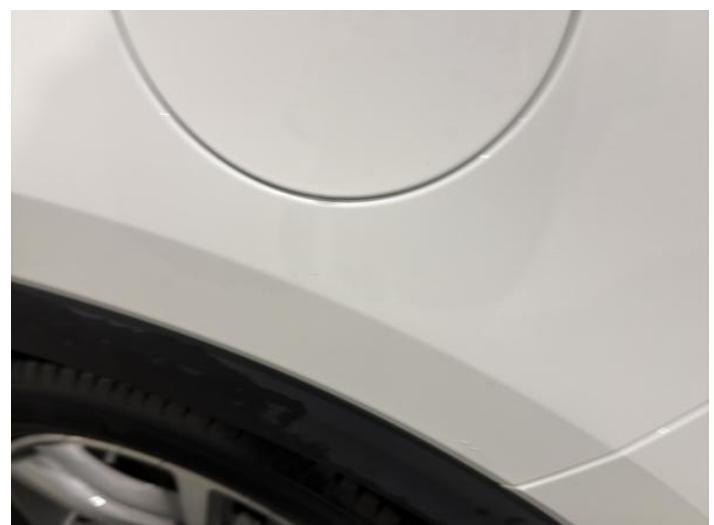
8: Qtr Panel nsr
Chipped
1 To 5

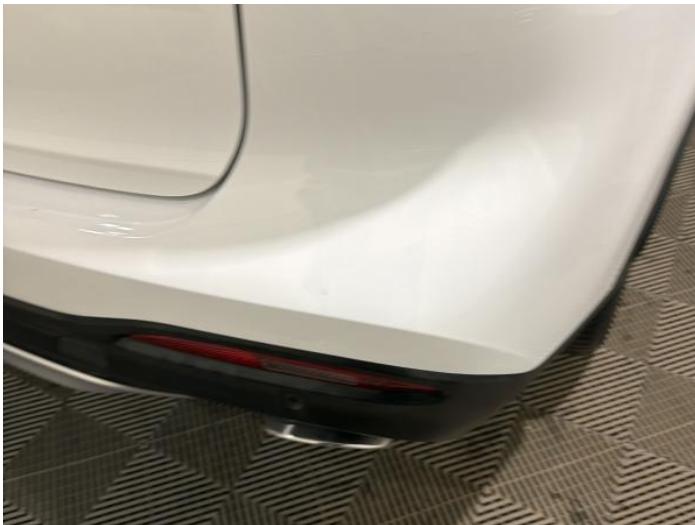
10: Bumper Rear
Scratched
Over 25mm Not Thru Paint

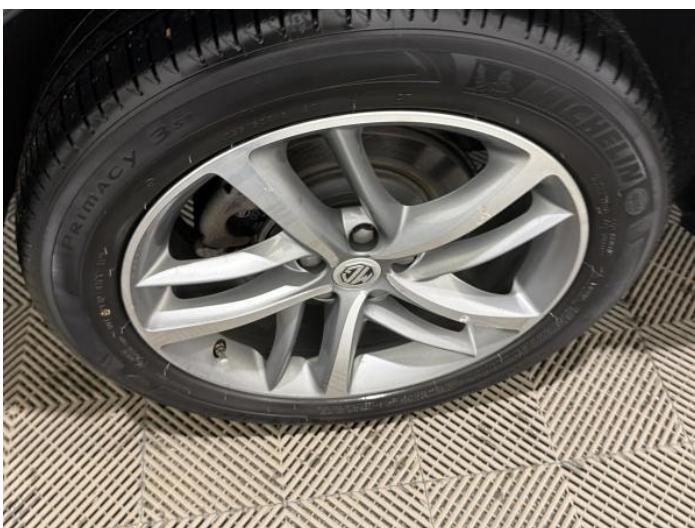
11: Wheel osr
Scratched
Over 50mm

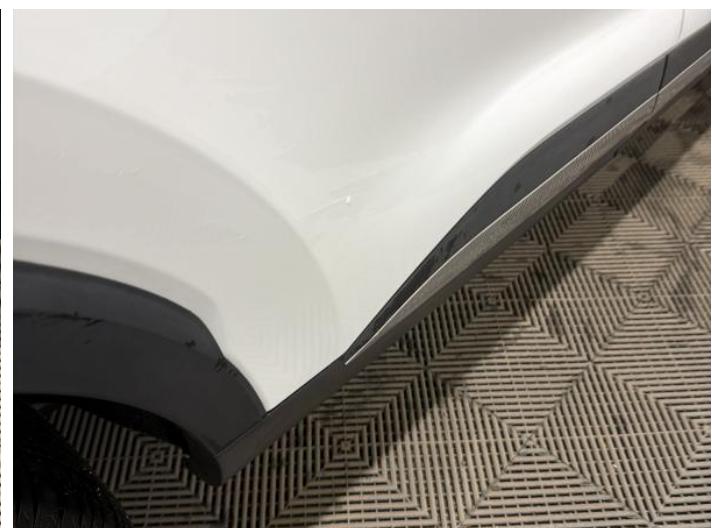
12: Door osr
Dented
Over 2 UpTo 10mm

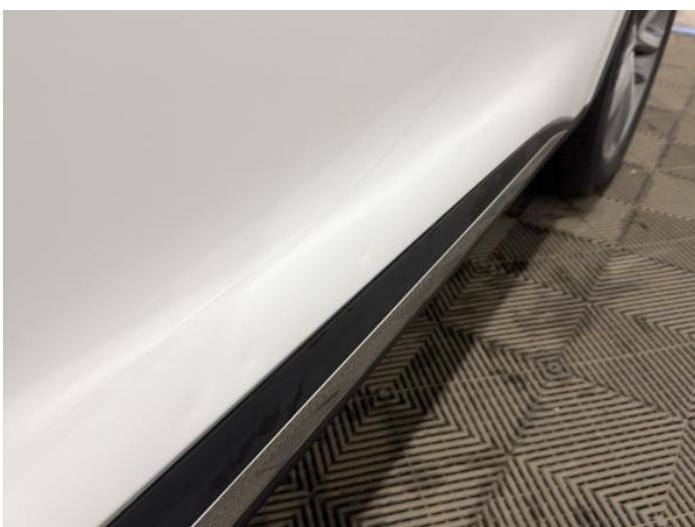
13: Door osf
Dented
Between 10mm + 30mm

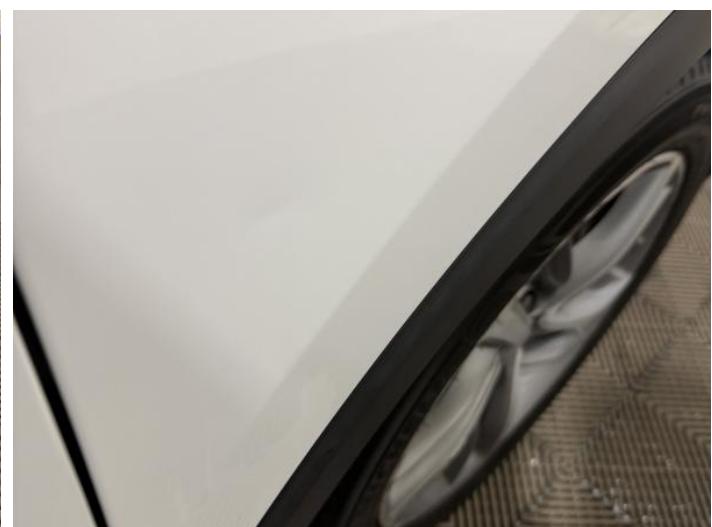
14: Wing osf
Dented
Between 10mm + 30mm

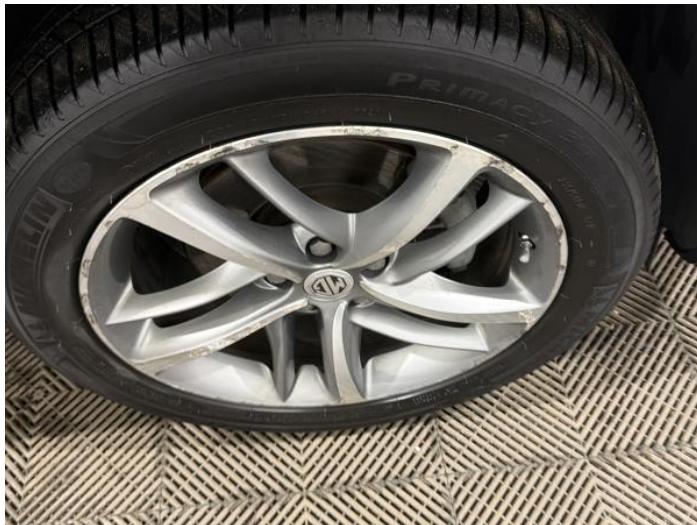
15: Wheel osf
Scratched
Over 50mm
