VEHICLE INSPECTION REPORT

GY14KVB

Ford Focus 2.0T ST-2 5dr

nama
GRADE
3

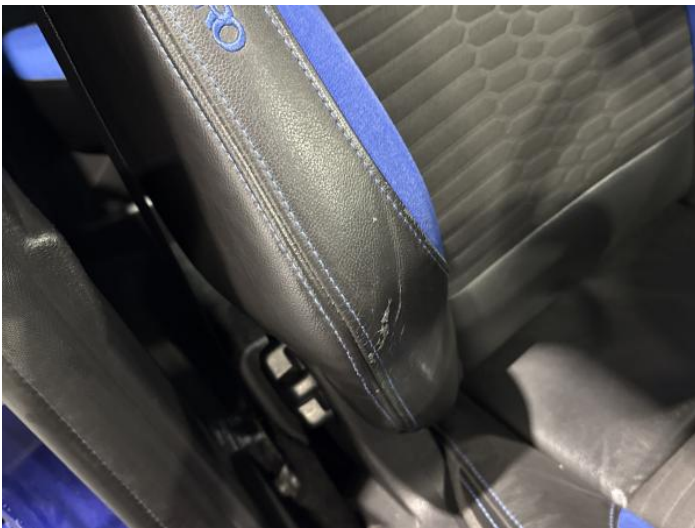
1: Seat Back Cover osf
Scuffed
Over 25mm

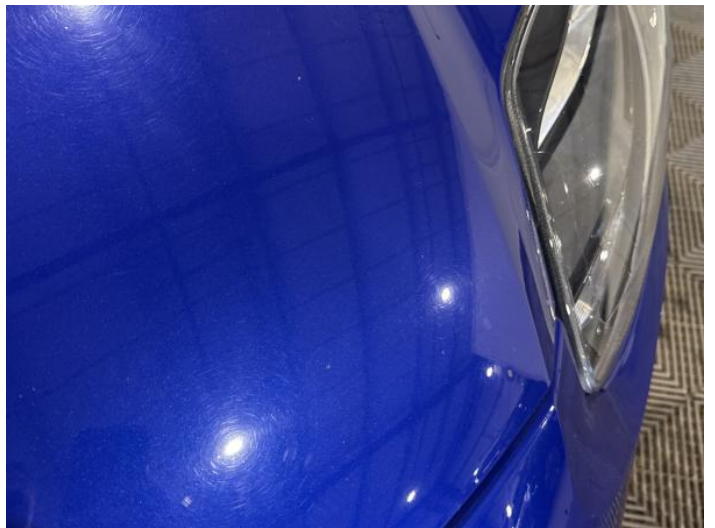
2: Bonnet
Chipped
1 To 5

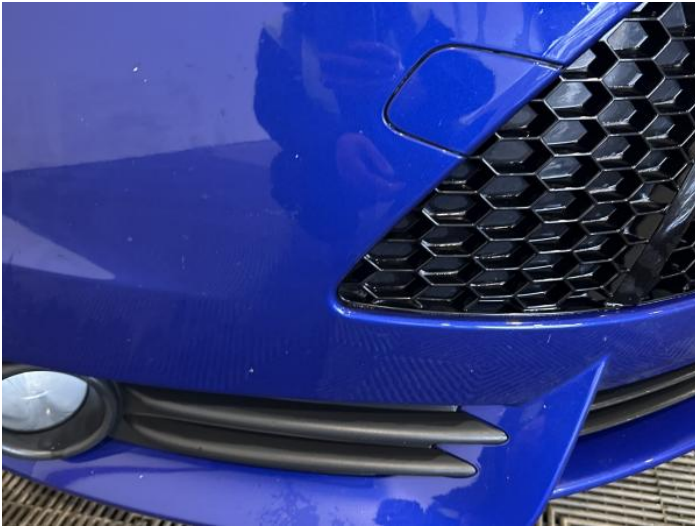
3: Bumper Front
Chipped
Multiple Chips

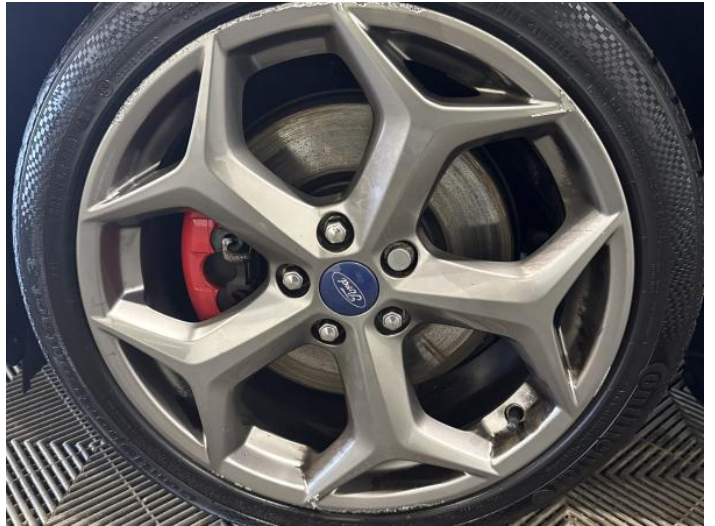
4: Wheel nsf
Scratched
Over 50mm

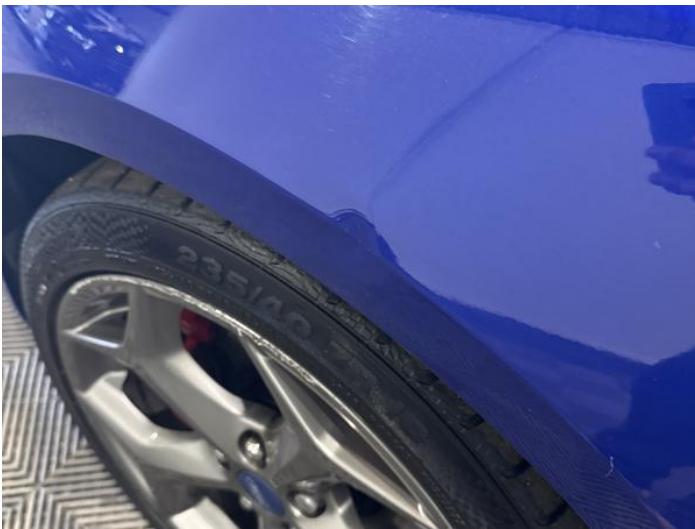
5: Wing nsf
Dented
Over 30mm

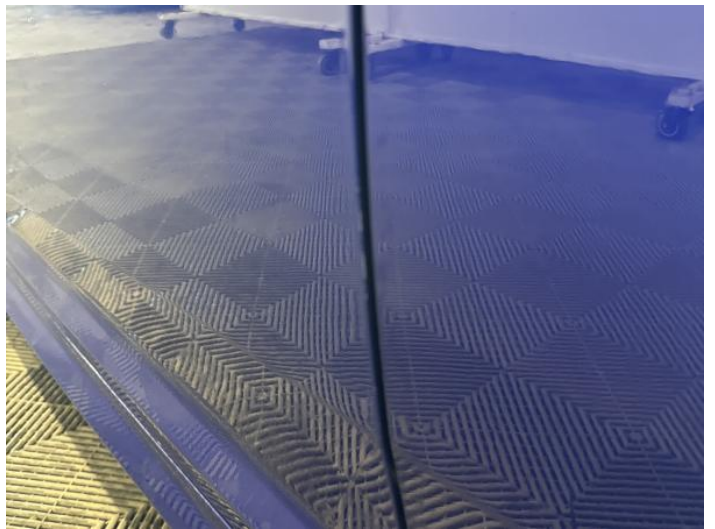
6: Door nsf
Chipped
Edge Chip

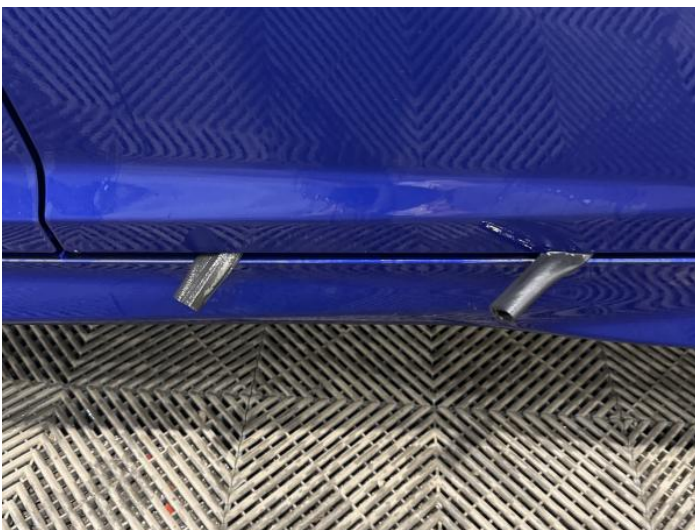
7: Aperture Seal nsr
Broken
Replace

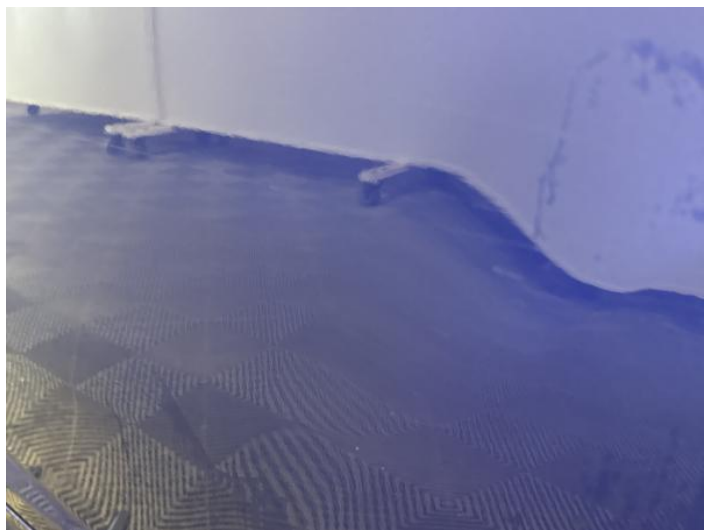
8: Door nsr
Scratched
Over 25mm Thru Paint

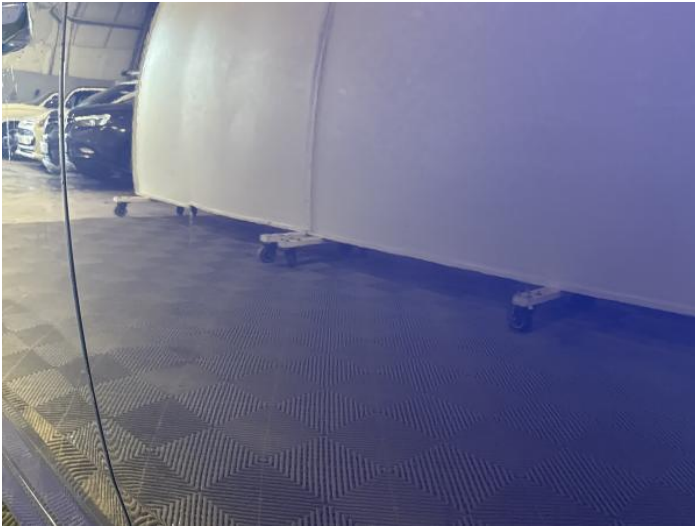
9: Door nsr
Dented
Over 30mm

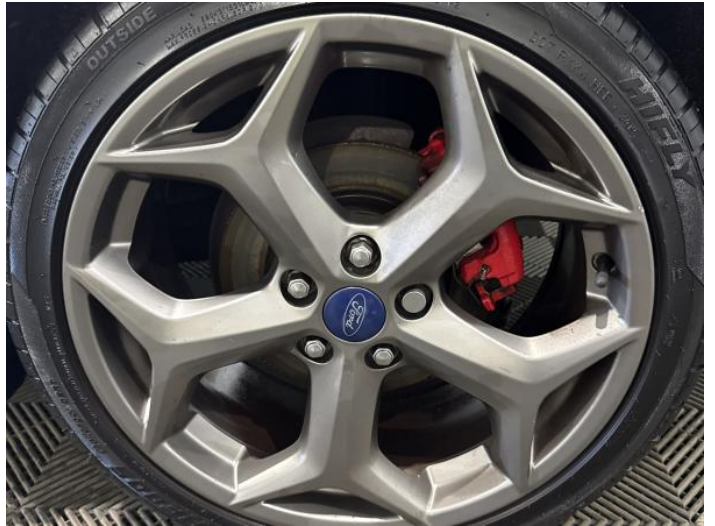
10: Wheel osr
Scratched
Up To 50mm

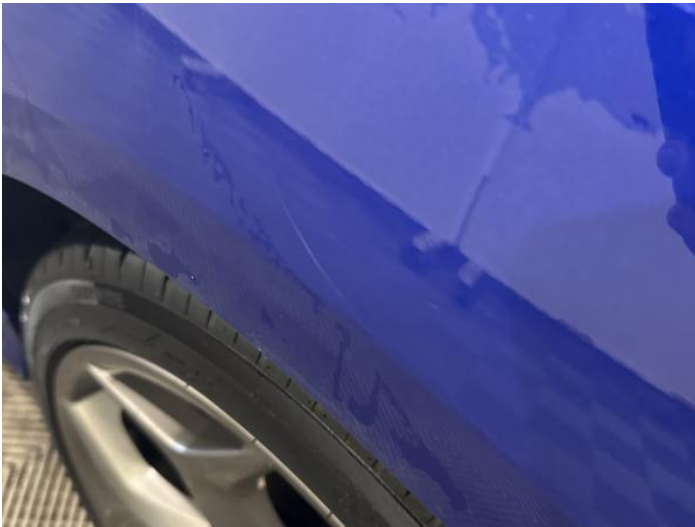
11: Qtr Panel nsr
Scratched
Up To 25mm Thru Paint

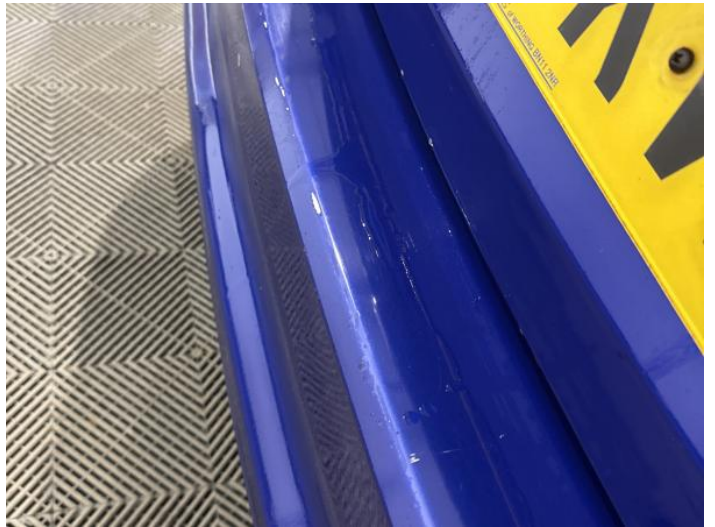
12: Bumper Rear
Scratched
25 to 100mm Thru Paint

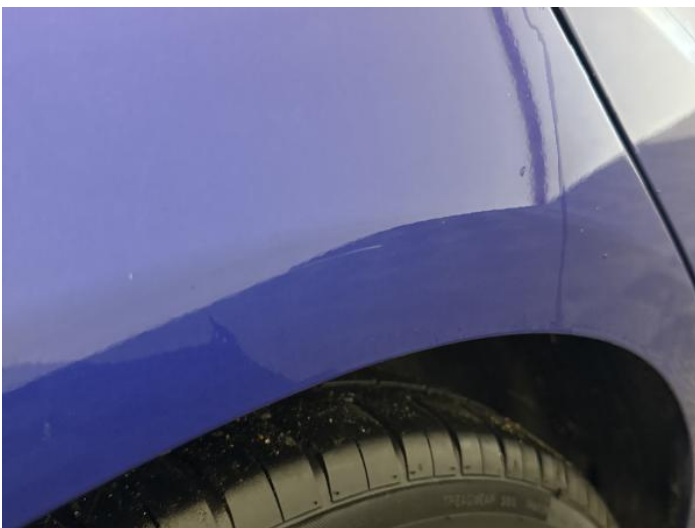
13: Qtr Panel osr
Scratched
Up To 25mm Thru Paint

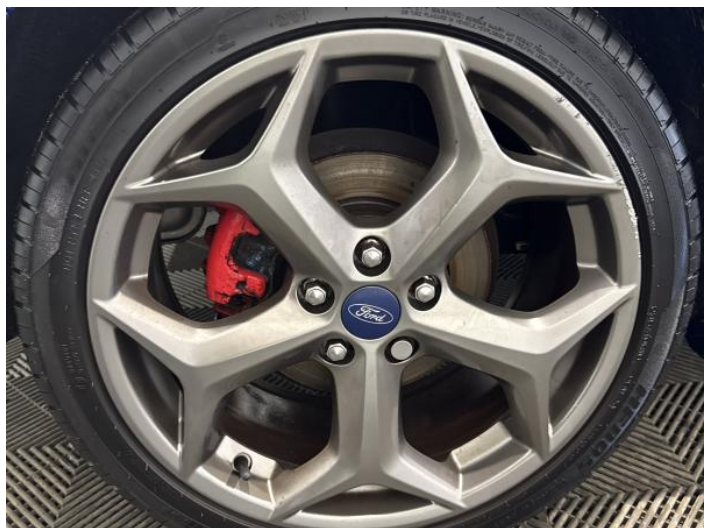
14: Wheel osr
Scratched
Over 50mm

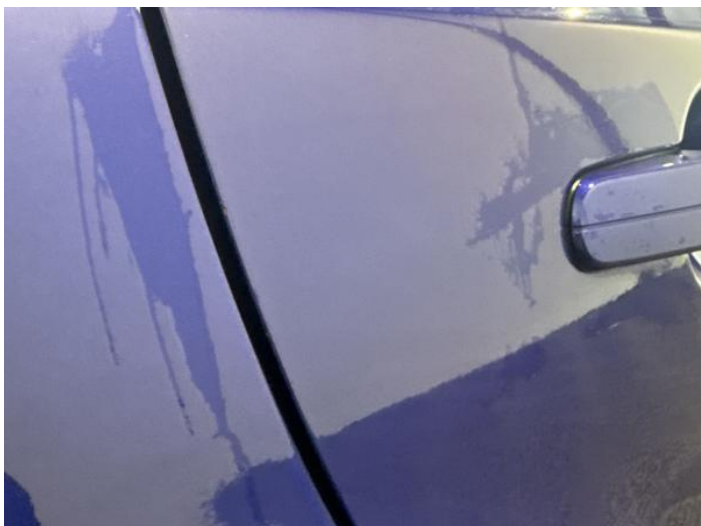
15: Door osr
Chipped
Edge Chip

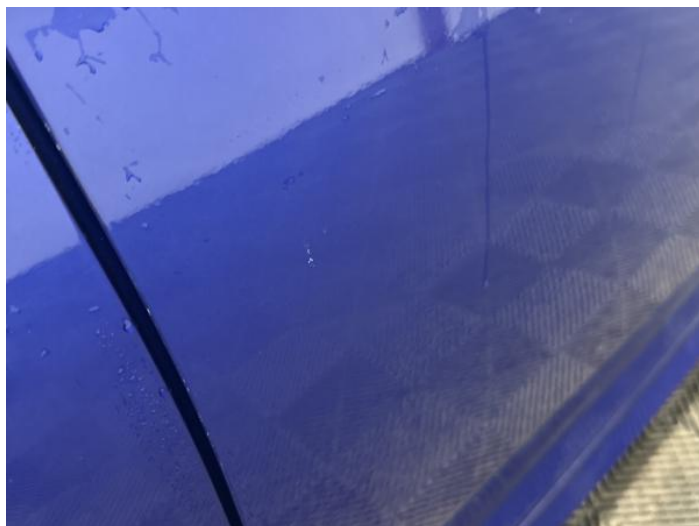
16: Door osf
Scratched
UpTo 25mm Thru Paint

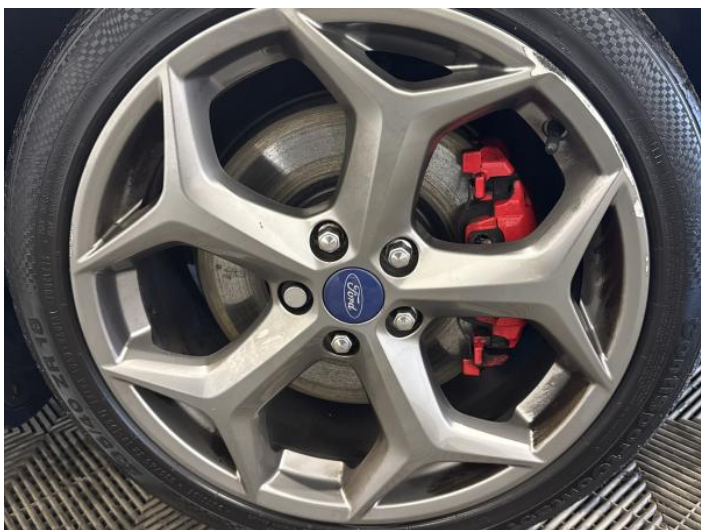
17: Wheel osf
Scratched
Over 50mm

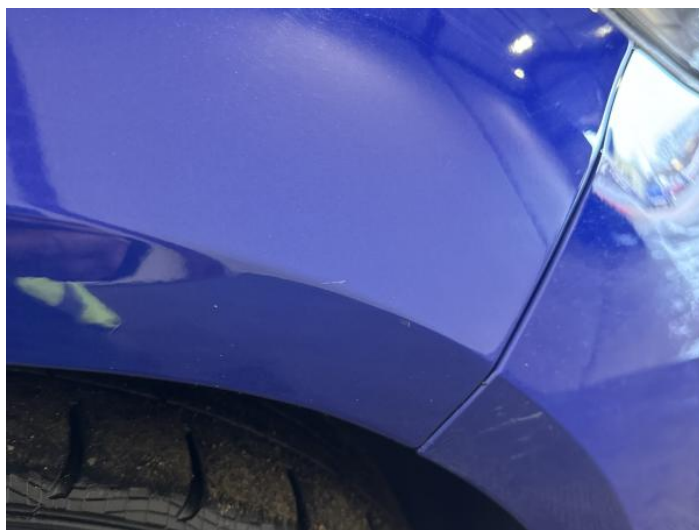
18: Wing osf
Scratched
UpTo 25mm Thru Paint
