VEHICLE INSPECTION REPORT

AK13JFY

Volvo XC60 T6 [304] R DESIGN Nav 5dr AWD Geartronic

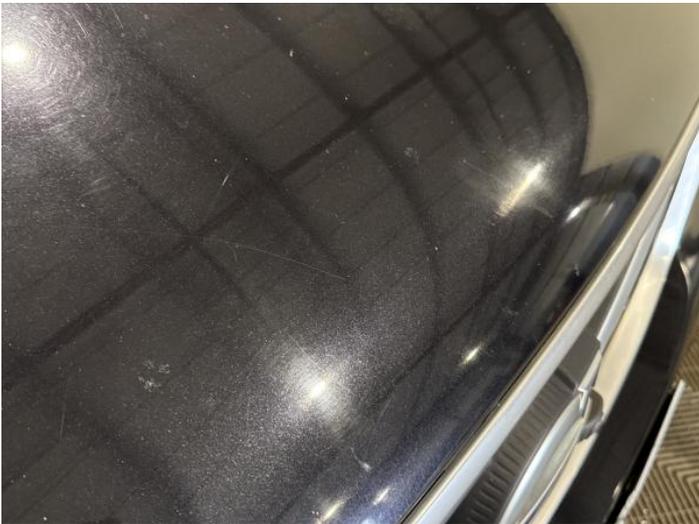
1: Bonnet
Chipped
Multiple Chips

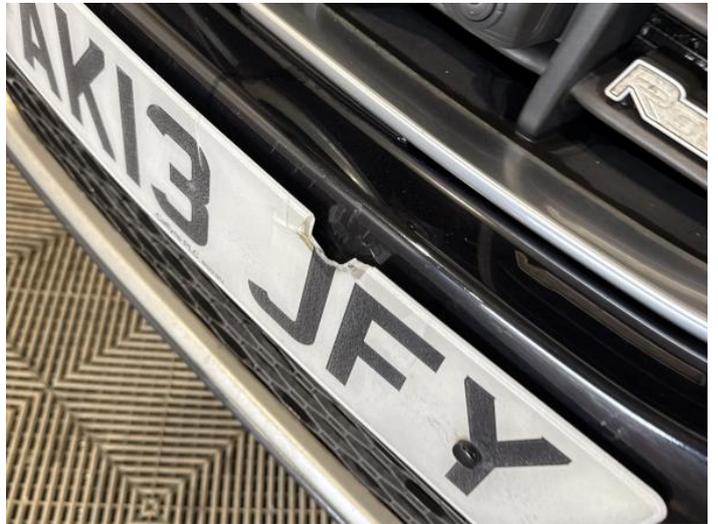
2: Number Plate Front
Broken
Replace

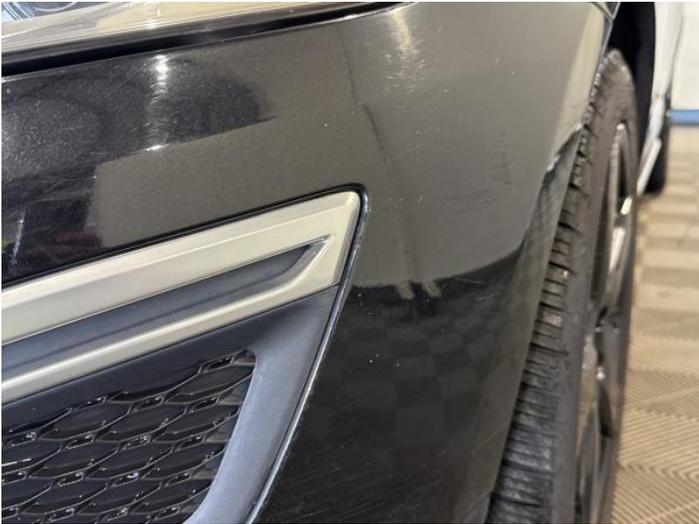
3: Bumper Front
Scratched
25 to 100mm Thru Paint

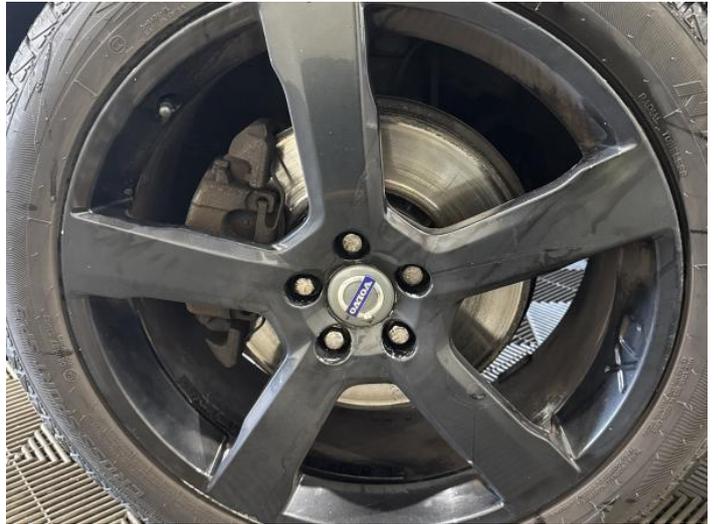
4: Wheel nsf
Scratched
Over 50mm

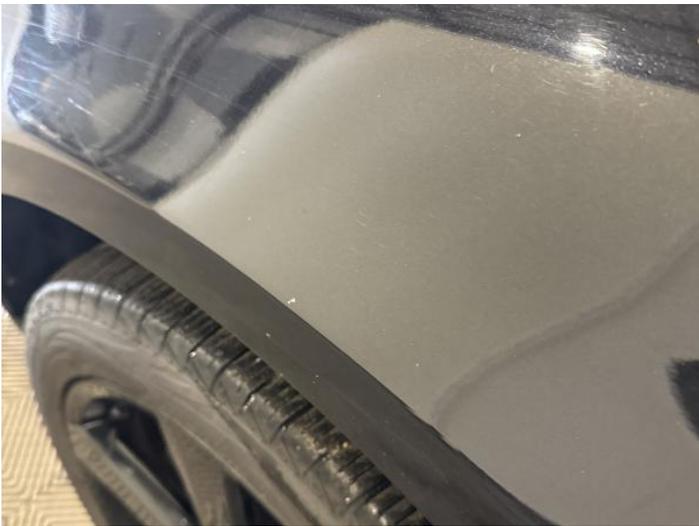
5: Wing nsf
Chipped
1 To 5

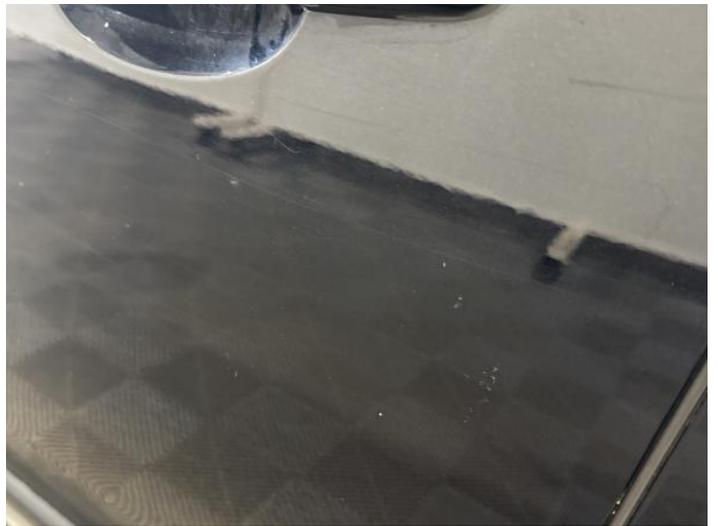
6: Door nsf
Scratched
Over 25mm Thru Paint

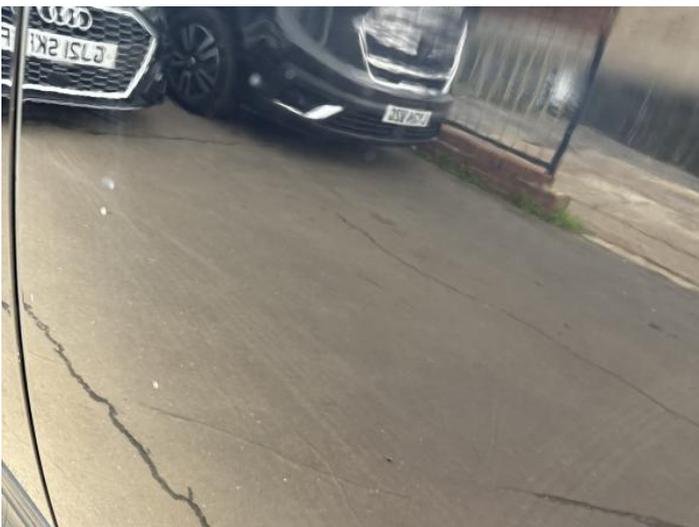
7: Door nsr
Scratched
Over 25mm Thru Paint

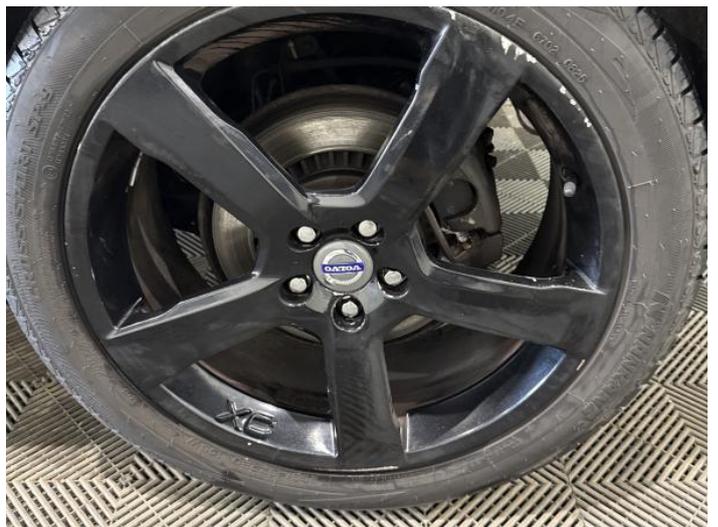
8: Wheel nsr
Scratched
Over 50mm

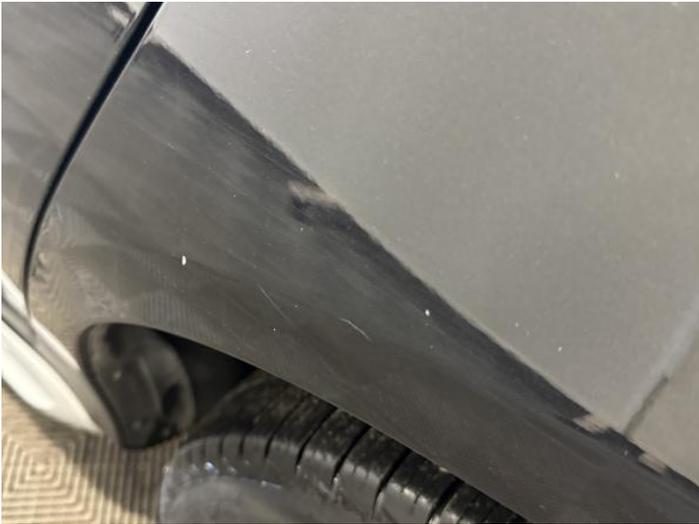
9: Qtr Panel nsr
Scratched
UpTo 25mm Thru Paint

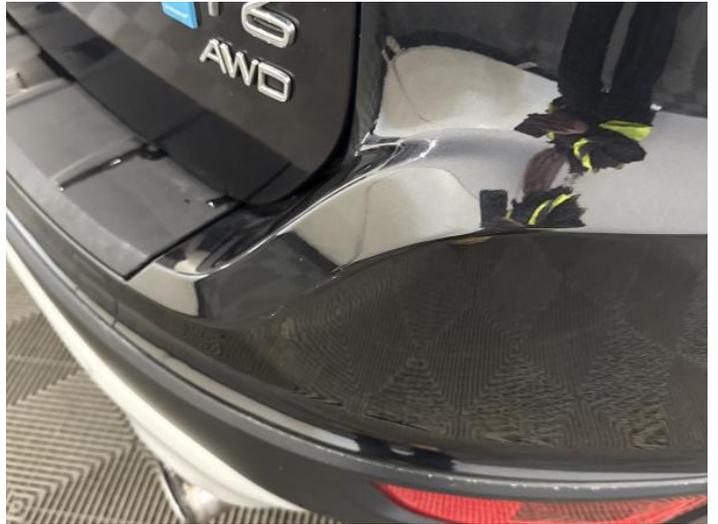
10: Bumper Rear
Scratched
25 to 100mm Thru Paint

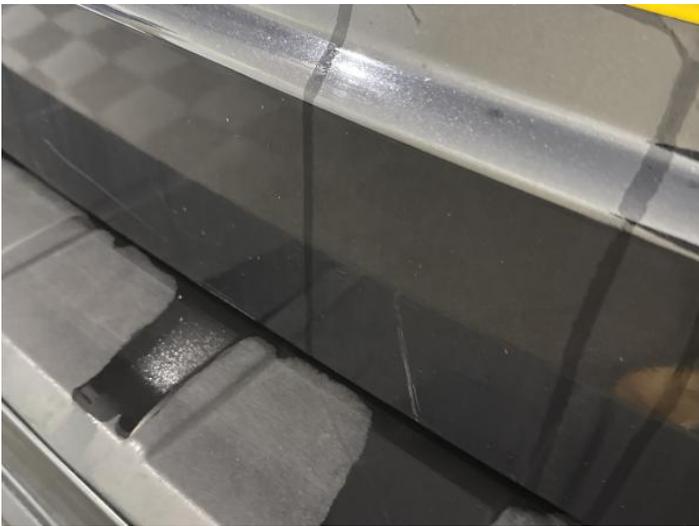
11: Tailgate
Scratched
Over 25mm Thru Paint

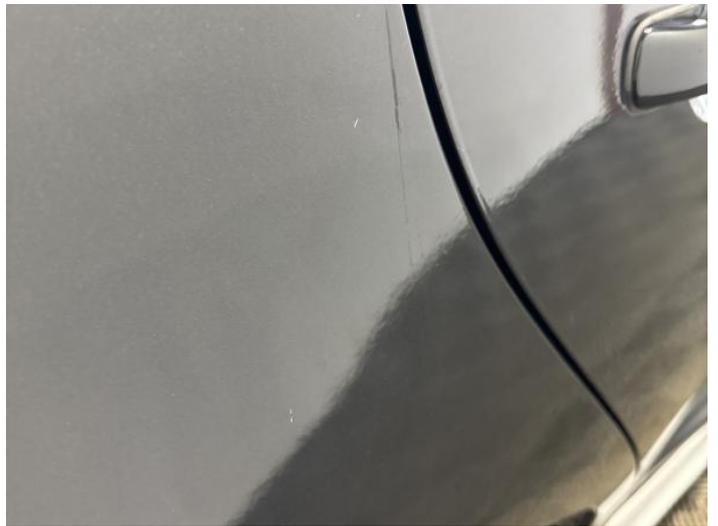
12: Qtr Panel osr
Poor Previous Repair
Rippled UpTo 30%

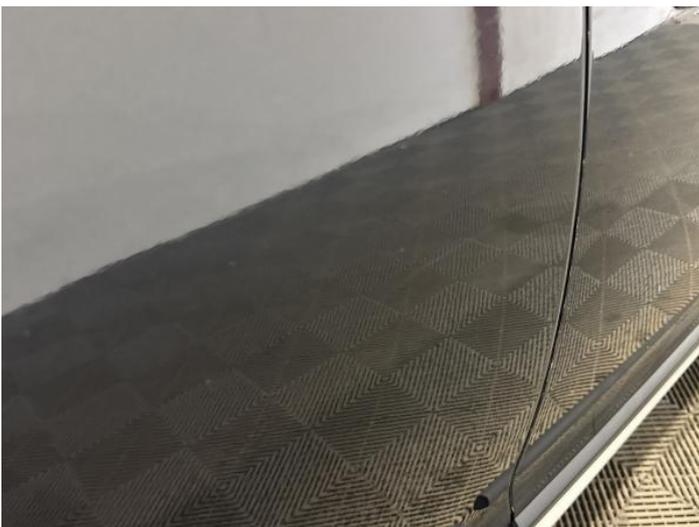
13: Door osr
Poor Previous Repair
Poor Paint

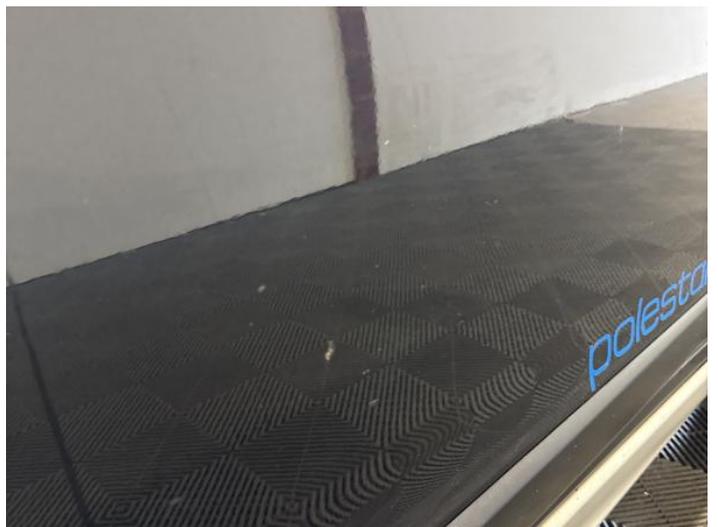
14: Door osf
Chipped
1 To 5

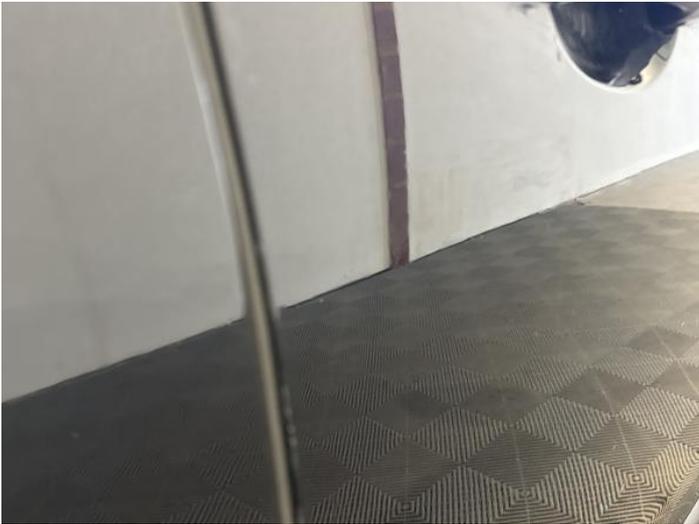
15: Door osf
Dented
2 Or Less UpTo 10mm

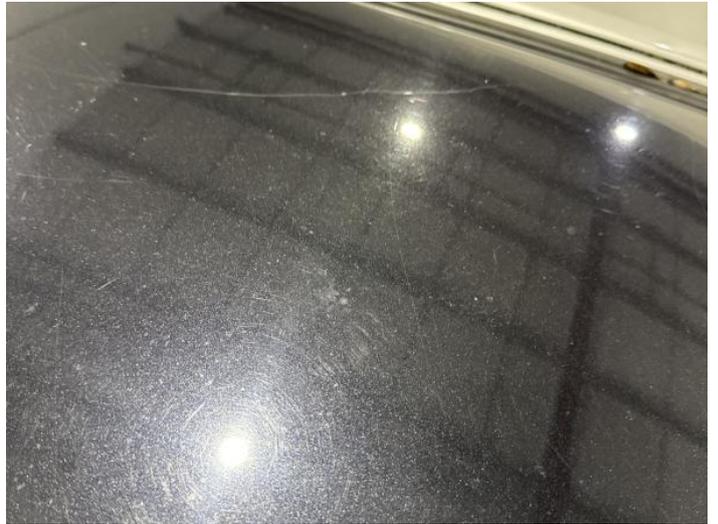
16: Roof
Scratched
Over 25mm Thru Paint

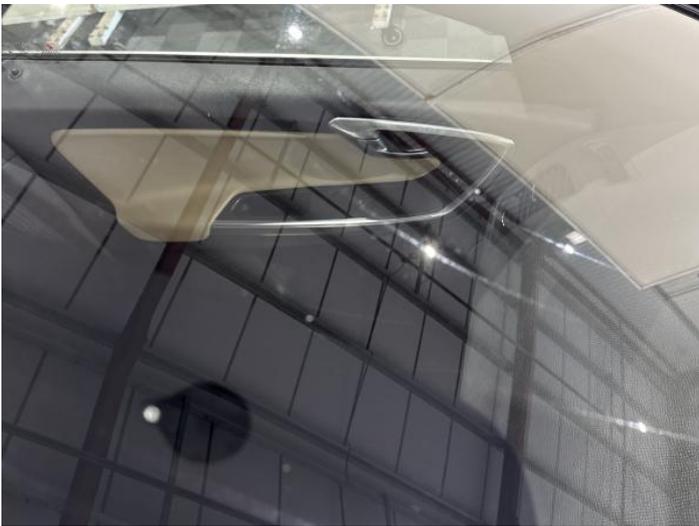
17: Screen Front
Chipped
UpTo 10mm

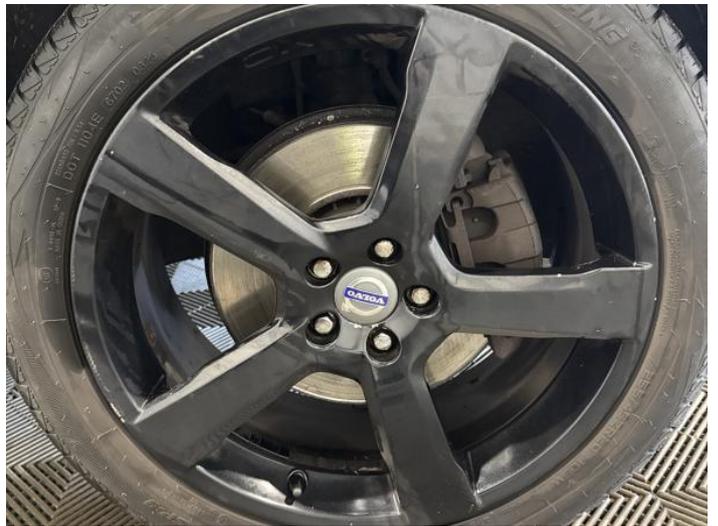
18: Wheel osf
Scratched
Over 50mm

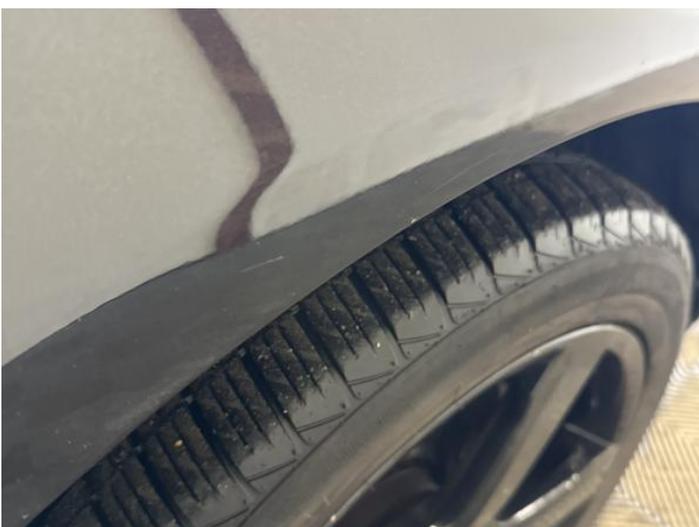
19: Wing osf
Scratched
UpTo 25mm Thru Paint
