# VEHICLE INSPECTION REPORT

**KP71EXE**

## Land Rover Range Rover Evoque 2.0 D200 R-Dynamic HSE 5dr Auto

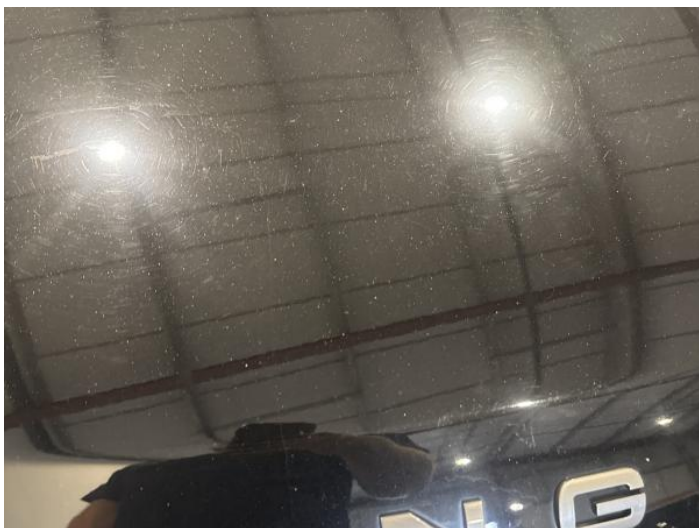
1: Bonnet  
Chipped  
1 To 5

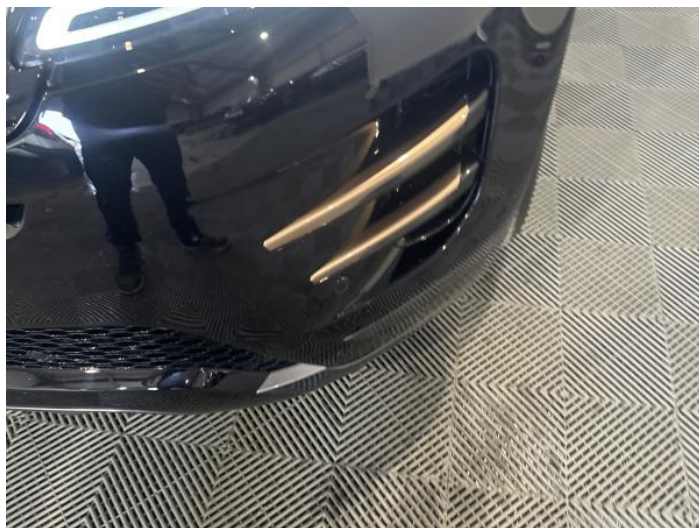
2: Bumper Front  
Chipped  
Multiple Chips

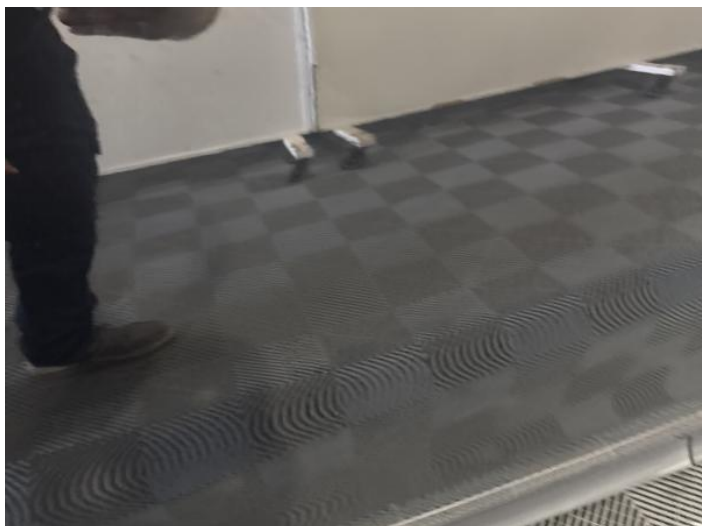
3: Door nsf  
Chipped  
1 To 5

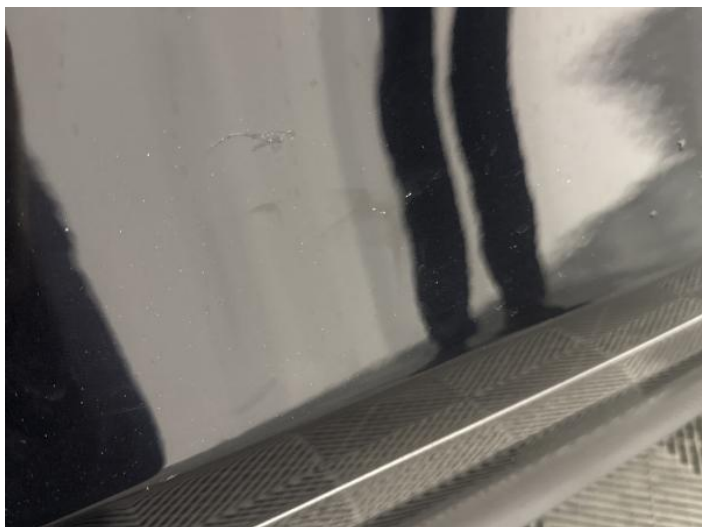
7: Door osf  
Chipped  
1 To 5
