VEHICLE INSPECTION REPORT

AY68ULA

Land Rover Range Rover Velar 2.0 P300 R-Dynamic SE 5dr Auto

nama
GRADE
3

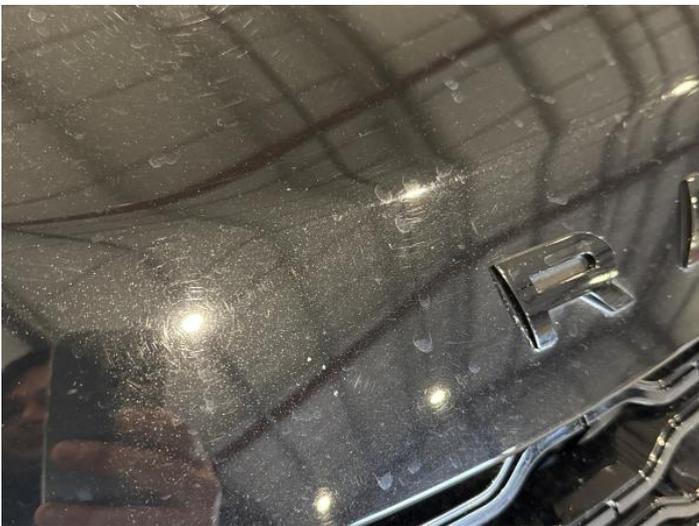
1: Bonnet
Chipped
1 To 5

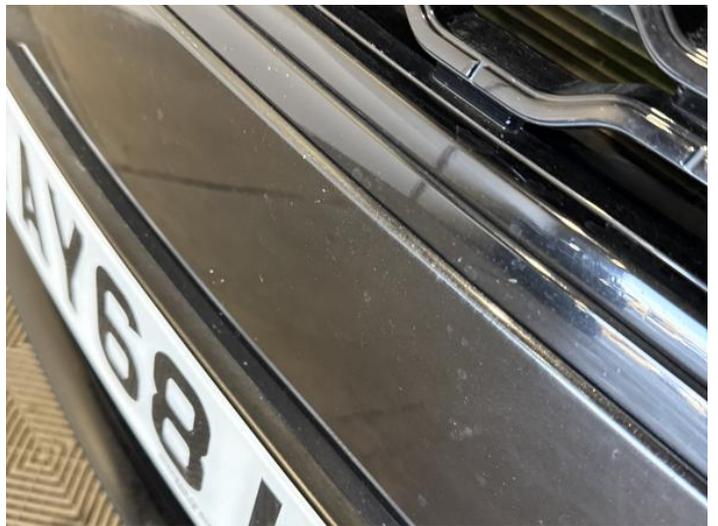
2: Bumper Front
Chipped
1 To 5

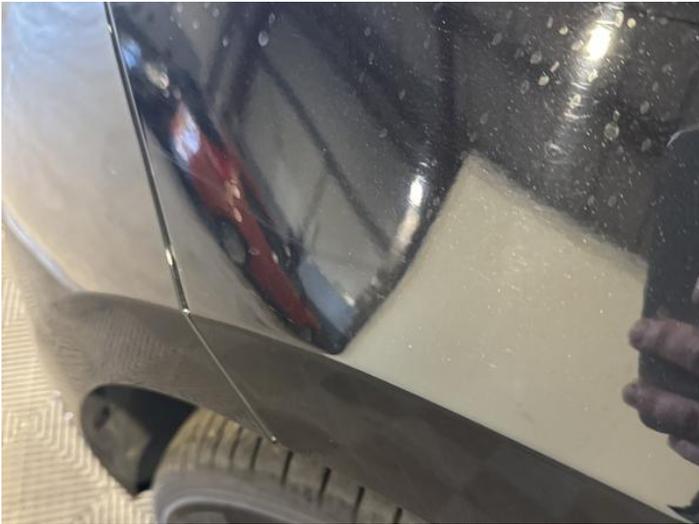
3: Wing nsf
Chipped
1 To 5

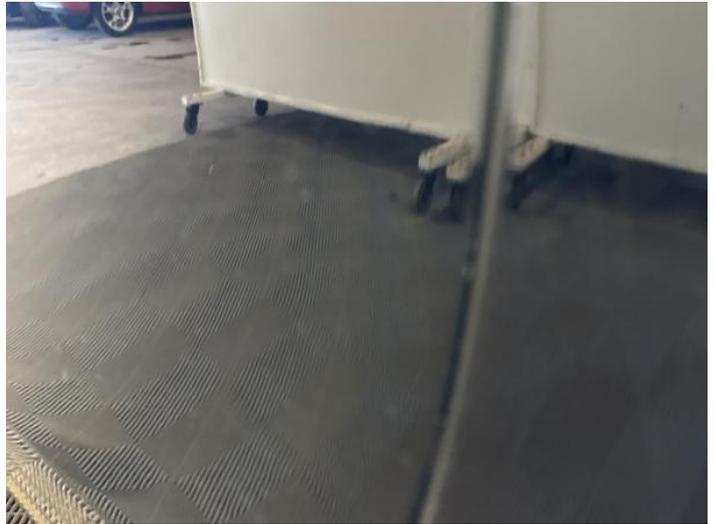
4: Door nsf
Chipped
Edge Chip

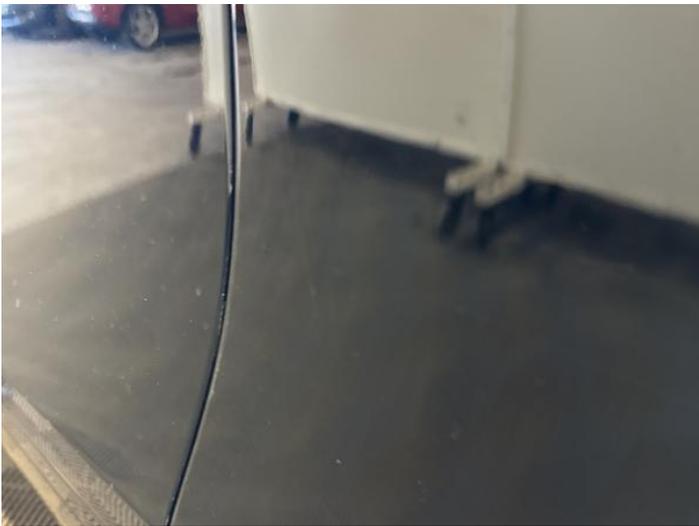
5: Door nsf
Scratched
Over 25mm Thru Paint

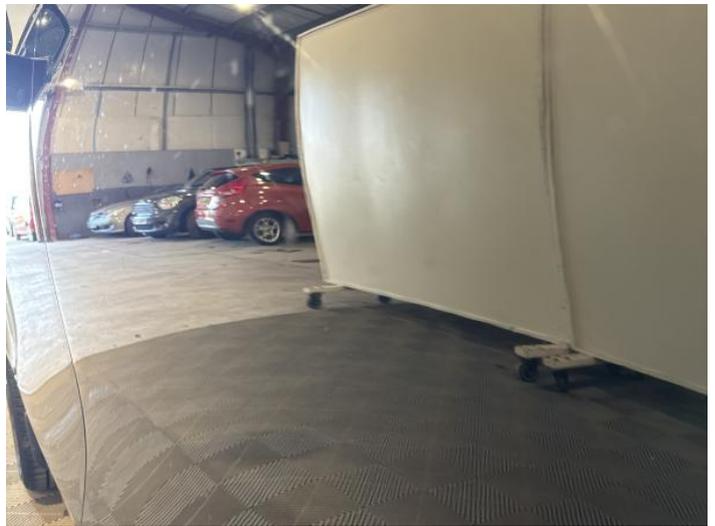
6: Door nsr
Dented
2 Or Less UpTo 10mm

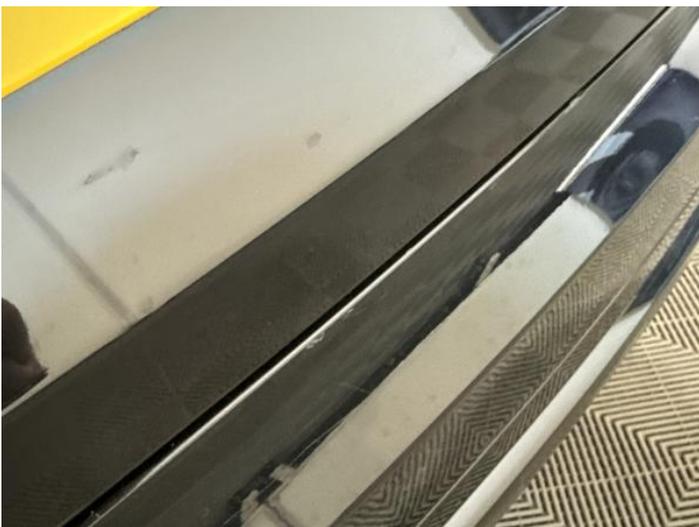
7: Bumper Rear
Scratched
25 to 100mm Thru Paint

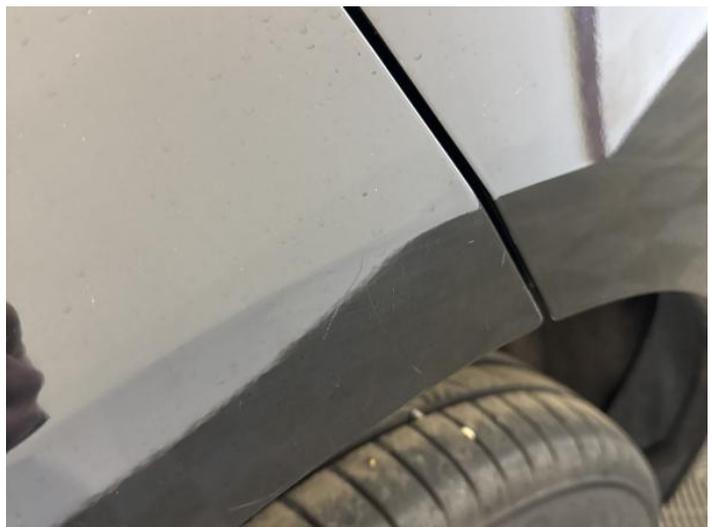
8: Qtr Panel osr
Scratched
UpTo 25mm Thru Paint

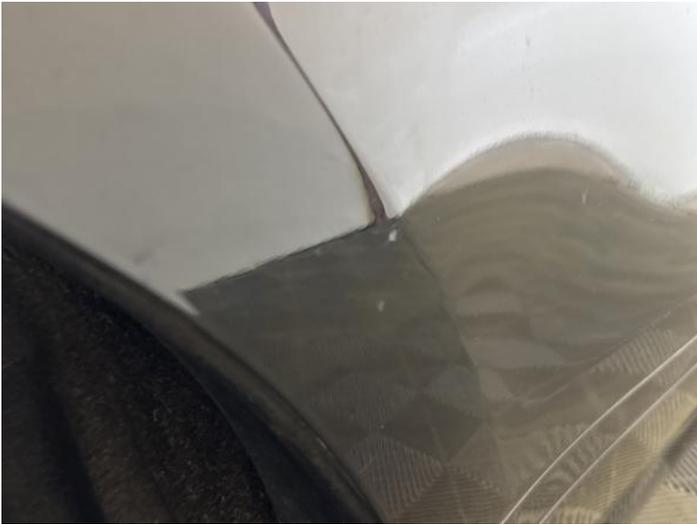
9: Door osr
Poor Previous Repair
Poor Paint

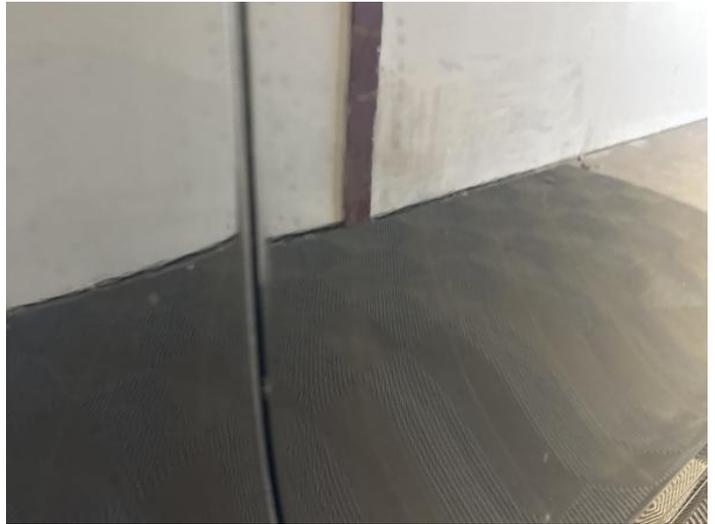
10: Door osf
Chipped
Edge Chip

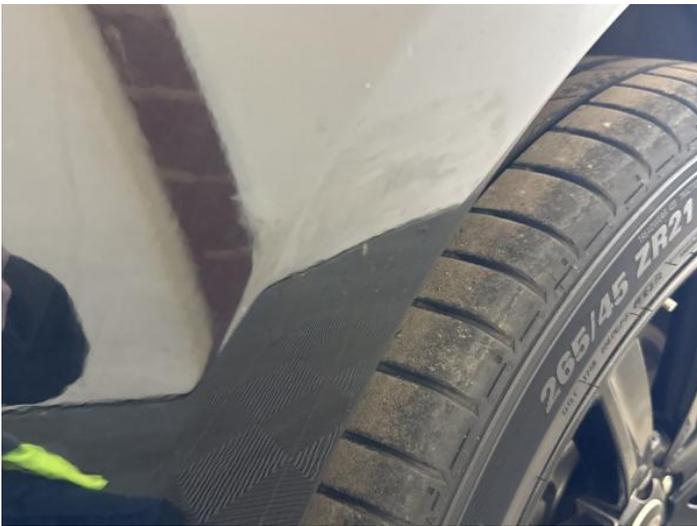
11: Wing osf
Poor Previous Repair
Poor Paint

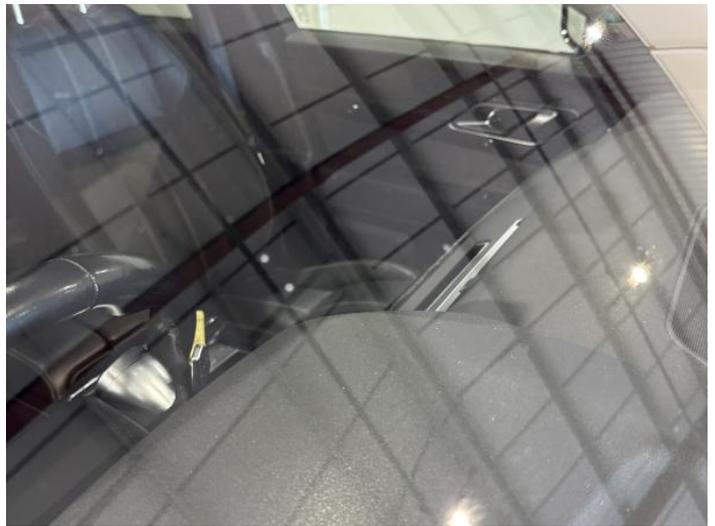
12: Screen Front
Chipped
UpTo 10mm
