# VEHICLE INSPECTION REPORT

**AO11LHL**

## Mercedes-Benz B-Class B200 CDI SE

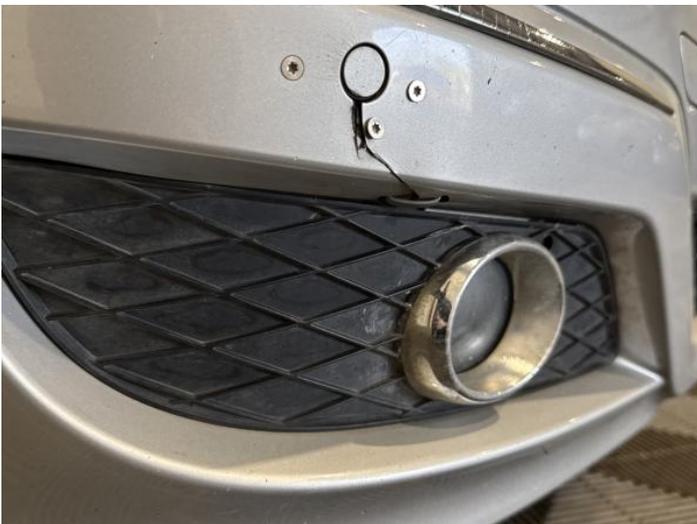
1: Bumper Front  
Cracked  
Over 25mm

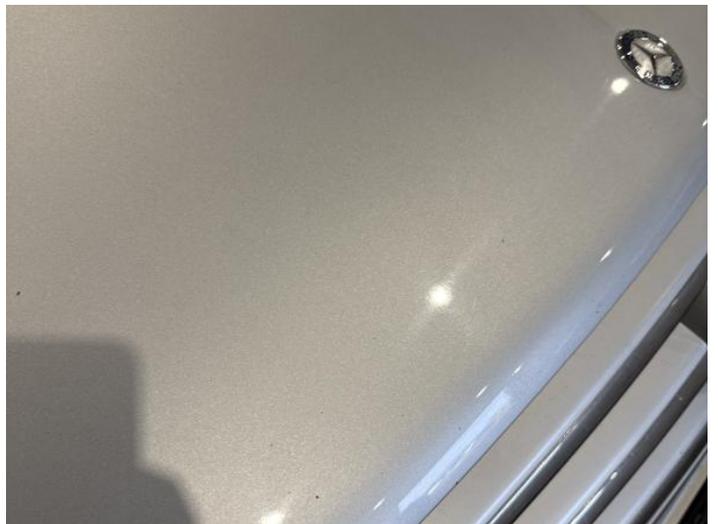
2: Bonnet  
Chipped  
Multiple Chips

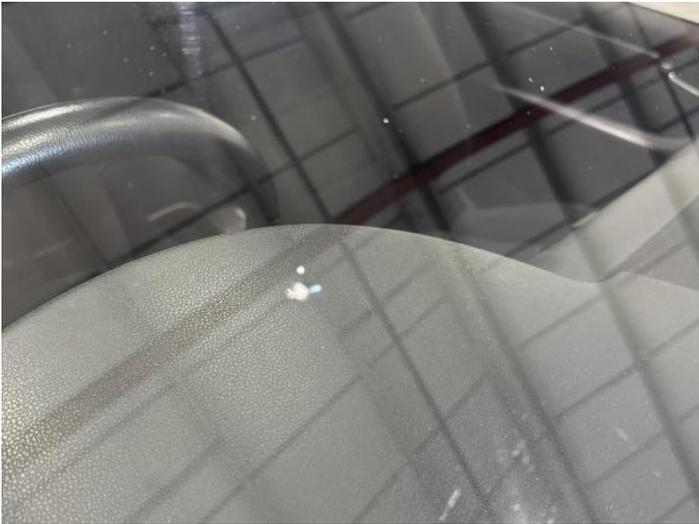
3: Screen Front  
Cracked  
Replace

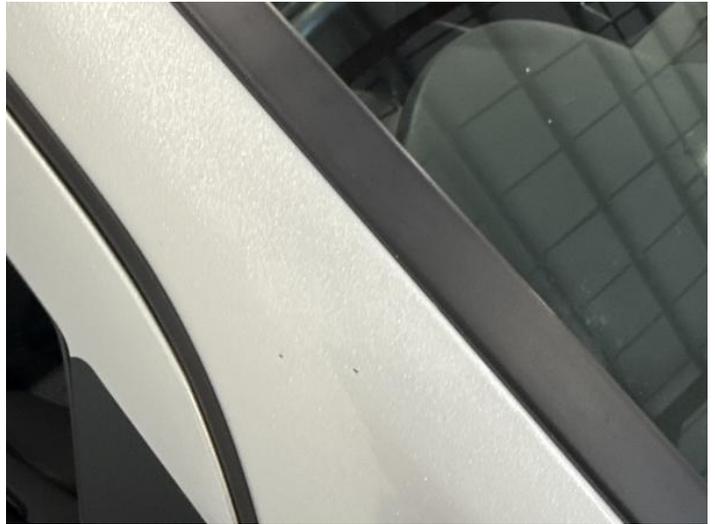
4: A Post os  
Chipped  
1 To 5

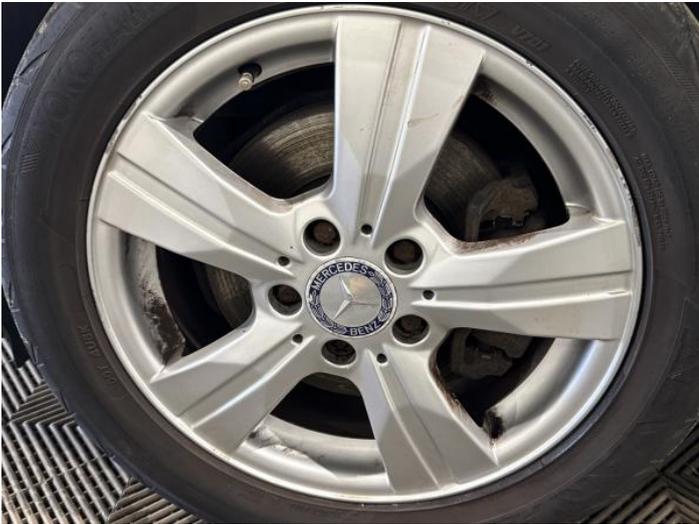
5: Wheel nsf  
Scratched  
Over 50mm

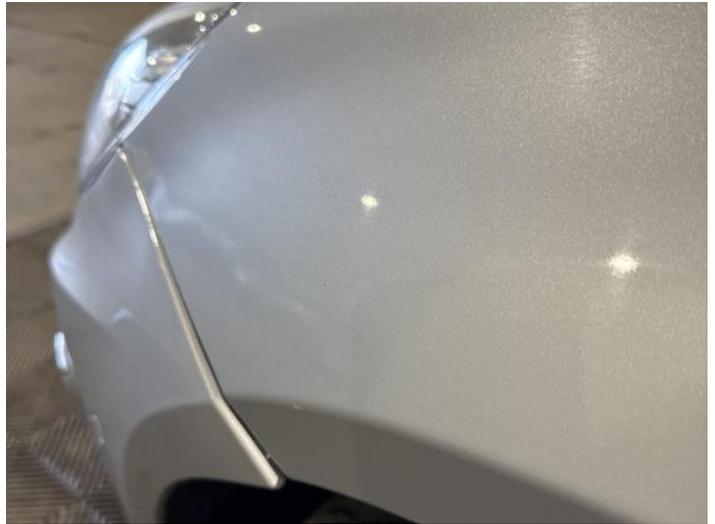
6: Wing nsf  
Chipped  
1 To 5

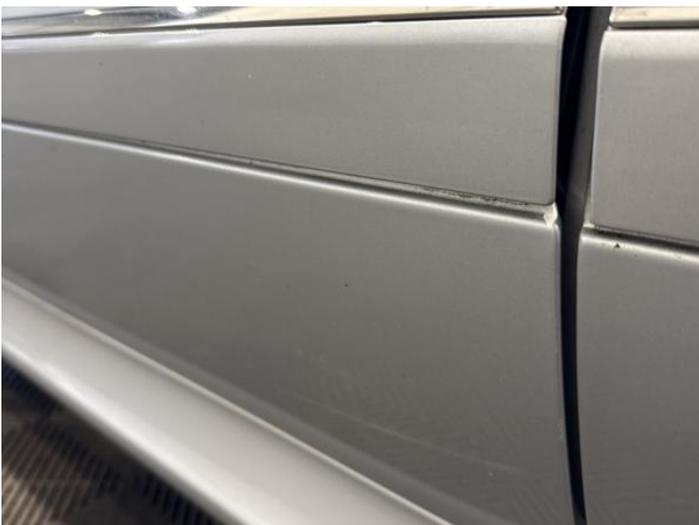
7: Door nsf  
Scratched  
Over 25mm Thru Paint

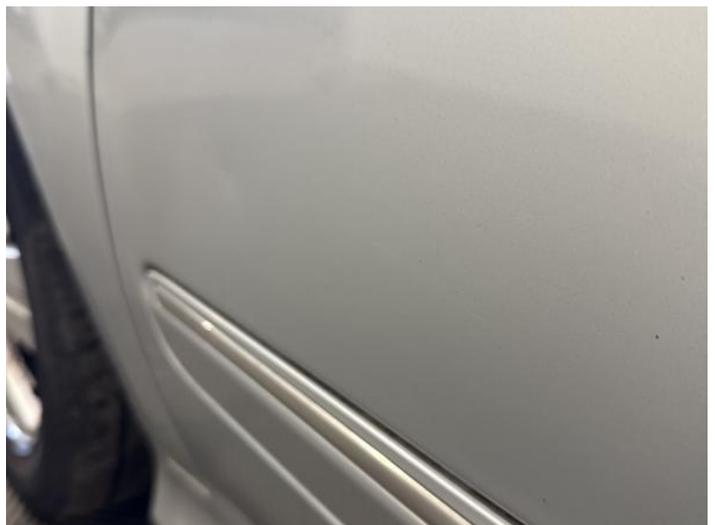
8: Door nsf  
Dented  
Over 30mm

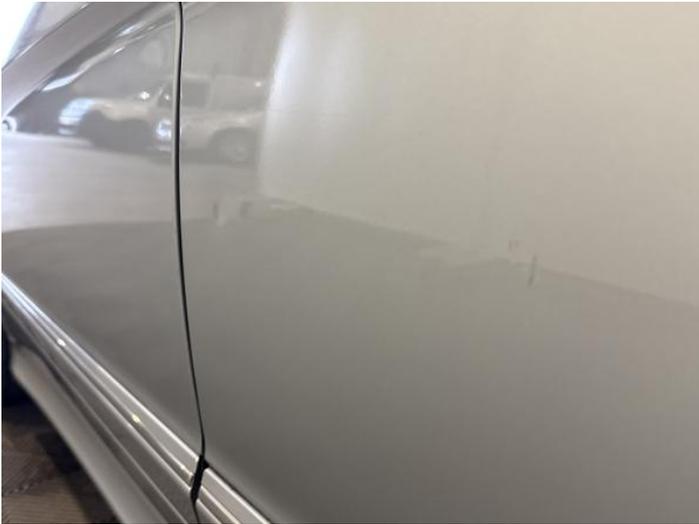
9: Door nsr  
Dented  
With Paint Damage

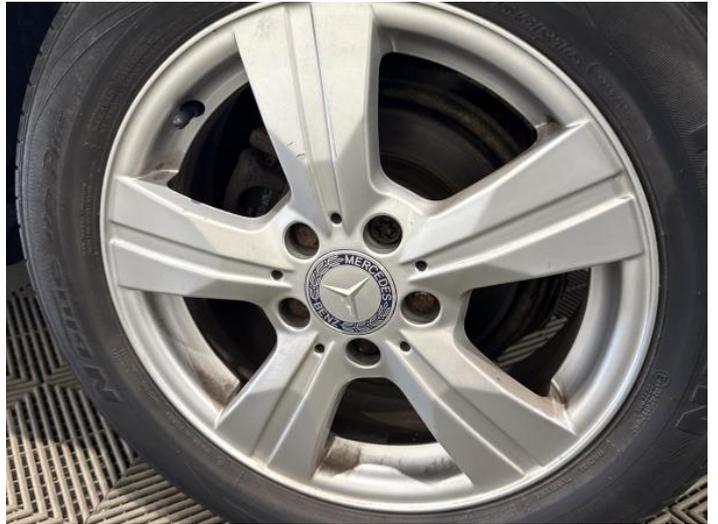
10: Wheel nsr  
Scratched  
Up To 50mm

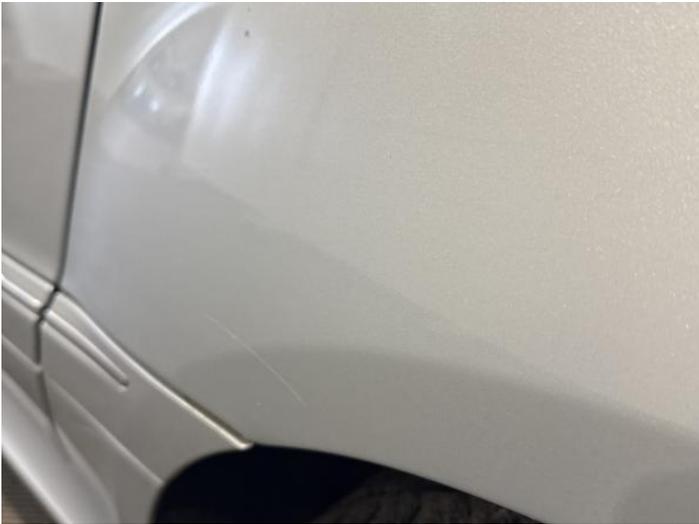
11: Qtr Panel nsr  
Scratched  
Over 25mm Thru Paint

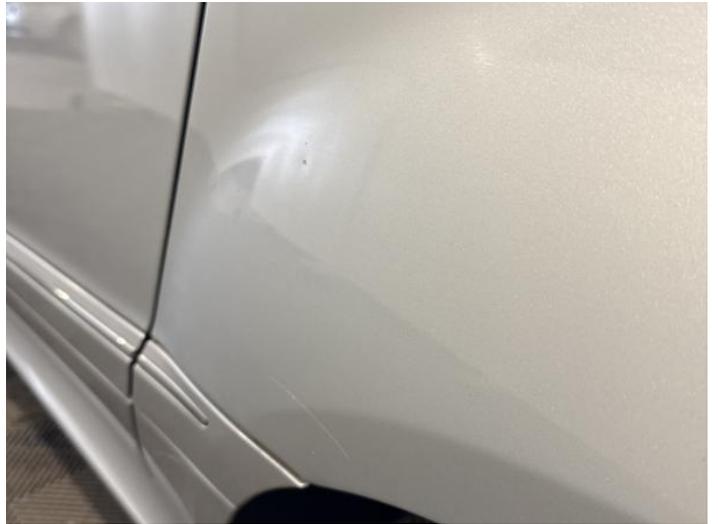
12: Qtr Panel nsr  
Dented  
2 Or Less Up To 10mm

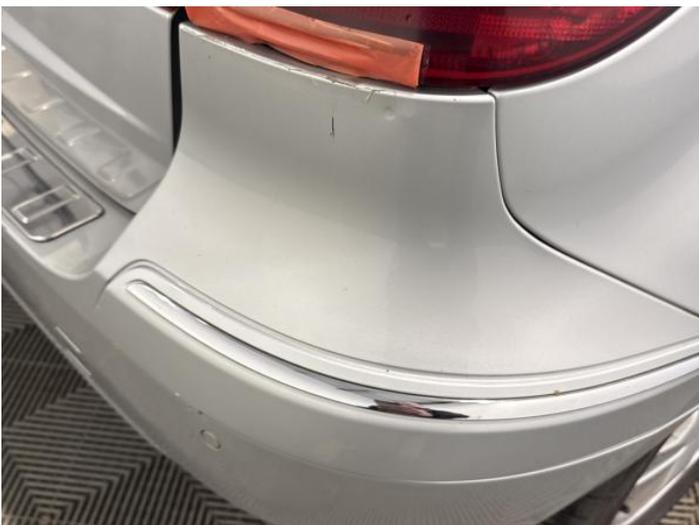
13: Bumper Rear  
Dented  
With Paint Damage

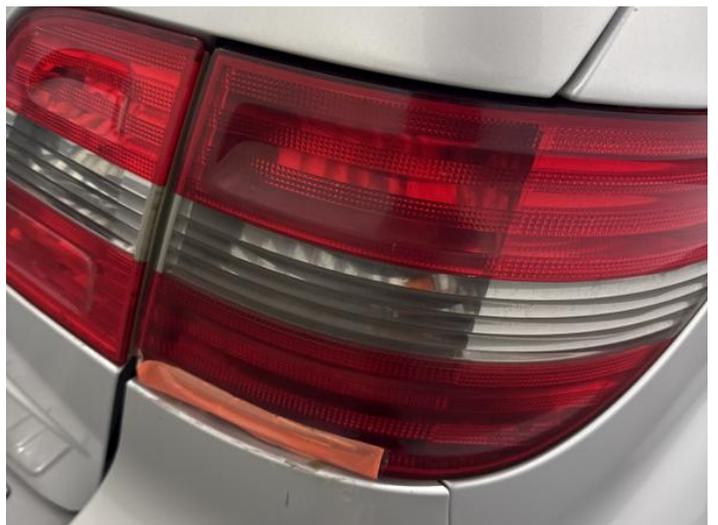
14: Lamp osr  
Broken  
Replace

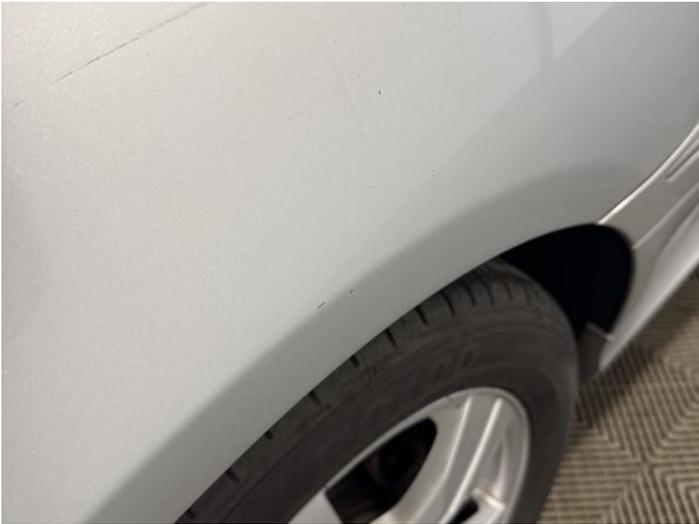
15: Qtr Panel osr  
Scratched  
Rusted

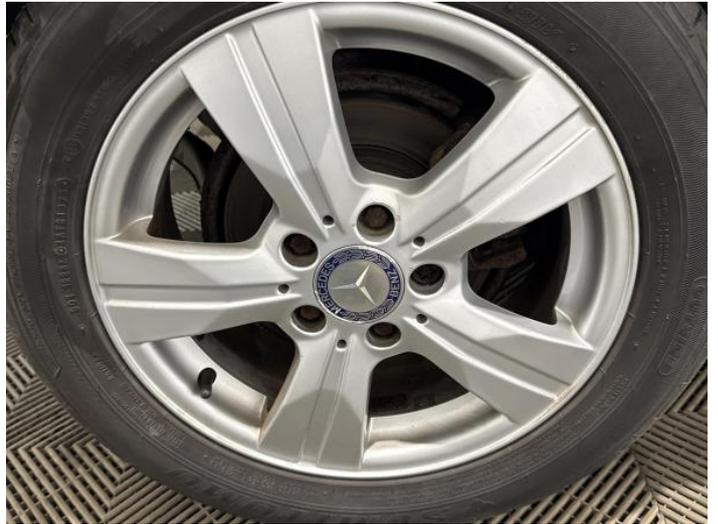
16: Wheel osr  
Scratched  
Up To 50mm

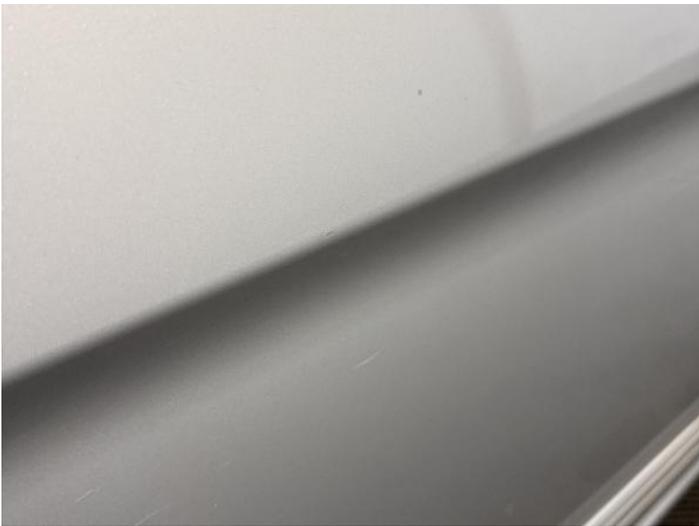
17: Door osr  
Scratched  
Up To 25mm Thru Paint

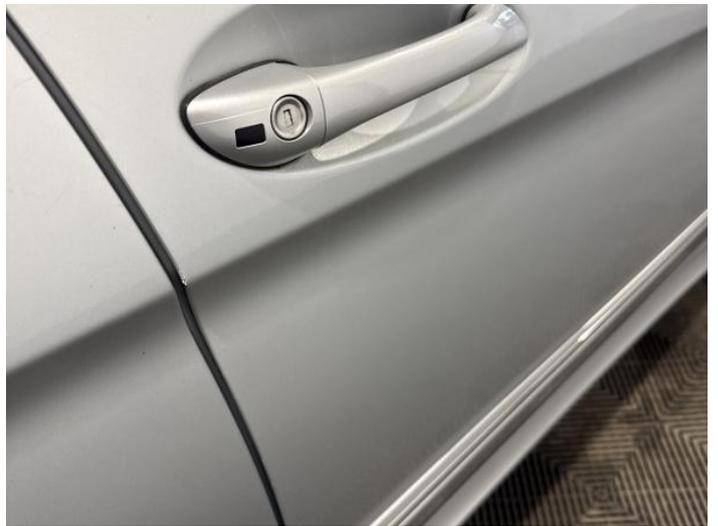
18: Door osf  
Scratched  
Up To 25mm Thru Paint

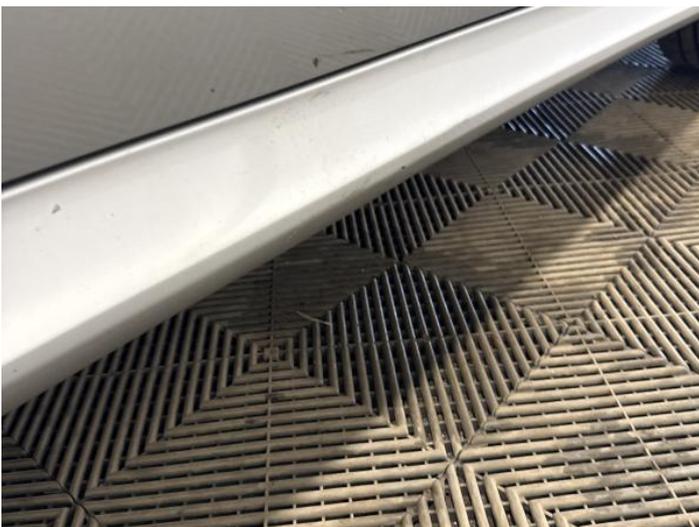
19: Sill Panel Trim os  
Scratched (Painted)  
Over 25mm Thru Paint

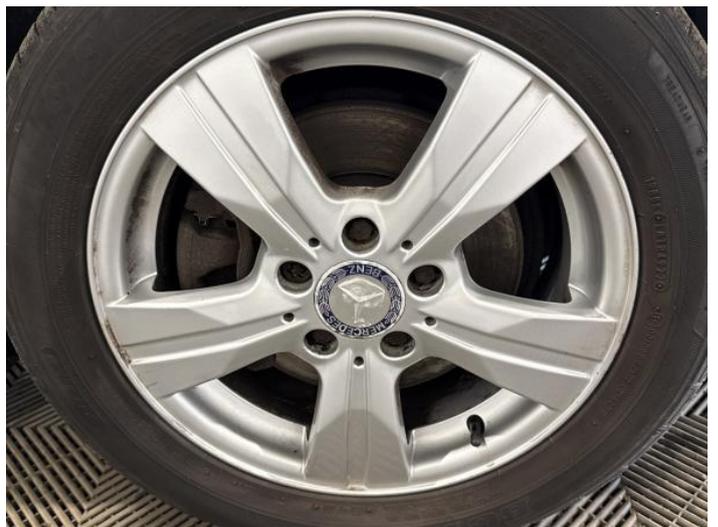
20: Wheel osf  
Scratched  
Up To 50mm

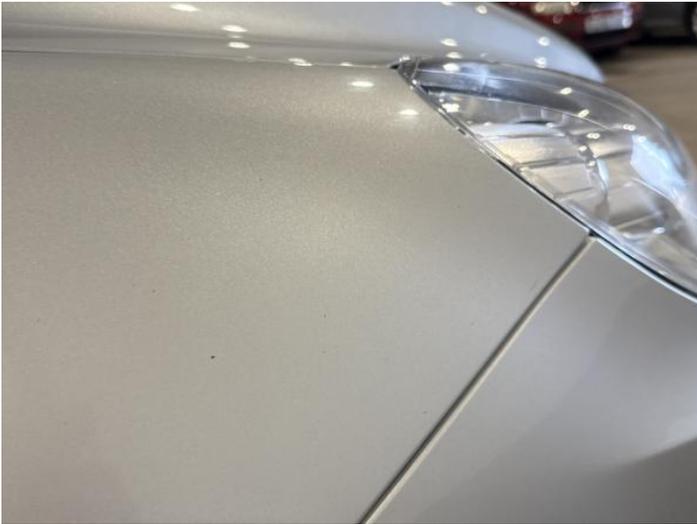
21: Wing osf  
Chipped  
1 To 5
