VEHICLE INSPECTION REPORT

GY65RSZ

Nissan Juke 1.6 N-Connecta 5dr Xtronic

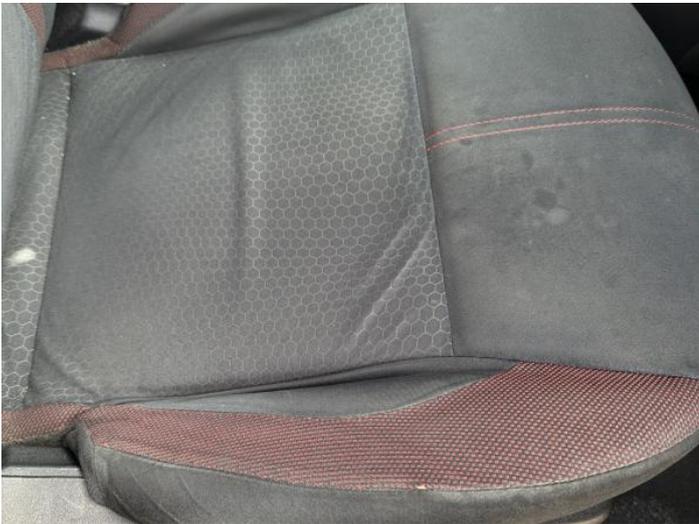
1: Seat Base Cover osf
Scuffed
UpTo 25mm

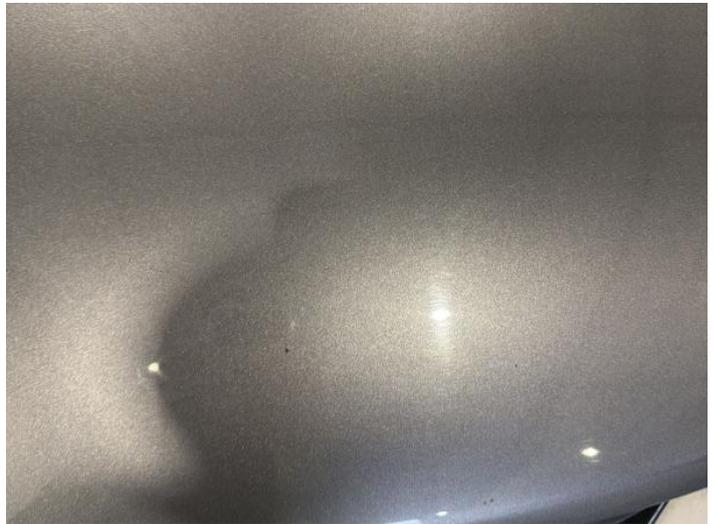
2: Bonnet
Chipped
1 To 5

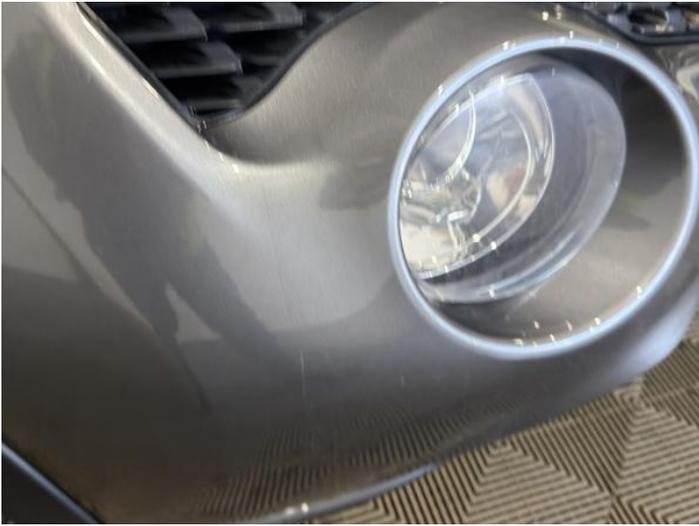
3: Bumper Front
Poor Previous Repair
Poor Paint

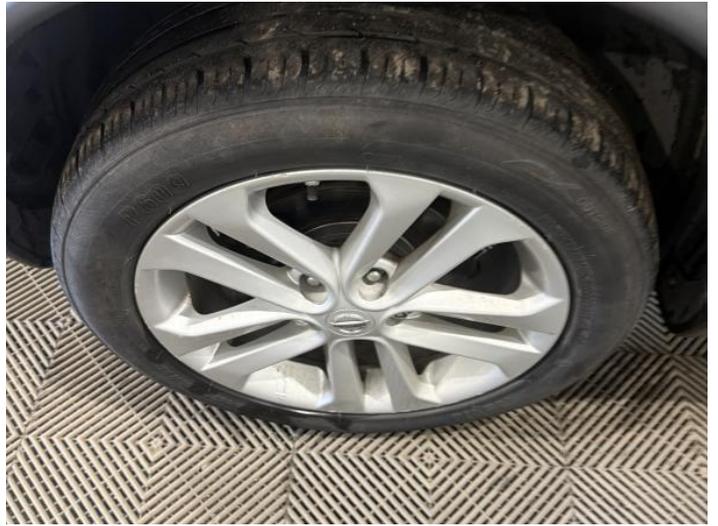
4: Wheel nsf
Scratched
Over 50mm

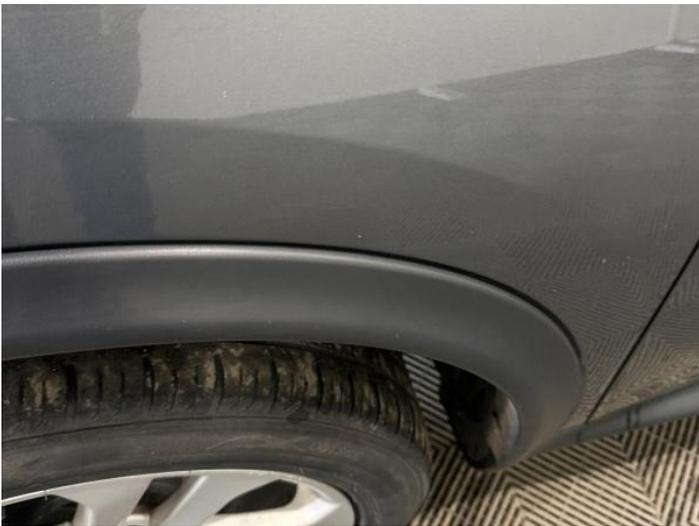
5: Wing nsf
Chipped
1 To 5

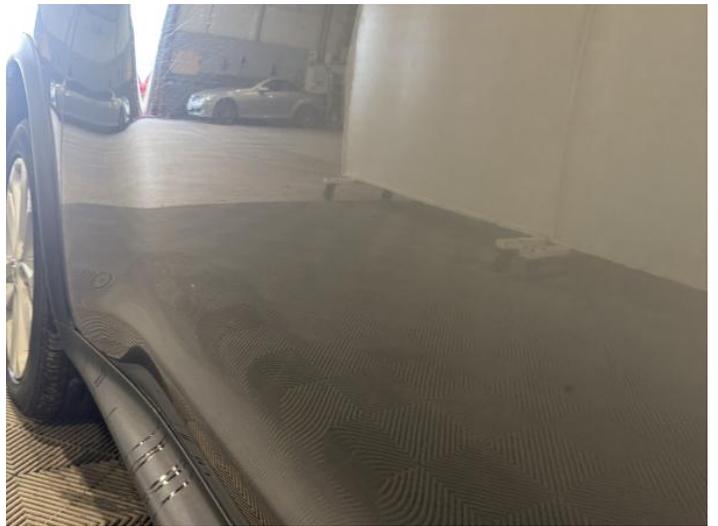
6: Door nsf
Chipped
1 To 5

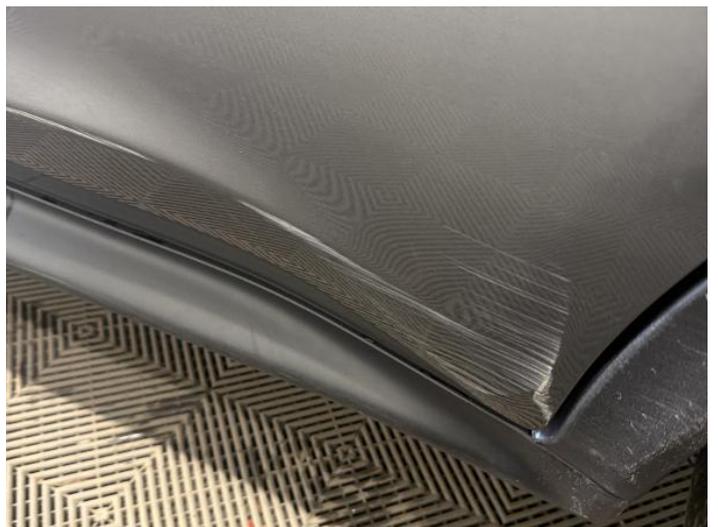
8: Door nsr
Dented
With Paint Damage

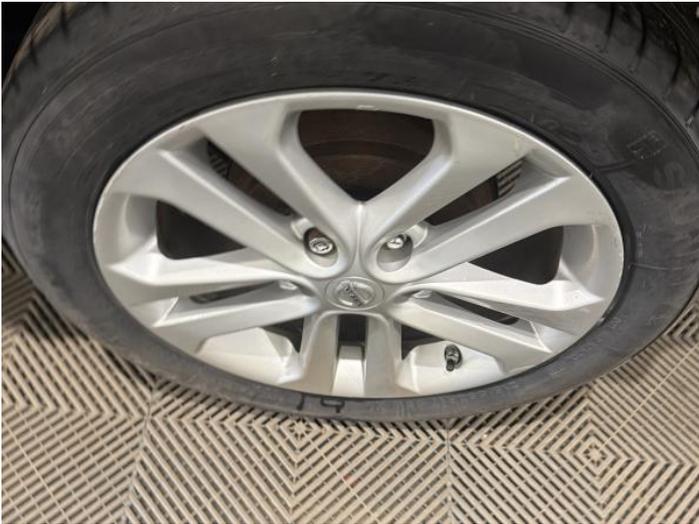
9: Wheel nsr
Scratched
Over 50mm

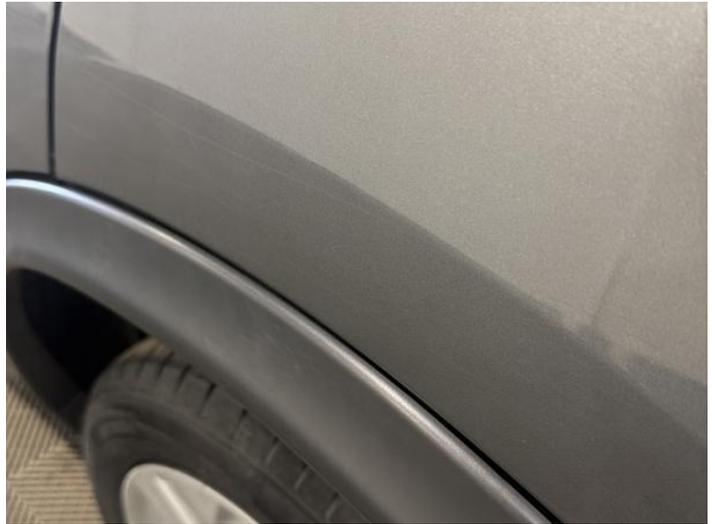
10: Qtr Panel nsr
Chipped
1 To 5

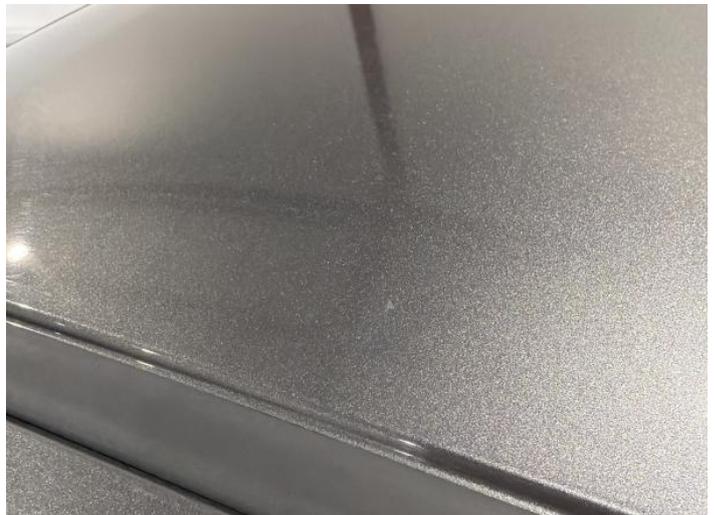
12: Roof
Dented
Over 30mm

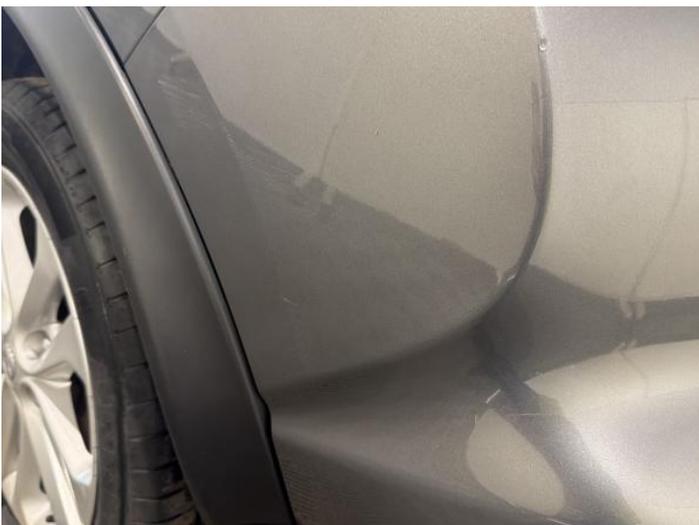
13: Bumper Rear
Scratched
25 to 100mm Thru Paint

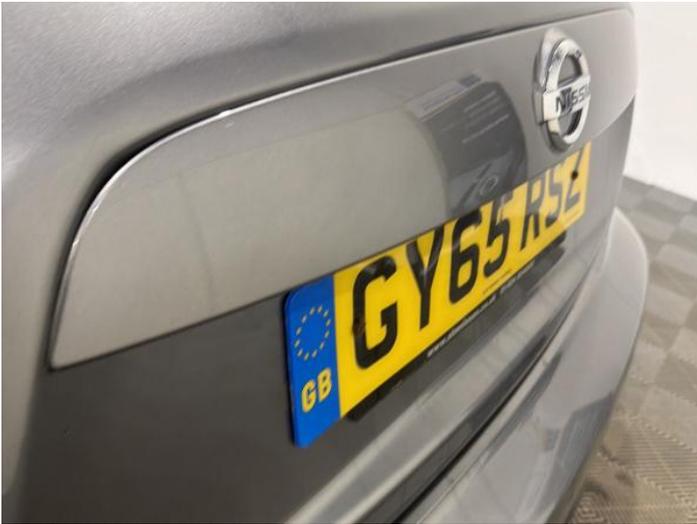
15: Boot Lid
Dented
Over 2 UpTo 10mm

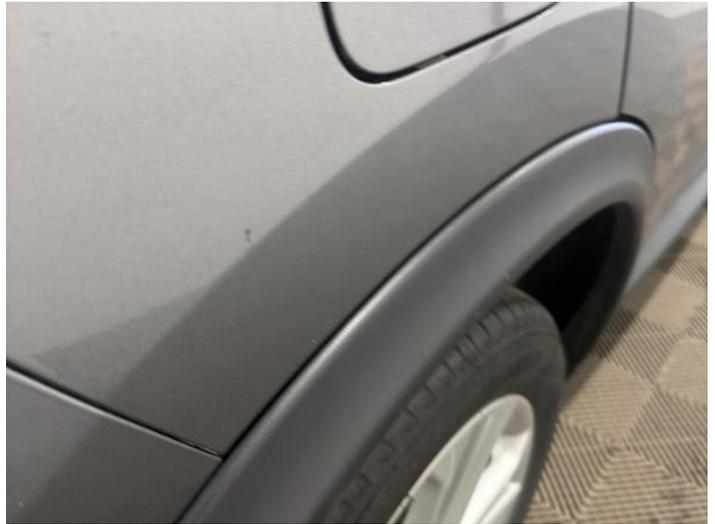
16: Qtr Panel osr
Dented
2 Or Less UpTo 10mm

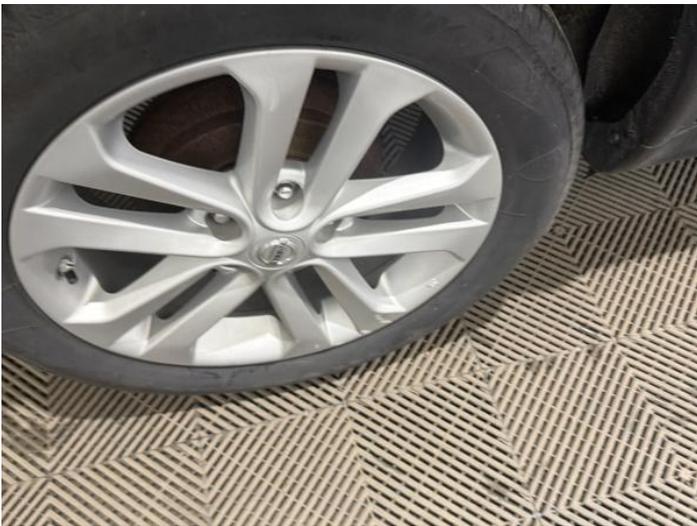
17: Wheel osr
Scratched
Over 50mm

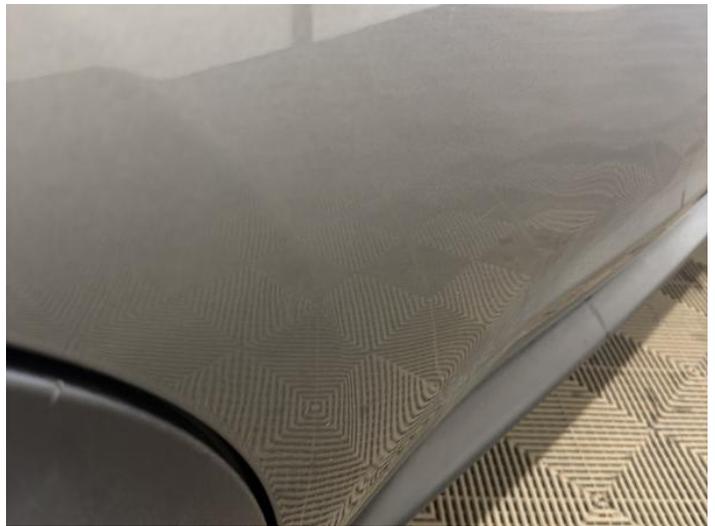
18: Door osf
Dented
Over 2 UpTo 10mm

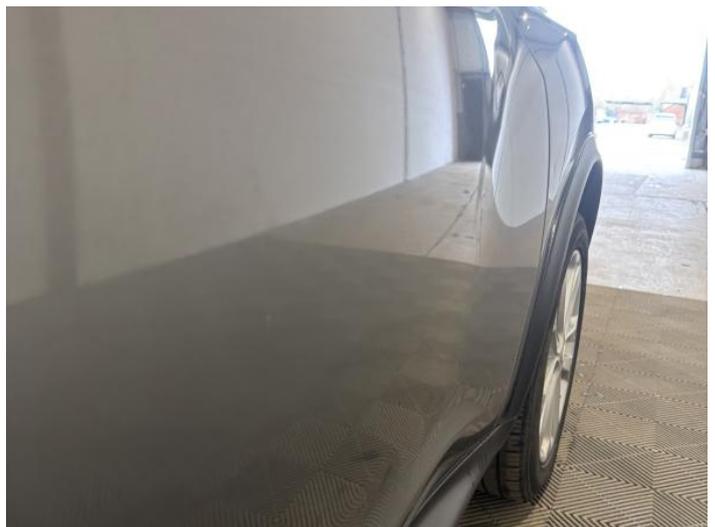
20: Door osf
Poor Previous Repair
Poor Paint

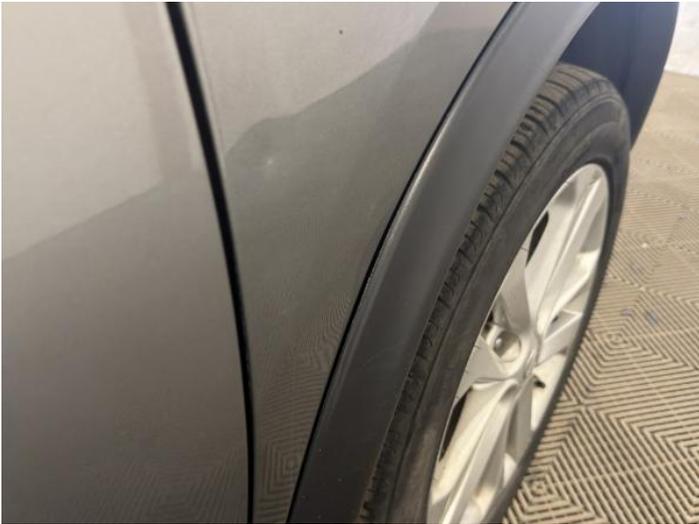
21: Wing of
Dented
Between 10mm + 30mm

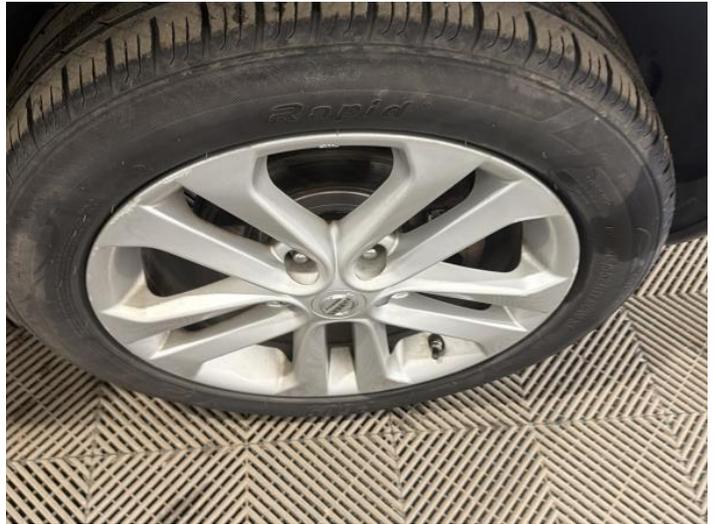
22: Wheel of
Scratched
Over 50mm

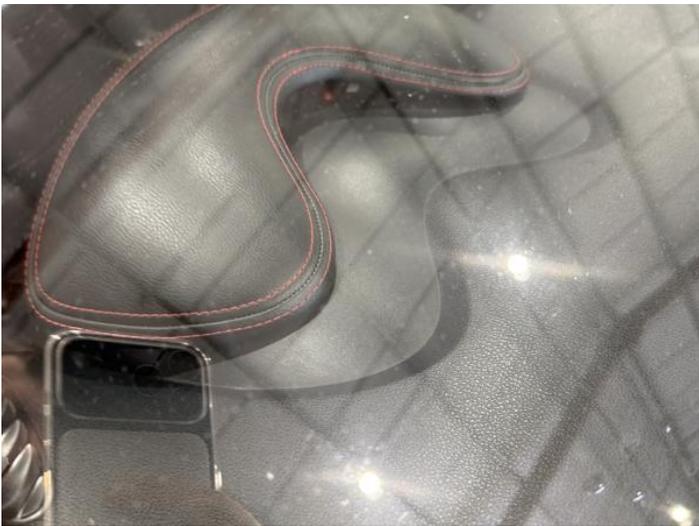
23: Screen Front
Chipped
Up To 10mm
