VEHICLE INSPECTION REPORT

HW70UZL

Ford Ranger Pick Up Double Cab Wildtrak 2.0 EcoBlue 213 Auto

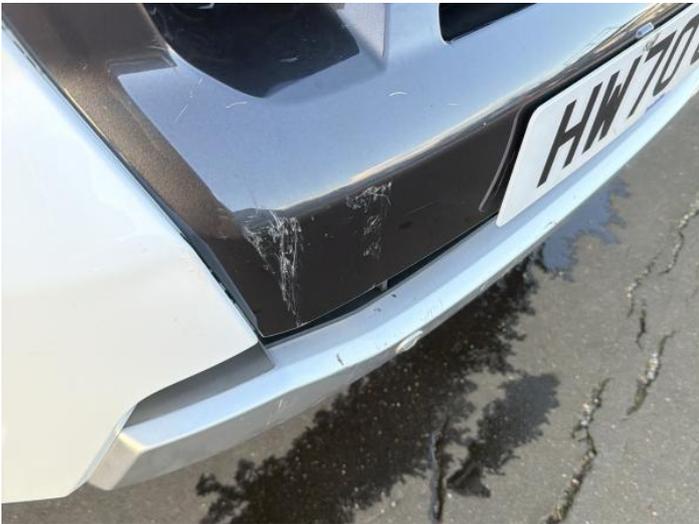
1: Bumper Front Moulding
Scratched (Painted)
Over 25mm Thru Paint

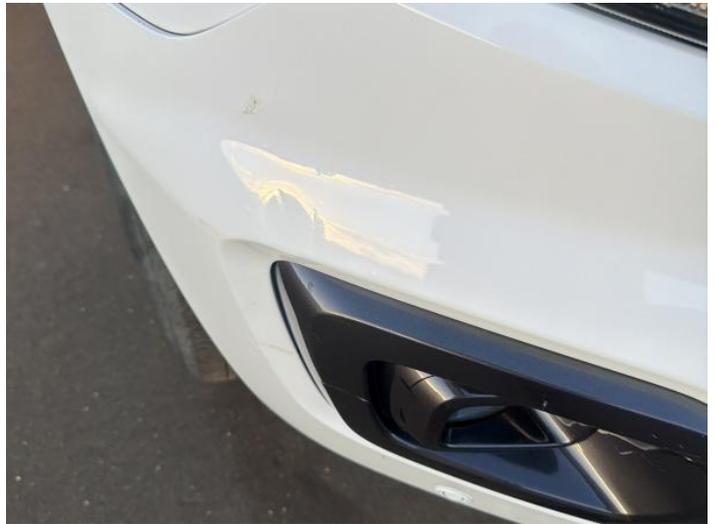
2: Bumper Front
Dented
Over 30mm

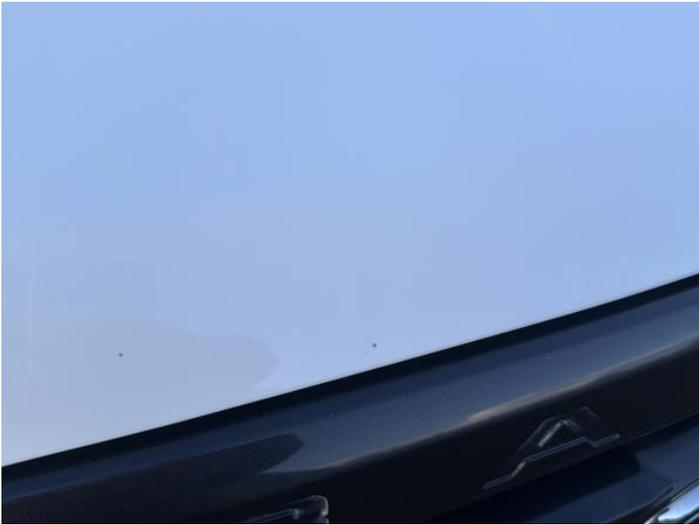
3: Bonnet
Chipped
1 To 5

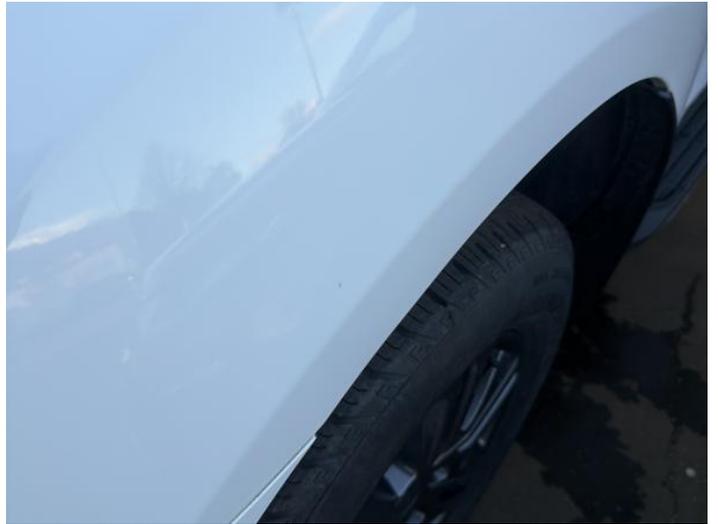
4: Wing nsf
Chipped
1 To 5

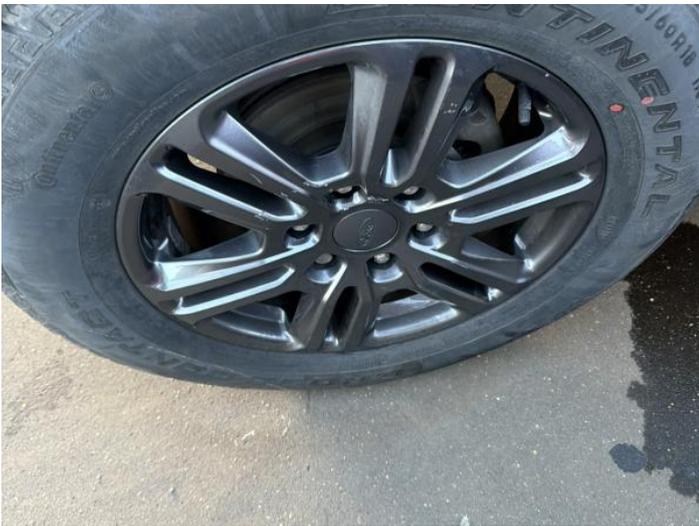
5: Wheel nsf
Scratched
Over 50mm

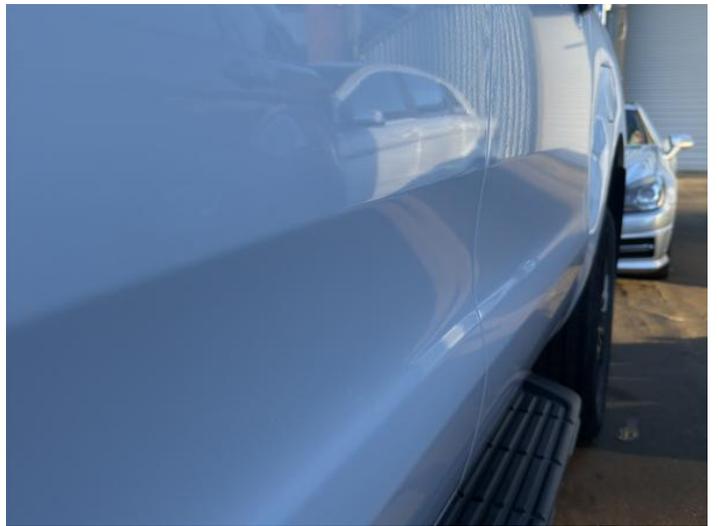
6: Door nsf
Dented
Over 30mm

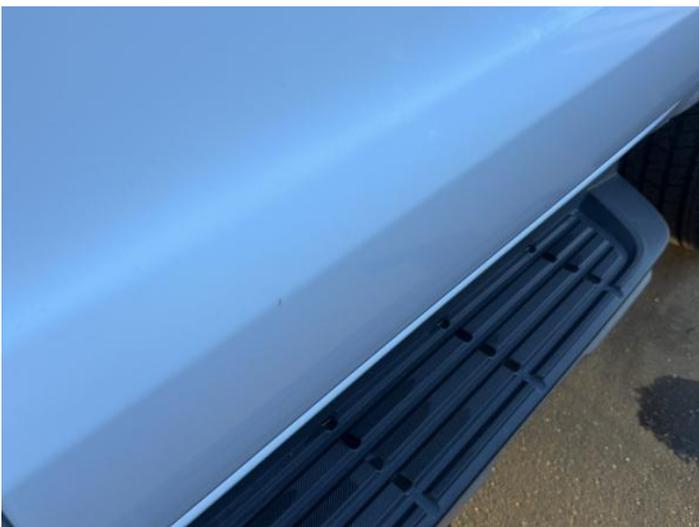
7: Door nsr
Chipped
1 To 5

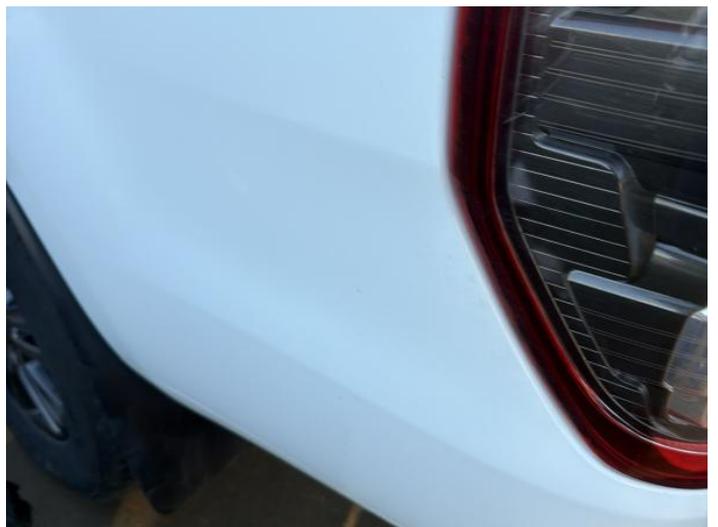
8: Qtr Panel nsr
Chipped
1 To 5

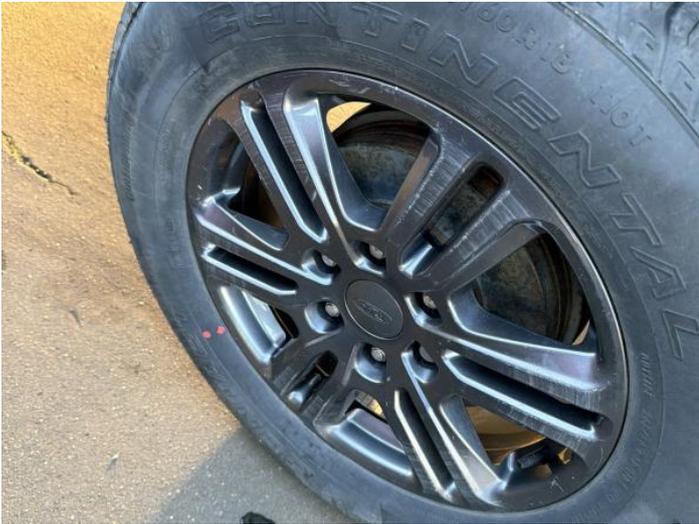
9: Wheel nsr
Scratched
Over 50mm

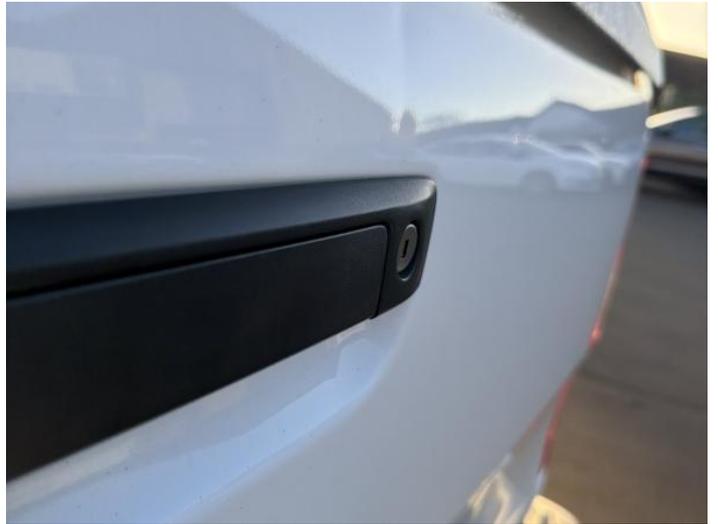
10: Boot Lid
Dented
Over 30mm

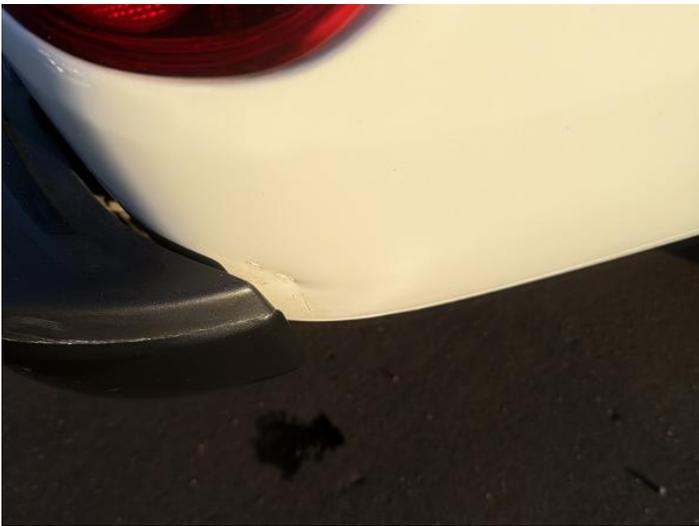
11: Qtr Panel osr
Dented
Over 30mm

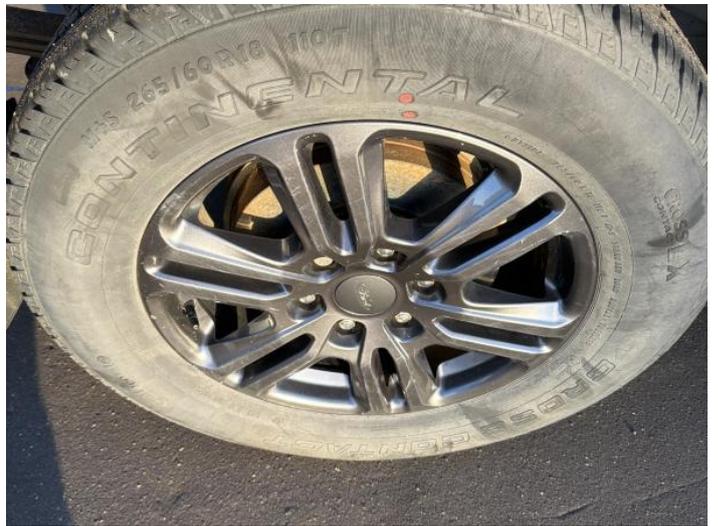
12: Wheel osr
Scratched
Over 50mm

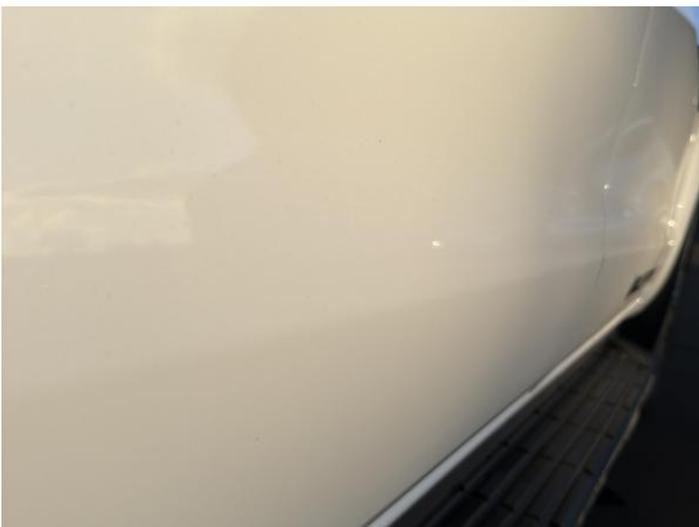
13: Door osr
Dented
Over 2 UpTo 10mm

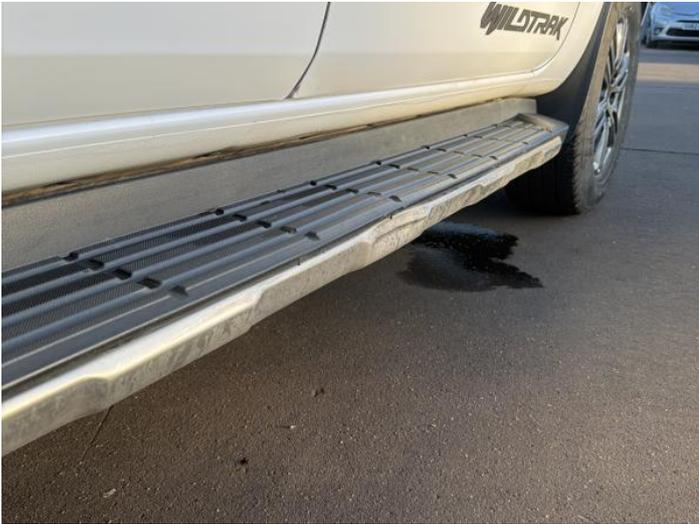
15: Sill Panel Trim os
Broken
Replace

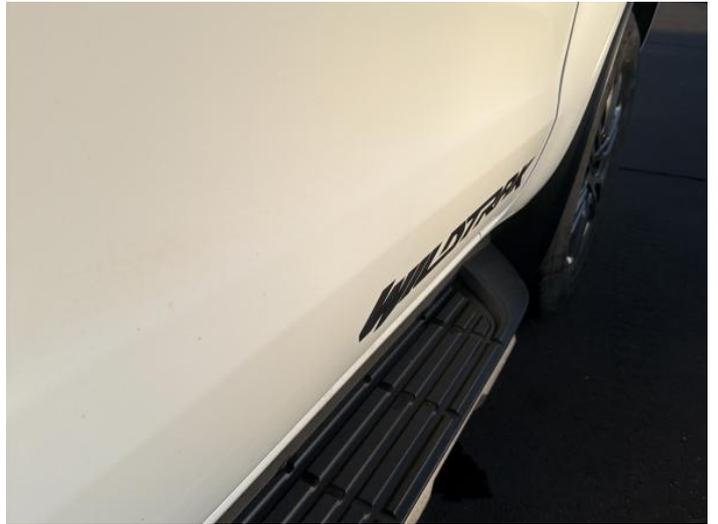
16: Door osf
Dented
Over 30mm

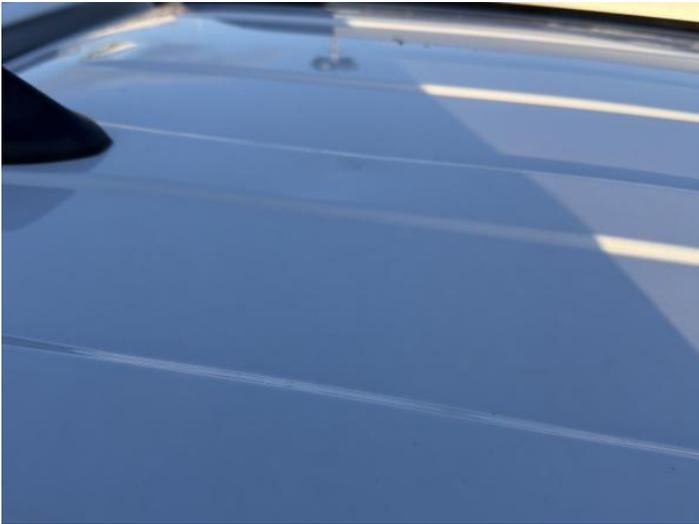
17: Roof
Dented
Over 30mm

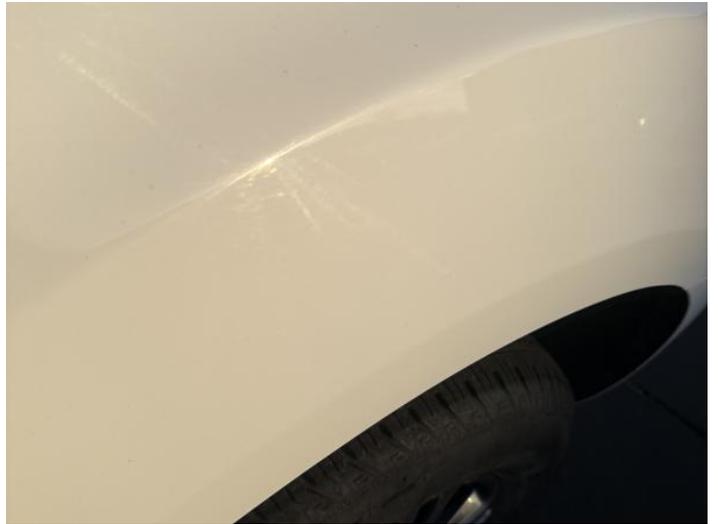
18: Wing osf
Chipped
1 To 5

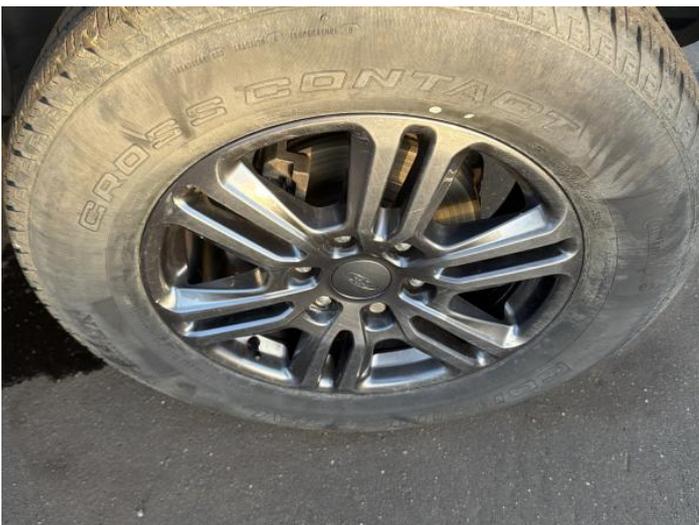
19: Wheel osf
Scratched
Up To 50mm
