VEHICLE INSPECTION REPORT

LJ72AJW

Toyota Corolla 1.8 VVT-i Hybrid GR Sport 5dr CVT

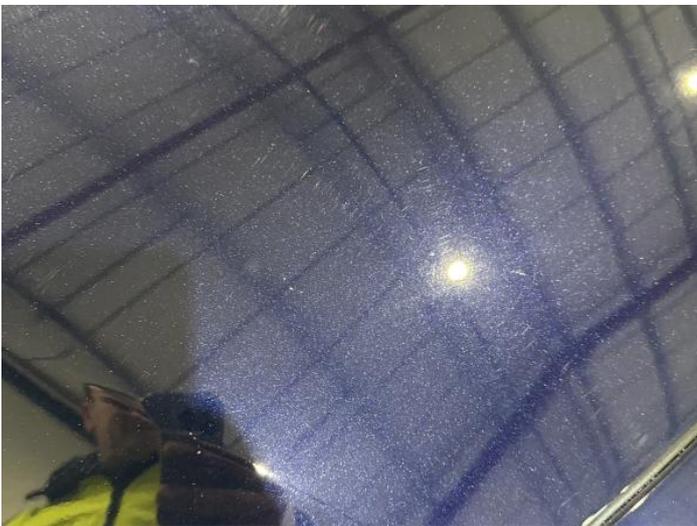
1: Bonnet
Chipped
1 To 5

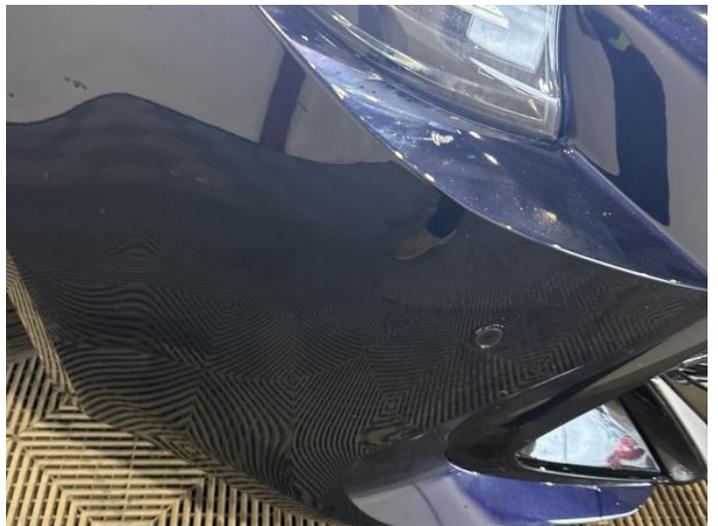
2: Bumper Front
Scratched
25 to 100mm Thru Paint

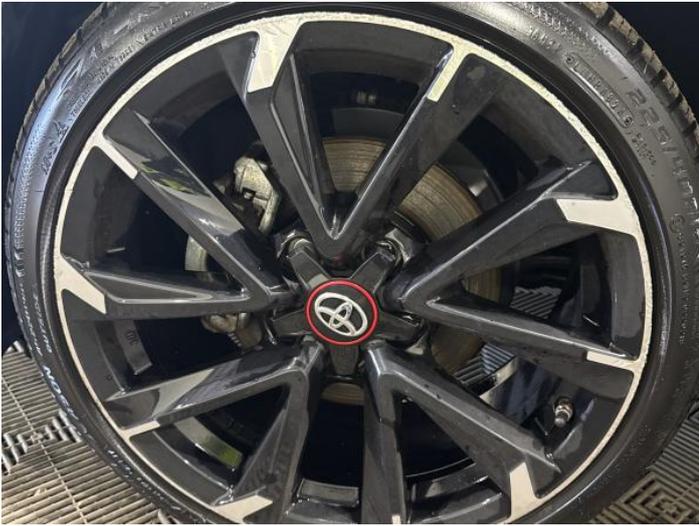
3: Wheel nsf
Scratched
Over 50mm

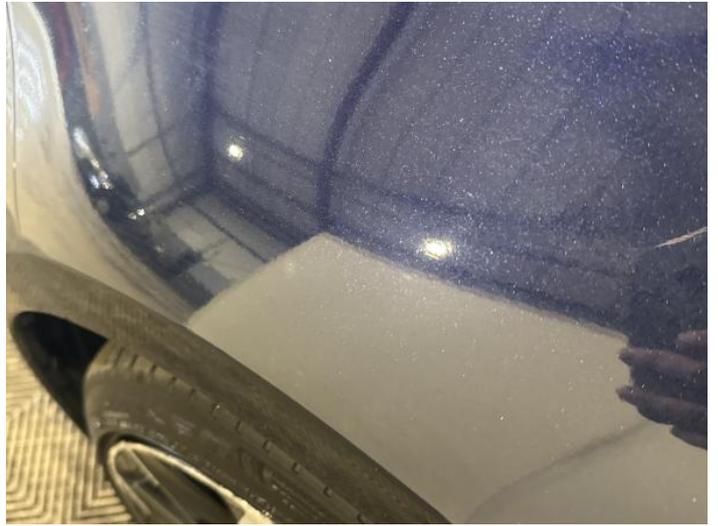
4: Wing nsf
Chipped
1 To 5

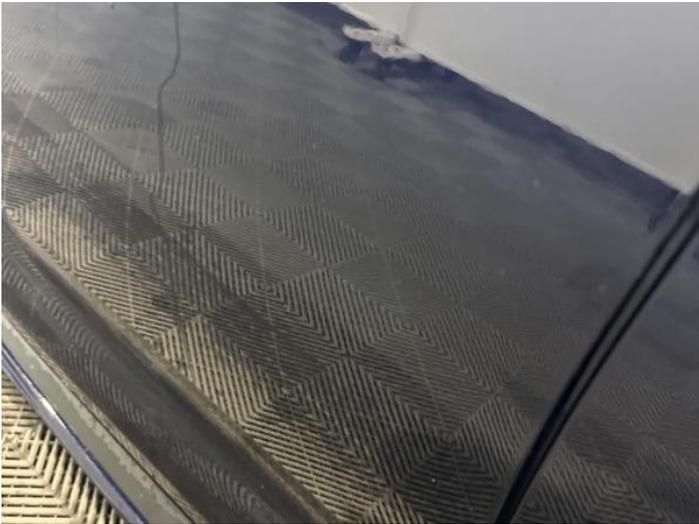
5: Door nsf
Chipped
1 To 5

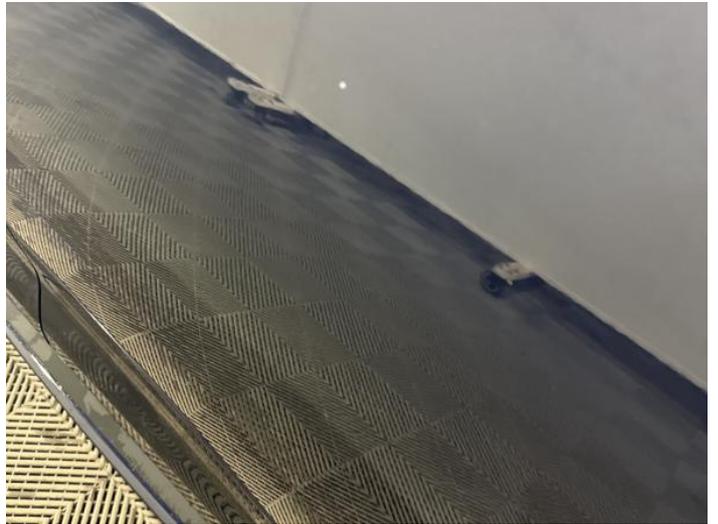
6: Door nsr
Scratched
Over 25mm Thru Paint

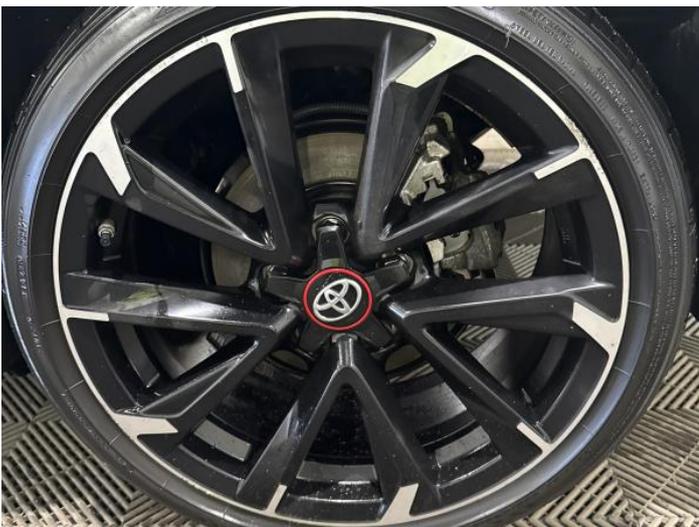
7: Wheel nsr
Scratched
Over 50mm

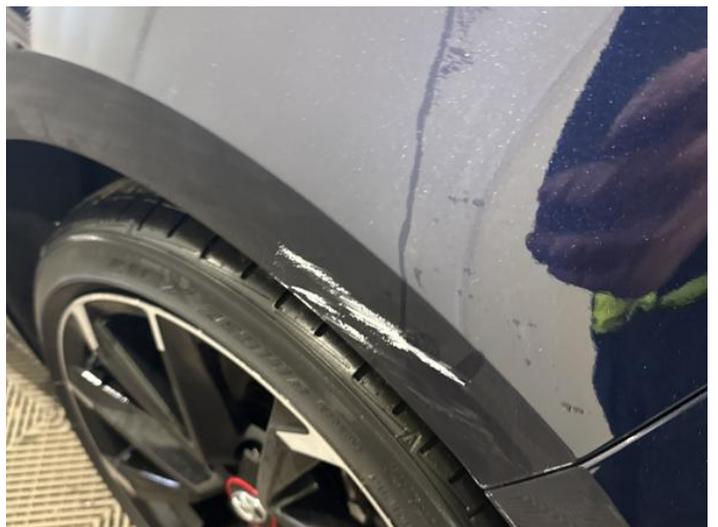
8: Qtr Panel nsr
Scratched
Over 25mm Thru Paint

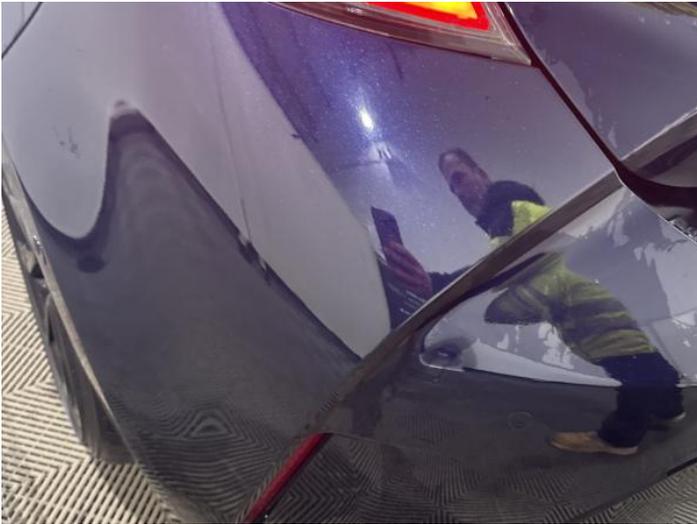
9: Bumper Rear
Scratched
Over 100mm Thru Paint

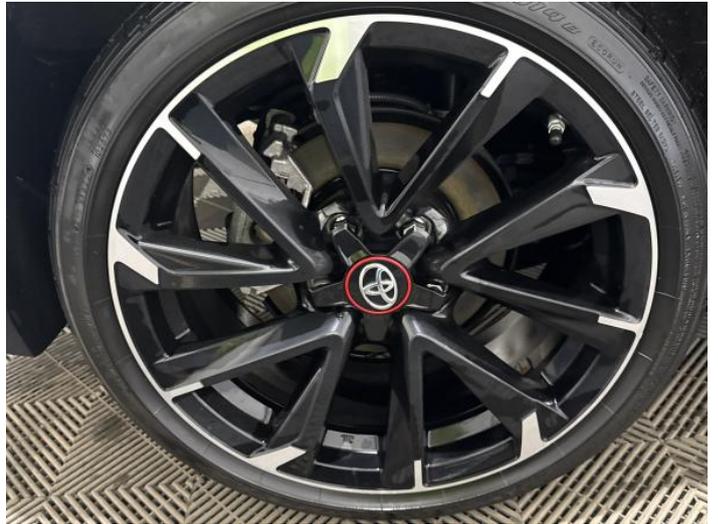
10: Wheel osr
Scratched
Up To 50mm

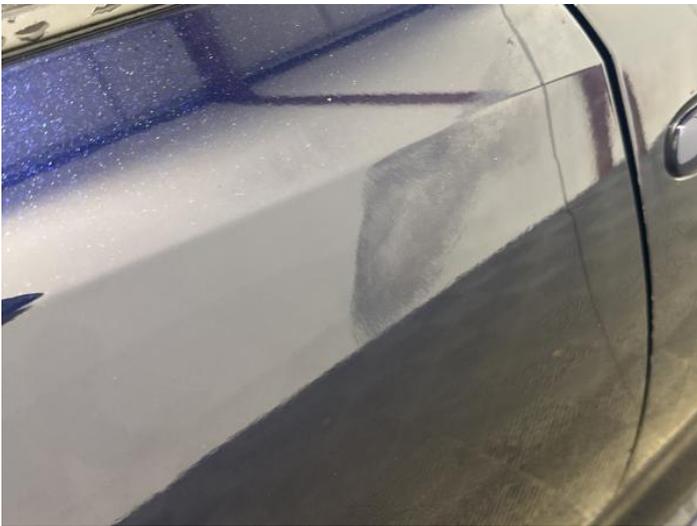
11: Door osr
Scratched
Over 25mm Thru Paint

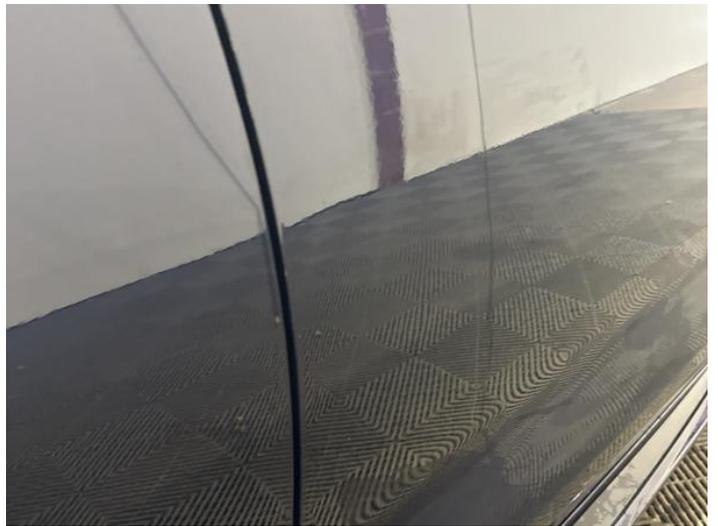
12: Door osf
Chipped
Edge Chip

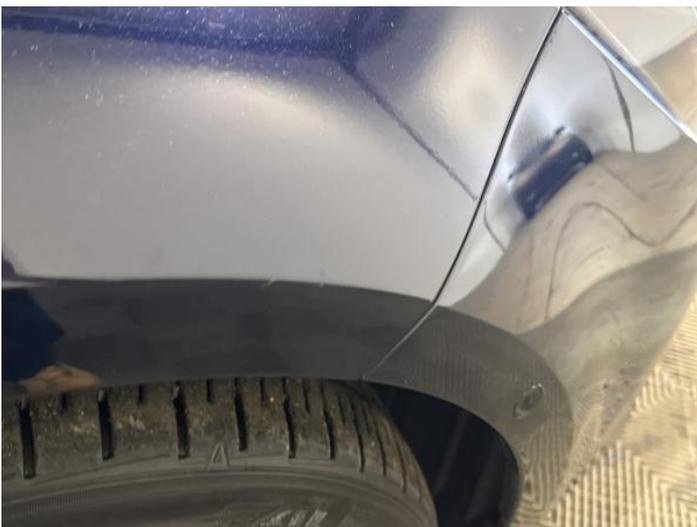
13: Wing osf
Scratched
Up To 25mm Thru Paint

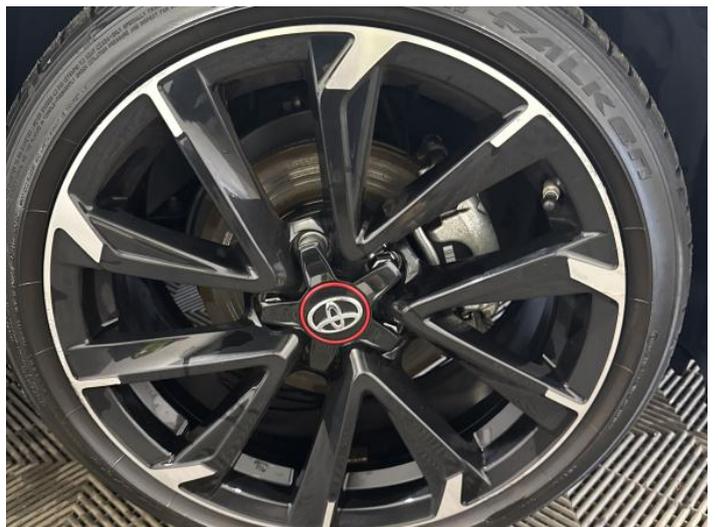
14: Wheel osf
Scratched
Over 50mm
