VEHICLE INSPECTION REPORT

LK64ZTX

Peugeot 3008 2.0 HDi 163 Allure 5dr Auto

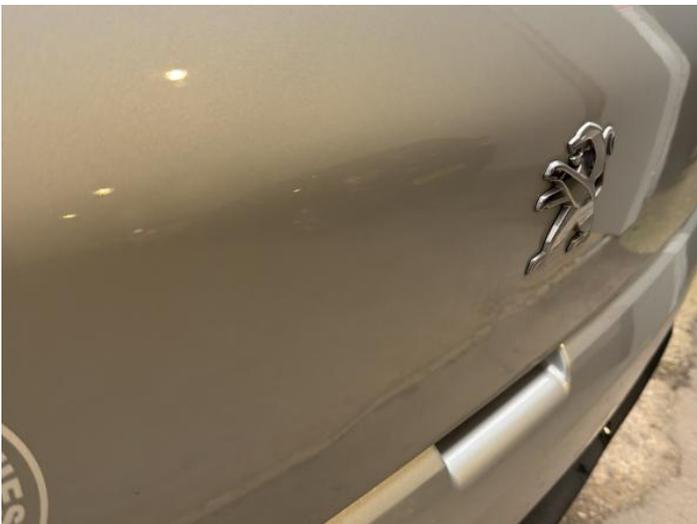
1: Boot Lid
Dented
Over 30mm

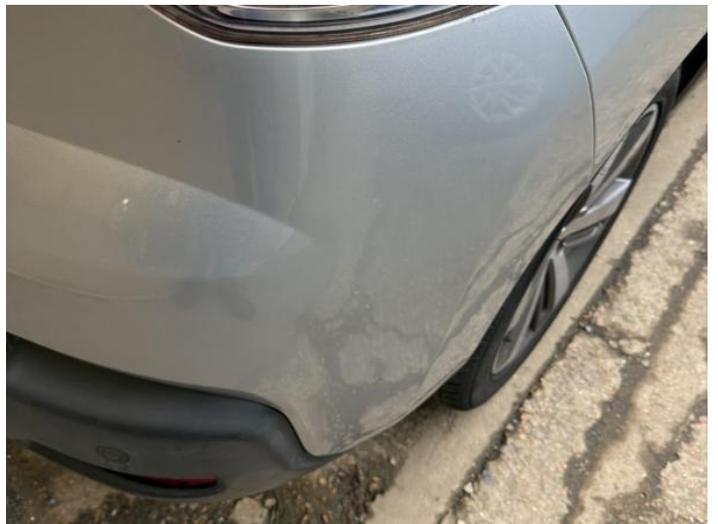
2: Bumper Rear
Poor Previous Repair
Poor Paint

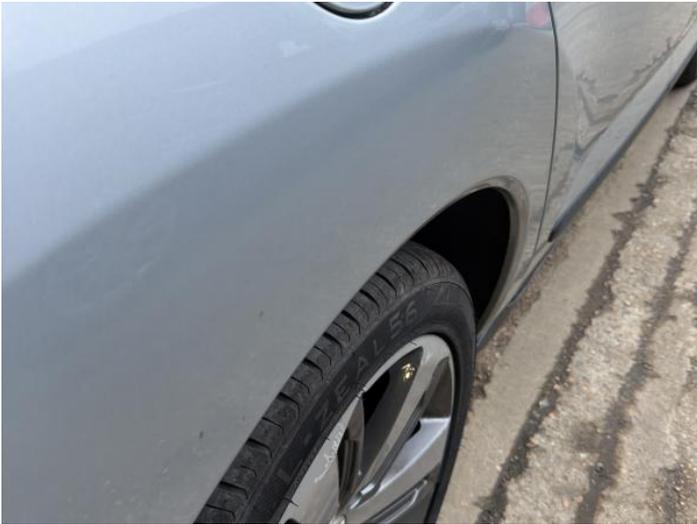
3: Qtr Panel osr
Poor Previous Repair
Poor Paint

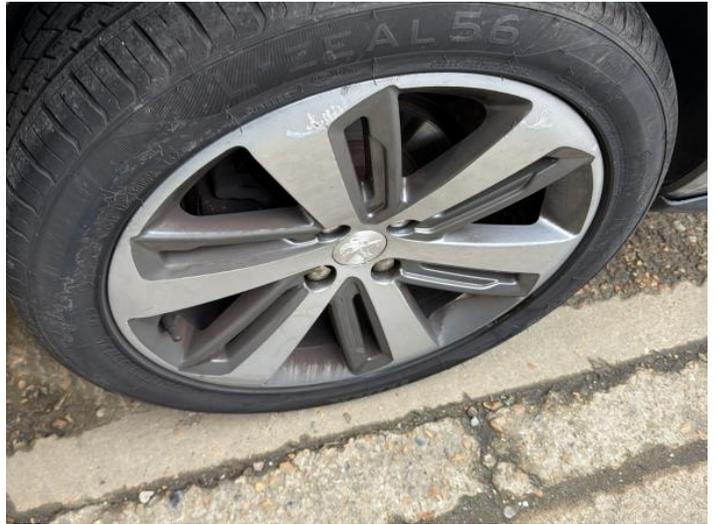
4: Wheel osr
Scratched
Over 50mm

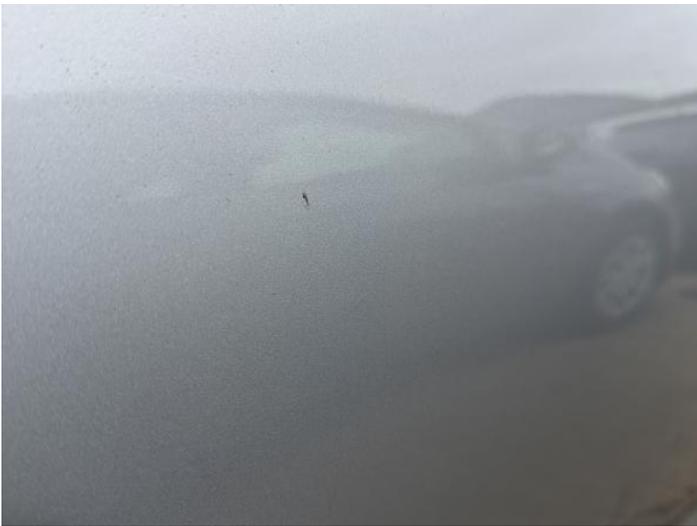
5: Door osr
Chipped
1 To 5

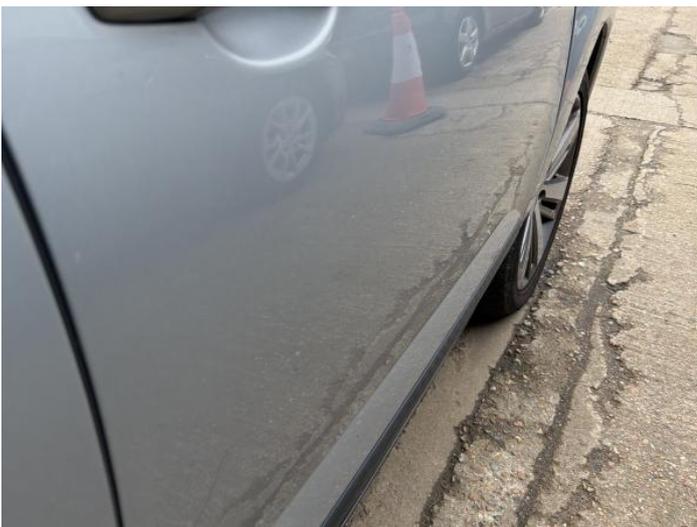
7: Door osf
Poor Previous Repair
Poor Paint

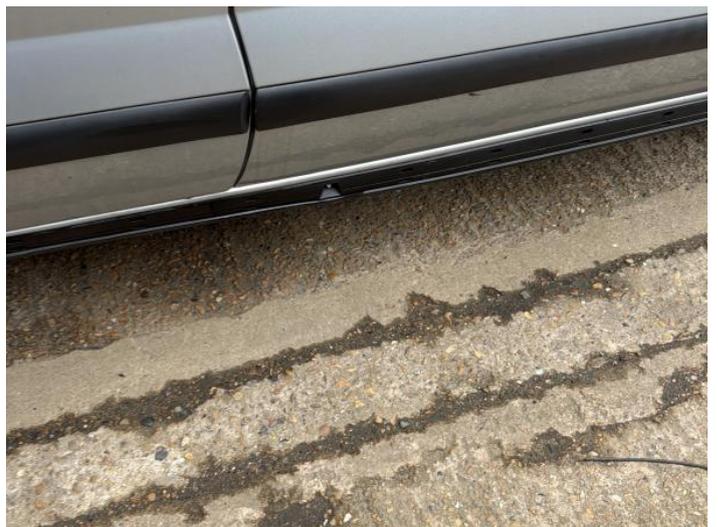
8: Sill Panel Trim os
Broken
Replace

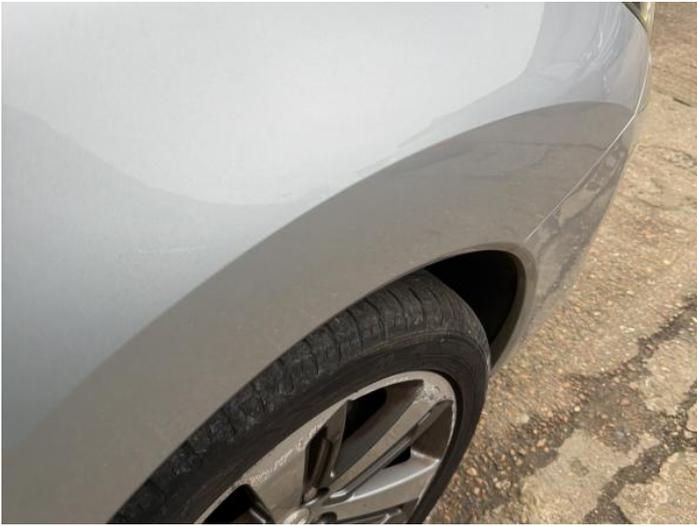
9: Wing osf
Chipped
1 To 5

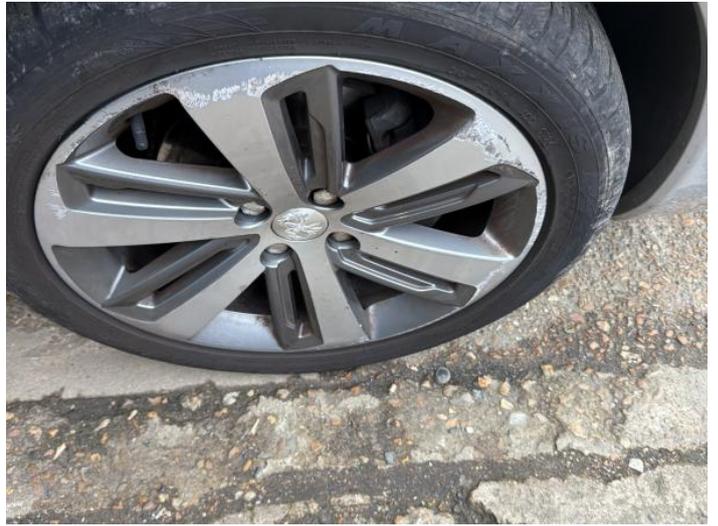
10: Wheel osf
Scratched
Over 50mm

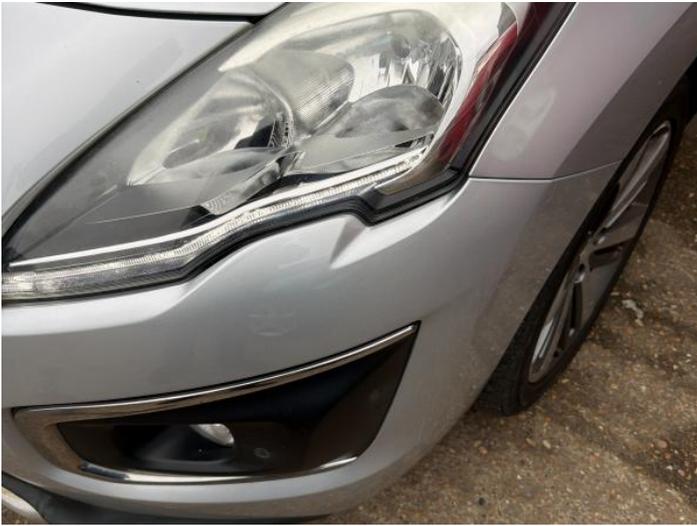
11: Bumper Front
Poor Previous Repair
Poor Colour

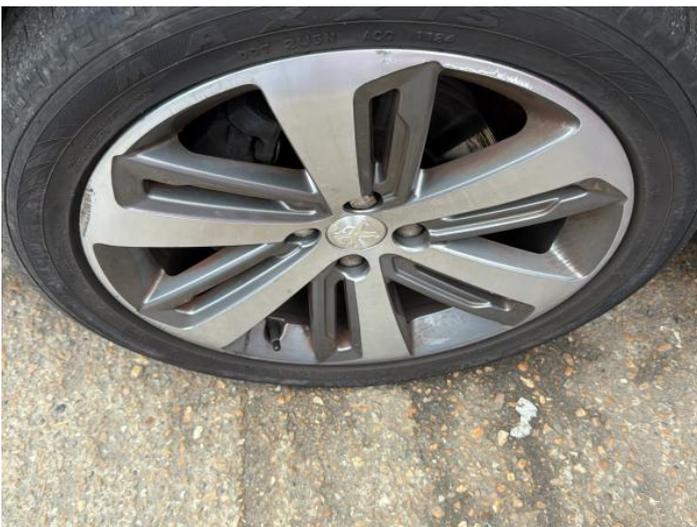
13: Wheel nsf
Scratched
Over 50mm

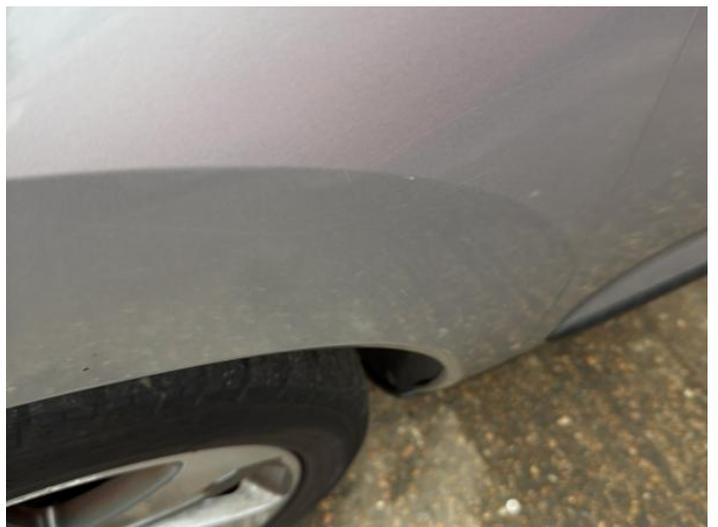
14: Wing nsf
Chipped
1 To 5

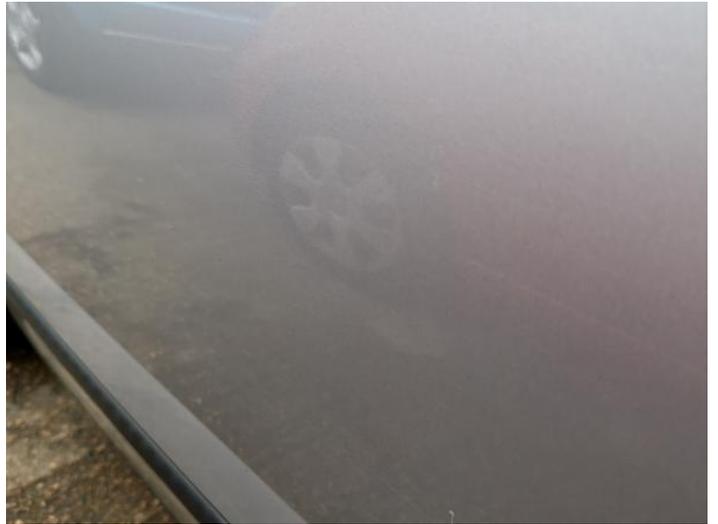
15: Wing nsf
Scratched
Over 25mm Not Thru Paint

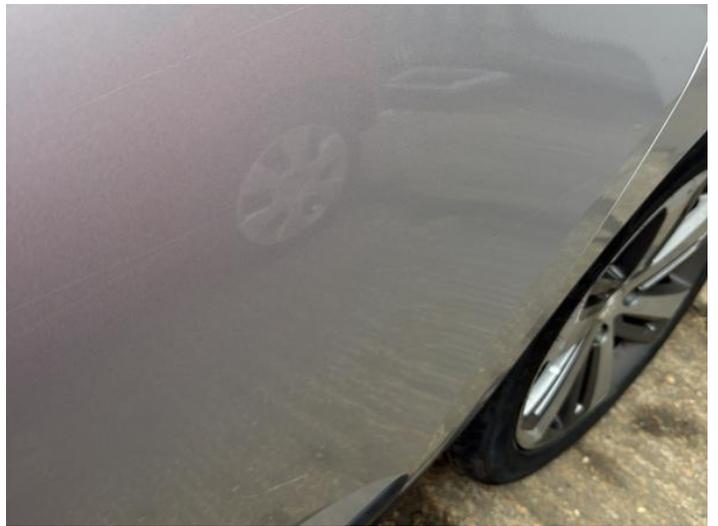
17: Door nsf
Scratched
Over 25mm Not Thru Paint

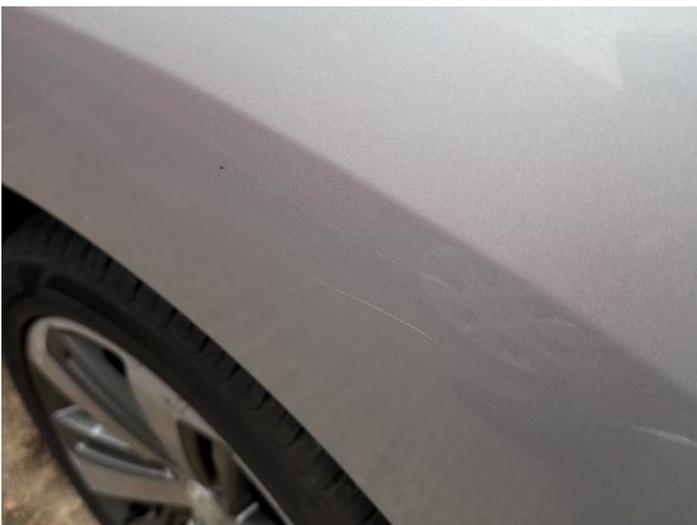
19: Qtr Panel nsr
Scratched
Over 25mm Thru Paint

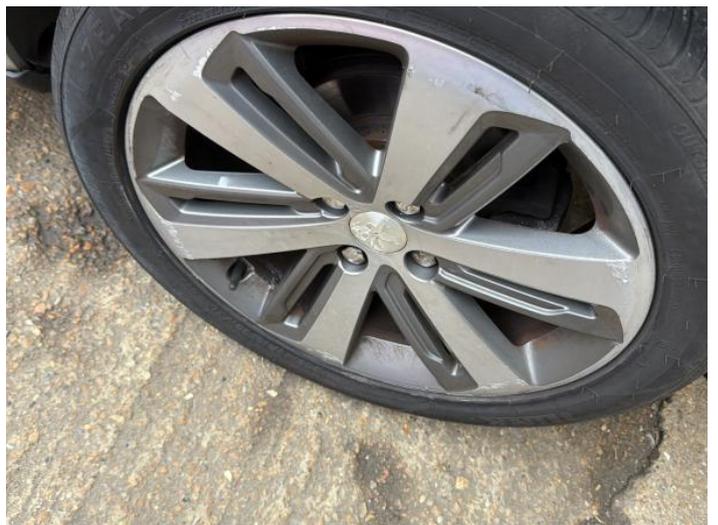
20: Wheel nsr
Scratched
Over 50mm
