VEHICLE INSPECTION REPORT

GV15BPX

Toyota Yaris 1.33 VVT-i Sport 5dr

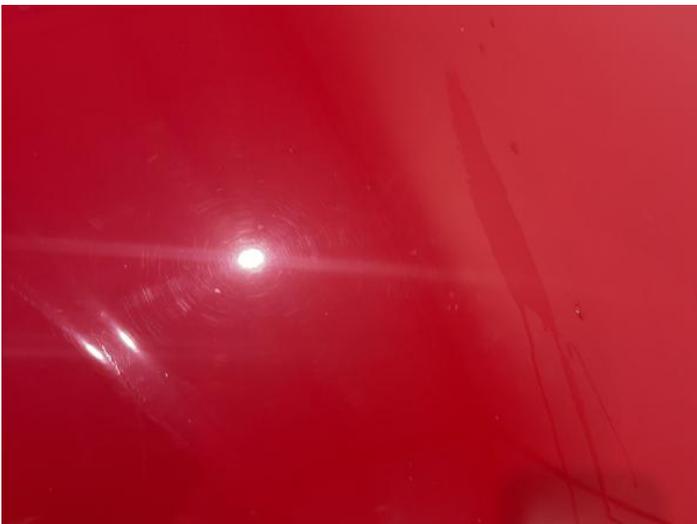
1: Bonnet
Poor Previous Repair
Poor Paint

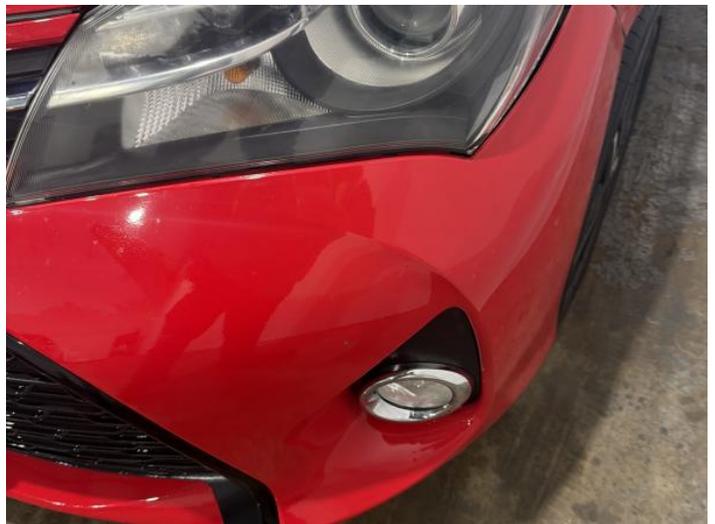
2: Bumper Front
Scratched
Over 100mm Thru Paint

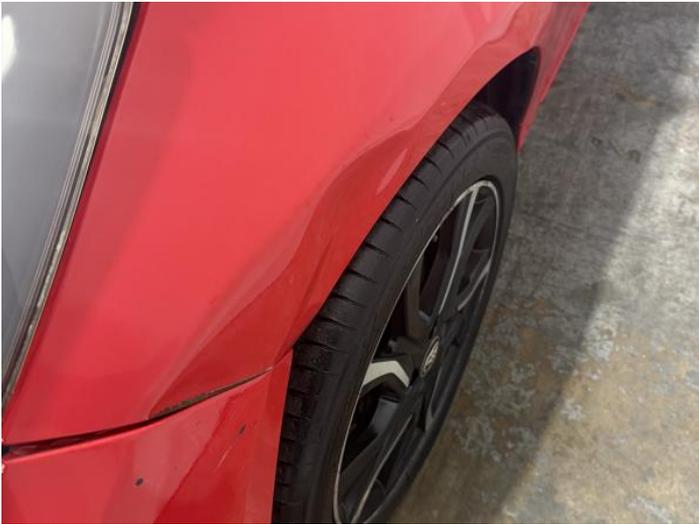
3: Wing nsf
Dented
Over 30mm

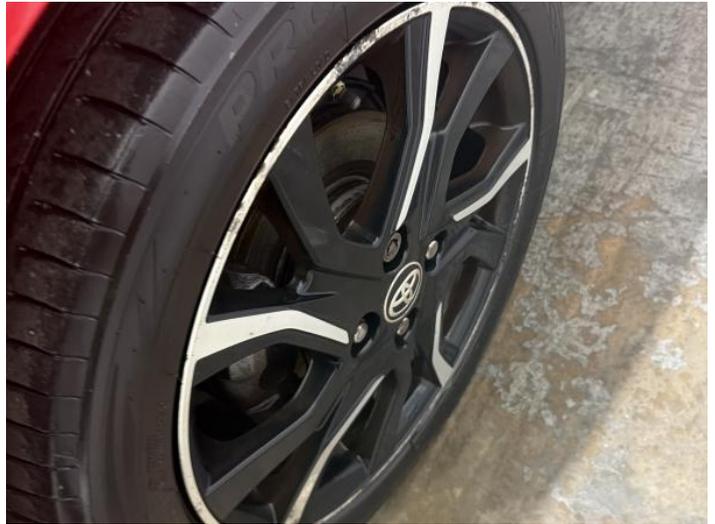
4: Wheel nsf
Scratched
Over 50mm

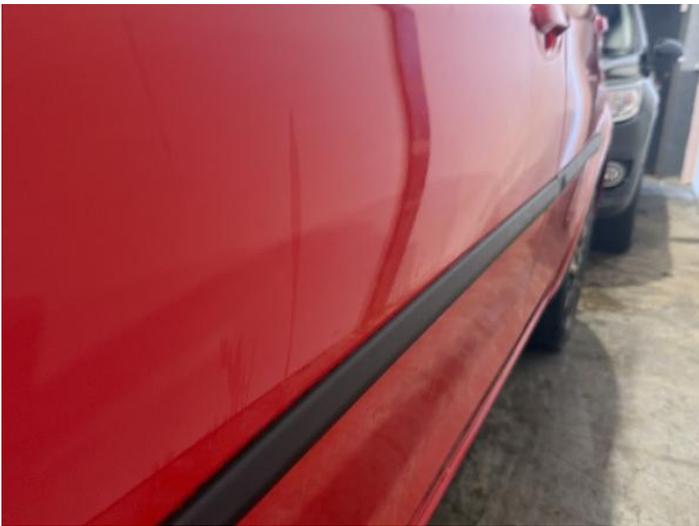
5: Door nsf
Poor Previous Repair
Poor Paint

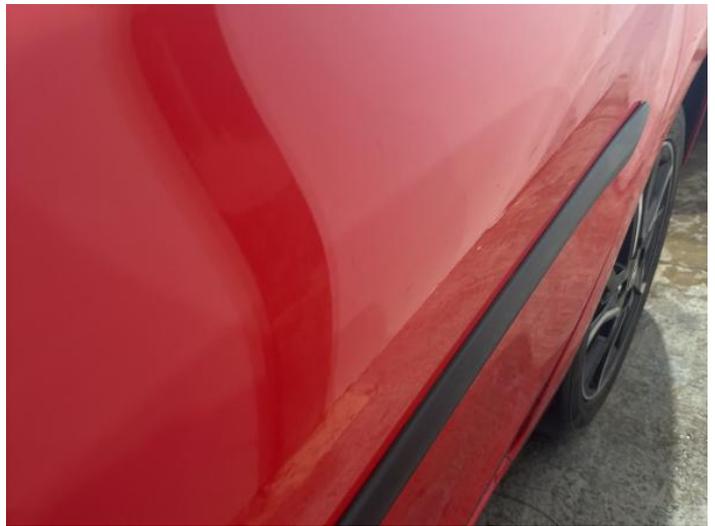
6: Door nsr
Poor Previous Repair
Poor Paint

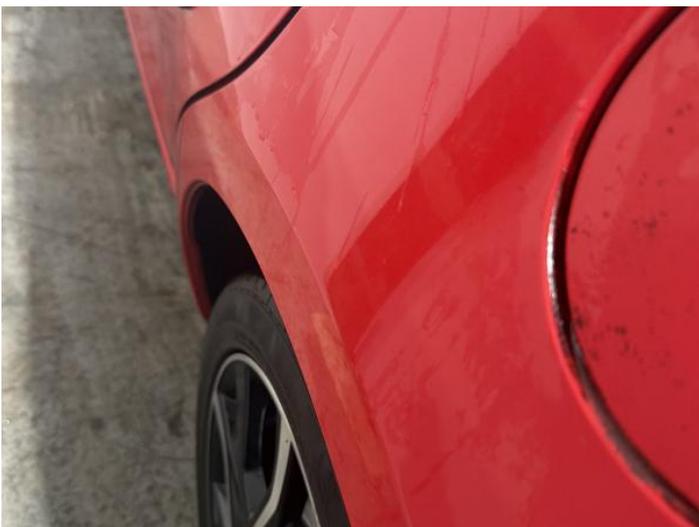
7: Qtr Panel nsr
Chipped
1 To 5

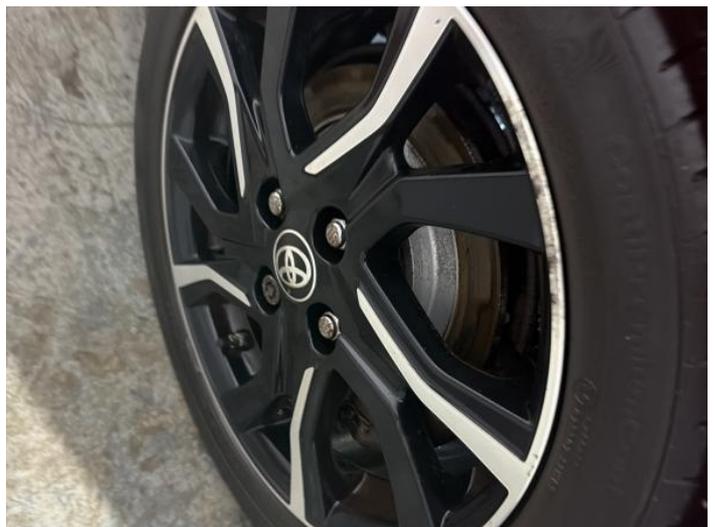
8: Wheel nsr
Scratched
Over 50mm

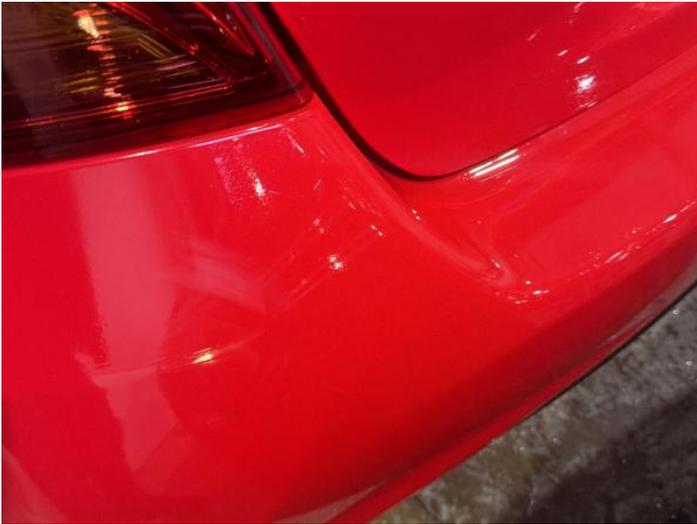
9: Bumper Rear
Poor Previous Repair
Poor Paint

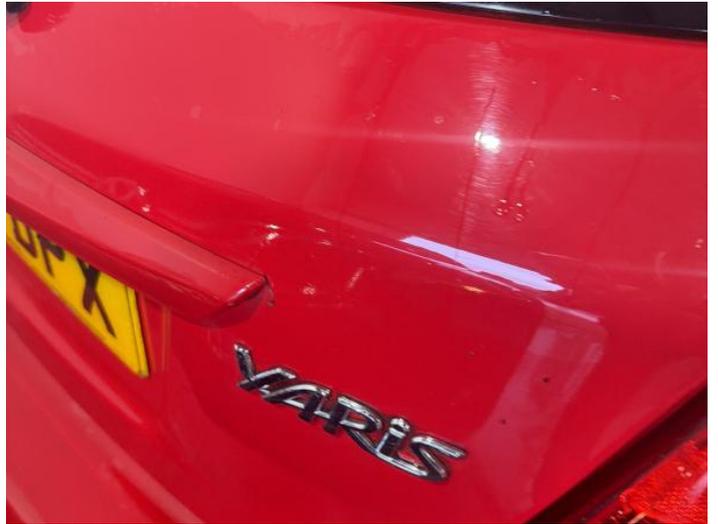
10: Boot Lid
Poor Previous Repair
Poor Paint

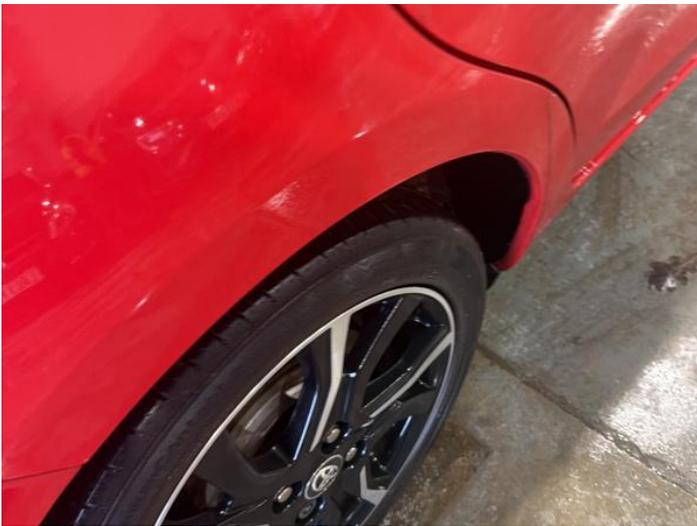
11: Qtr Panel osr
Poor Previous Repair
Poor Paint

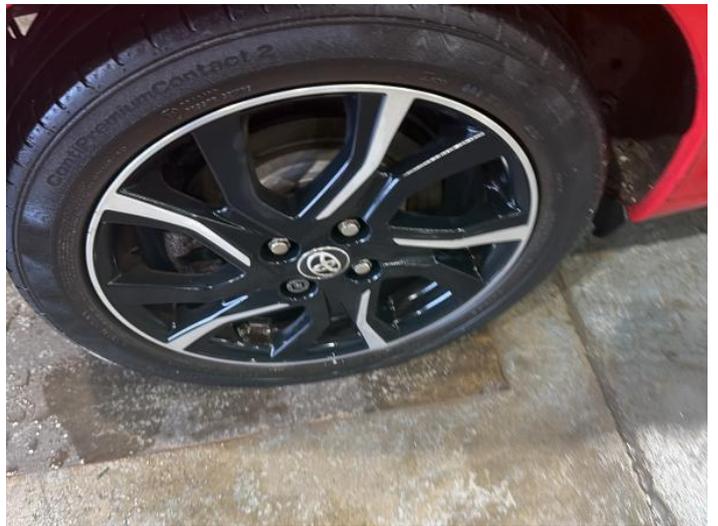
12: Wheel osr
Scratched
Up To 50mm

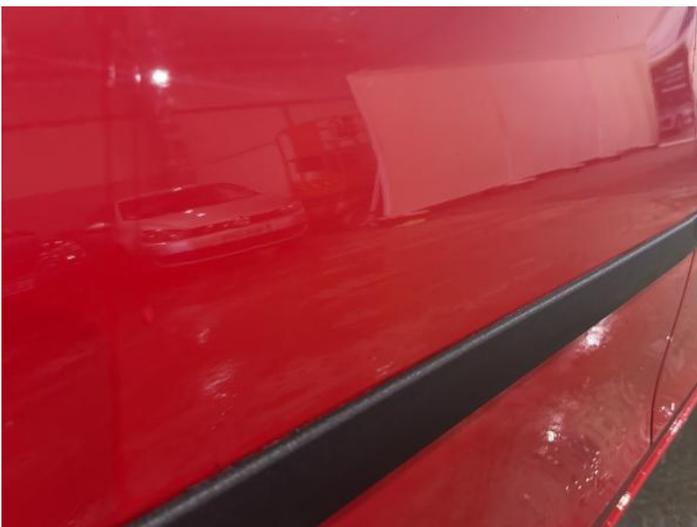
13: Door osr
Poor Previous Repair
Poor Paint

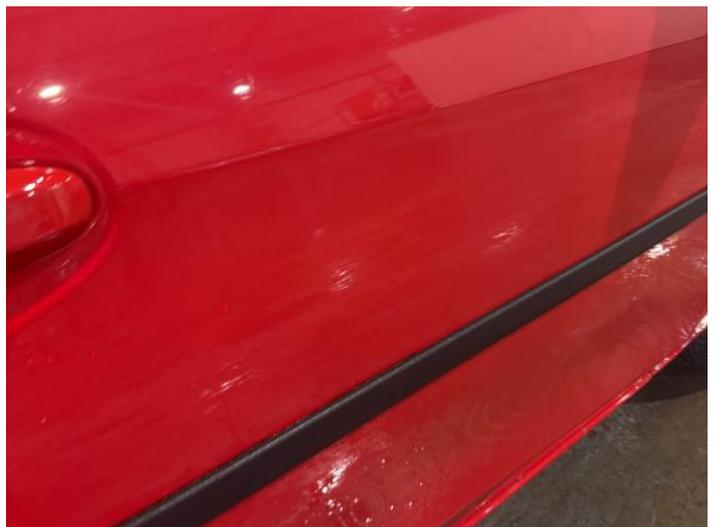
14: Door osf
Poor Previous Repair
Poor Paint

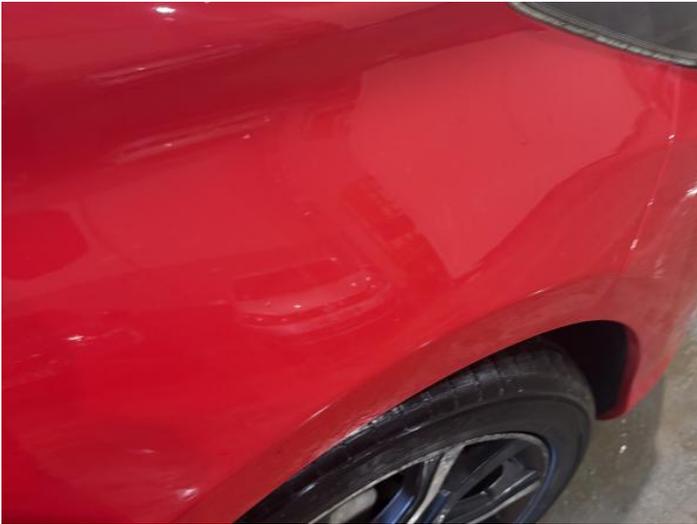
15: Wing of
Poor Previous Repair
Poor Paint

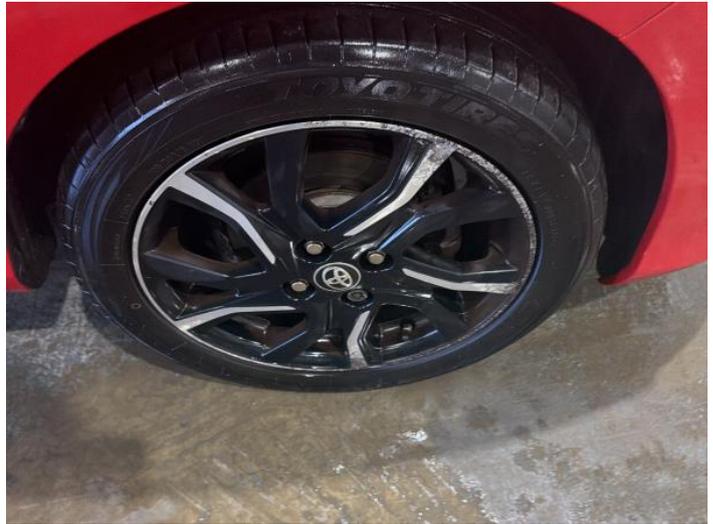
16: Wheel of
Scratched
Over 50mm

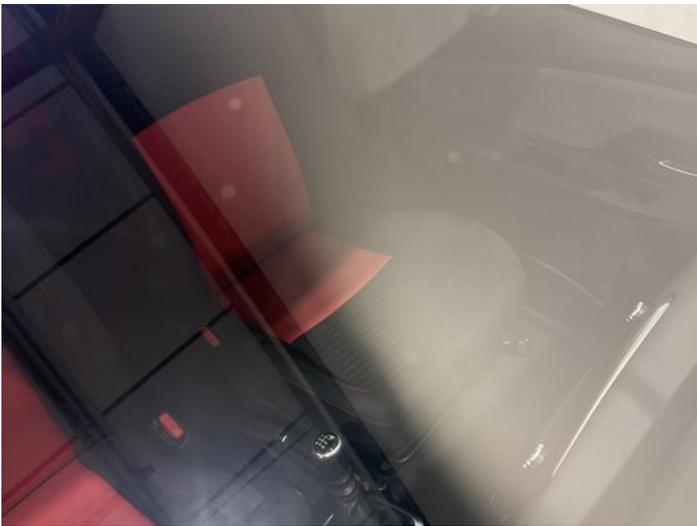
17: Screen Front
Chipped
Up To 10mm
