VEHICLE INSPECTION REPORT

LR10VVL

Volvo XC90 2.4 D5 Active 5dr

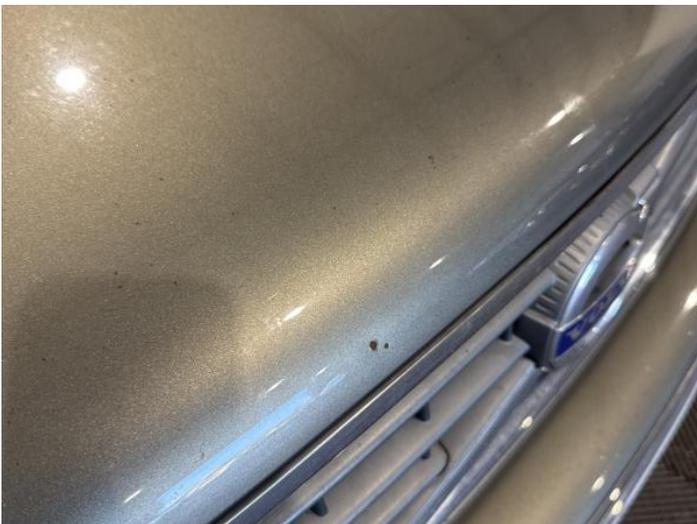
1: Bonnet
Chipped
Multiple Chips

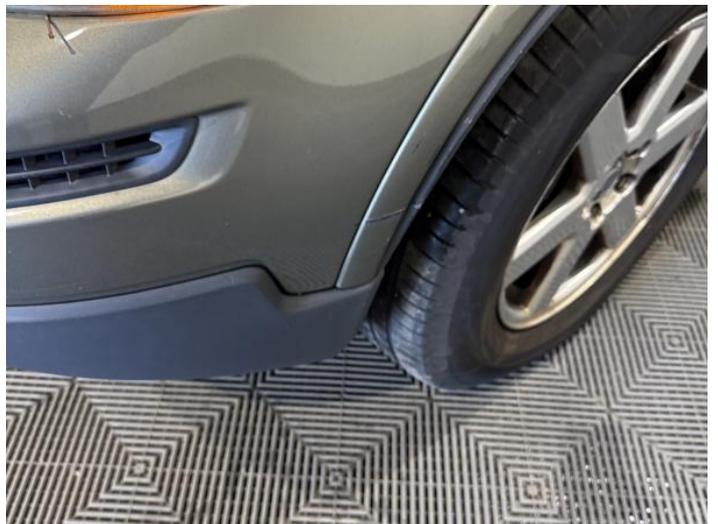
2: Bumper Front
Scratched
Over 100mm Thru Paint

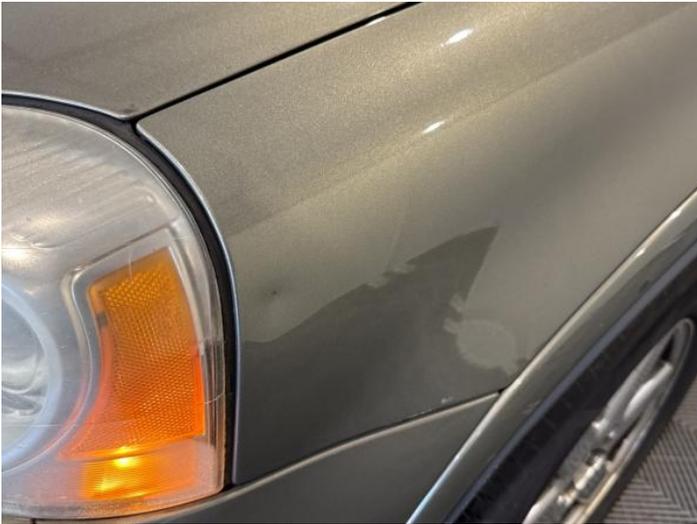
3: Wing nsf
Dented
Between 10mm + 30mm

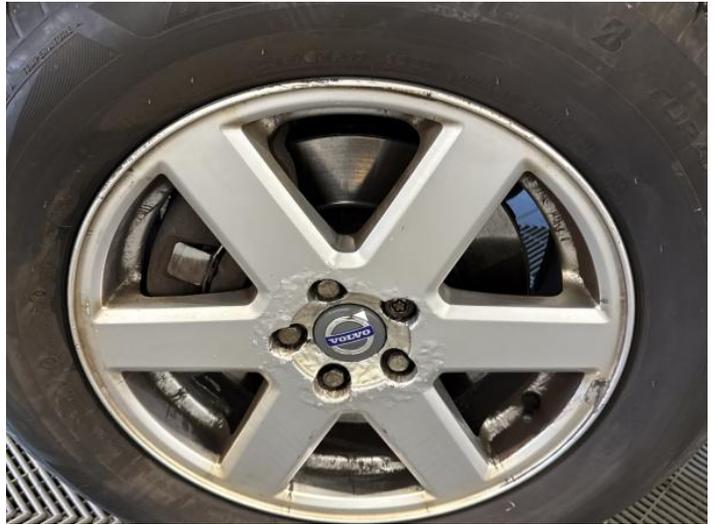
4: Wheel nsf
Scratched
Over 50mm

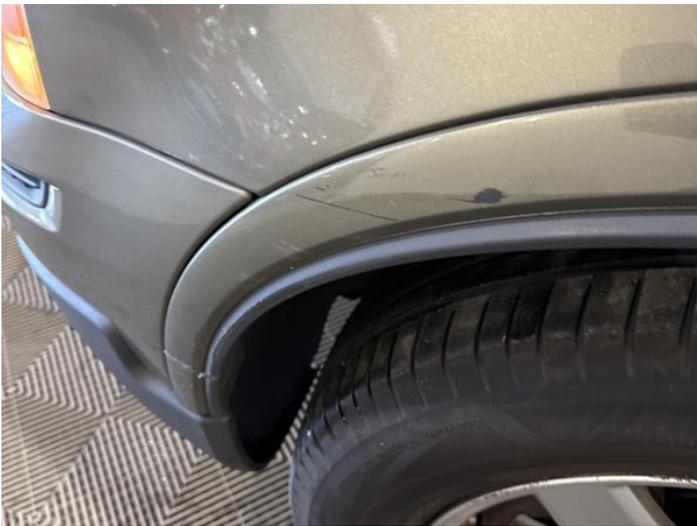
5: Wing Front Arch Extension ns
Scratched (Painted)
Over 25mm Thru Paint

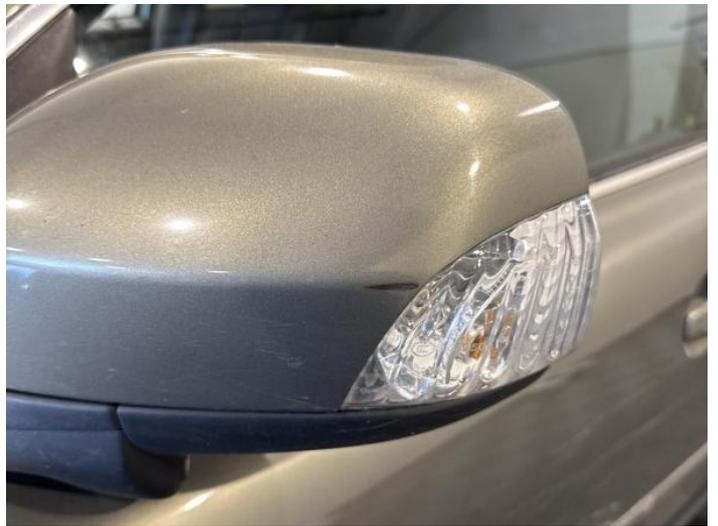
6: Door Mirror Assy nsf
Scratched (Painted)
UpTo 25mm Thru Paint

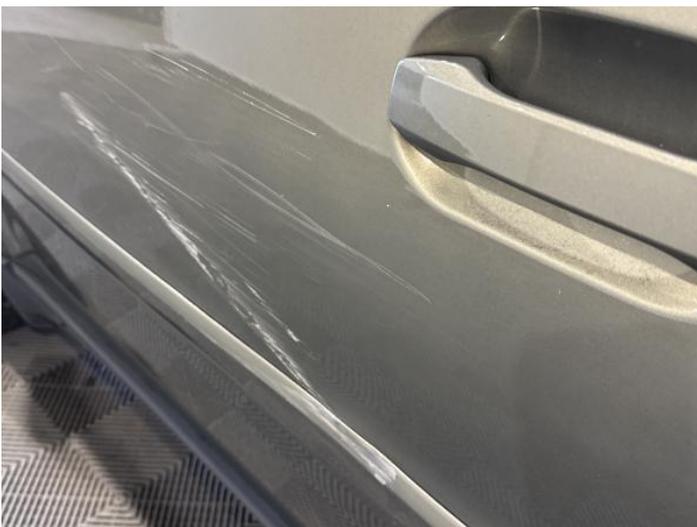
7: Door nsf
Dented
With Paint Damage

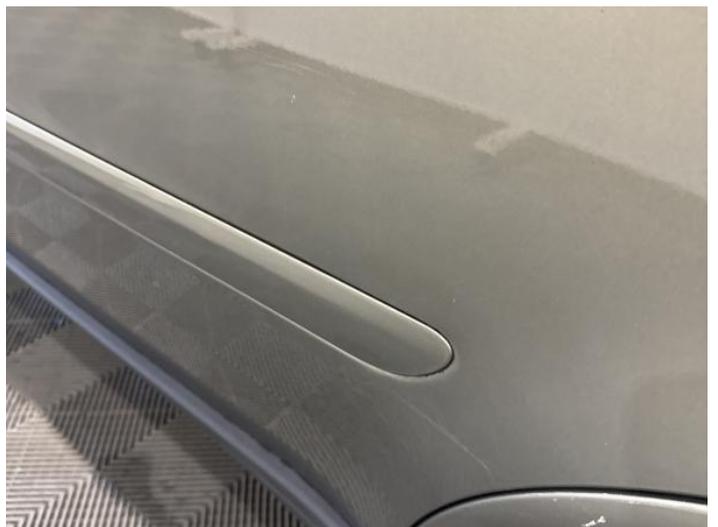
8: Door nsr
Scratched
Over 25mm Thru Paint

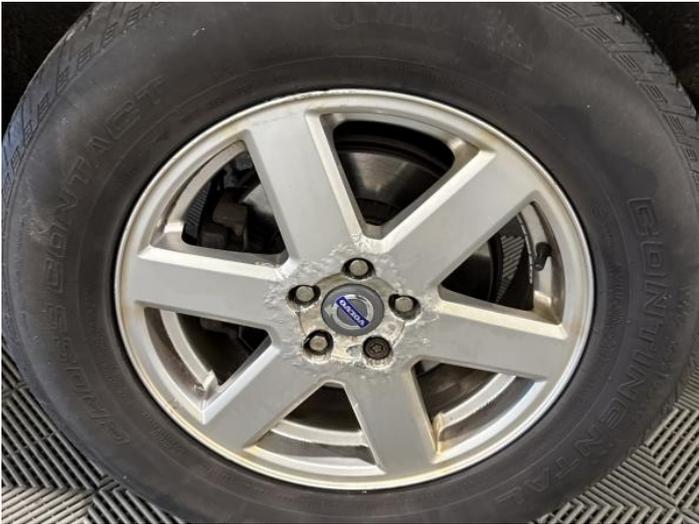
9: Wheel nsr
Corroded
Light

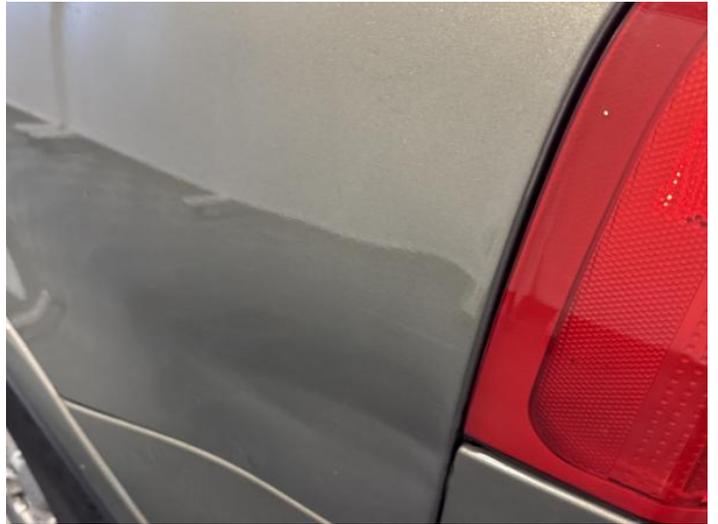
10: Qtr Panel nsr
Dented
Over 30mm

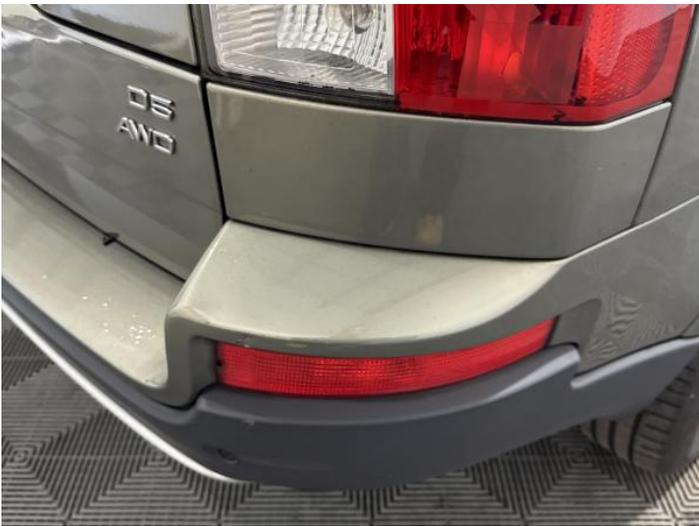
11: Bumper Rear
Scratched
25 to 100mm Thru Paint

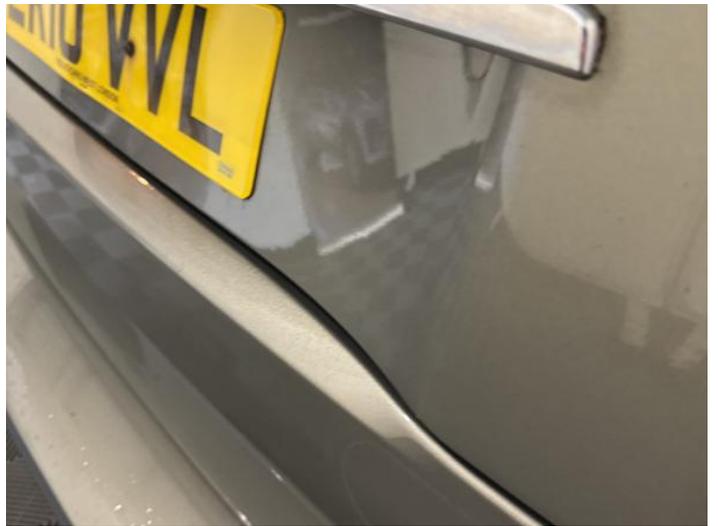
12: Tailgate
Dented
Between 10mm + 30mm

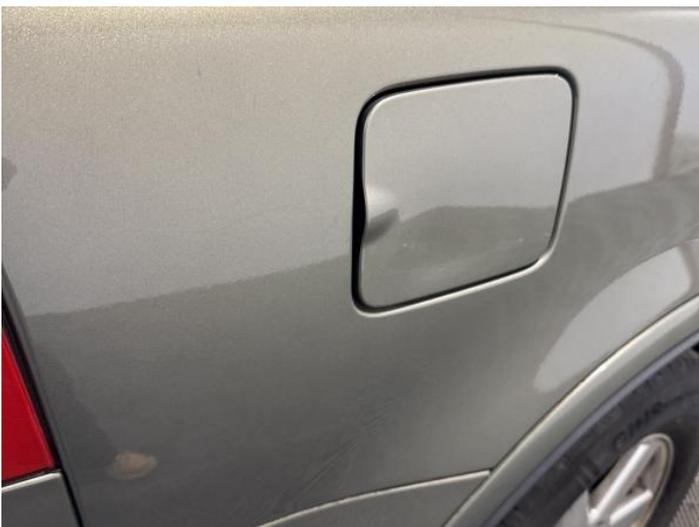
13: Qtr Panel osr
Scratched
Over 25mm Thru Paint

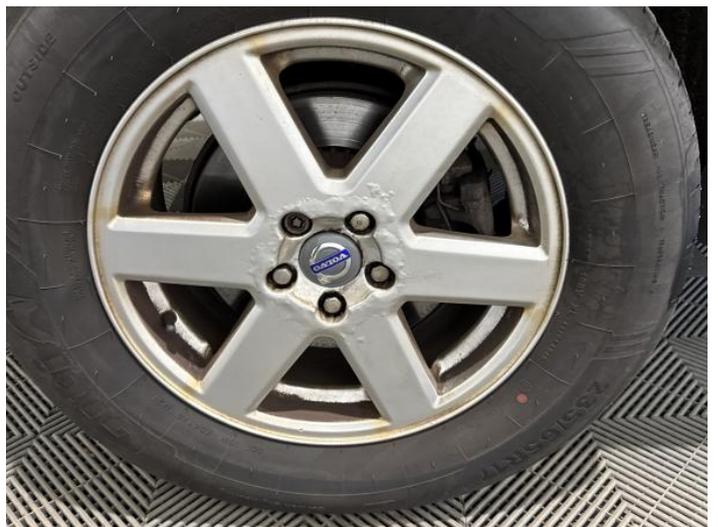
14: Wheel osr
Corroded
Light

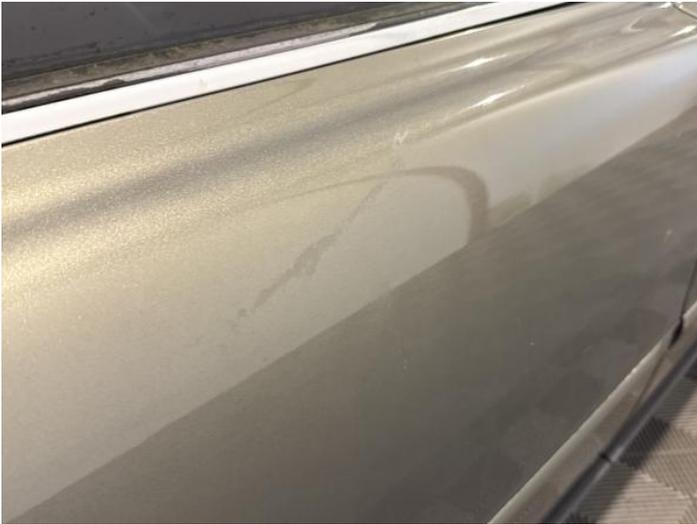
15: Door osr
Scratched
Over 25mm Thru Paint

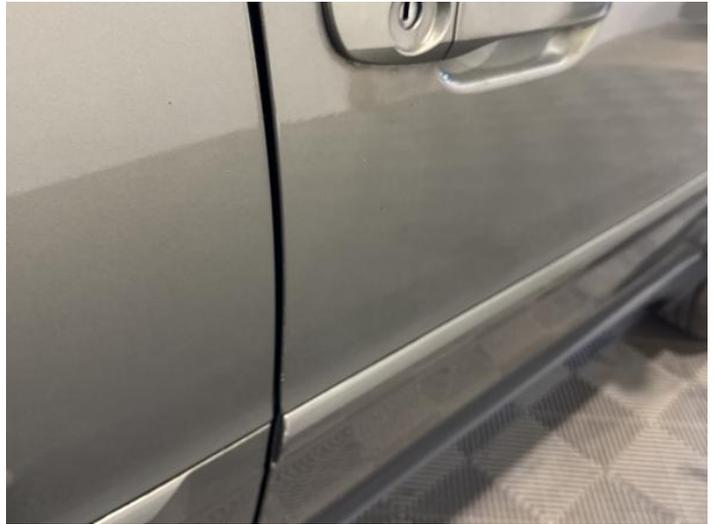
16: Door osf
Chipped
Edge Chip

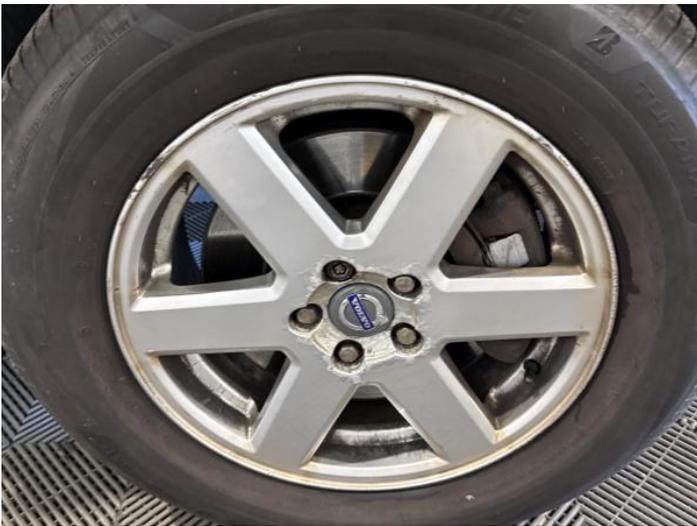
17: Wheel osf
Scratched
Over 50mm

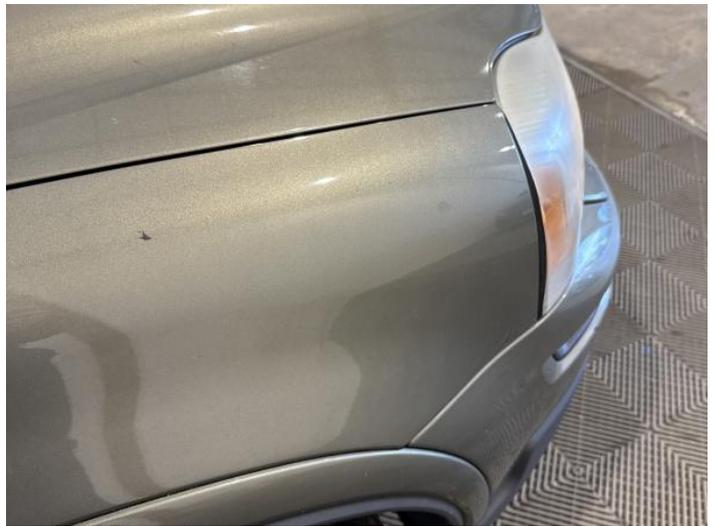
18: Wing osf
Chipped
1 To 5
