VEHICLE INSPECTION REPORT

AF56URM

Volvo XC90 2.4 D5 SE 5dr Geartronic [185]

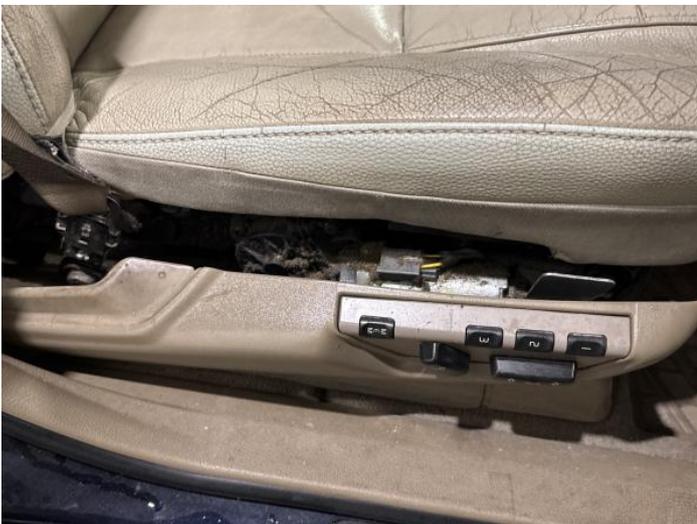
1: Fascia Trim
Damaged
Replace

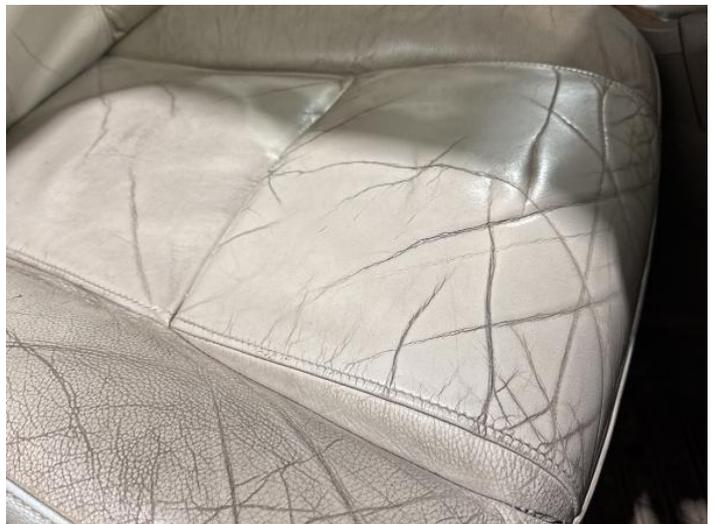
2: Seat Base Cover osf
Scuffed
Over 25mm

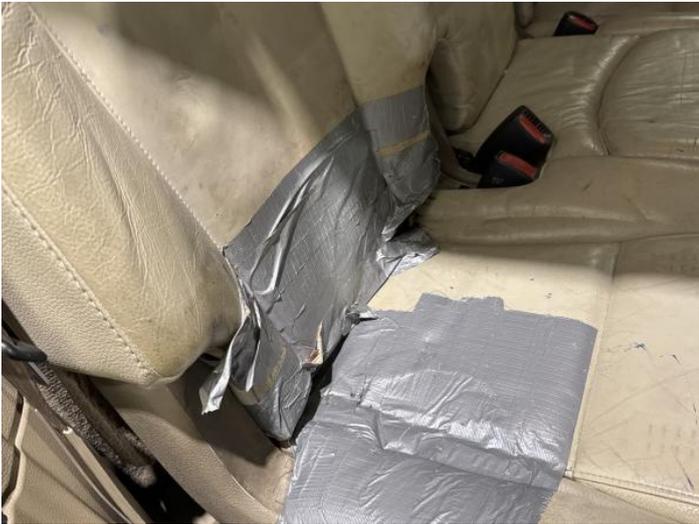
3: Seat Back Cover osr
Holed
Over 3mm

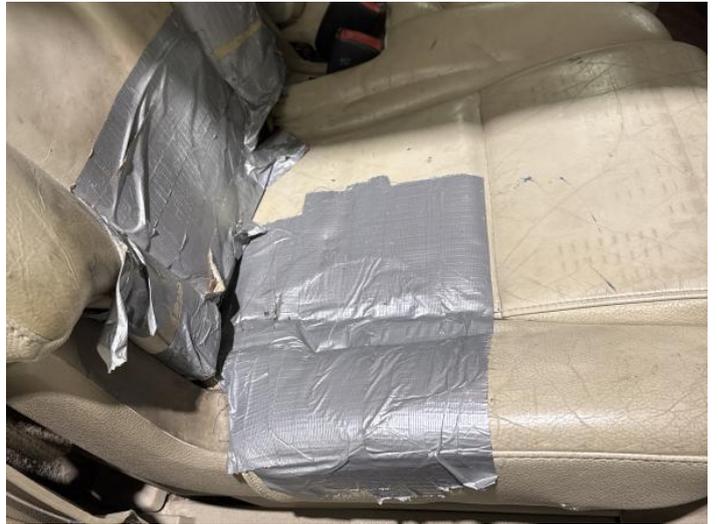
4: Seat Base Cover osr
Holed
Over 3mm

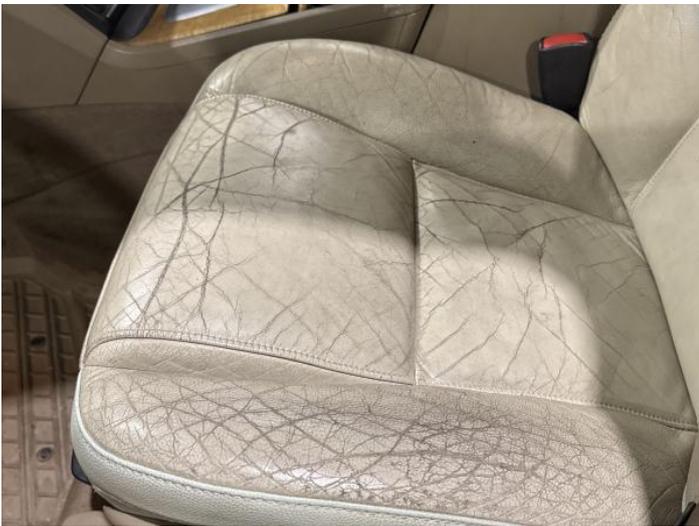
5: Seat Base Cover nsf
Scuffed
Over 25mm

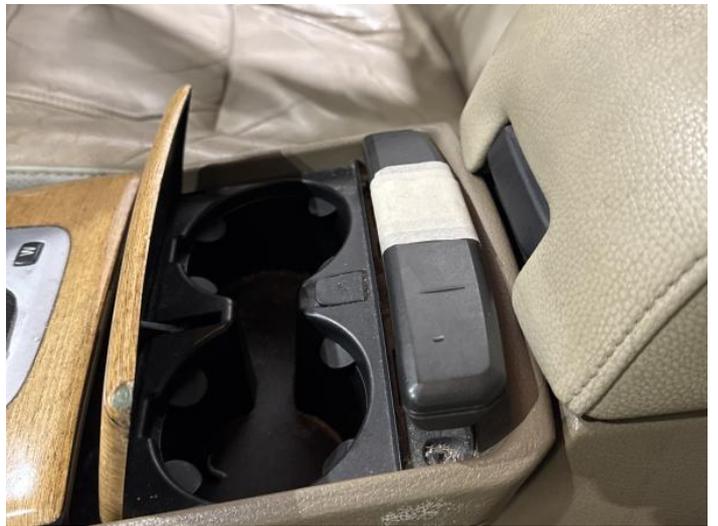
6: Fascia Trim
Damaged
Replace

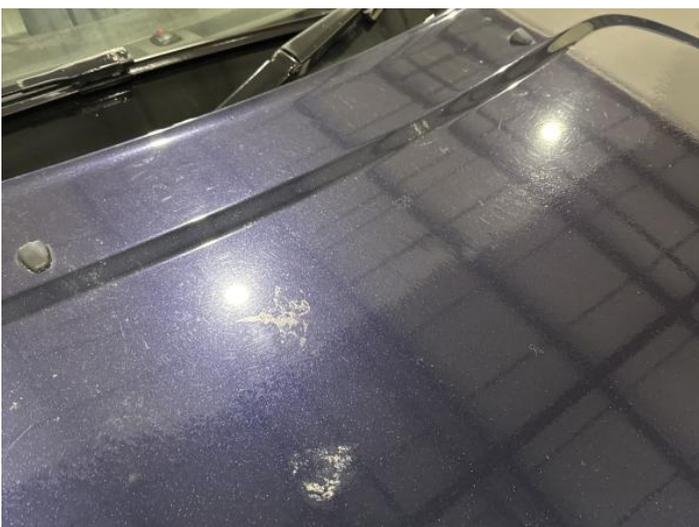
7: Bonnet
Scratched
Over 25mm Thru Paint

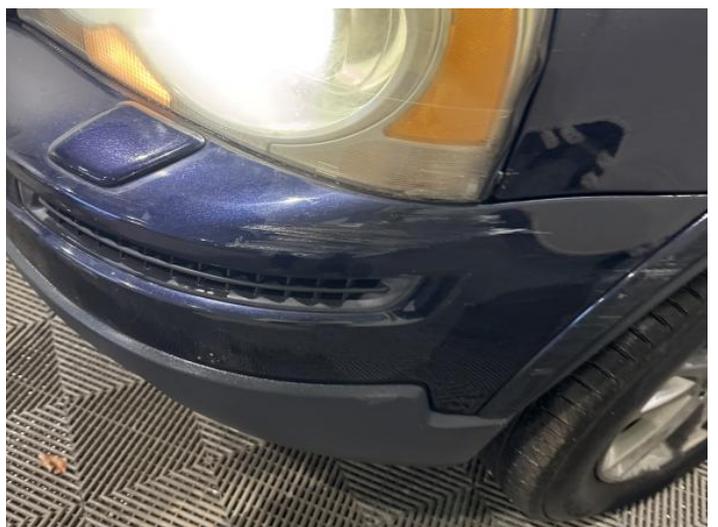
8: Bumper Front
Scratched
Over 100mm Thru Paint

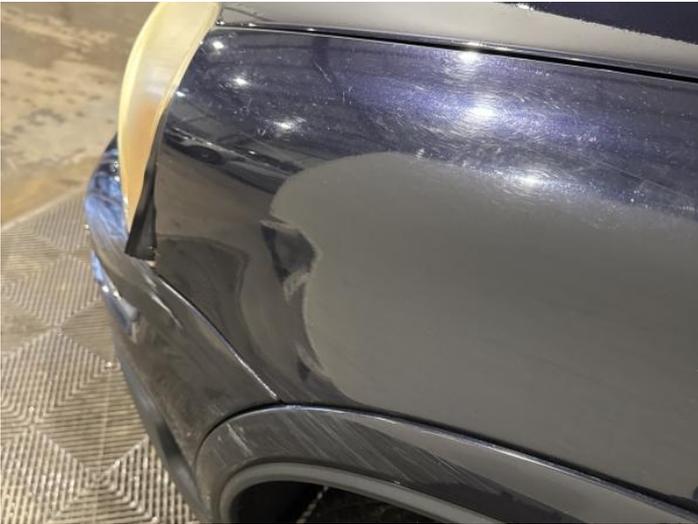
9: Wing nsf
Scratched
Over 25mm Thru Paint

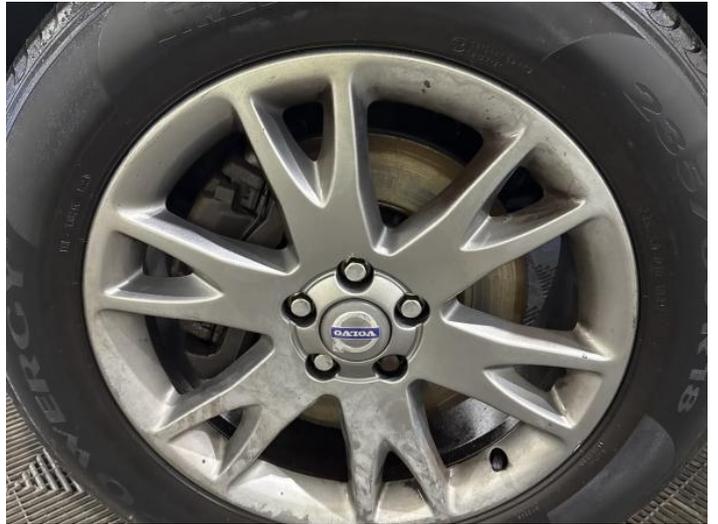
10: Wheel nsf
Scratched
Over 50mm

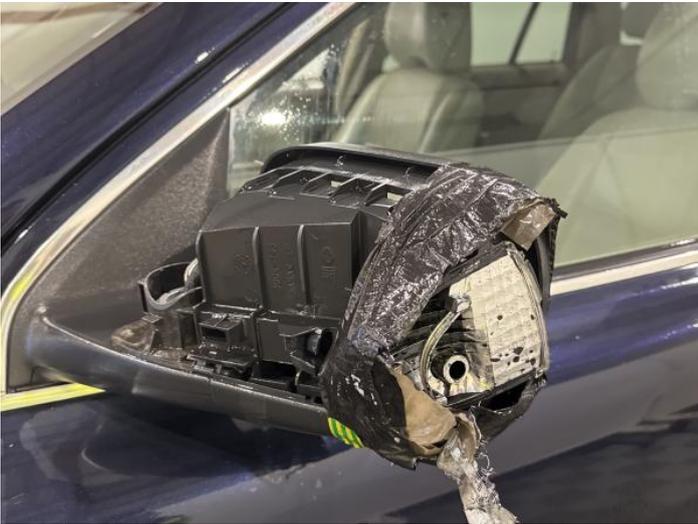
11: Door Mirror Assy nsf
Broken
Replace

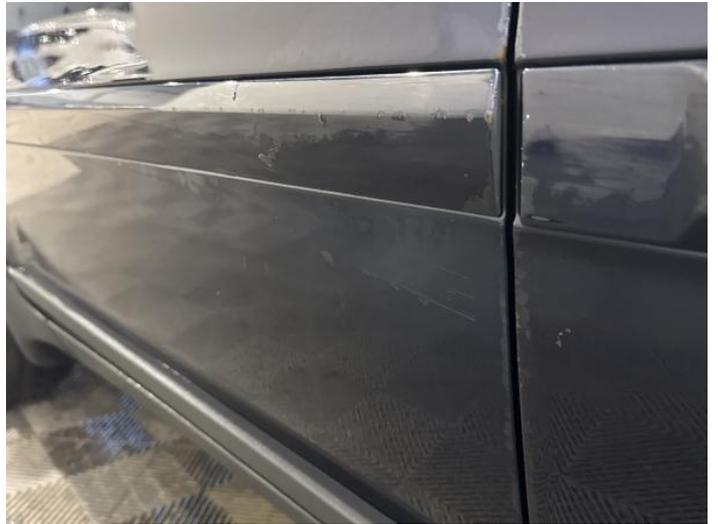
12: Door nsf
Dented
With Paint Damage

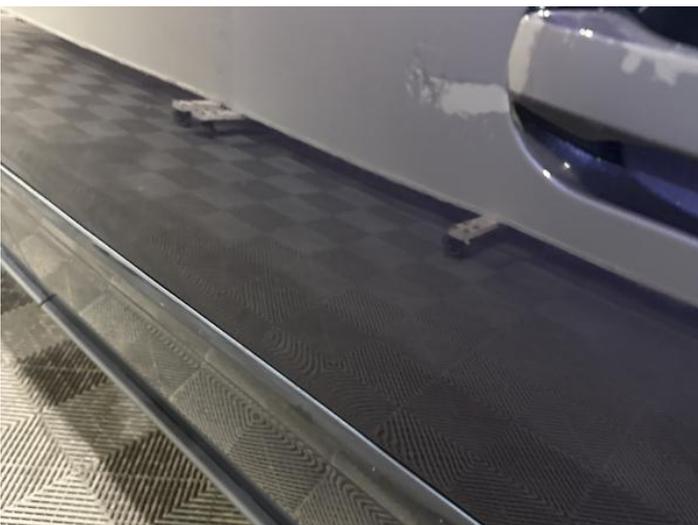
13: Door nsr
Scratched
Over 25mm Thru Paint

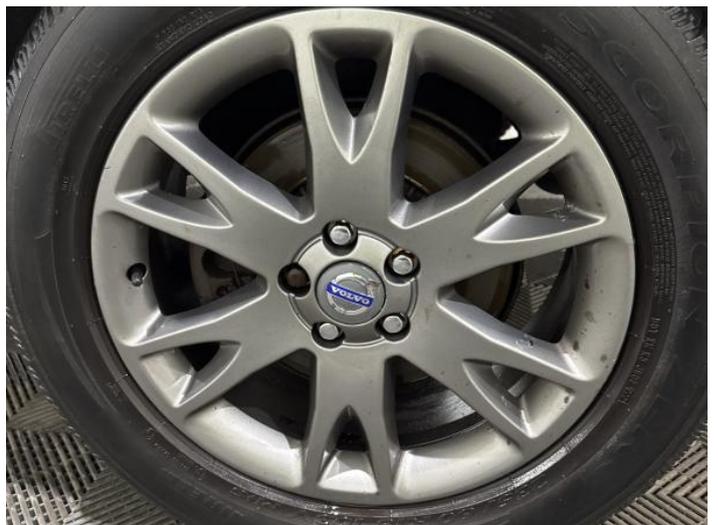
14: Wheel nsr
Corroded
Light

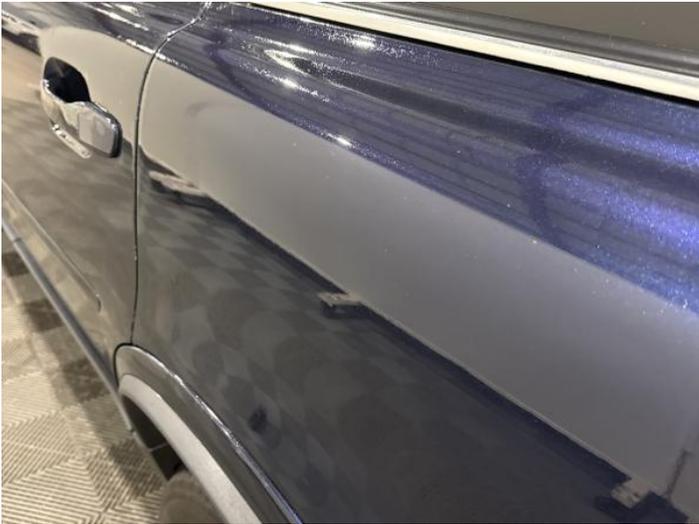
15: Qtr Panel nsr
Dented
Between 10mm + 30mm

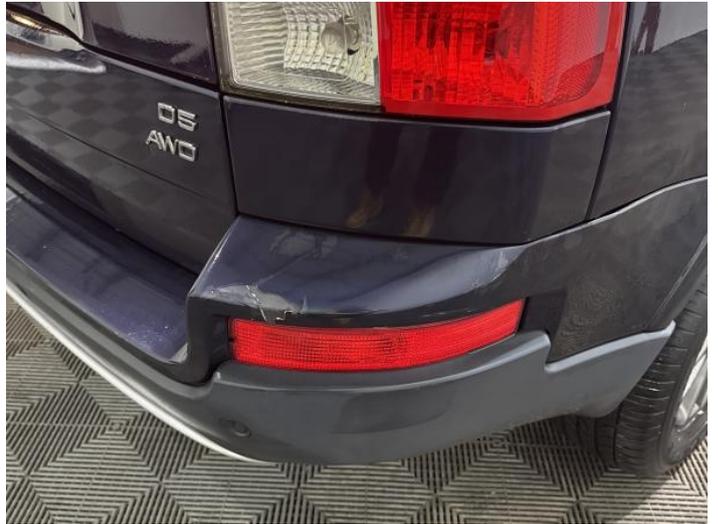
16: Bumper Rear
Dented
With Paint Damage

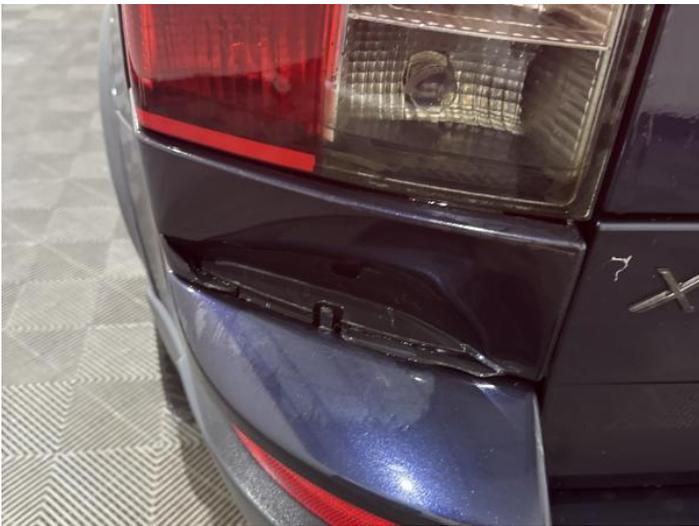
17: Bumper Rear Moulding
Broken
Replace

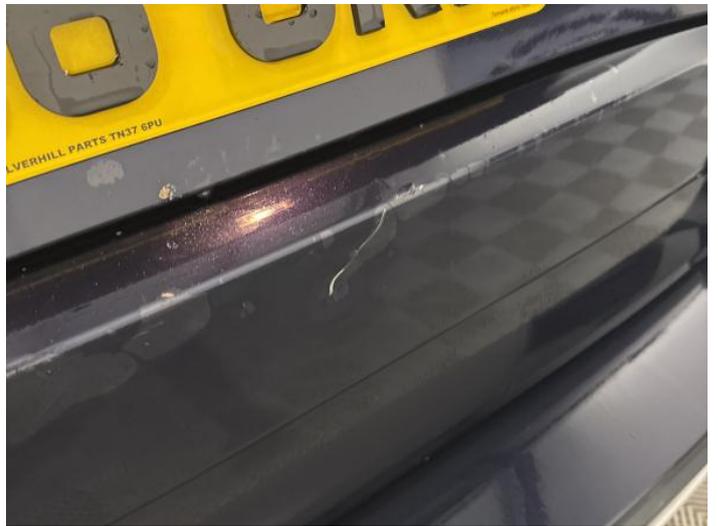
18: Tailgate
Dented
With Paint Damage

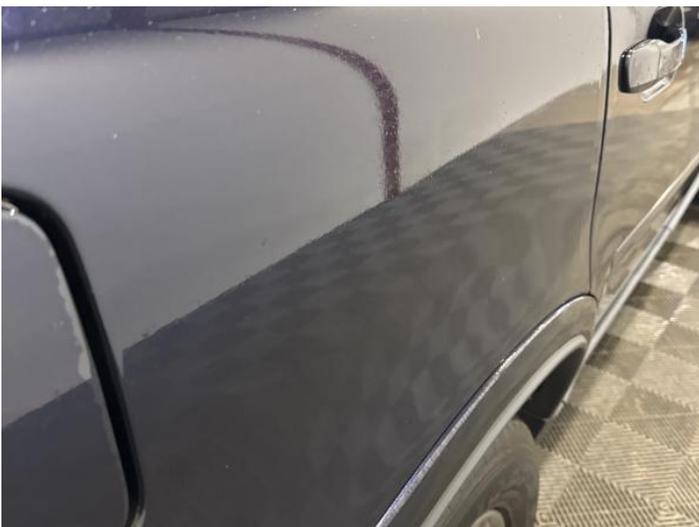
19: Qtr Panel osr
Dented
Between 10mm + 30mm

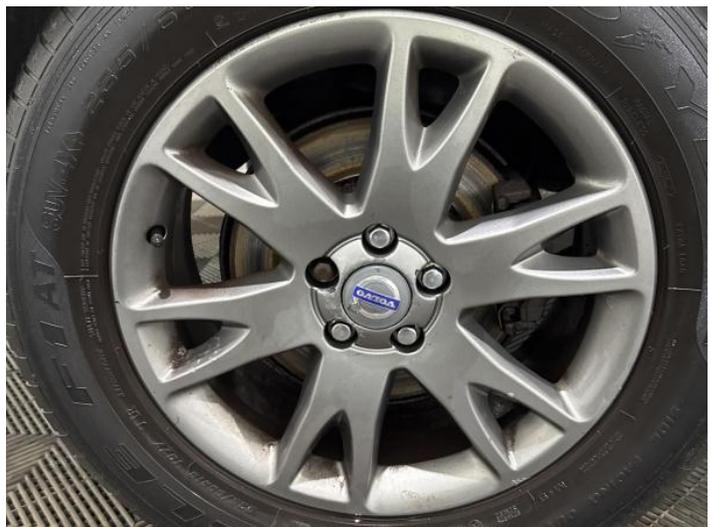
20: Wheel osr
Scratched
Over 50mm

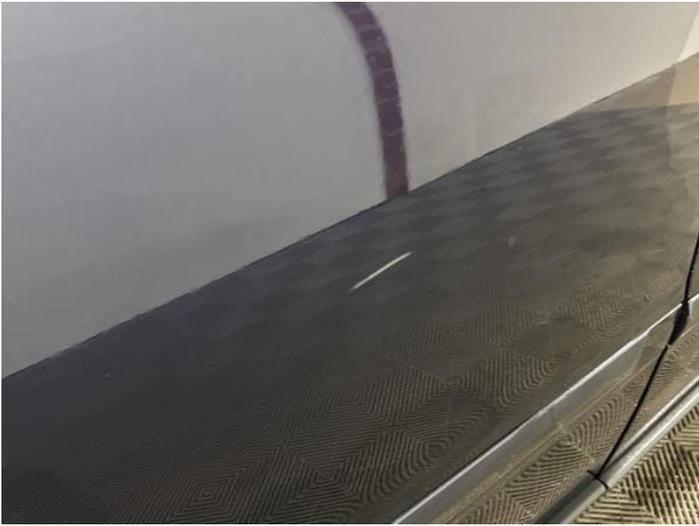
21: Door osr
Scratched
Over 25mm Thru Paint

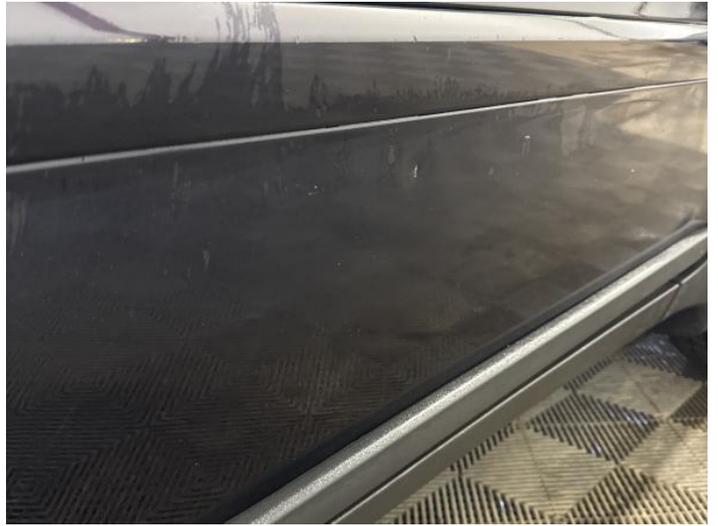
22: Door osf
Dented
With Paint Damage

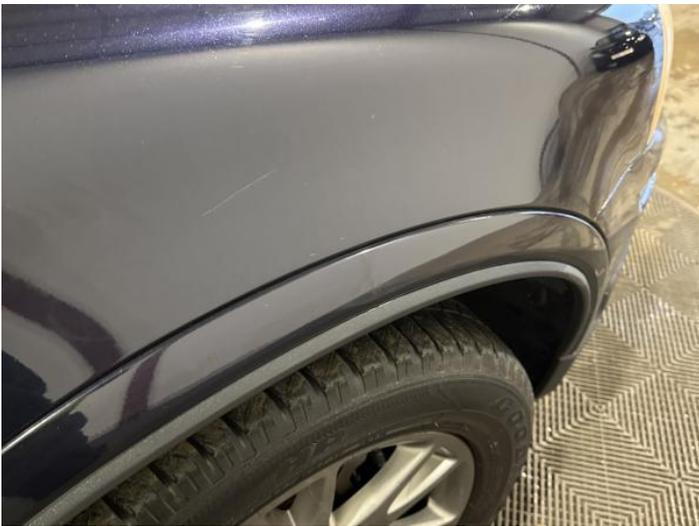
23: Wing osf
Scratched
Over 25mm Thru Paint

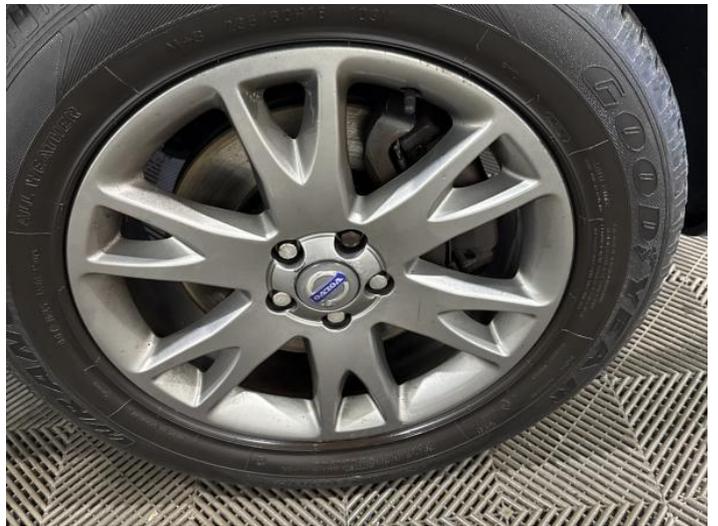
24: Wheel osf
Scratched
Up To 50mm

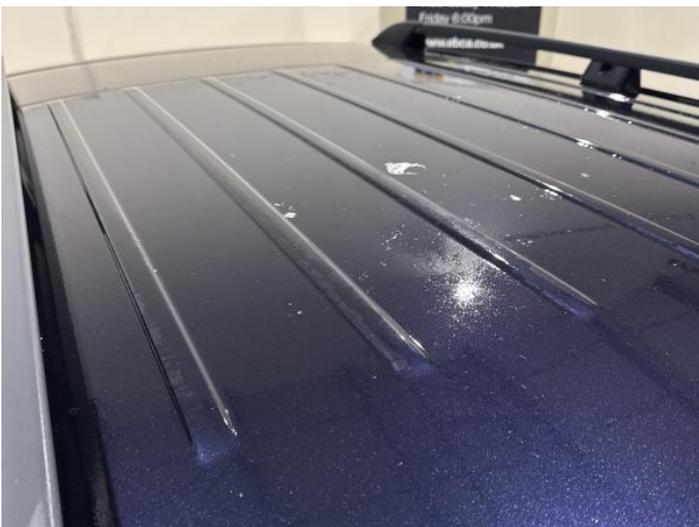
25: Roof
Dented
Between 10mm + 30mm
