# VEHICLE INSPECTION REPORT

**GY71HUV**

## Volvo V60 2.0 T6 Recharge PHEV R DESIGN 5dr AWD Auto

nama  
 GRADE  
**3**

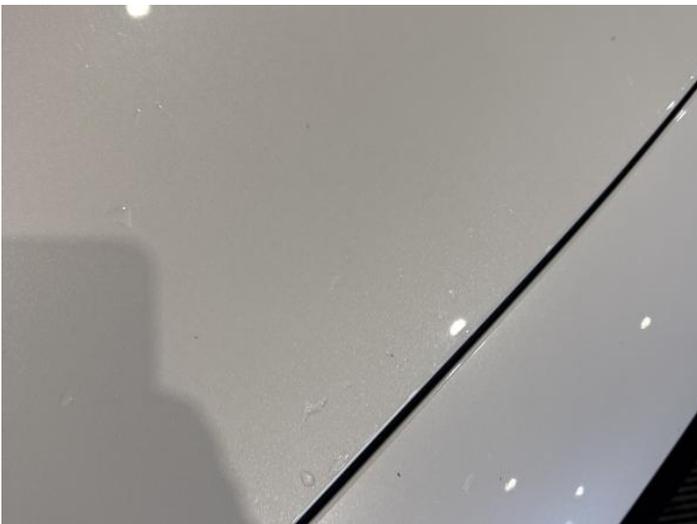
1: Bonnet  
Chipped  
1 To 5

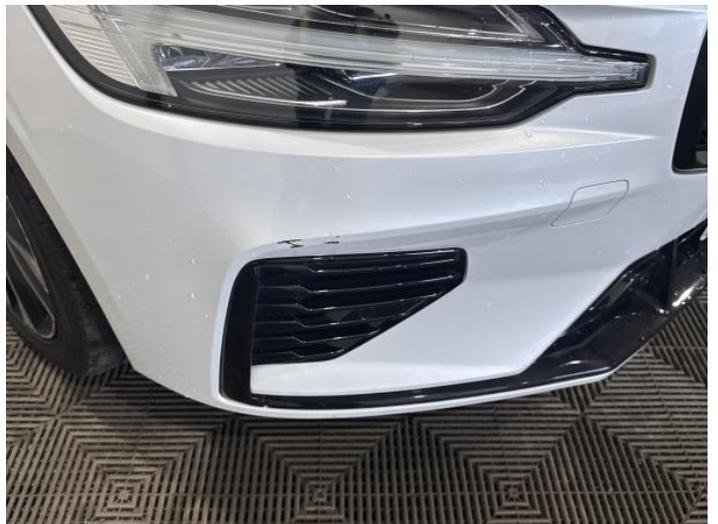
2: Bumper Front  
Scratched  
25 to 100mm Thru Paint

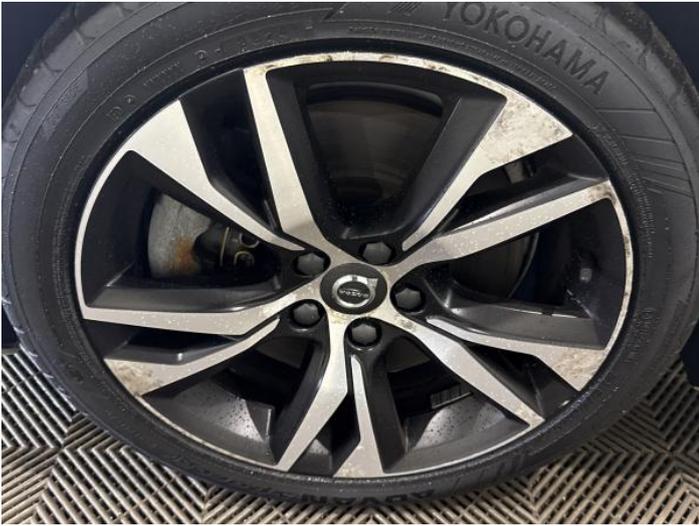
3: Wheel nsf  
Scratched  
Over 50mm

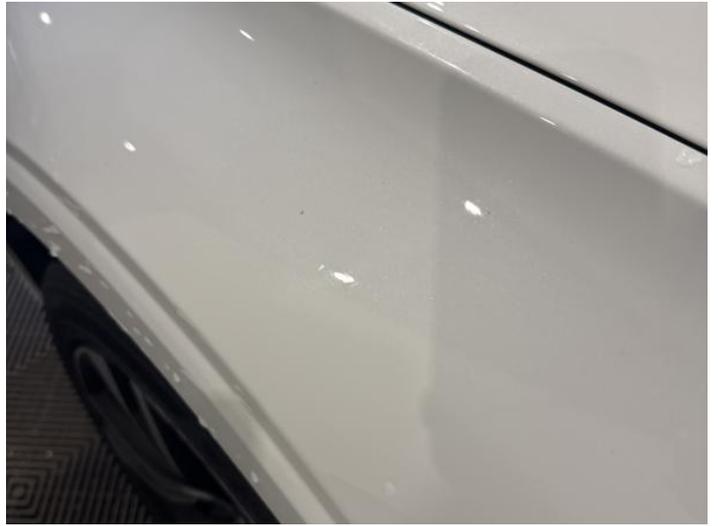
4: Wing nsf  
Chipped  
1 To 5

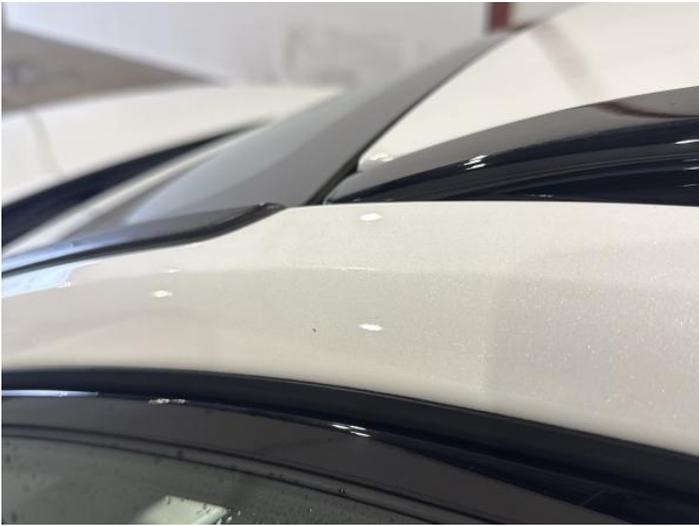
5: A Post ns  
Chipped  
1 To 5

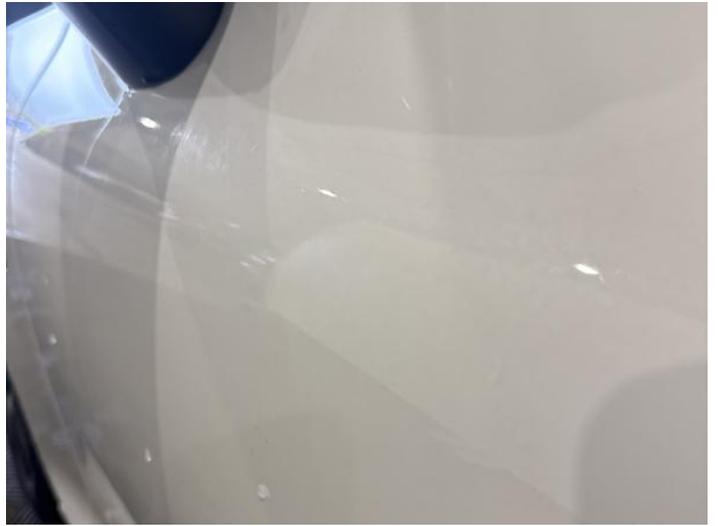
6: Door nsf  
Scratched  
Over 25mm Thru Paint

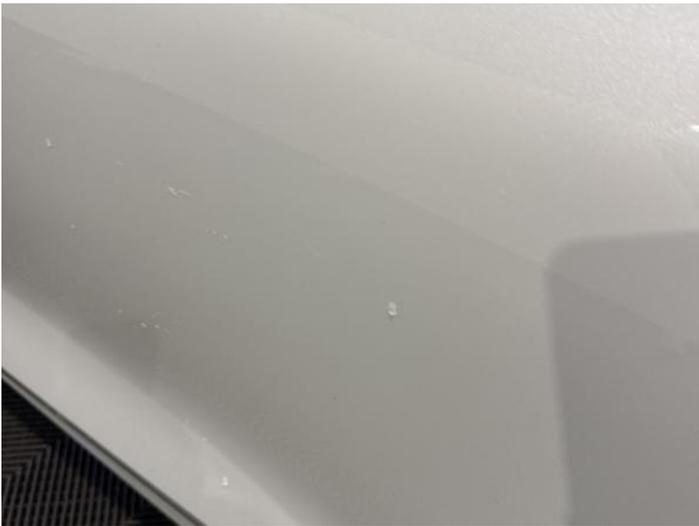
7: Door nsr  
Scratched  
Up To 25mm Thru Paint

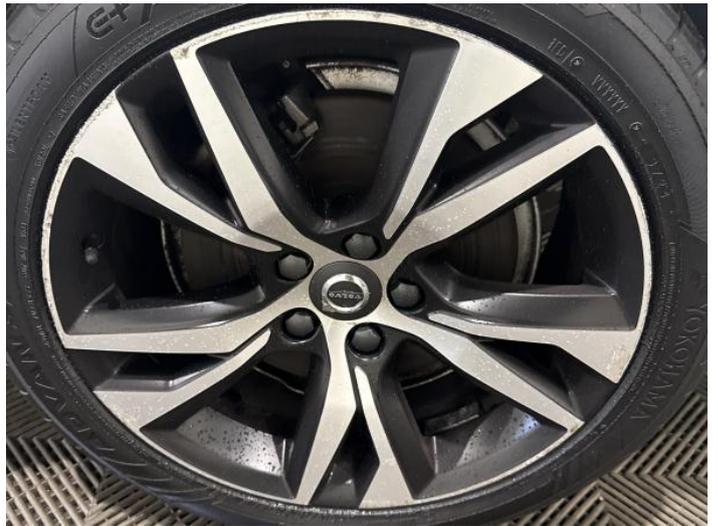
8: Wheel nsr  
Scratched  
Over 50mm

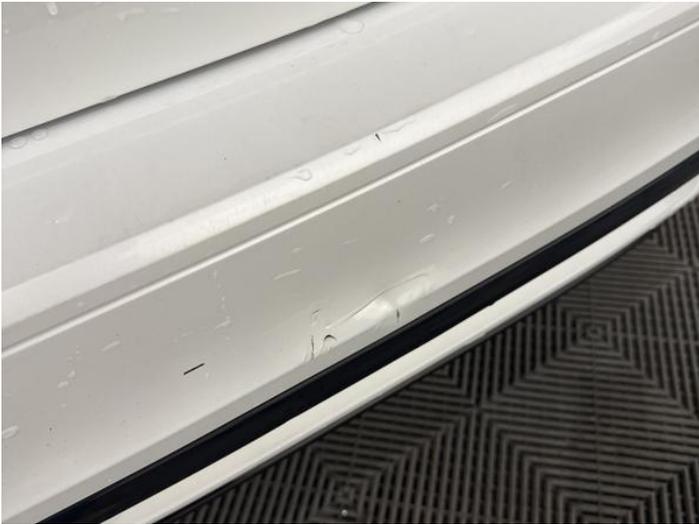
9: Bumper Rear  
Cracked  
UpTo 25mm

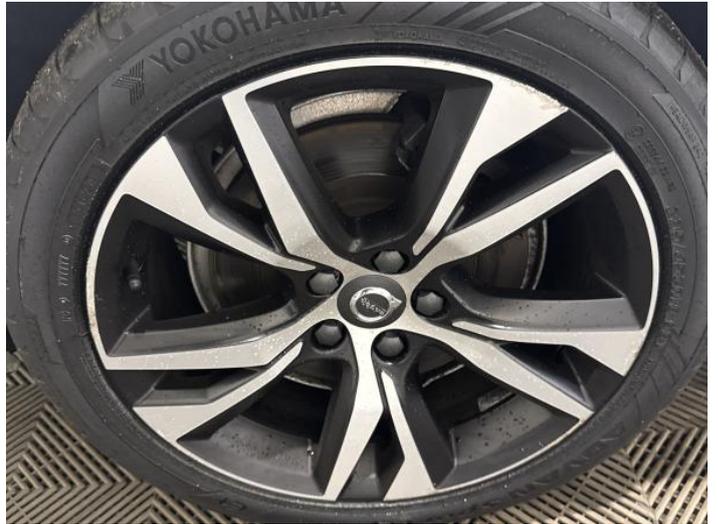
10: Wheel osr  
Scratched  
Over 50mm

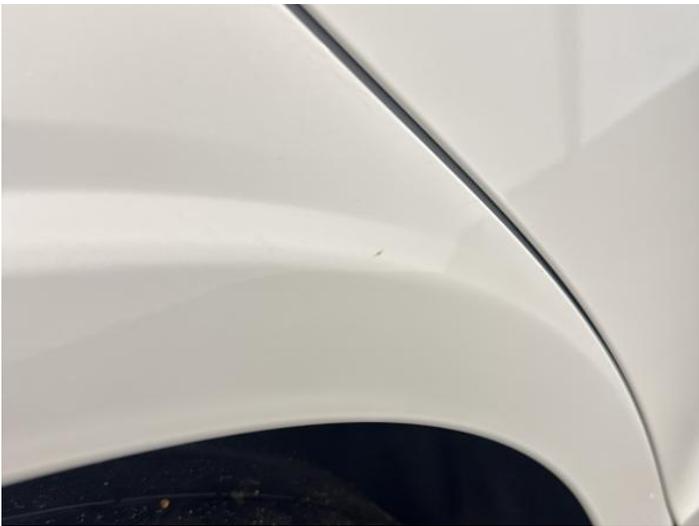
11: Qtr Panel osr  
Scratched  
UpTo 25mm Thru Paint

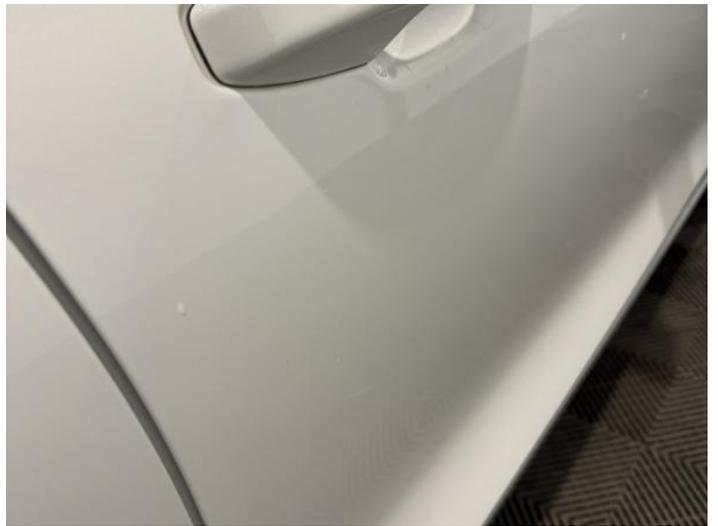
12: Door osf  
Dented  
Over 30mm

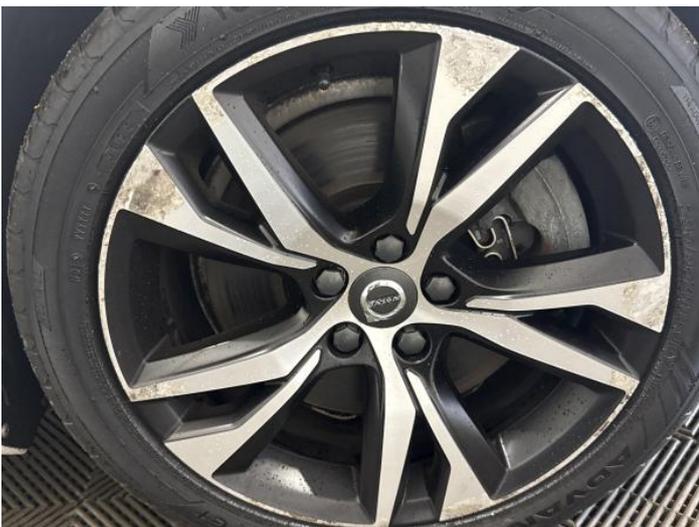
13: Wheel osf  
Scratched  
Over 50mm

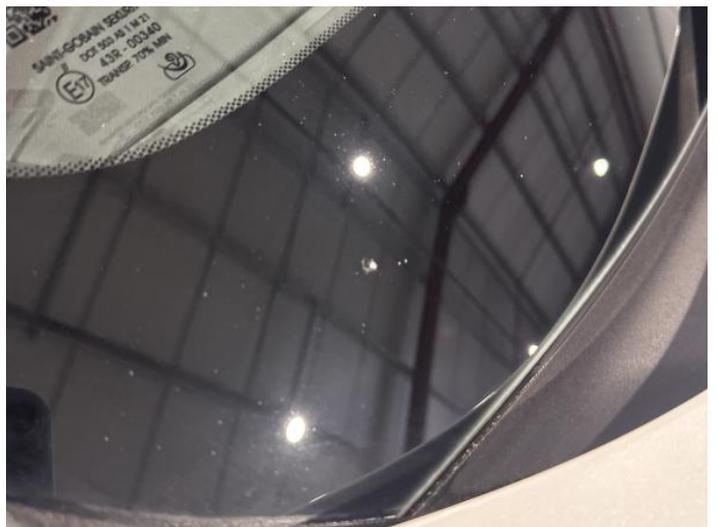
14: Screen Front  
Chipped  
UpTo 10mm
