# VEHICLE INSPECTION REPORT

**GN67ZPX**

## Lexus CT 200h 1.8 Advance 5dr CVT Auto

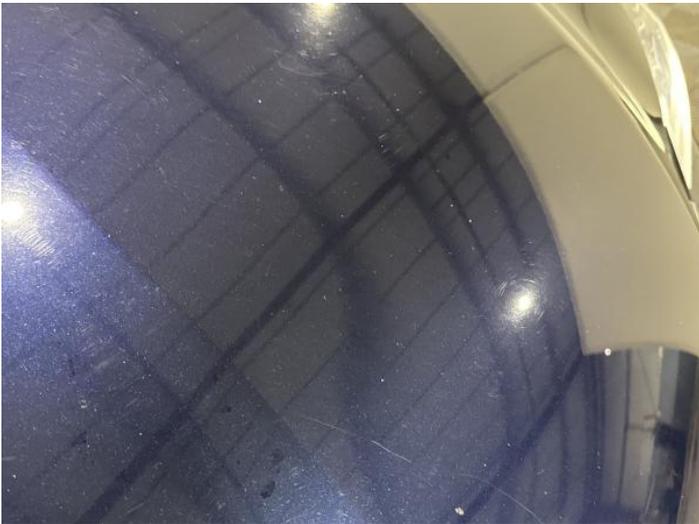
1: Bonnet  
Chipped  
Multiple Chips

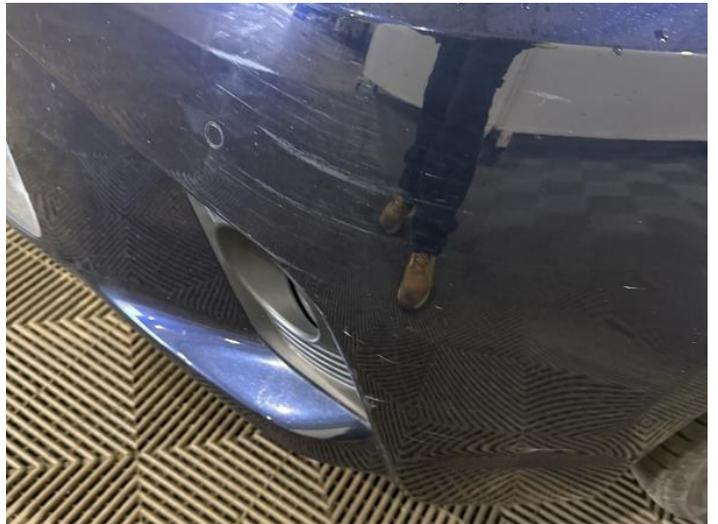
2: Bumper Front  
Scratched  
Over 100mm Thru Paint

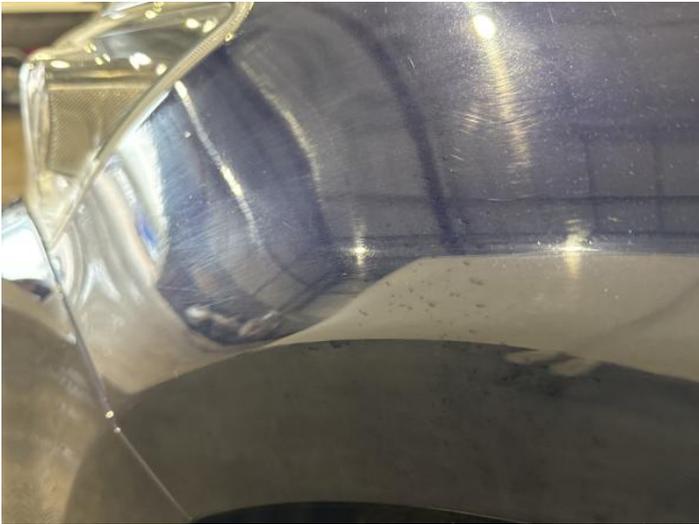
3: Wing nsf  
Poor Previous Repair  
Poor Paint

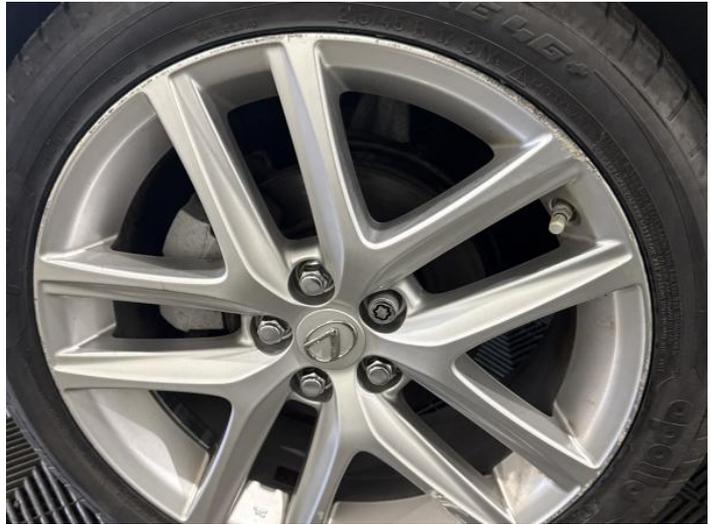
4: Wheel nsf  
Scratched  
Over 50mm

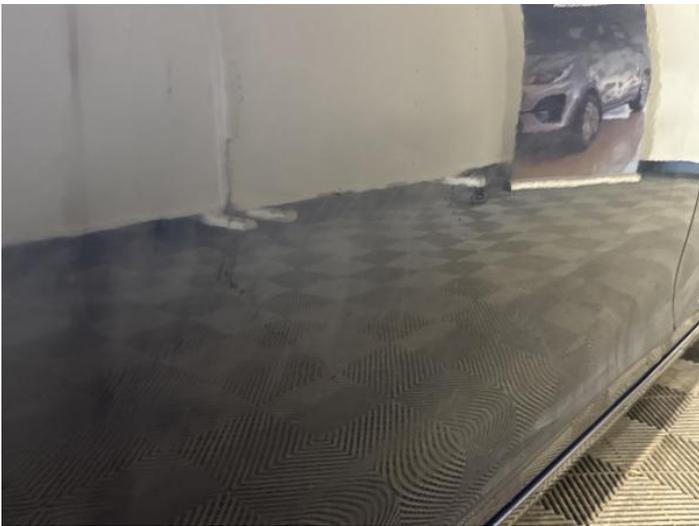
5: Door nsf  
Poor Previous Repair  
Rippled UpTo 30%

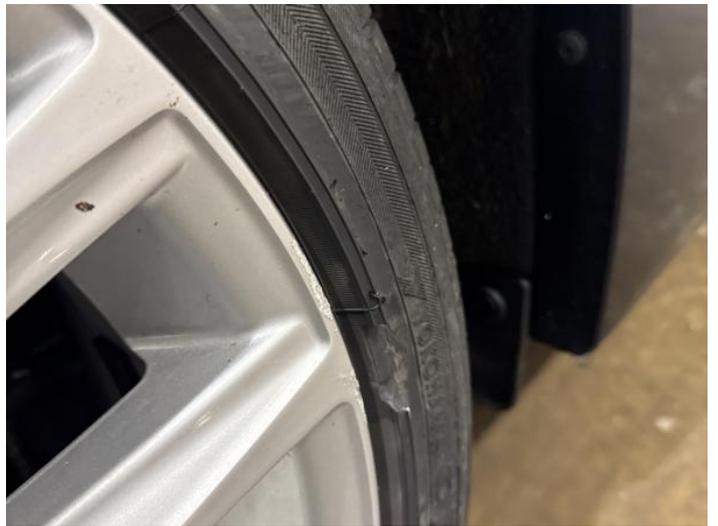
6: Tyre osr  
Damaged  
Replace

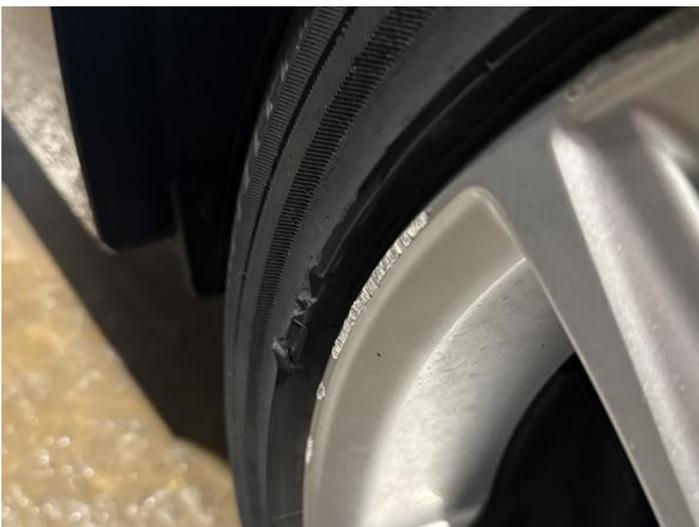
7: Tyre nsr  
Damaged  
Replace

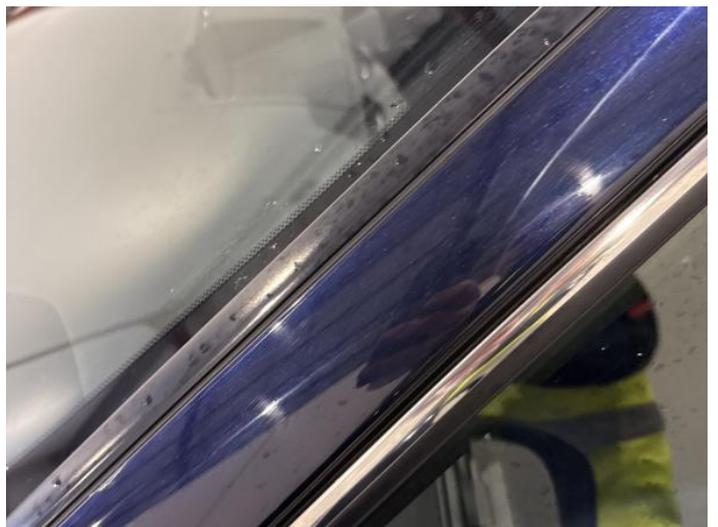
8: A Post ns  
Scratched  
UpTo 25mm Thru Paint

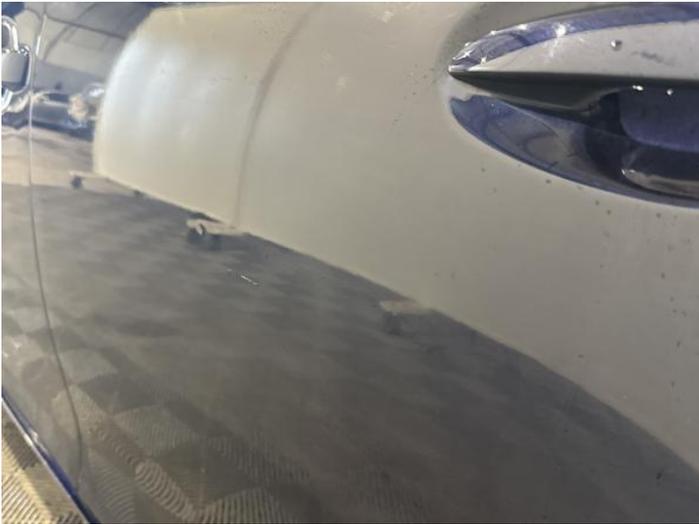
9: Door nsr  
Poor Previous Repair  
Rippled UpTo 30%

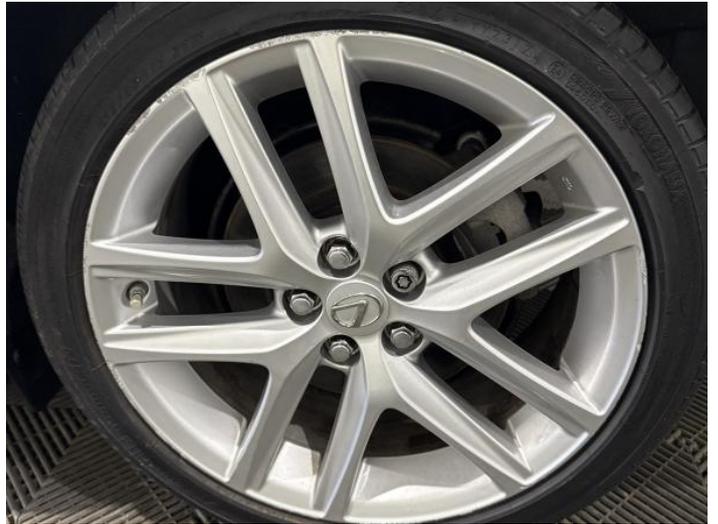
10: Wheel nsr  
Scratched  
Over 50mm

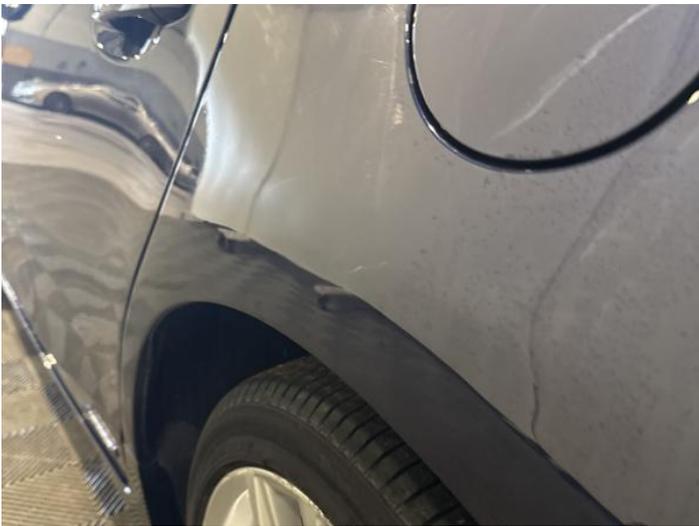
11: Qtr Panel nsr  
Poor Previous Repair  
Rippled UpTo 30%

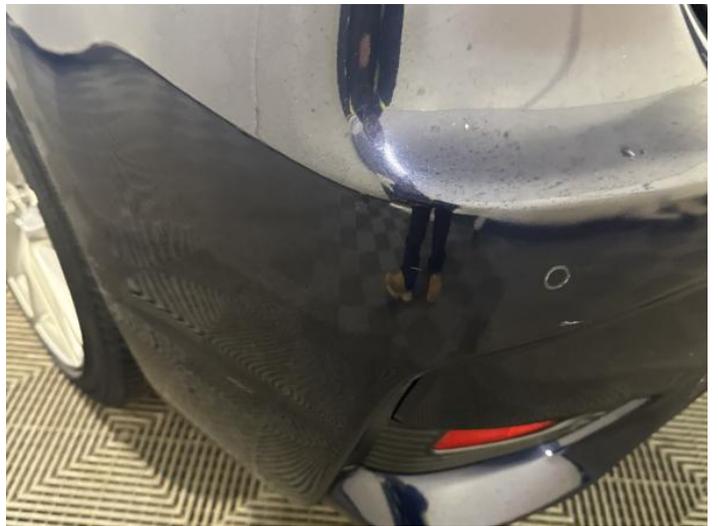
12: Bumper Rear  
Scratched  
Over 100mm Thru Paint

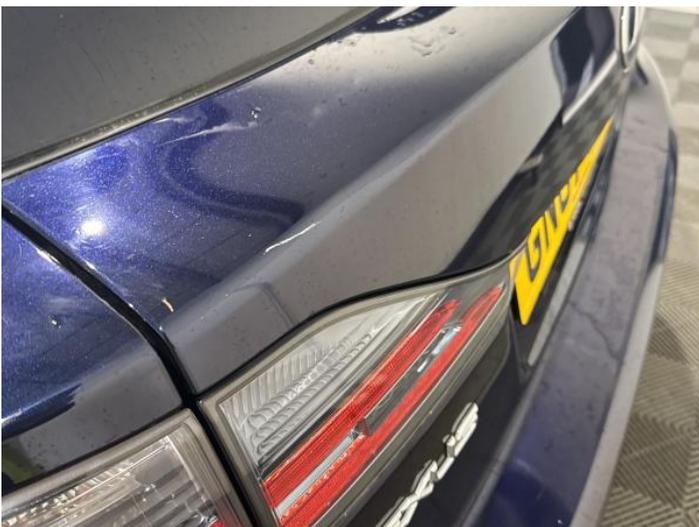
13: Tailgate  
Scratched  
Over 25mm Thru Paint

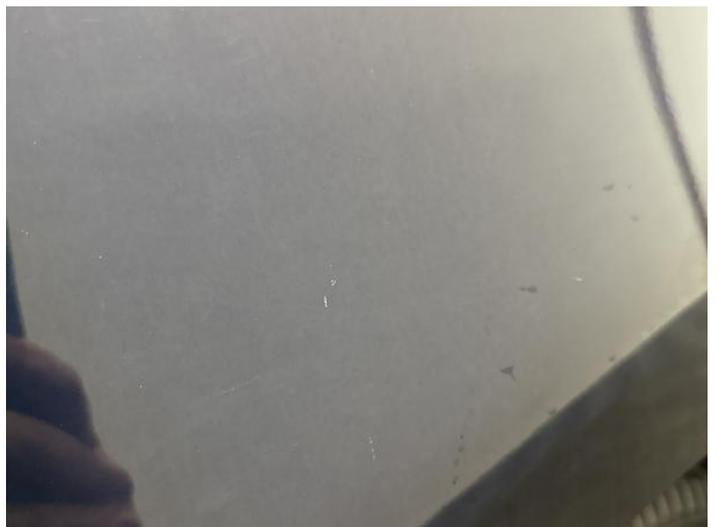
14: Qtr Panel osr  
Chipped  
1 To 5

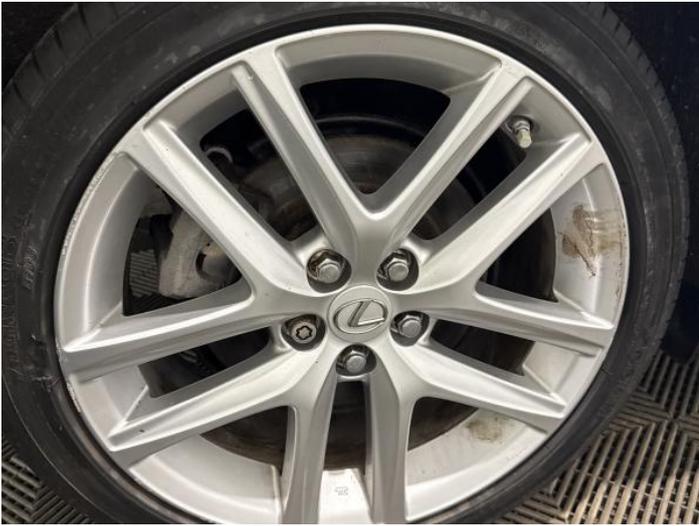
15: Wheel osr  
Scratched  
Over 50mm

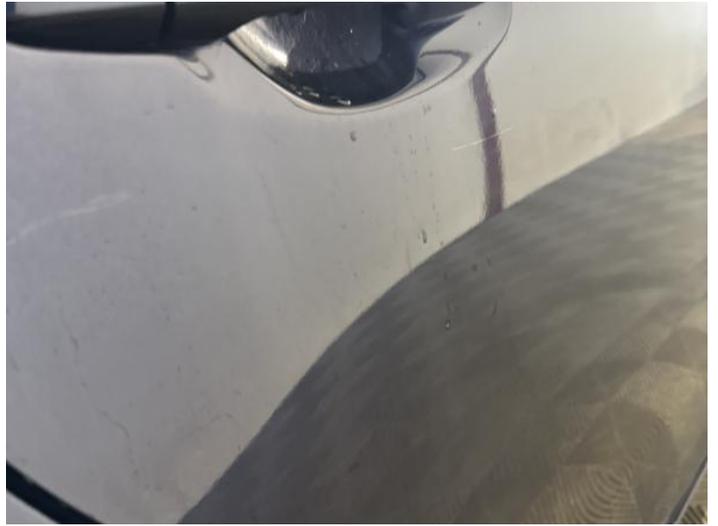
16: Door osr  
Scratched  
Over 25mm Thru Paint

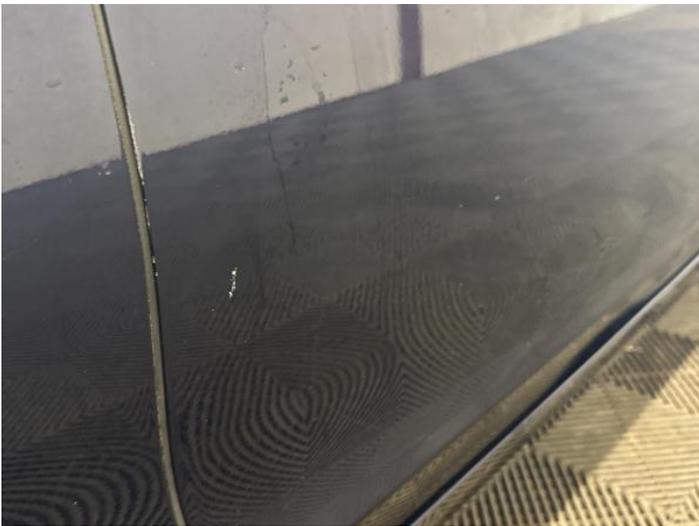
17: Door osf  
Scratched  
Over 25mm Thru Paint

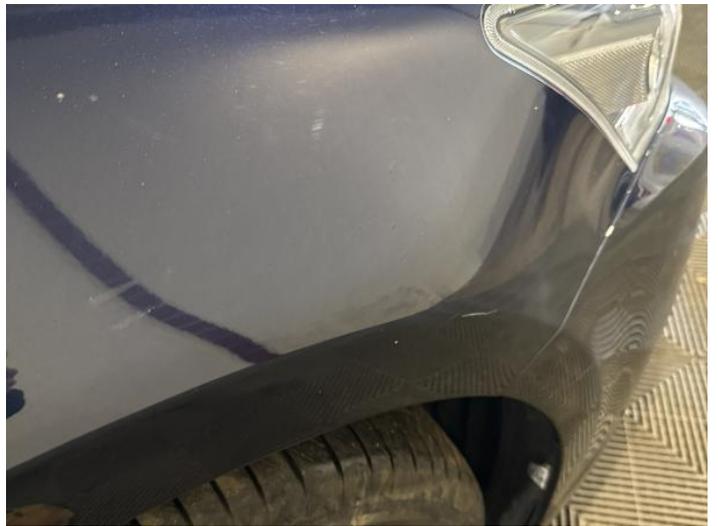
18: Wing osf  
Scratched  
Over 25mm Thru Paint

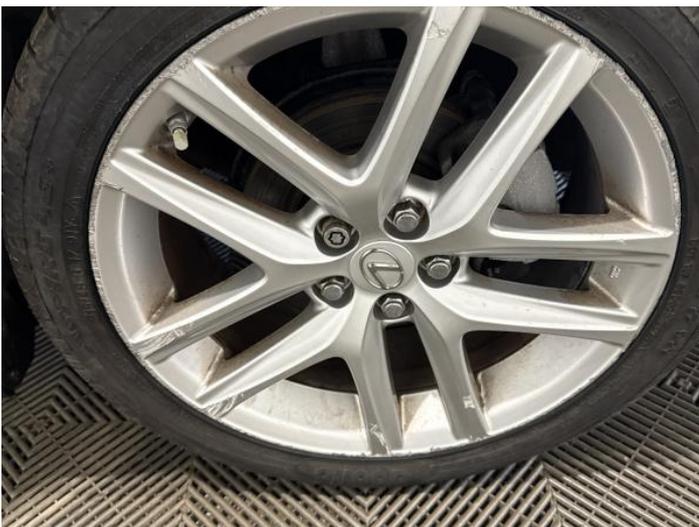
19: Wheel osf  
Scratched  
Over 50mm

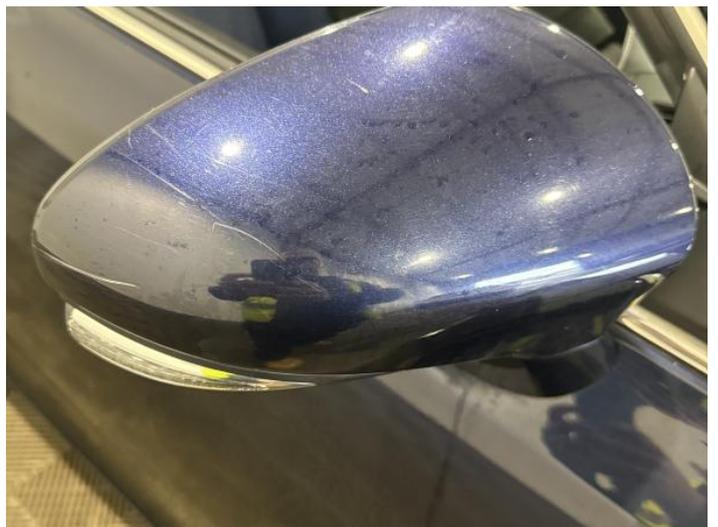
20: Door Mirror Assy osf  
Scratched (Painted)  
Over 25mm Thru Paint

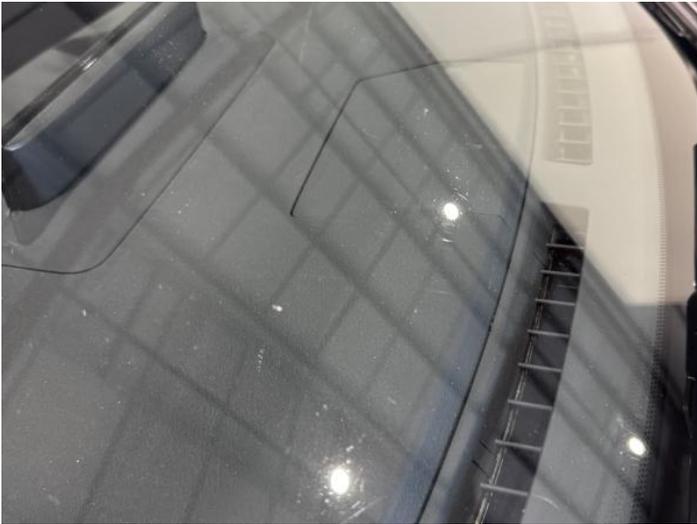
21: Screen Front  
Chipped  
UpTo 10mm
