# VEHICLE INSPECTION REPORT

**LM57JZT**

## Volkswagen Golf 1.6 Match FSI 5dr

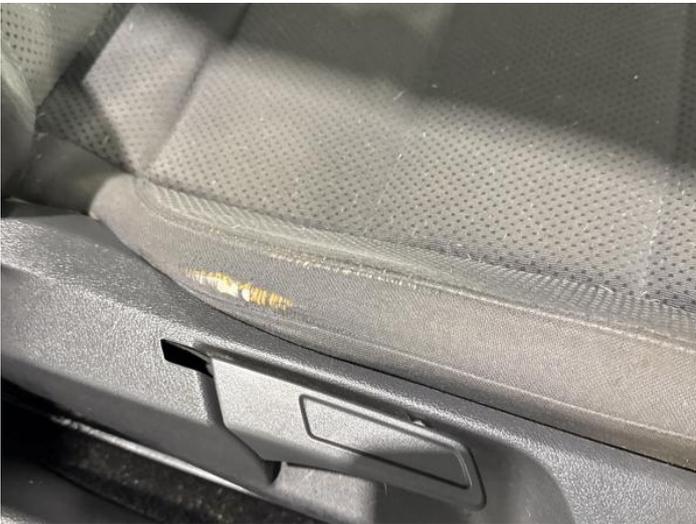
1: Seat Base Cover osf  
Torn  
Over 3mm

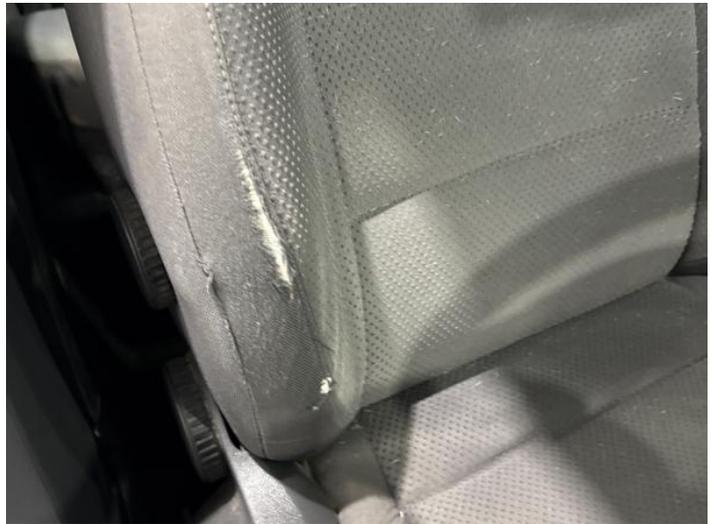
2: Seat Back Cover osf  
Scuffed  
Over 25mm

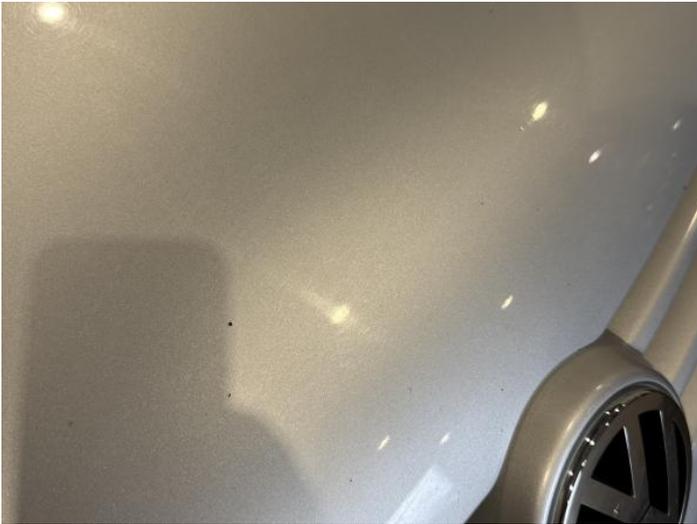
3: Bonnet  
Chipped  
Multiple Chips

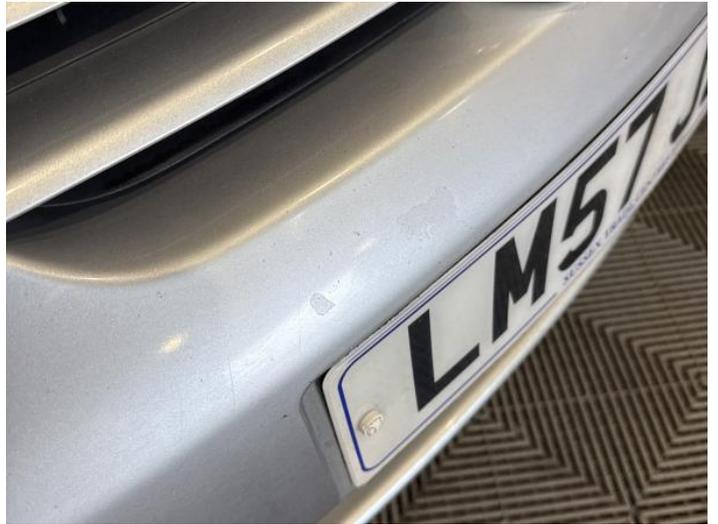
4: Bumper Front  
Poor Previous Repair  
Paint Flake

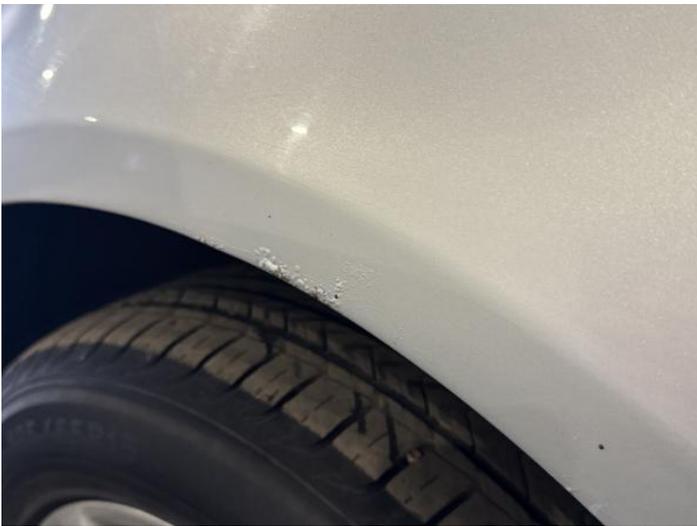
5: Wing nsf  
Rusted  
Over 5mm

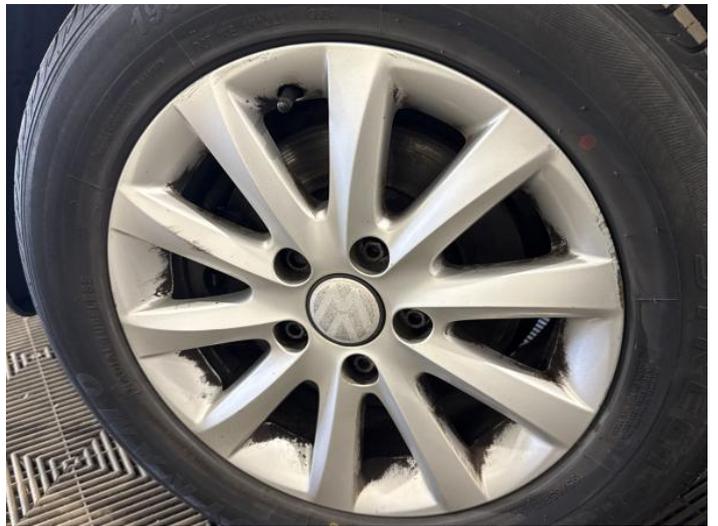
6: Wheel nsf  
Scratched  
Over 50mm

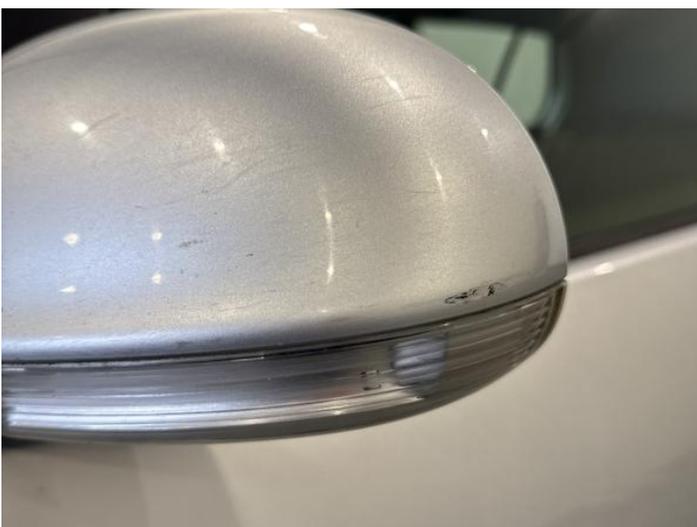
7: Door Mirror Assy nsf  
Scratched (Painted)  
UpTo 25mm Thru Paint

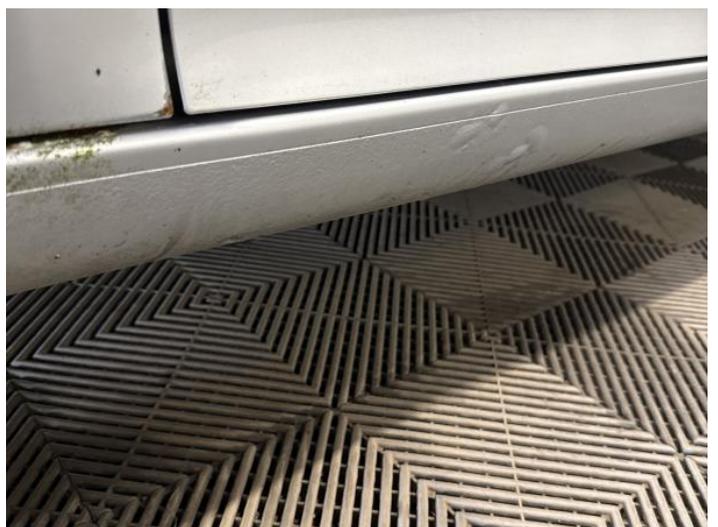
8: Sill ns  
Rusted  
Over 5mm

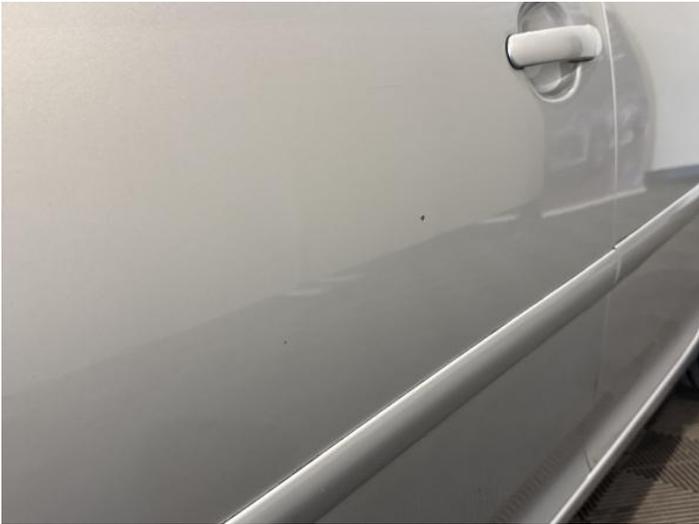
9: Door nsf  
Dented  
Over 30mm

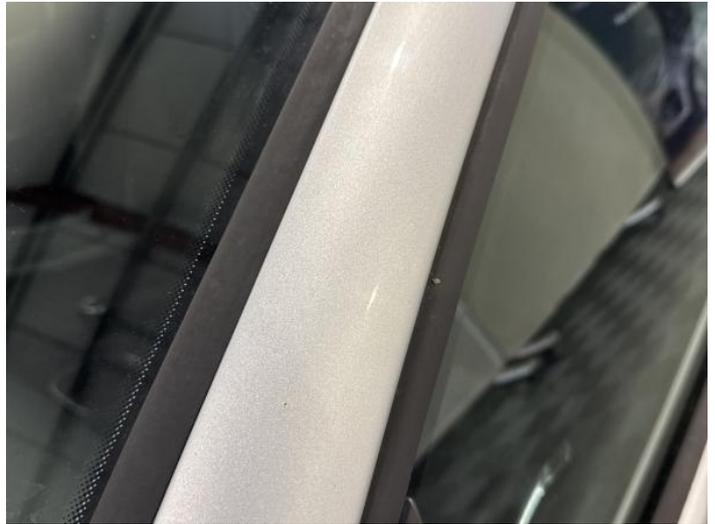
10: A Post ns  
Chipped  
1 To 5

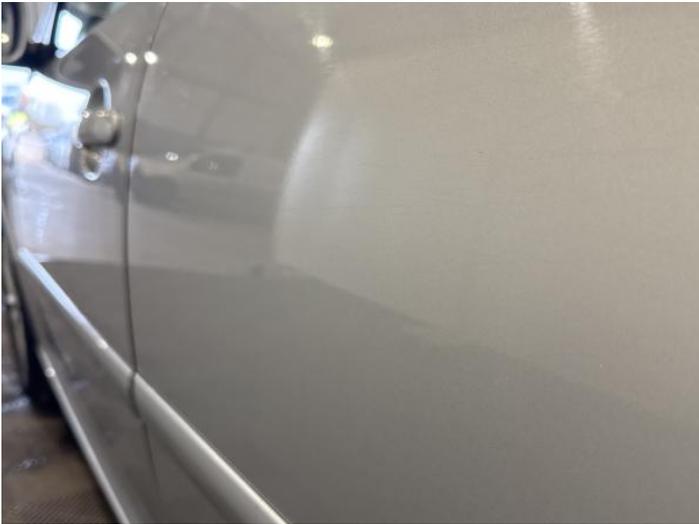
11: Door nsr  
Dented  
Over 30mm

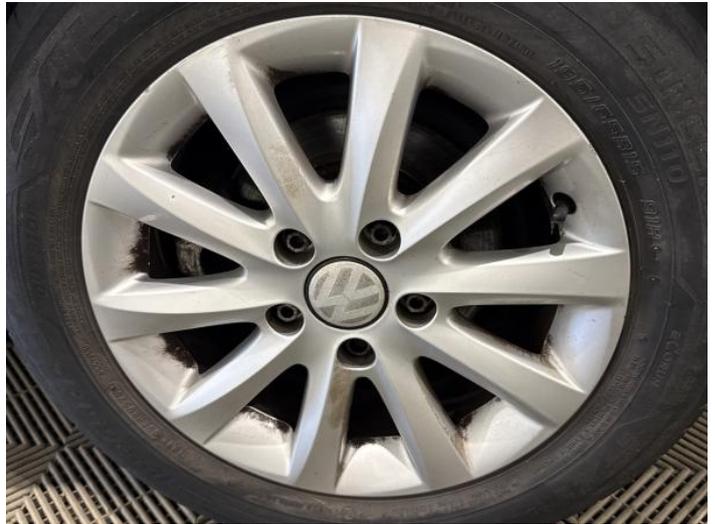
12: Wheel nsr  
Scratched  
Up To 50mm

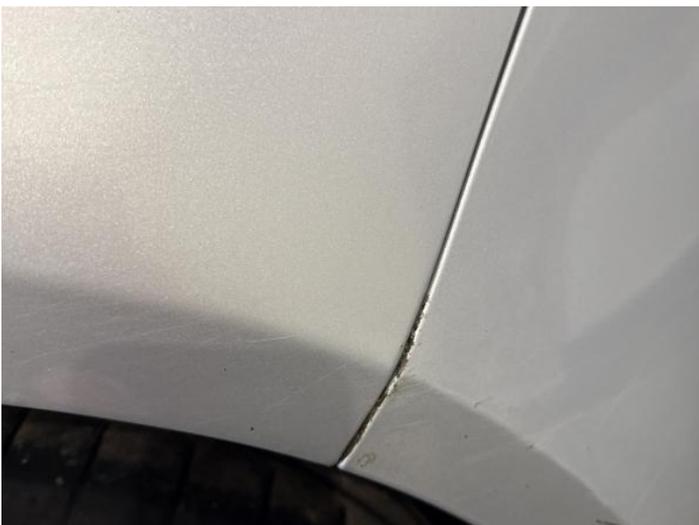
13: Qtr Panel osr  
Scratched  
Up To 25mm Thru Paint

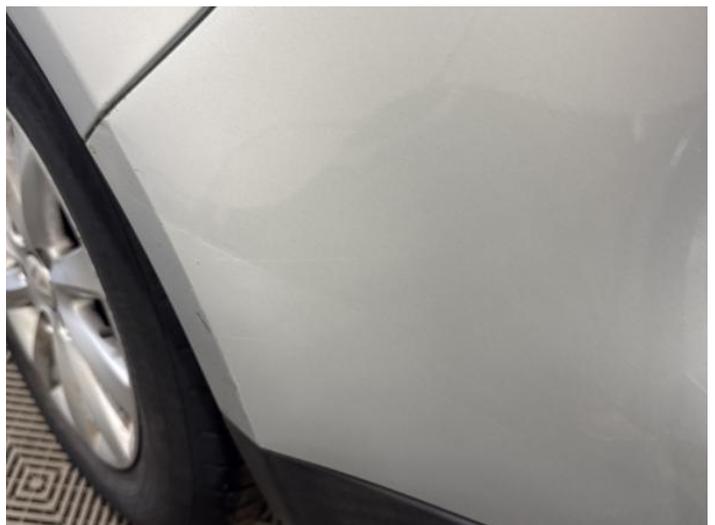
14: Bumper Rear  
Dented  
With Paint Damage

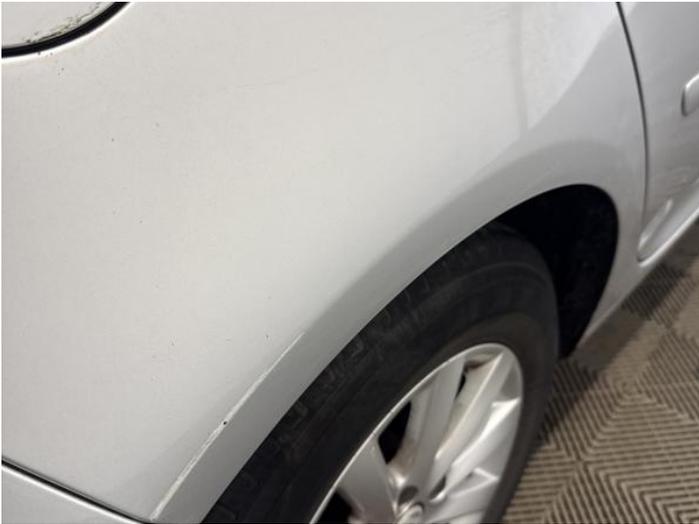
15: Qtr Panel osr  
Dented  
With Paint Damage

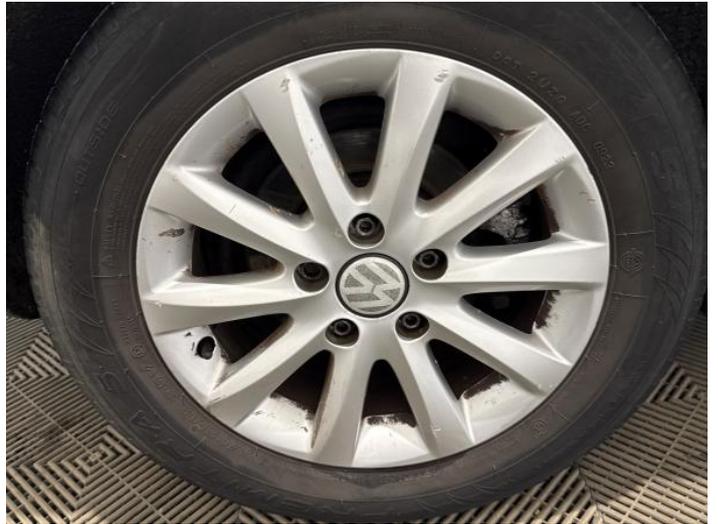
16: Wheel osr  
Scratched  
Over 50mm

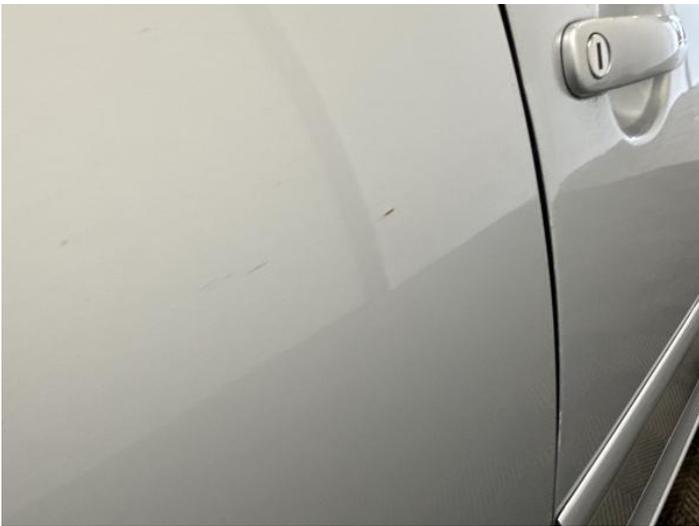
17: Door osr  
Scratched  
Over 25mm Thru Paint

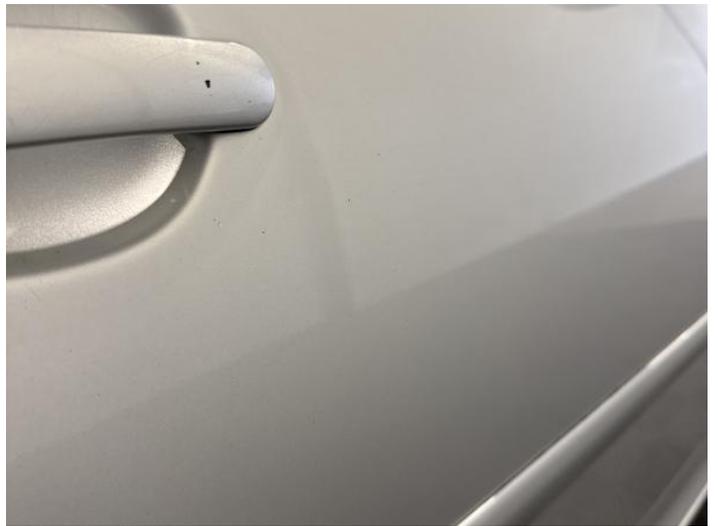
18: Door osf  
Dented  
Between 10mm + 30mm

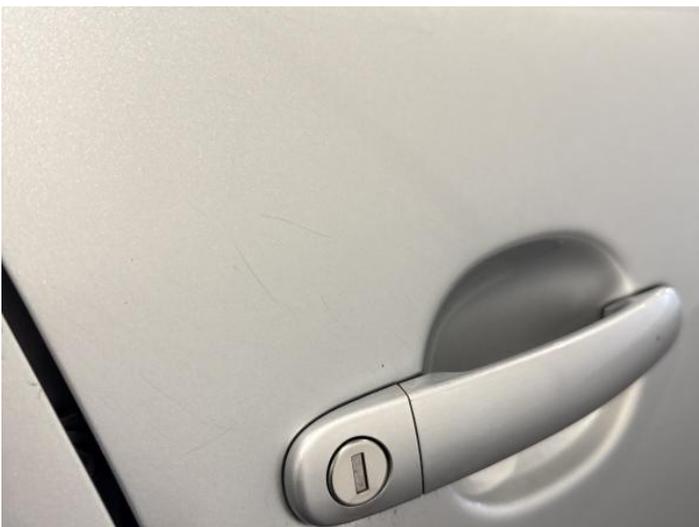
19: Door osf  
Scratched  
Up To 25mm Thru Paint

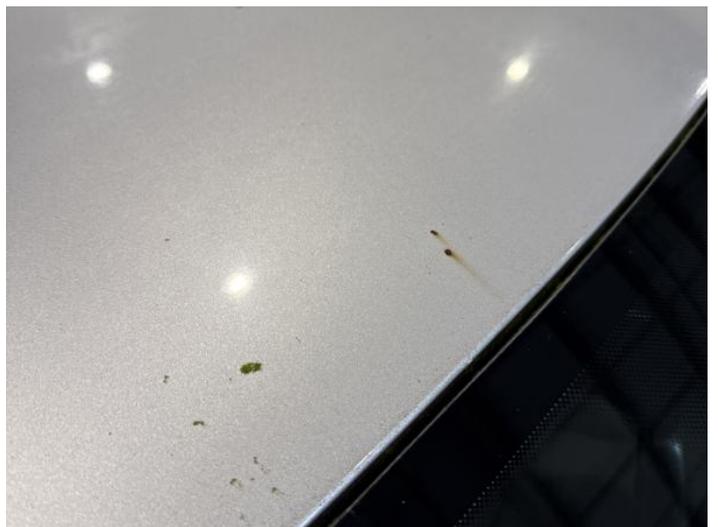
20: Roof  
Chipped  
Multiple Chips

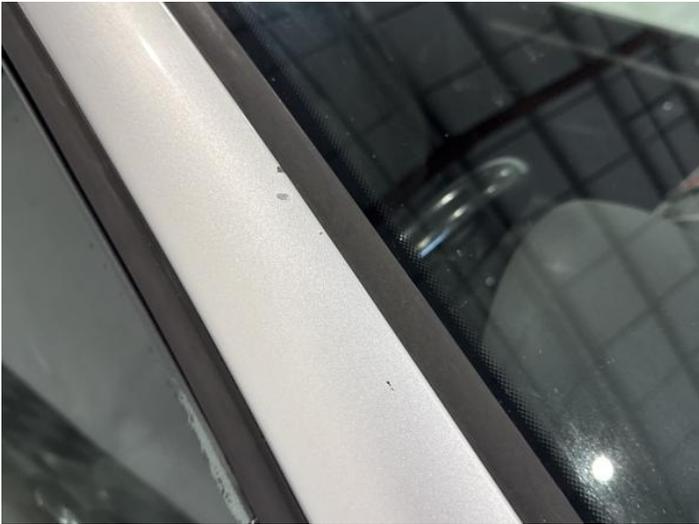
21: A Post os  
Chipped  
1 To 5

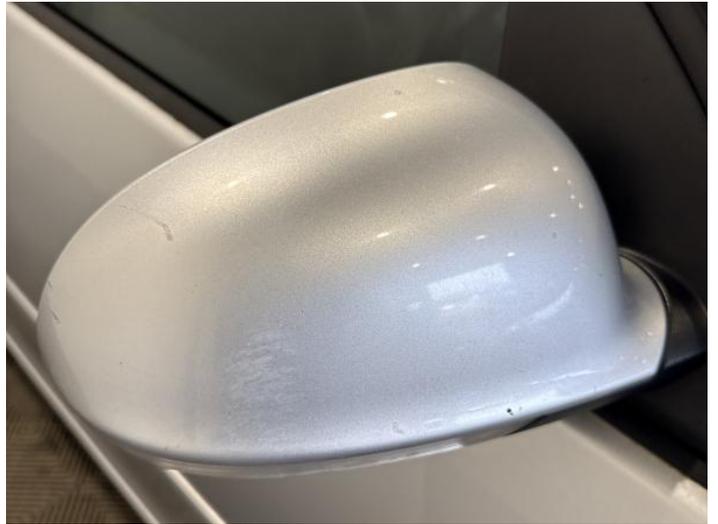
22: Door Mirror Assy osf  
Scratched (Painted)  
UpTo 25mm Thru Paint

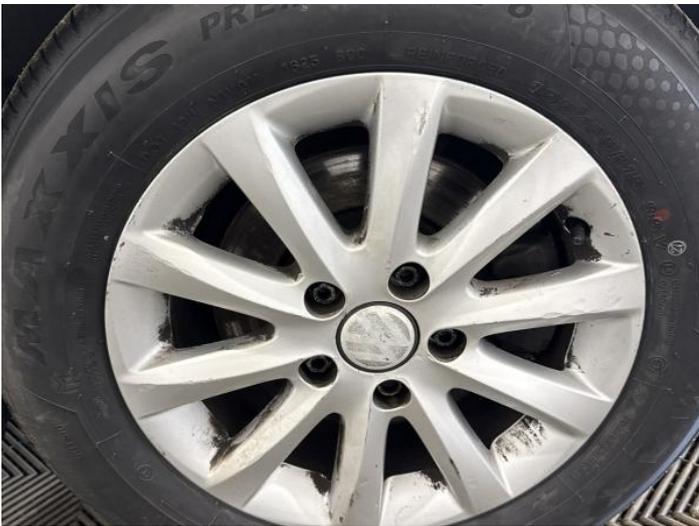
23: Wheel osf  
Scratched  
Over 50mm

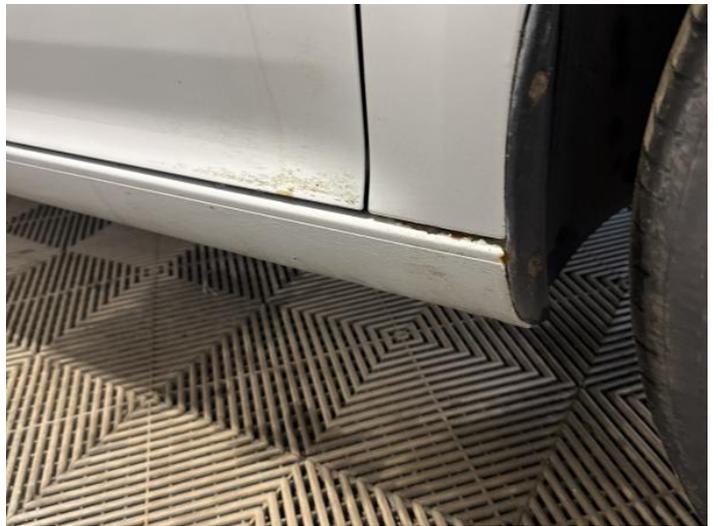
24: Sill os  
Rusted  
Over 5mm

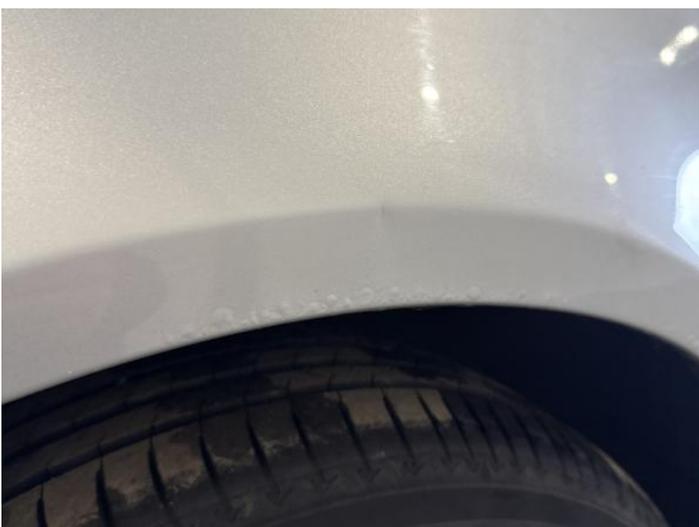
25: Wing osf  
Rusted  
Over 5mm
