## VEHICLE INSPECTION REPORT

**BG19SOA**

### Ford Galaxy 2.0 EcoBlue 150 Titanium 5dr

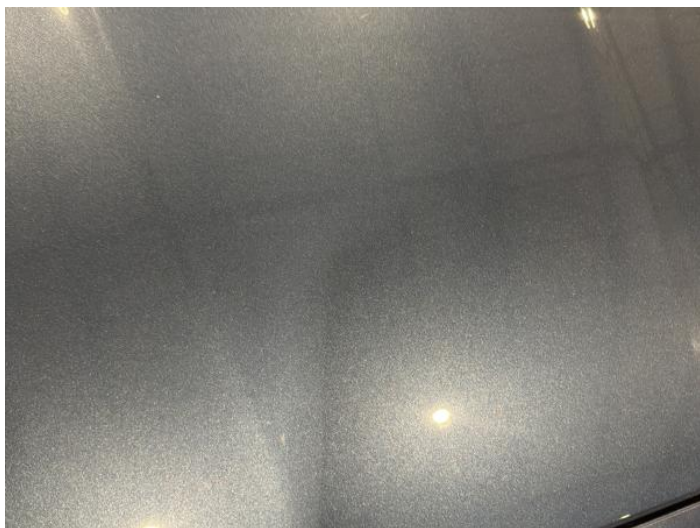
1: Bonnet  
Chipped  
1 To 5

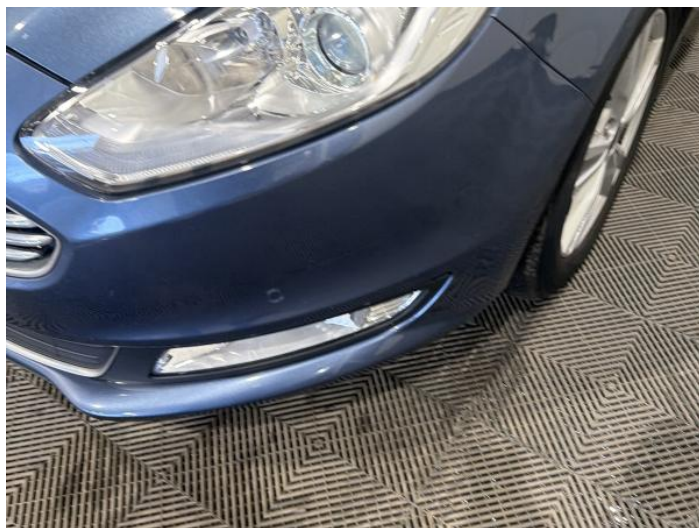
2: Bumper Front  
Chipped  
Multiple Chips

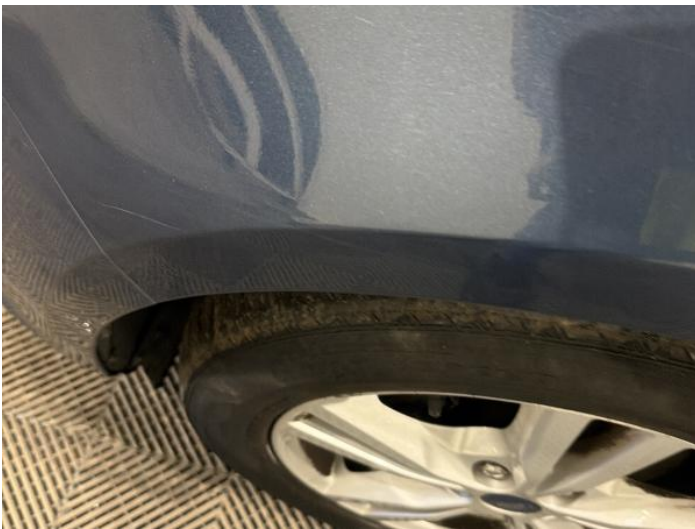
5: Wing nsf  
Scratched  
Up To 25mm Thru Paint

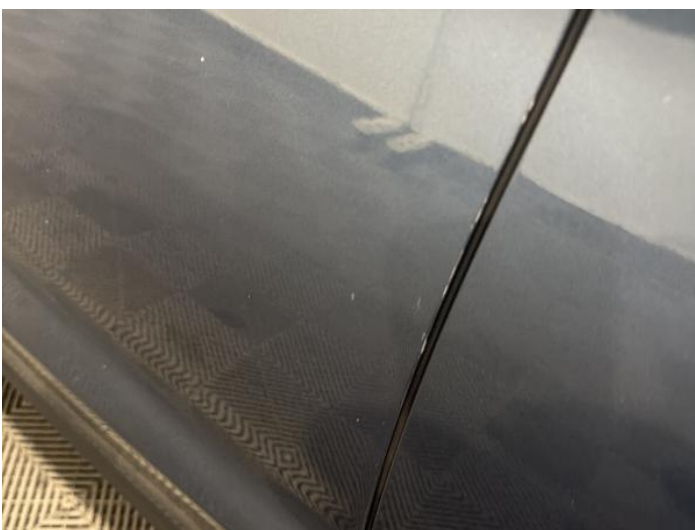
7: Door nsf  
Chipped  
1 To 5

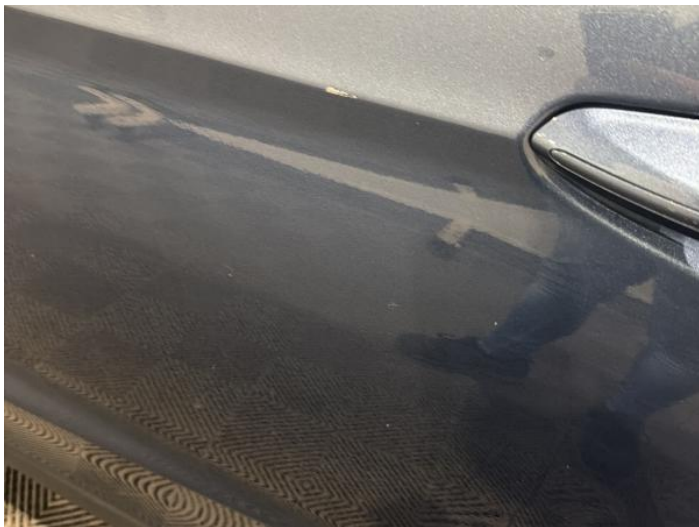
9: Door nsr  
Scratched  
Over 25mm Thru Paint

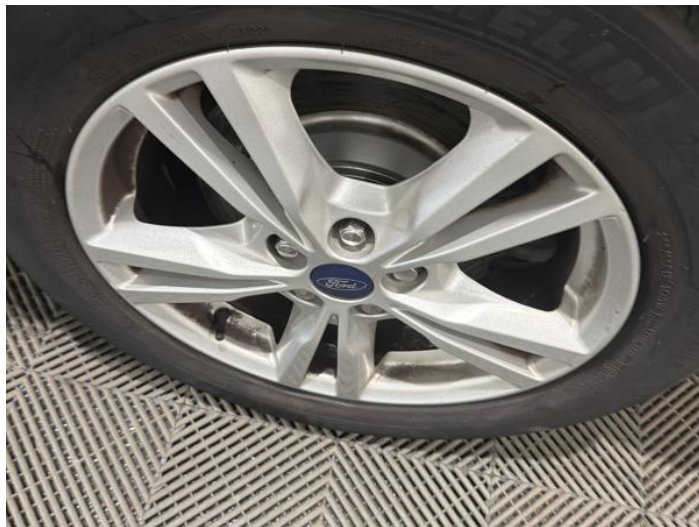
10: Wheel nsr  
Scratched  
Up To 50mm

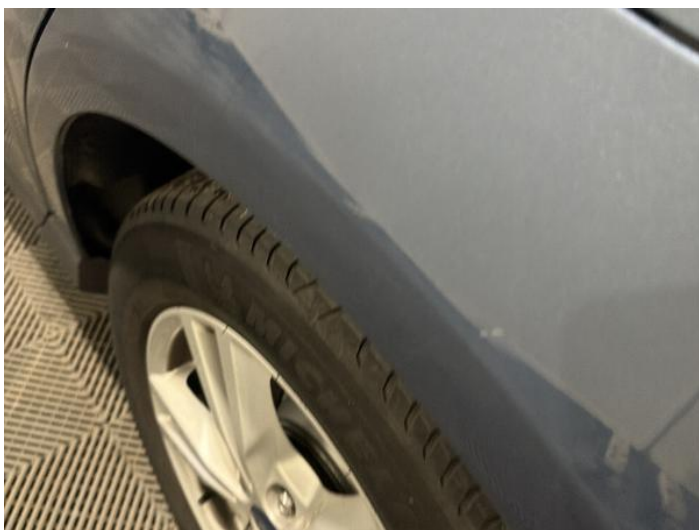
11: Qtr Panel nsr  
Dented  
With Paint Damage

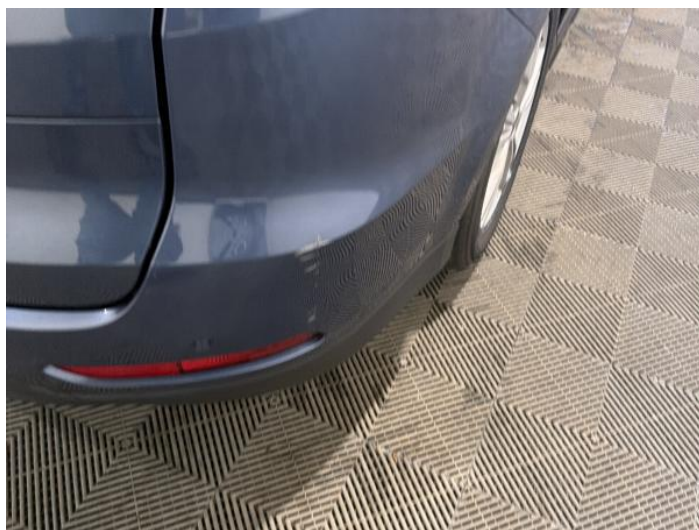
12: Bumper Rear  
Scratched  
Over 100mm Thru Paint

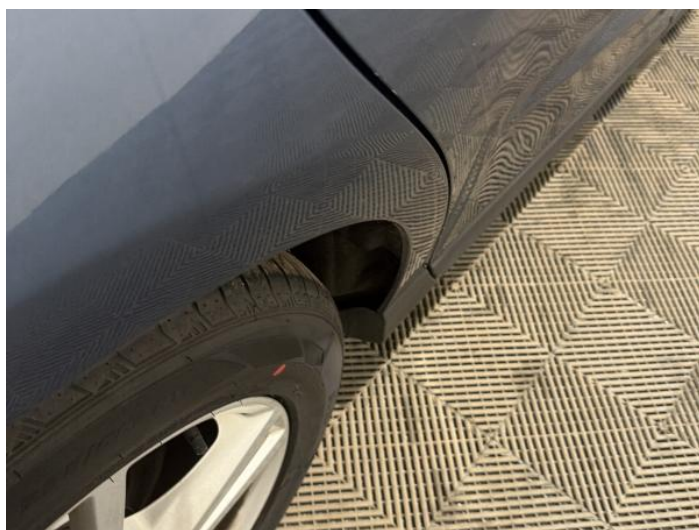
14: Qtr Panel osr  
Dented  
2 Or Less UpTo 10mm

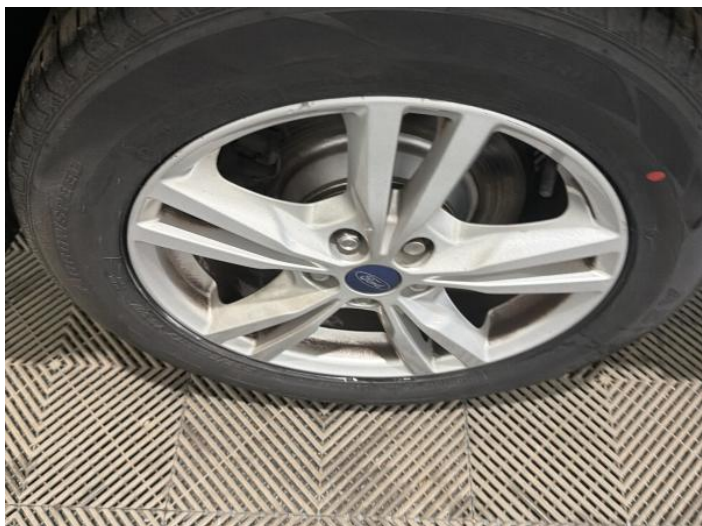
15: Wheel osr  
Scratched  
Up To 50mm

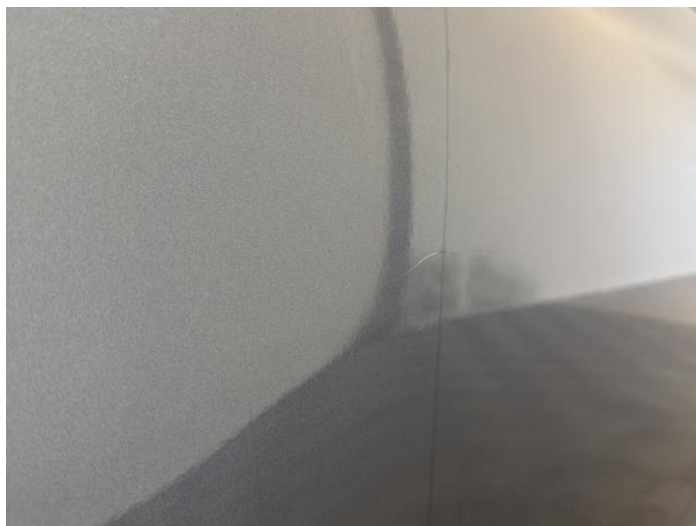
16: Door osr  
Scratched  
UpTo 25mm Thru Paint

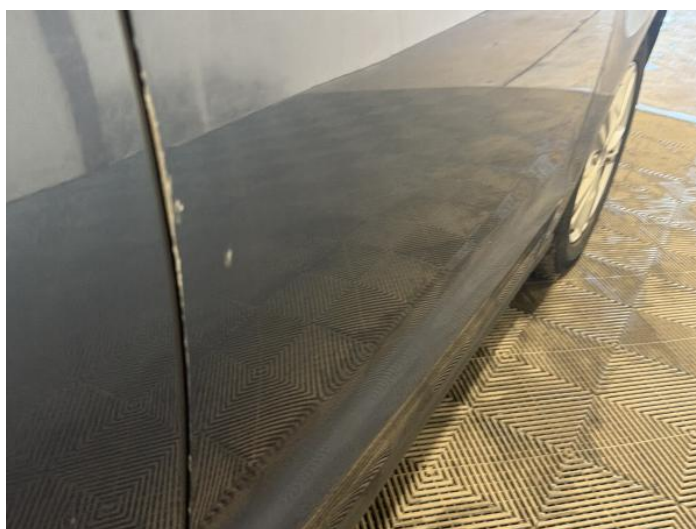
18: Door osf  
Scratched  
Over 25mm Thru Paint

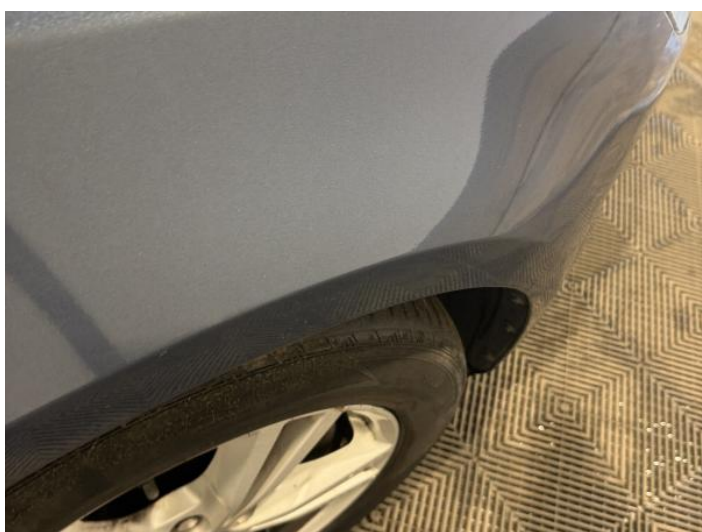
19: Wing osf  
Dented  
Between 10mm + 30mm

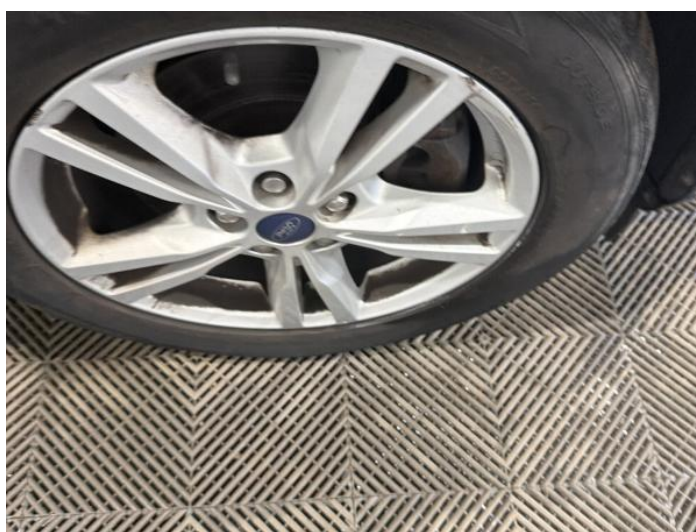
20: Wheel osf  
Scratched  
Over 50mm

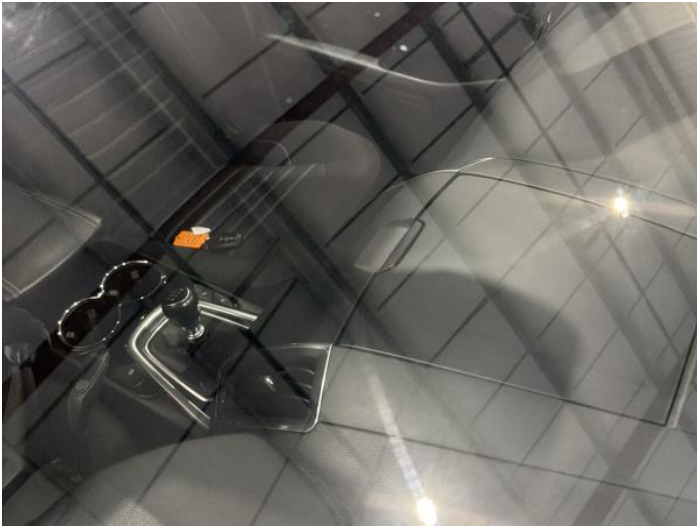
21: Screen Front  
Chipped  
UpTo 10mm

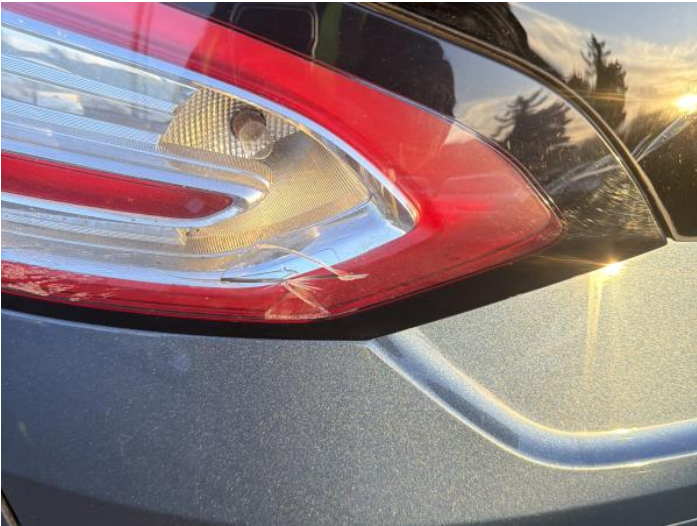
22: Lamp nsr  
Broken  
Replace

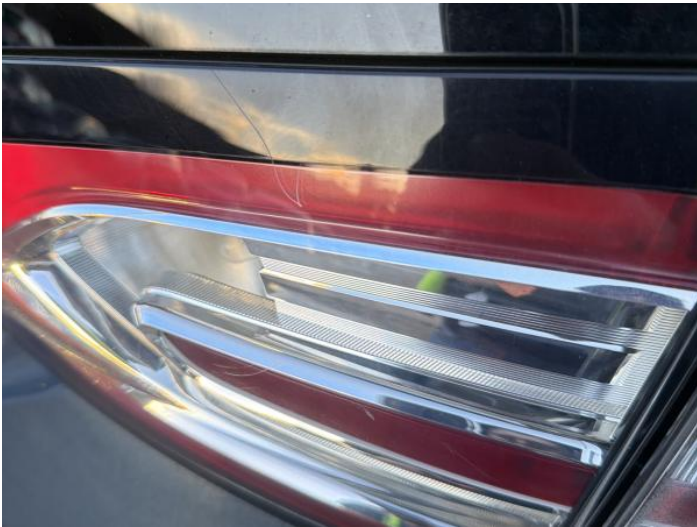
23: Lamp osr  
Broken  
Replace
