VEHICLE INSPECTION REPORT

DS69HCL

Mercedes-Benz A Class A180d AMG Line Executive 4dr Auto

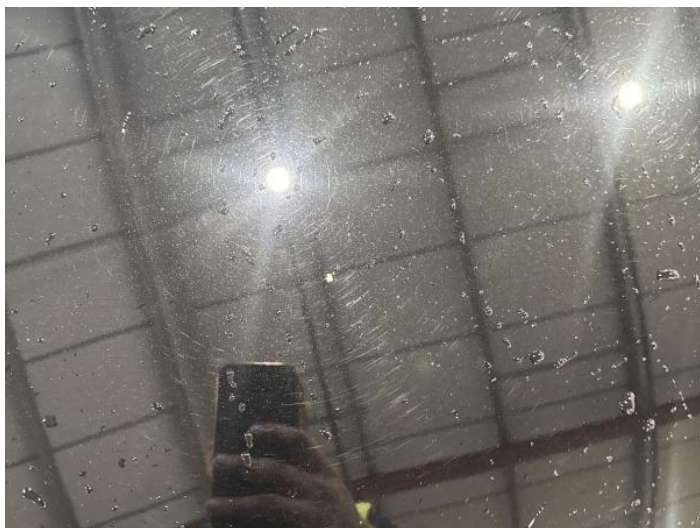
1: Bonnet
Chipped
1 To 5

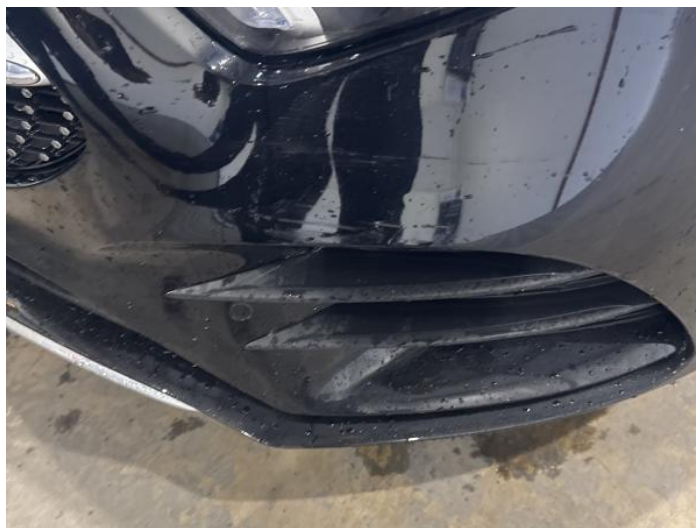
2: Bumper Front
Scratched
Over 100mm Thru Paint

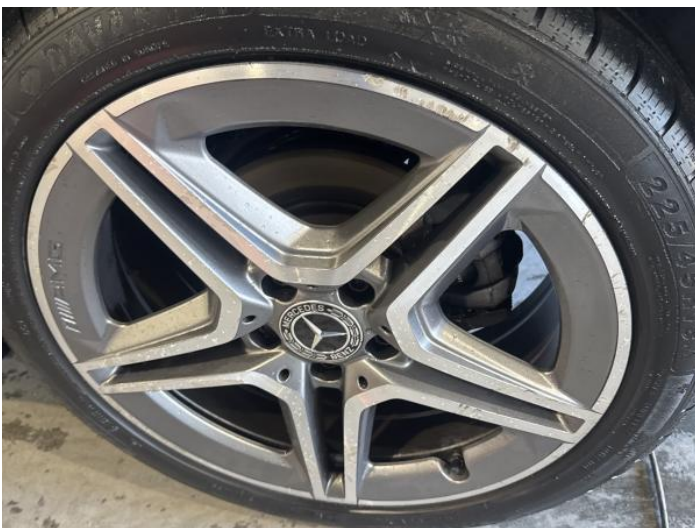
7: Wheel nsr
Scratched
Over 50mm

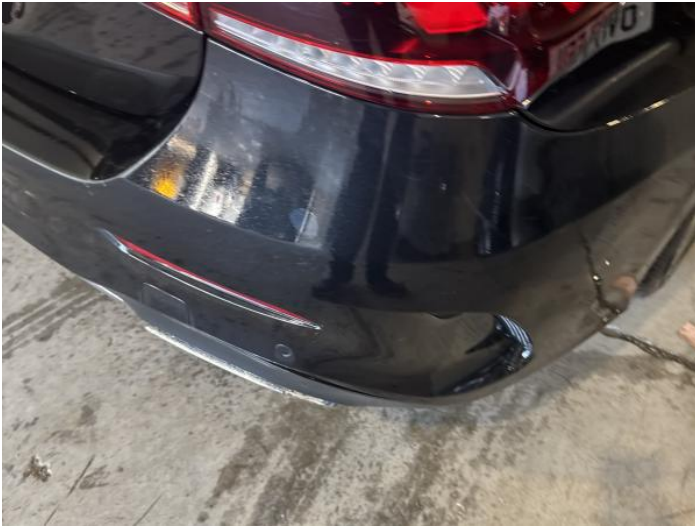
9: Bumper Rear
Chipped
Multiple Chips

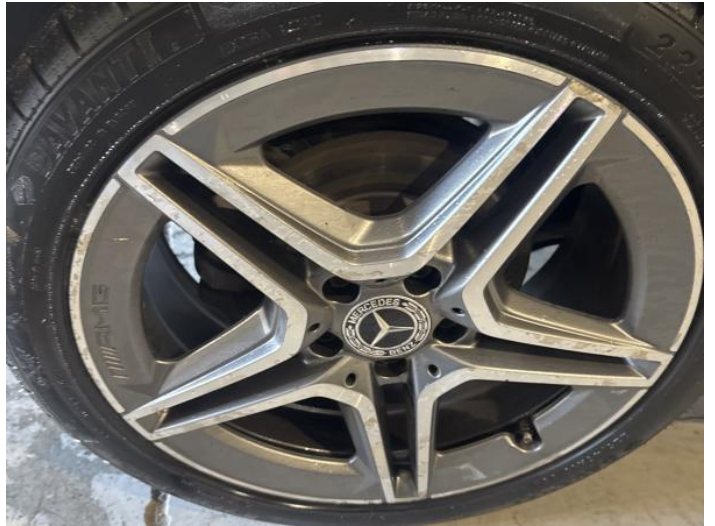
10: Wheel osr
Scratched
Over 50mm

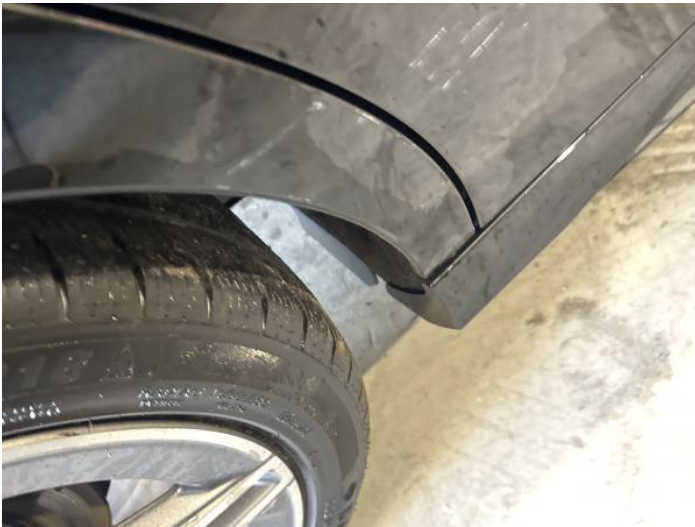
11: Qtr Panel osr
Dented
With Paint Damage

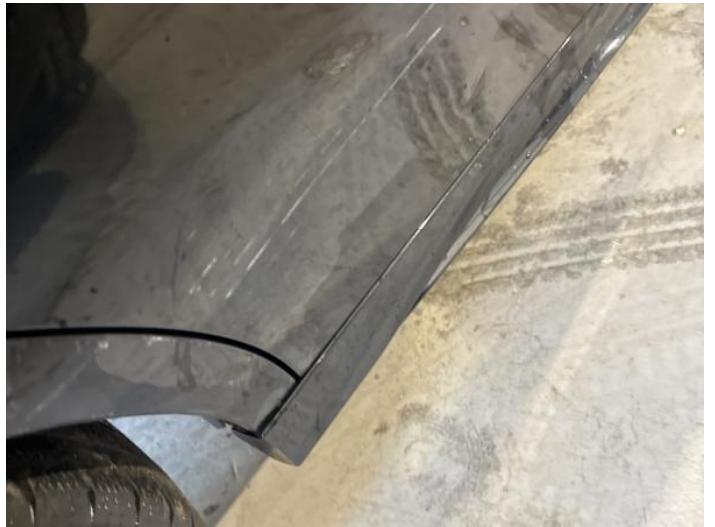
12: Door osr
Dented
With Paint Damage

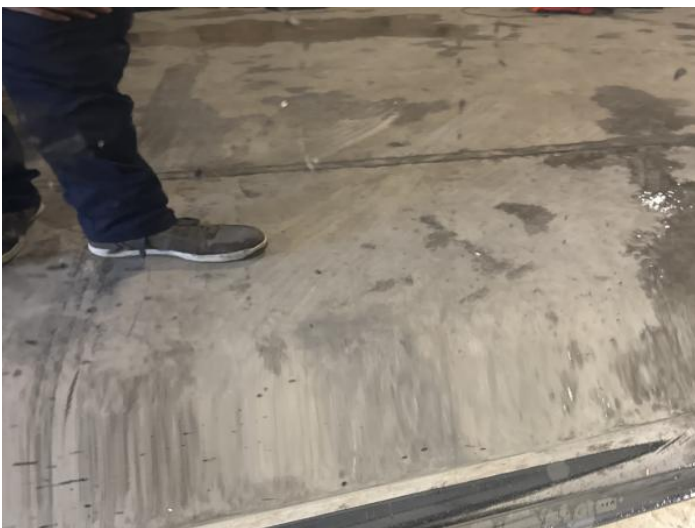
13: Door osf
Chipped
1 To 5

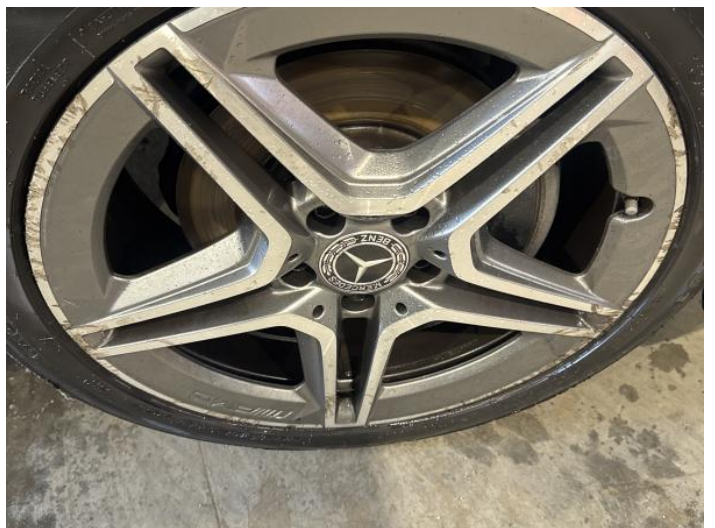
14: Wheel osf
Scratched
Over 50mm

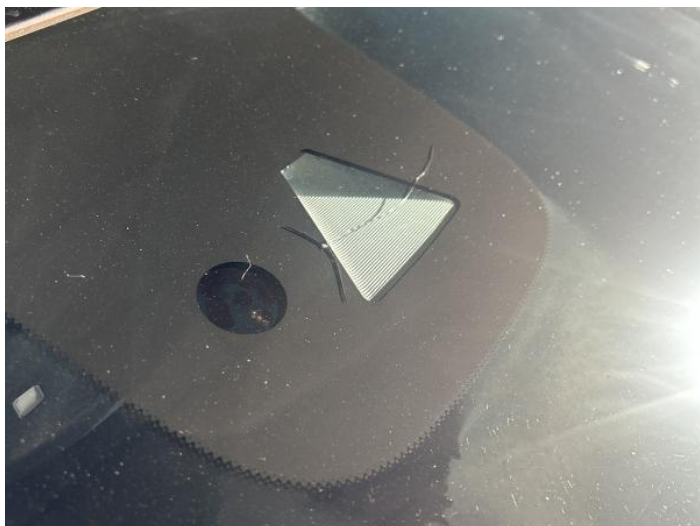
15: Screen Front
Cracked
Replace
