VEHICLE INSPECTION REPORT

DY16ZFC

Vauxhall Astra 1.4T 16V 150 Tech Line 5dr Auto

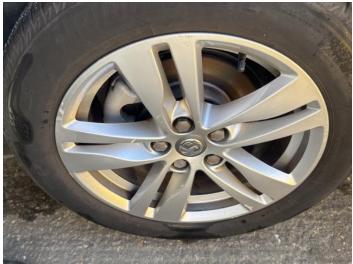
3: Wheel osr Scratched Over 50mm

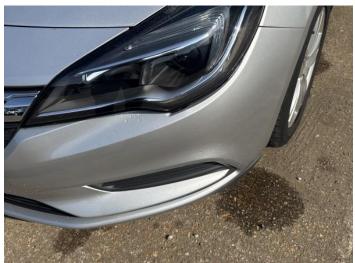
7: Bumper Front Chipped Multiple Chips

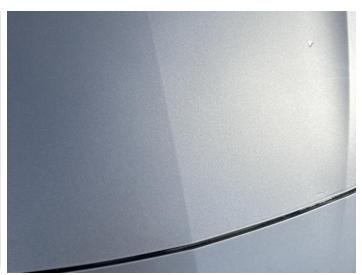
6: Bonnet Chipped 1 To 5

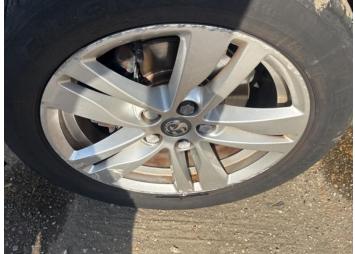
8: Wheel nsf Scratched Over 50mm

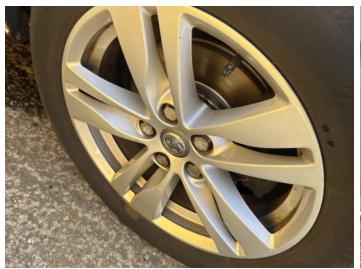
9: Wheel osf Scratched Up To 50mm

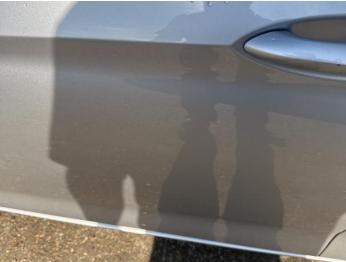
10: Door nsfChipped1 To 5

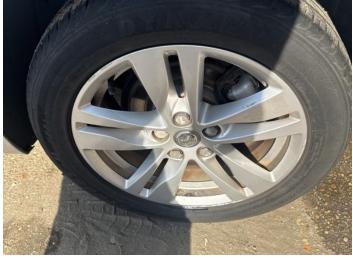
13: Wheel nsr Scratched Up To 50mm
