VEHICLE INSPECTION REPORT

LT16AMK

Kia Sorento 2.2 CRDi KX-4 5dr Auto

nama
GRADE
4

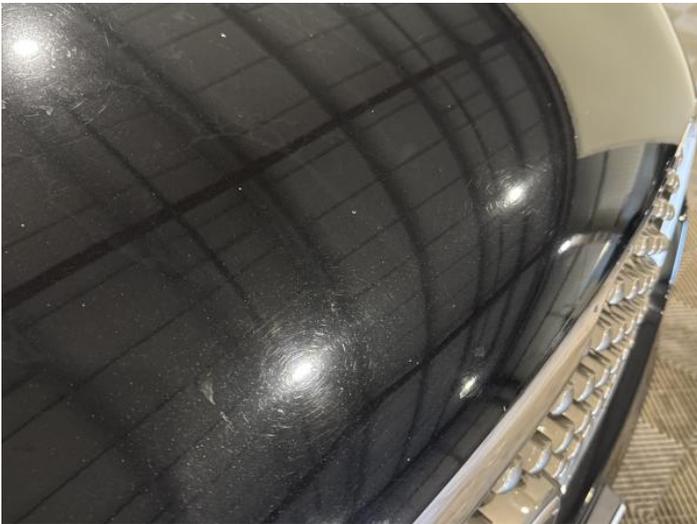
1: Bonnet
Chipped
Multiple Chips

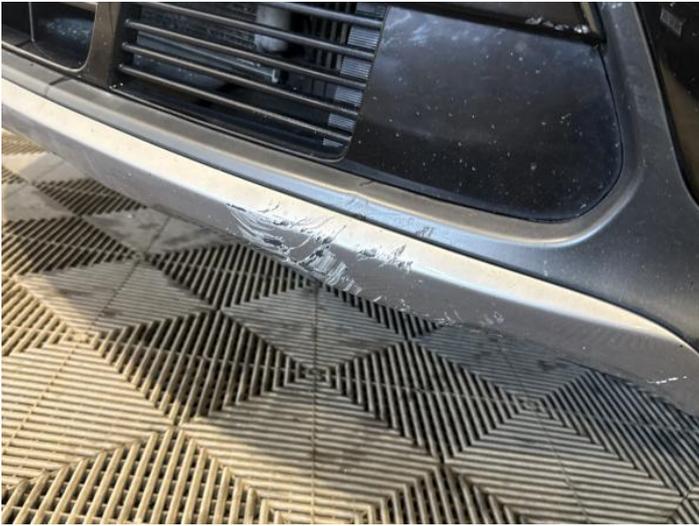
3: Bumper Front Moulding
Scratched (Painted)
Over 25mm Thru Paint

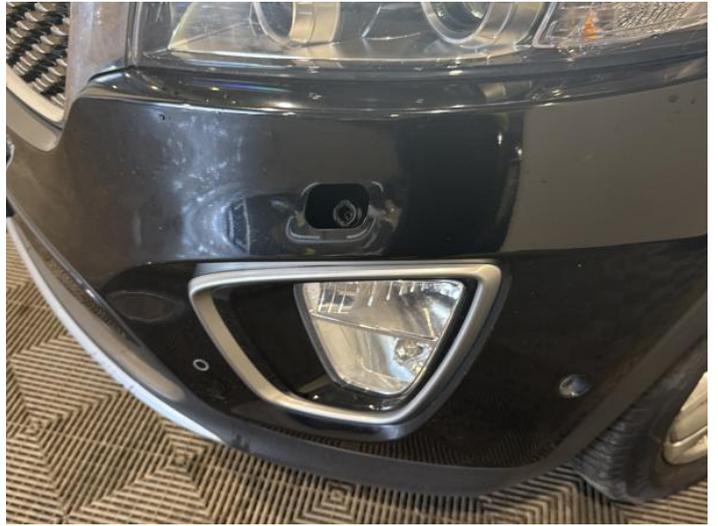
4: Bumper Front
Scratched
Over 100mm Thru Paint

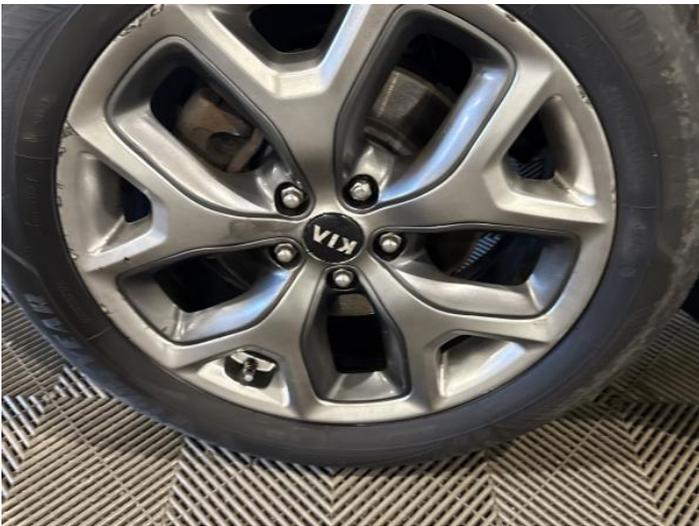
5: Wheel nsf
Scratched
Over 50mm

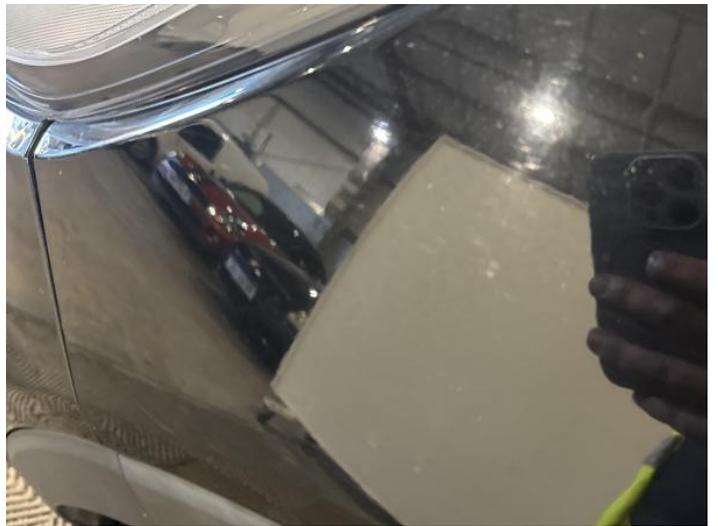
6: Wing nsf
Chipped
1 To 5

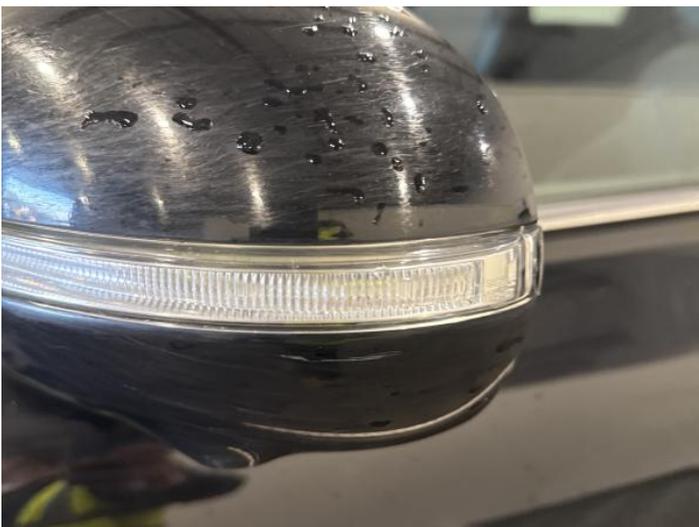
7: Door Mirror Assy nsf
Scratched (Painted)
UpTo 25mm Thru Paint

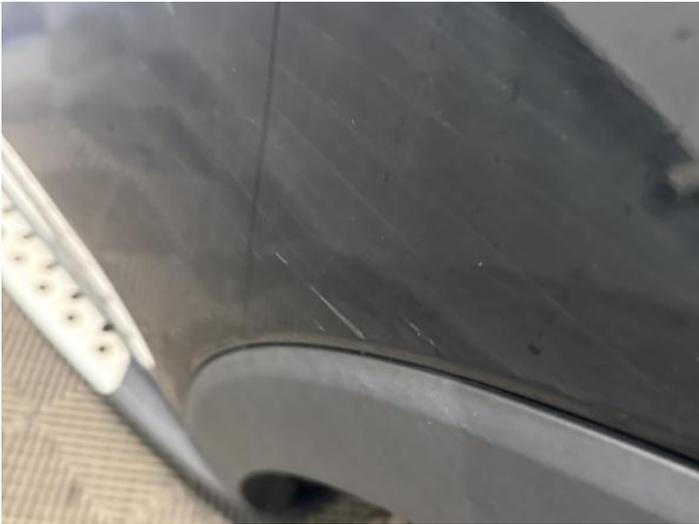
9: Door nsr
Scratched
Over 25mm Thru Paint

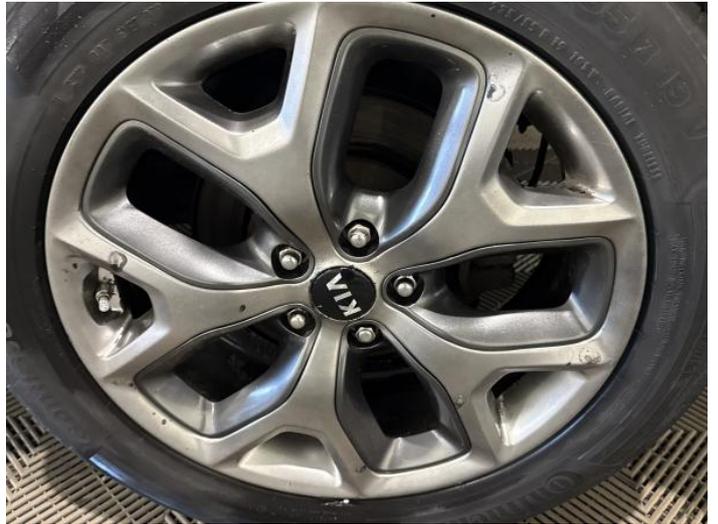
10: Wheel nsr
Scratched
Over 50mm

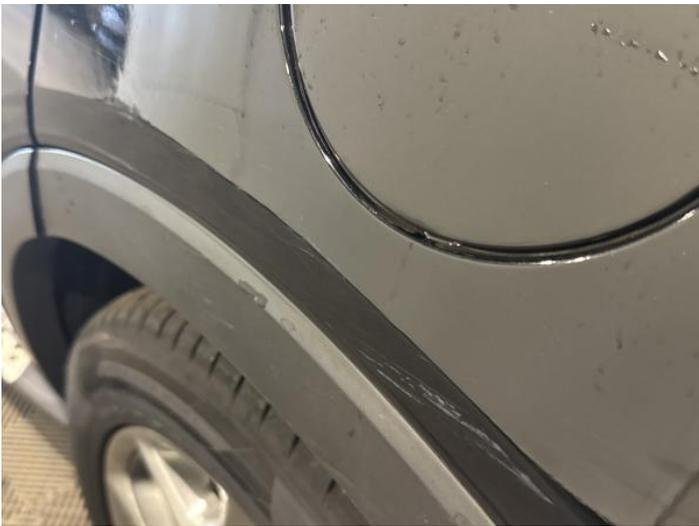
11: Qtr Panel nsr
Poor Previous Repair
Rippled UpTo 30%

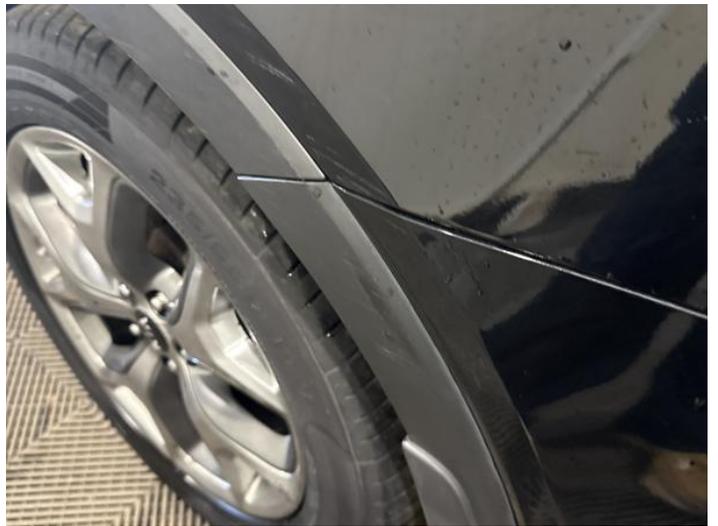
12: Qtr Panel Trim ns
Scuffed
Over 25mm

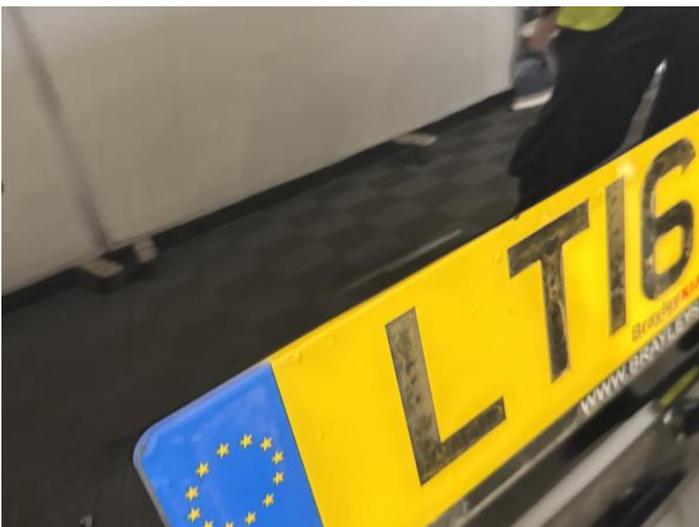
13: Tailgate
Scratched
UpTo 25mm Thru Paint

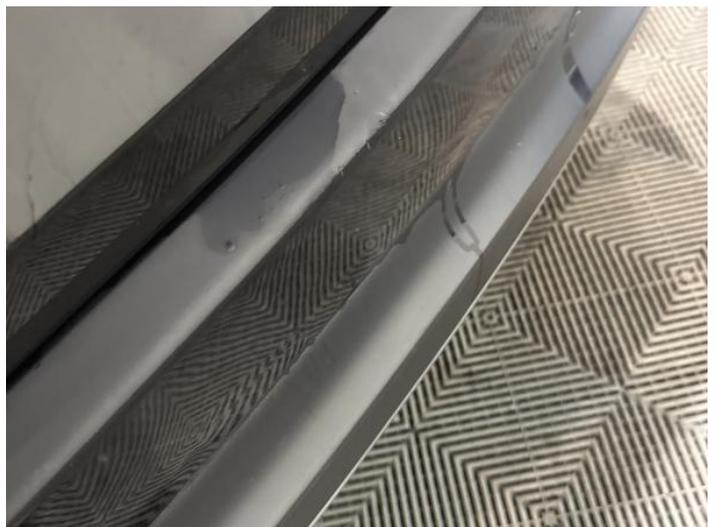
14: Bumper Rear
Scratched
25 to 100mm Thru Paint

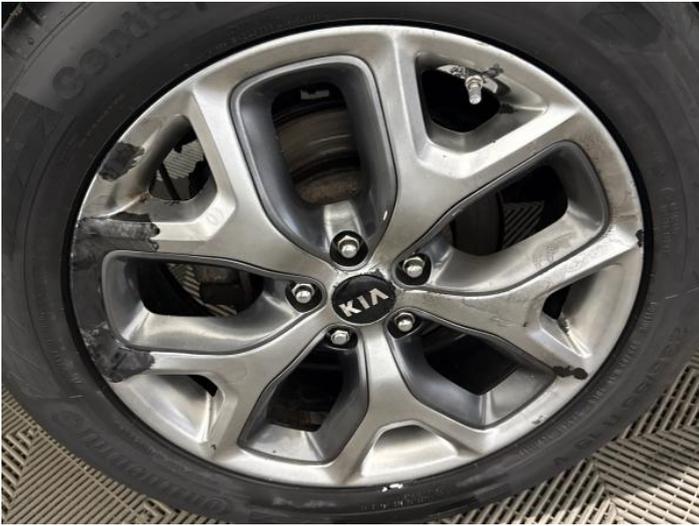
15: Wheel osr
Scratched
Over 50mm

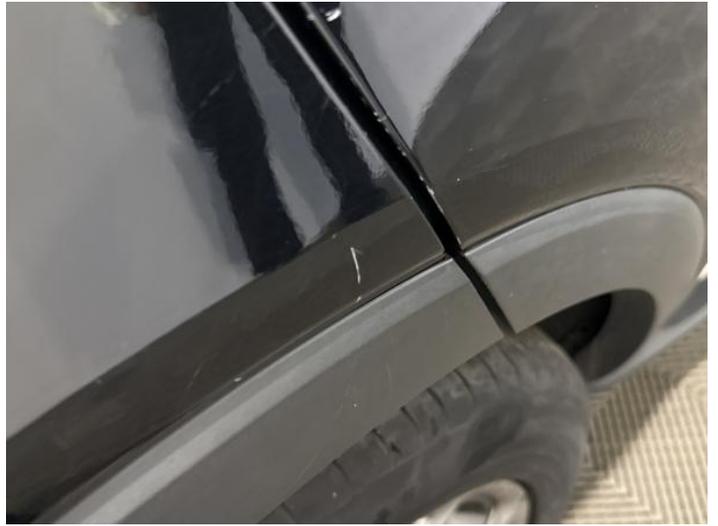
16: Qtr Panel osr
Scratched
UpTo 25mm Thru Paint

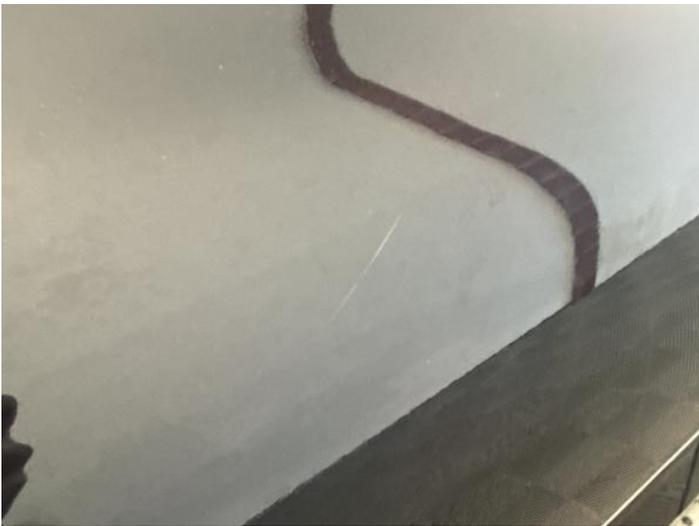
17: Door osr
Scratched
Over 25mm Thru Paint

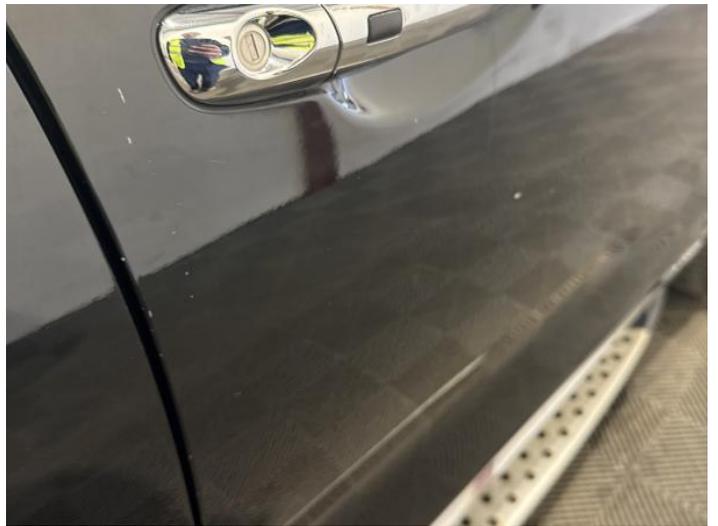
18: Door osf
Chipped
Multiple Chips

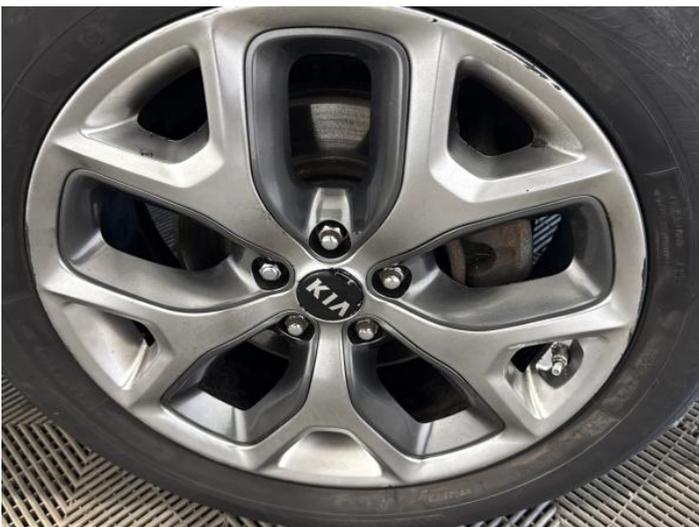
19: Wheel osf
Scratched
Up To 50mm

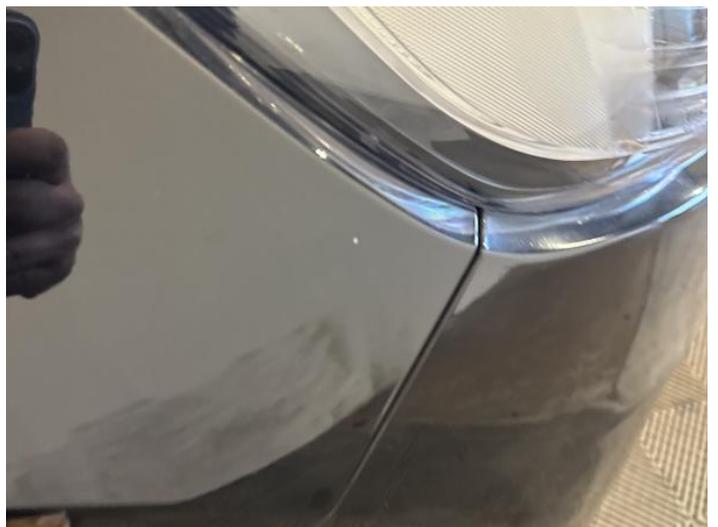
20: Wing osf
Chipped
1 To 5
