# VEHICLE INSPECTION REPORT

**RK62OFX**

## Mercedes-Benz Vito 116CDI Van

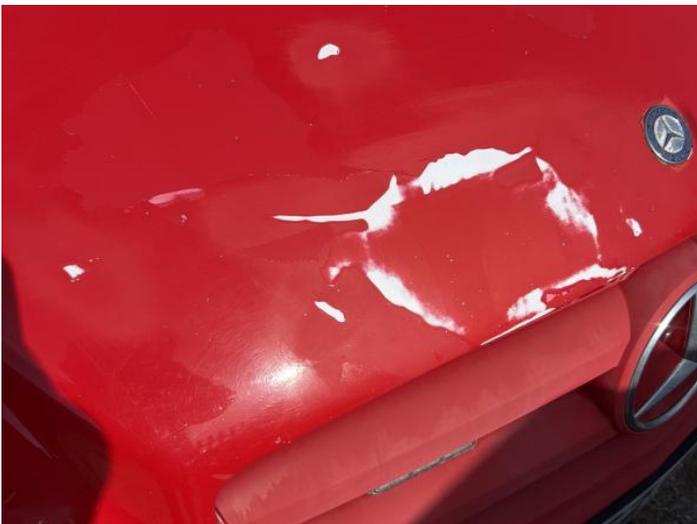
1: Bonnet  
Poor Previous Repair  
Paint Flake

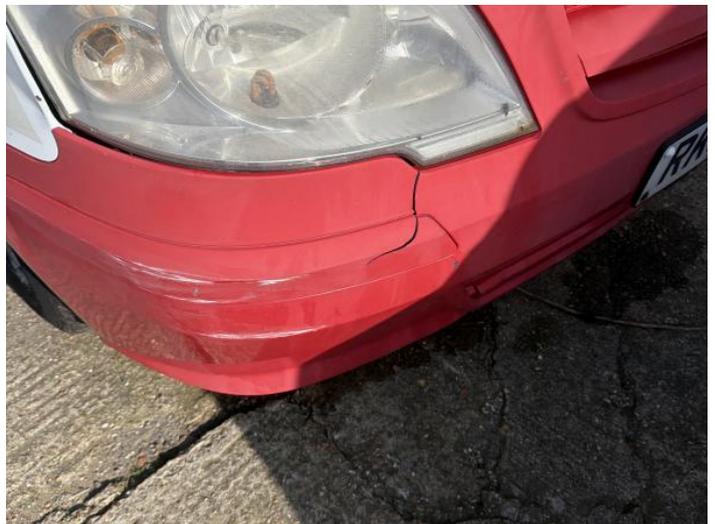
2: Bumper Front  
Cracked  
Over 25mm

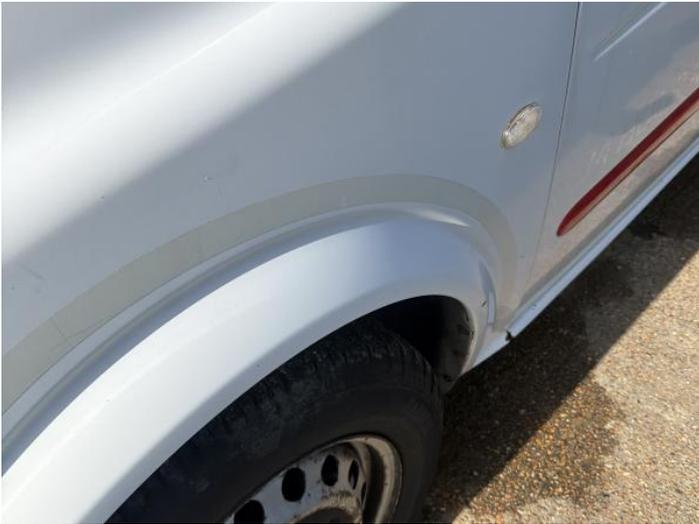
3: Wing nsf  
Rusted  
Over 5mm

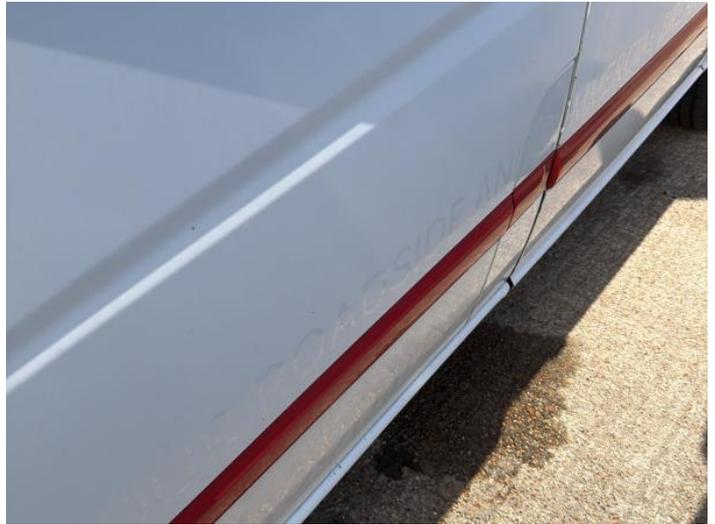
4: Door nsf  
Rusted  
Over 5mm

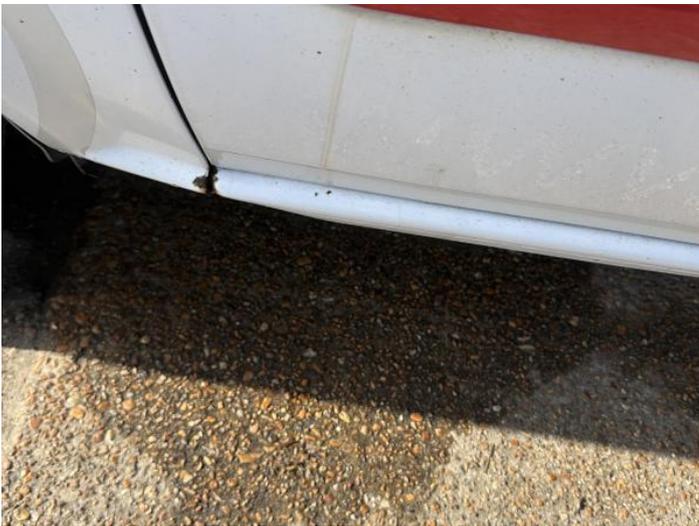
5: Sill ns  
Rusted  
Over 5mm

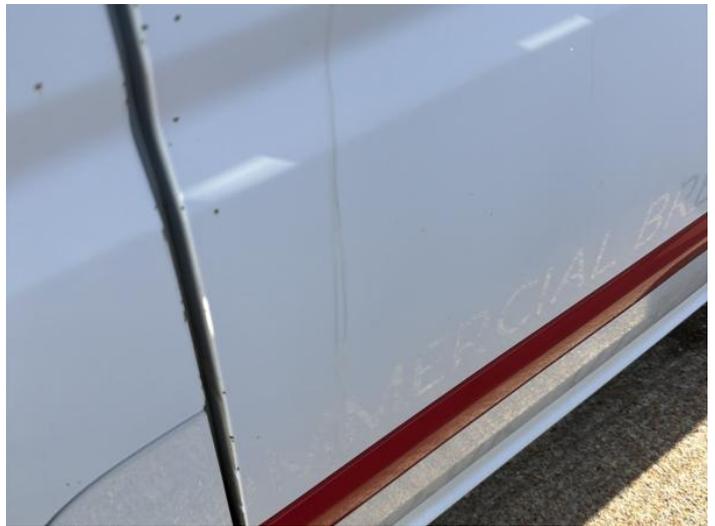
6: Door nsr  
Chipped  
Multiple Chips

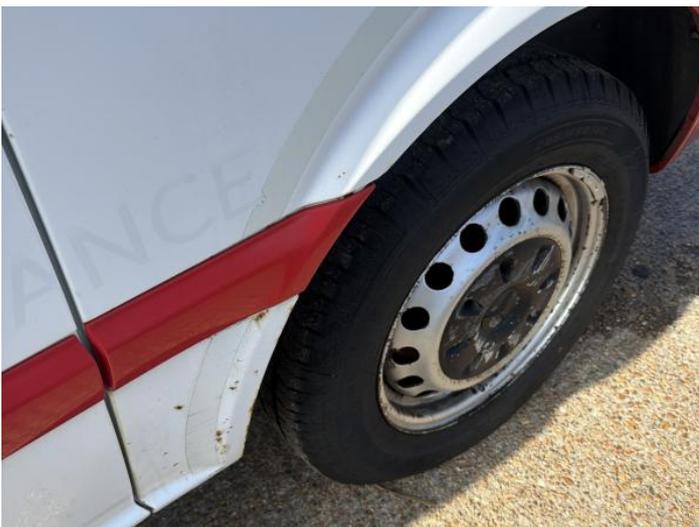
7: Qtr Panel nsr  
Rusted  
Over 5mm

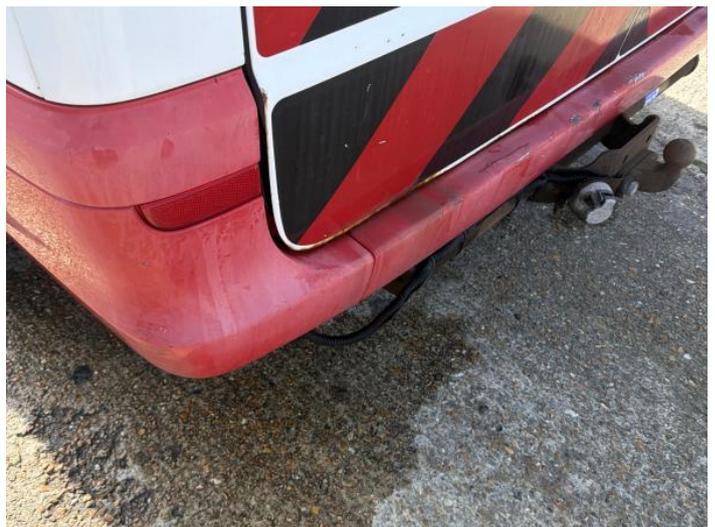
8: Bumper Rear  
Poor Previous Repair  
Poor Paint

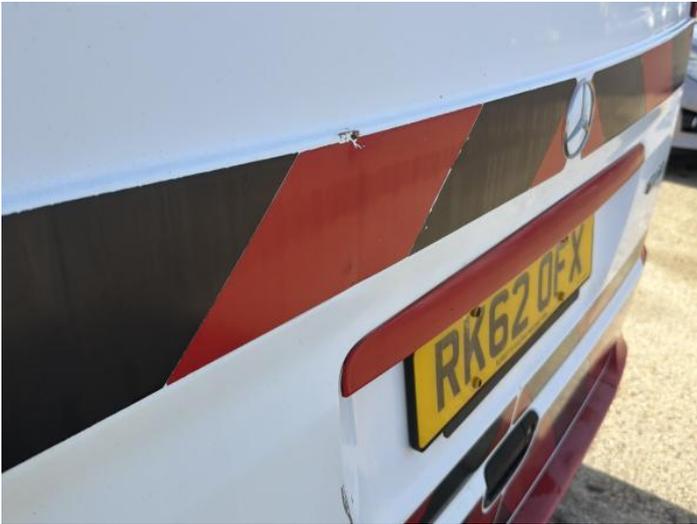
9: Boot Lid  
Dented  
With Paint Damage

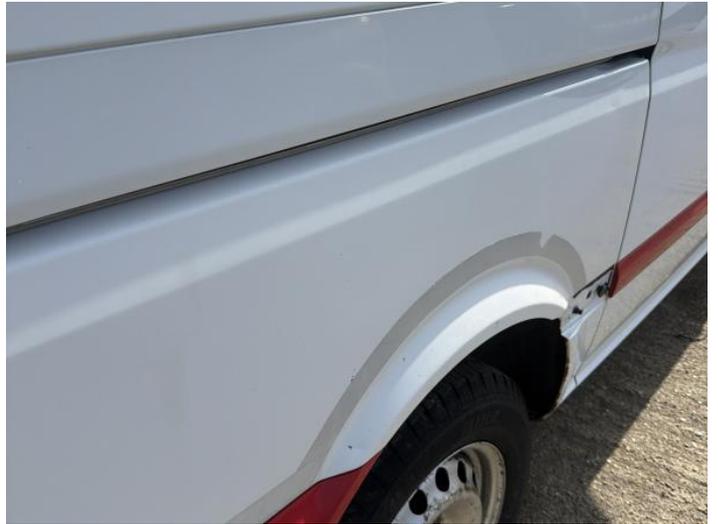
10: Qtr Panel osr  
Chipped  
Multiple Chips

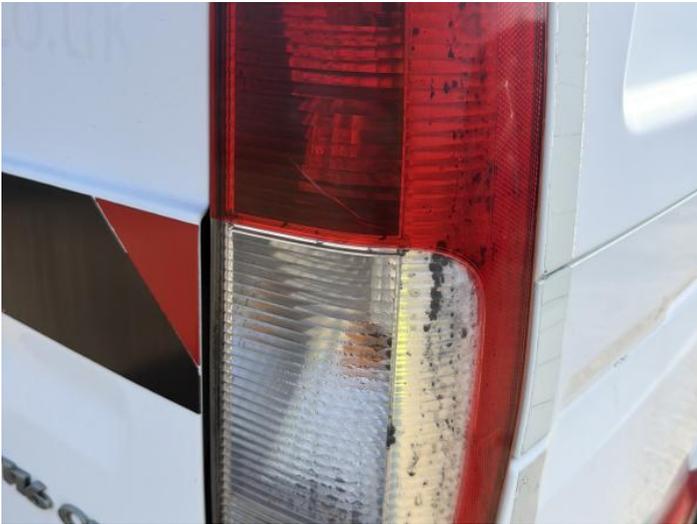
11: Lamp osr  
Broken  
Replace

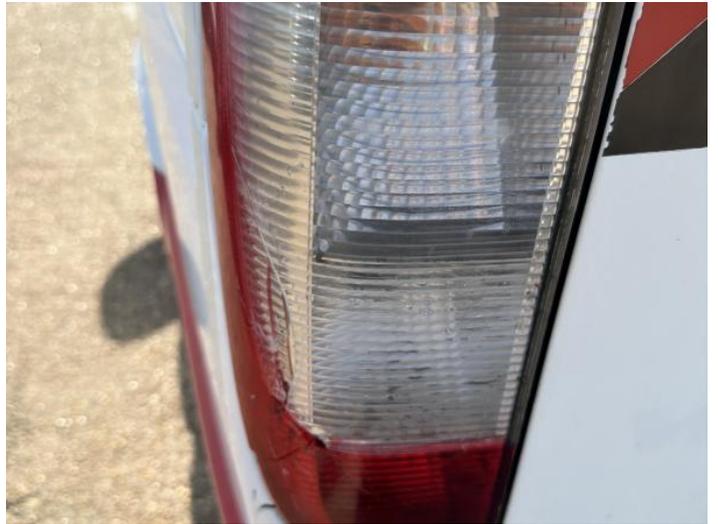
12: Lamp nsr  
Broken  
Replace

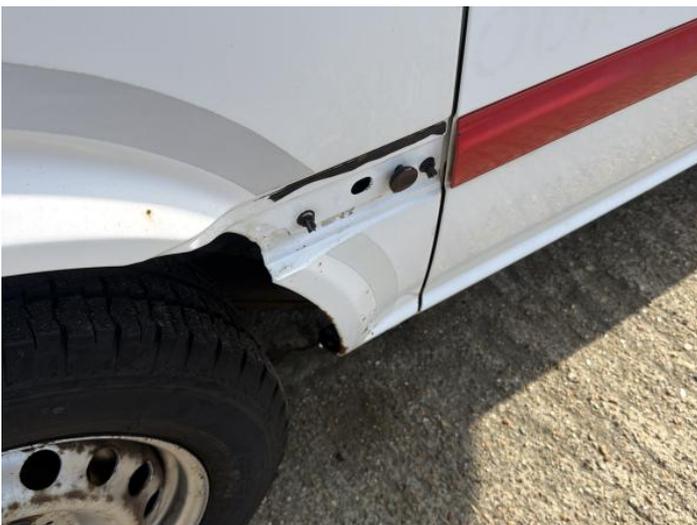
13: Qtr Panel Moulding os  
Missing  
Replace

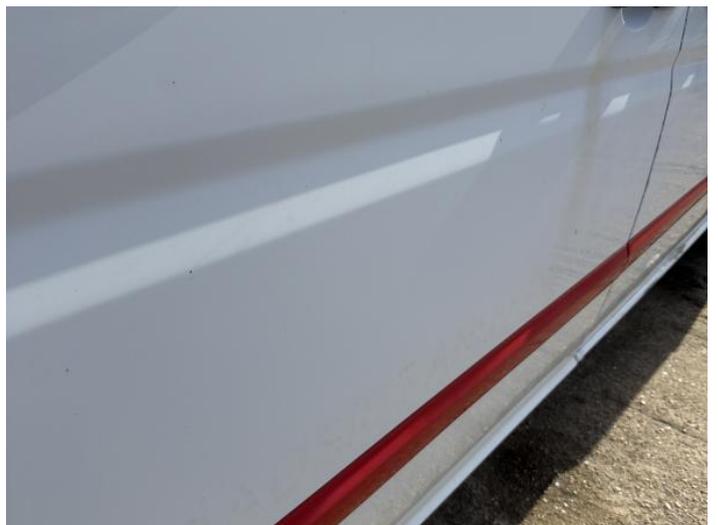
14: Door osr  
Dented  
With Paint Damage

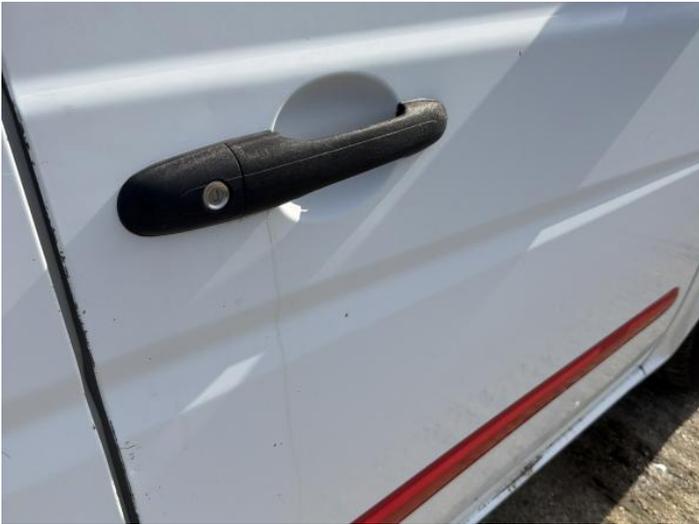
15: Door osf  
Chipped  
Multiple Chips

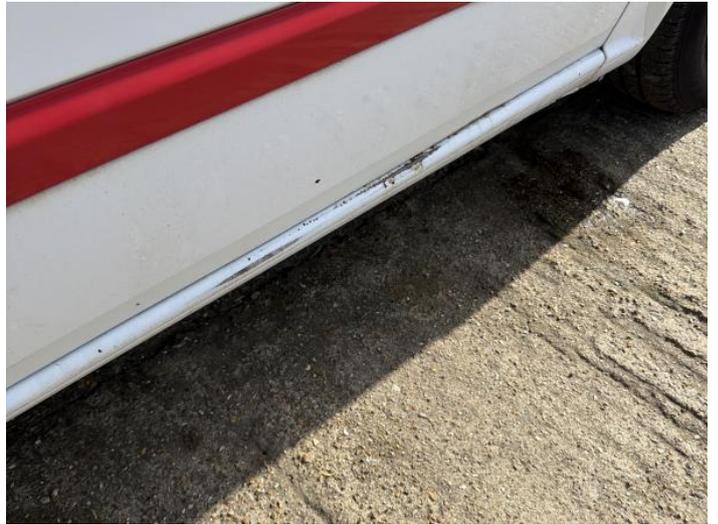
16: Sill os  
Rusted  
Over 5mm

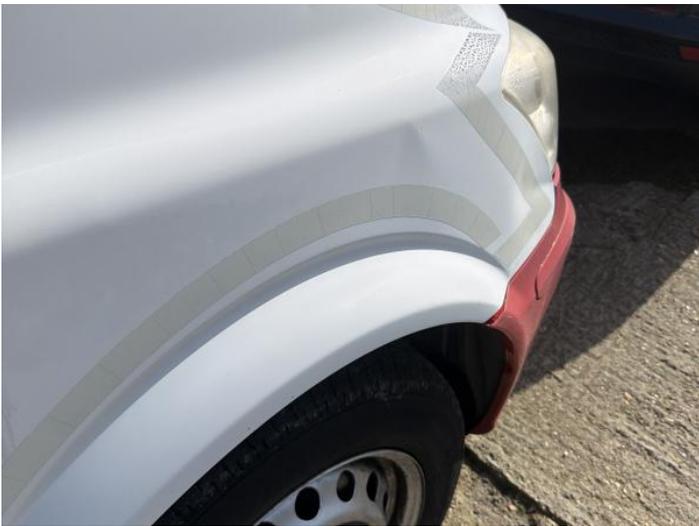
17: Wing osf  
Poor Previous Repair  
Poor Paint

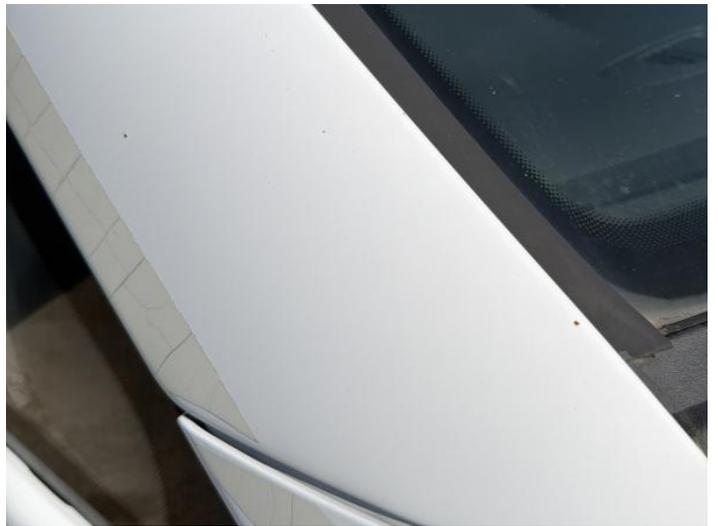
18: A Post os  
Rusted  
UpTo 5mm

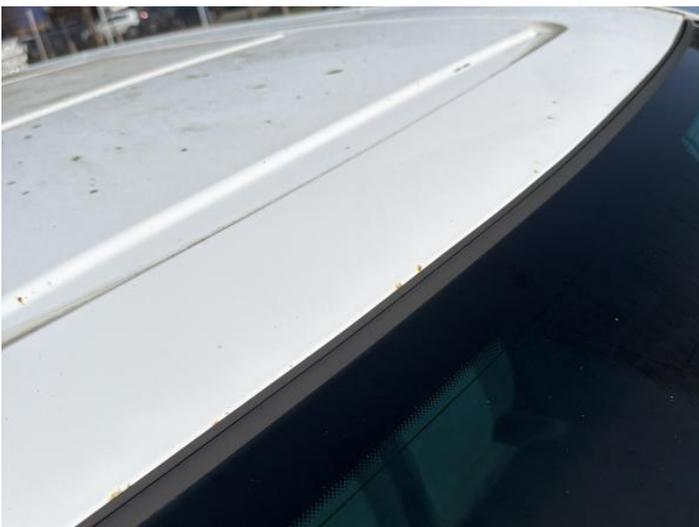
19: Roof  
Rusted  
UpTo 5mm

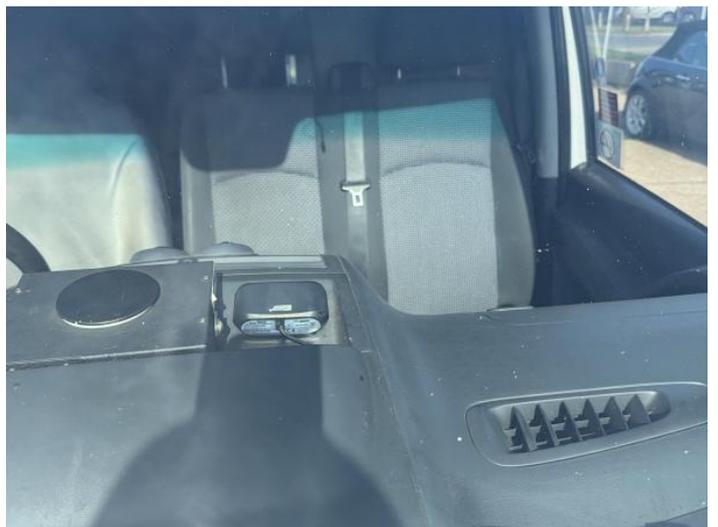
20: Screen Front  
Chipped  
UpTo 10mm
