VEHICLE INSPECTION REPORT

AO19ZGA

Nissan Navara Double Cab Pick Up N-Guard 2.3dCi 190 4WD Auto

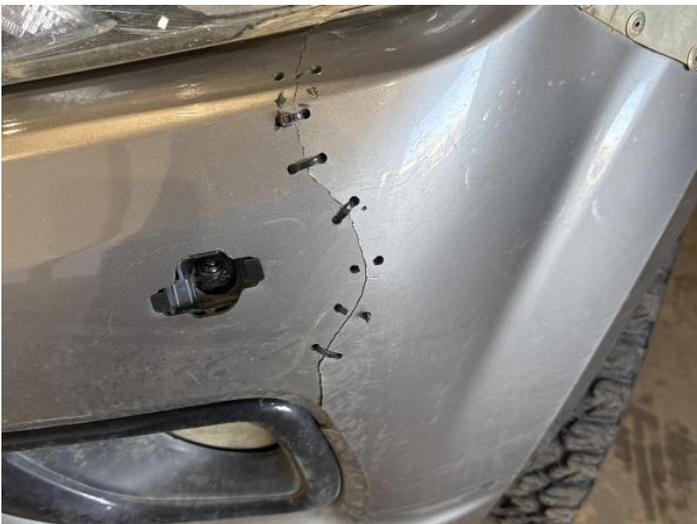
1: Bumper Front
Cracked
Over 25mm

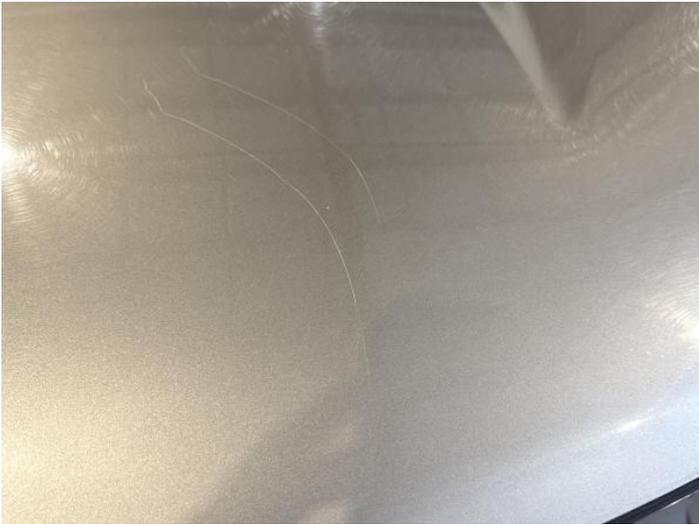
3: Bonnet
Scratched
Over 25mm Thru Paint

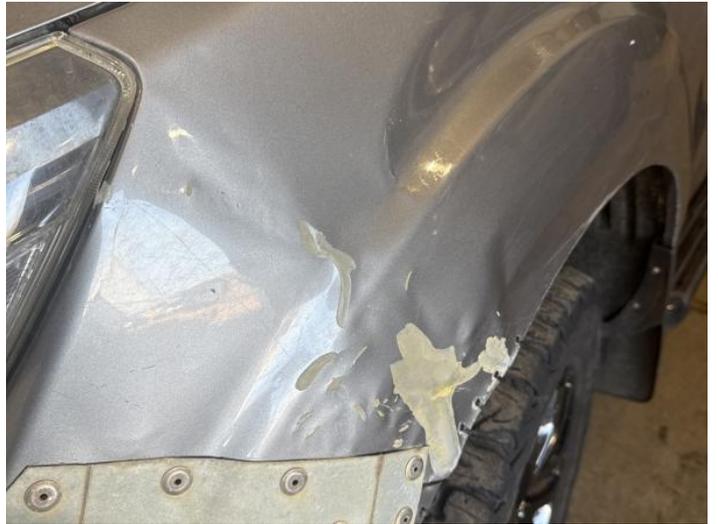
4: Wing nsf
Dented
With Paint Damage

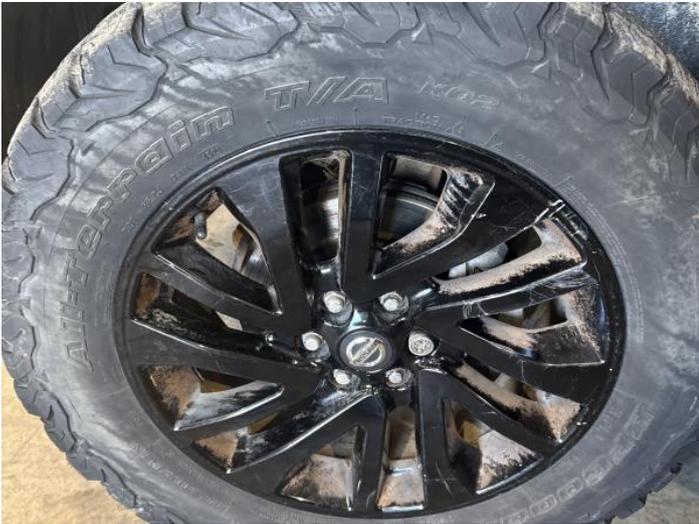
5: Wheel nsf
Scratched
Over 50mm

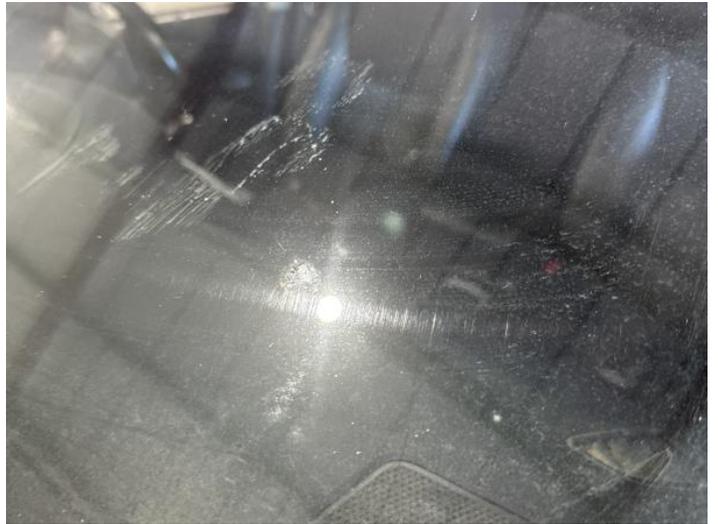
6: Screen Front
Cracked
Replace

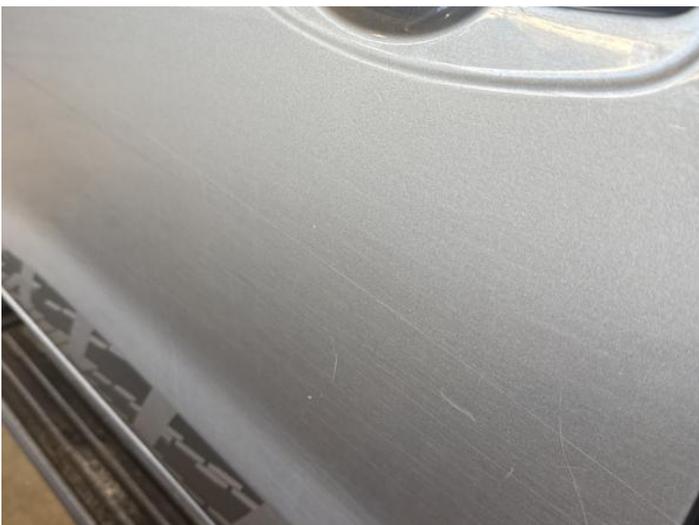
7: Door nsf
Scratched
Over 25mm Thru Paint

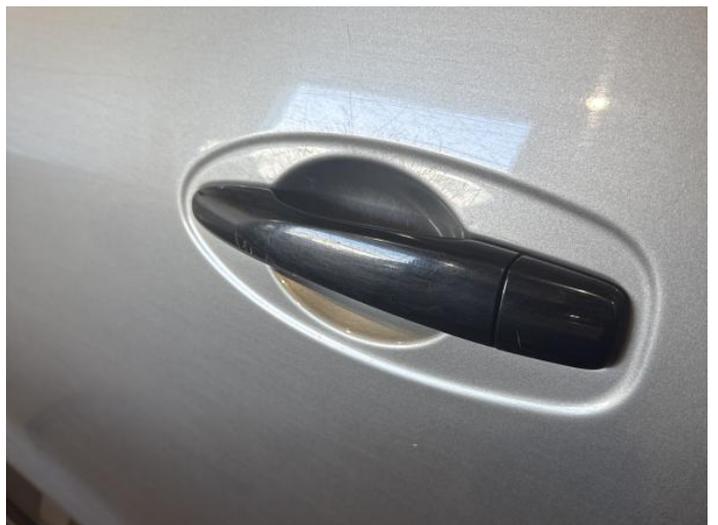
8: Door nsr
Scratched
Over 25mm Thru Paint

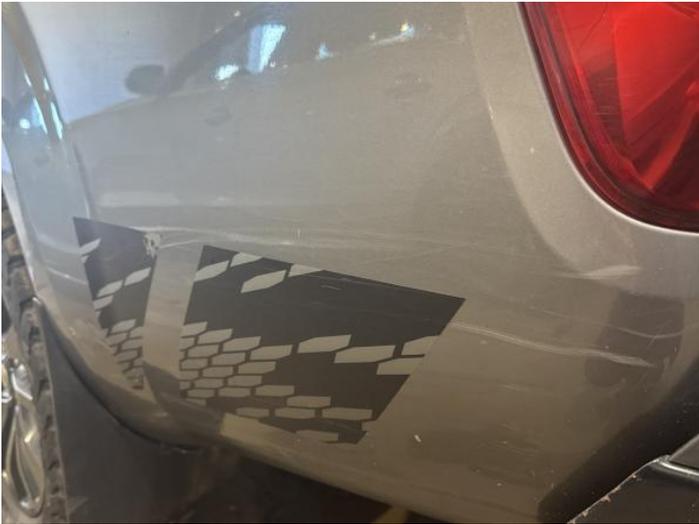
9: Qtr Panel nsr
Scratched
Over 25mm Thru Paint

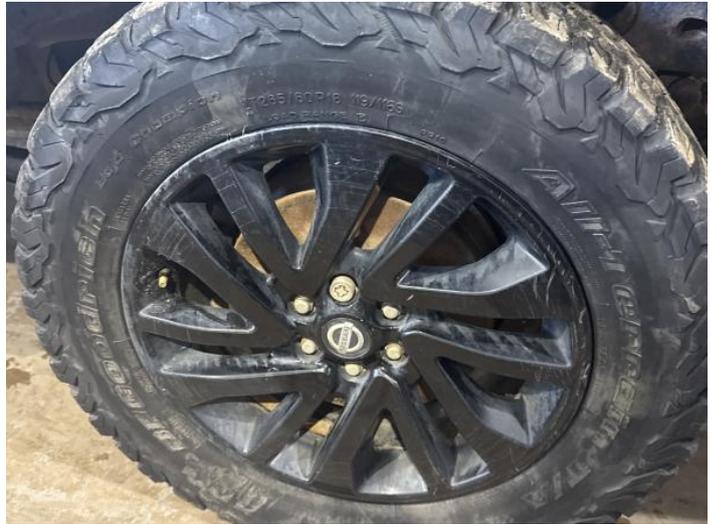
10: Wheel nsr
Scratched
Over 50mm

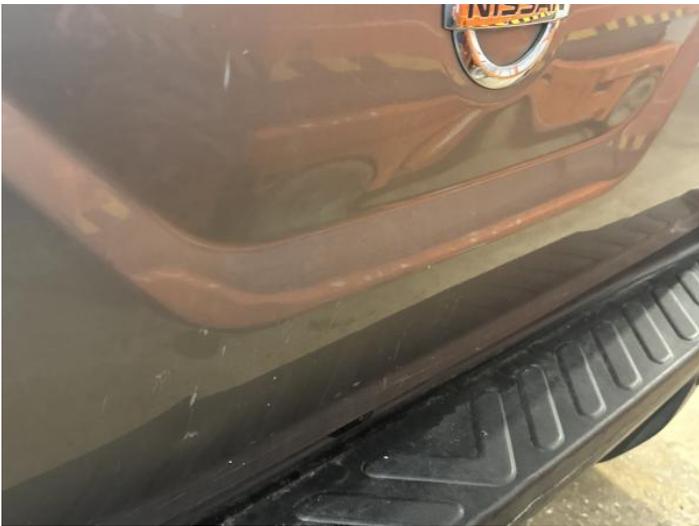
11: Tailgate
Dented
With Paint Damage

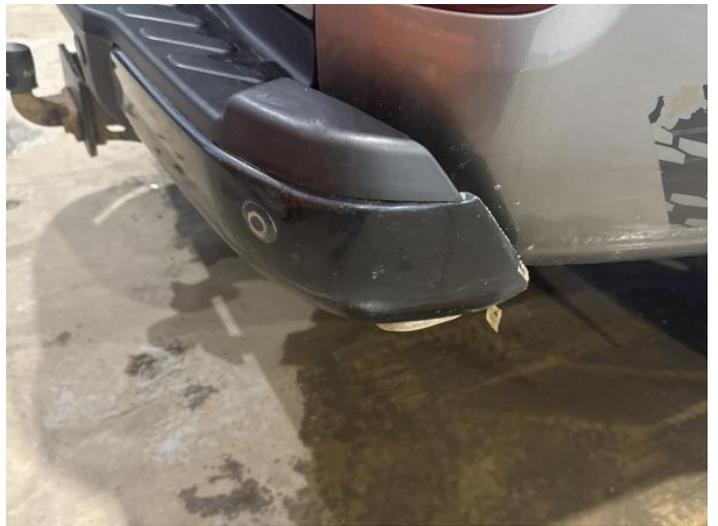
12: Bumper Rear
Scratched
Over 100mm Thru Paint

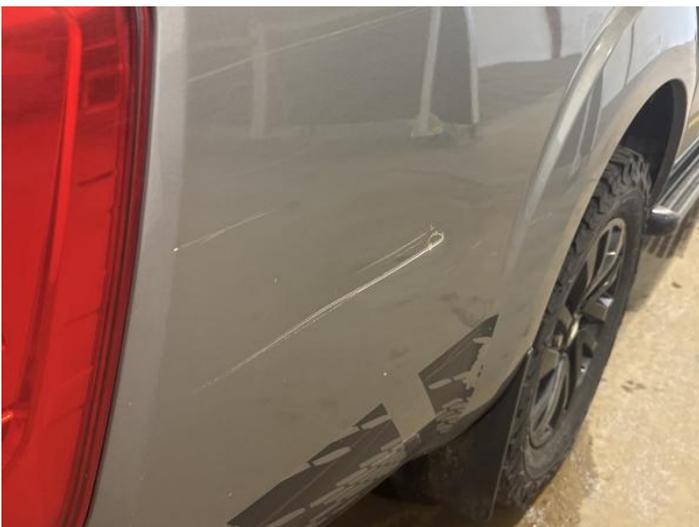
13: Qtr Panel osr
Dented
With Paint Damage

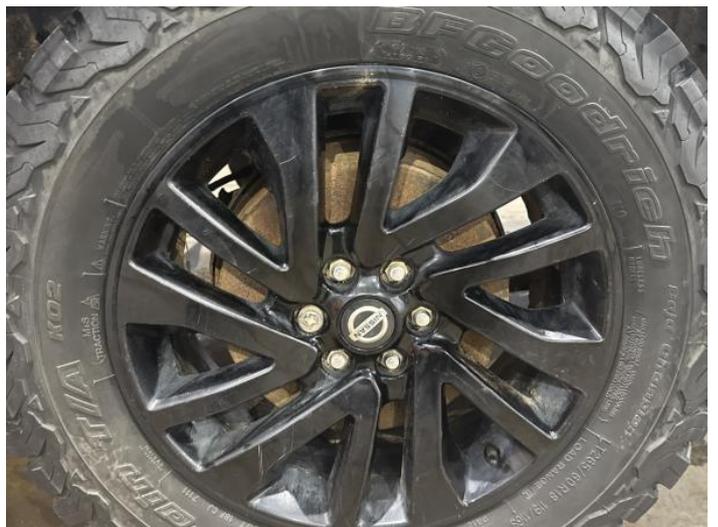
14: Wheel osr
Scratched
Over 50mm

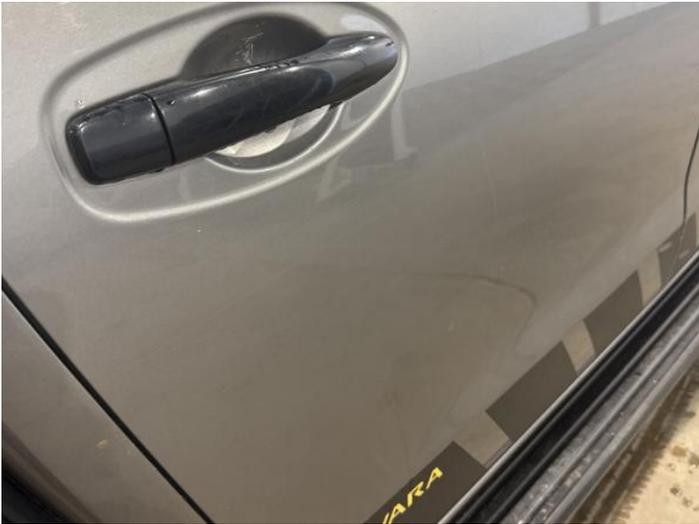
15: Door osf
Scratched
Over 25mm Thru Paint

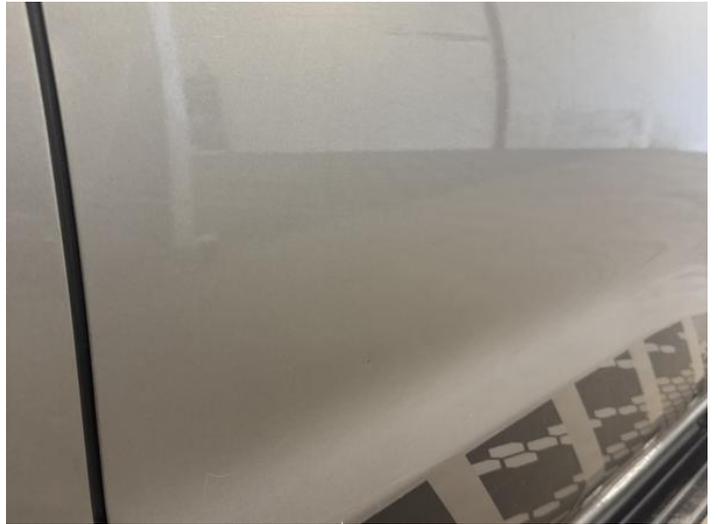
16: Door osf
Scratched
Over 25mm Thru Paint

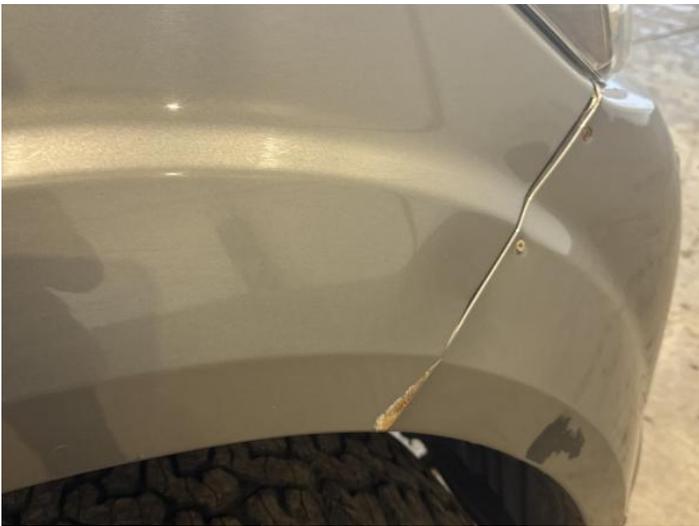
17: Wing osf
Scratched
Rusted

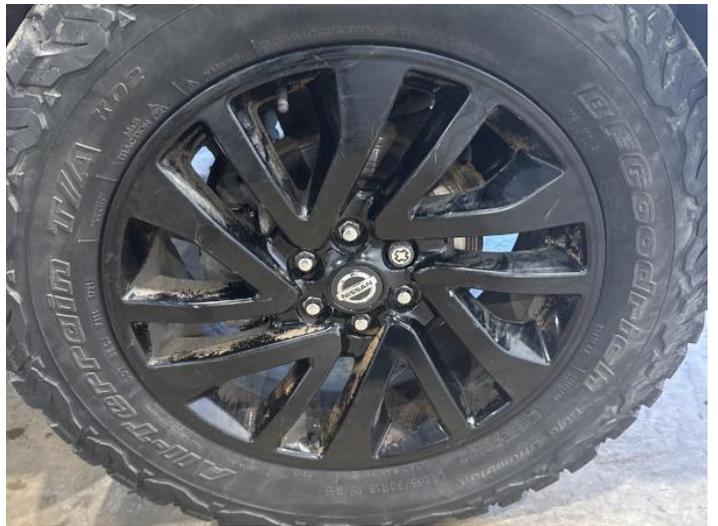
18: Wheel osf
Scratched
Over 50mm

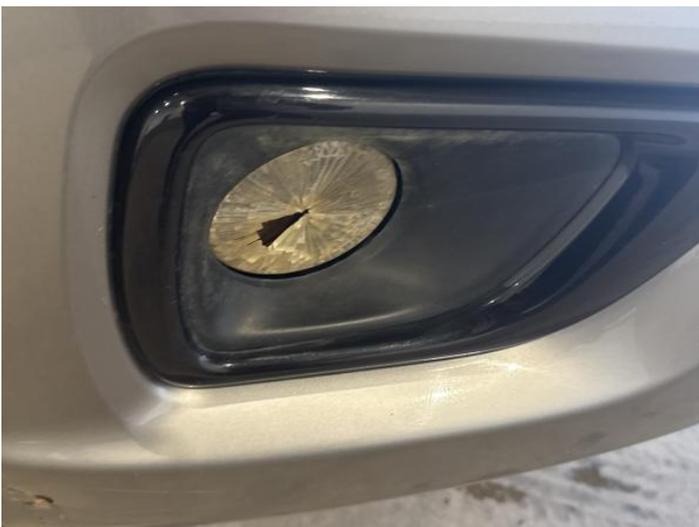
19: Fogdriving Lamp osf
Broken
Replace

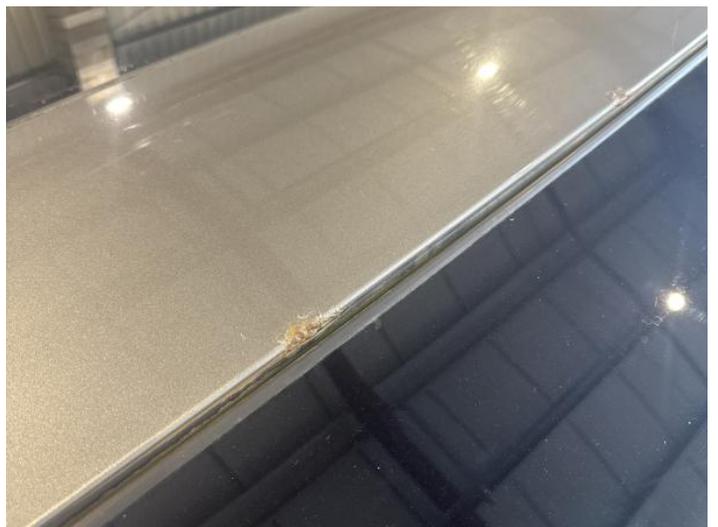
20: Roof
Dented
With Paint Damage

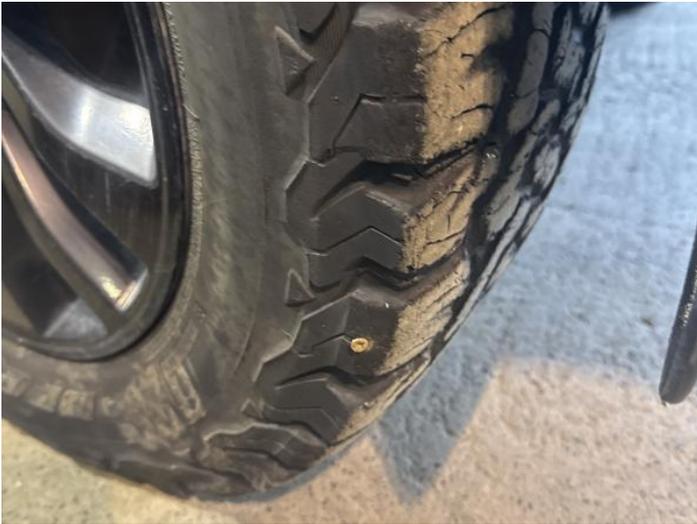
NSF	BFGOODRICH	7.0mm
NSR	BFGOODRICH	Damaged
OSF	BFGOODRICH	7.0mm
OSR	BFGOODRICH	7.0mm
Spare

21: Tyre nsr
 Damaged
 Replace
