VEHICLE INSPECTION REPORT

GF65CKN

Peugeot 5008 1.6 BlueHDi 120 Allure 5dr

nama
GRADE
4

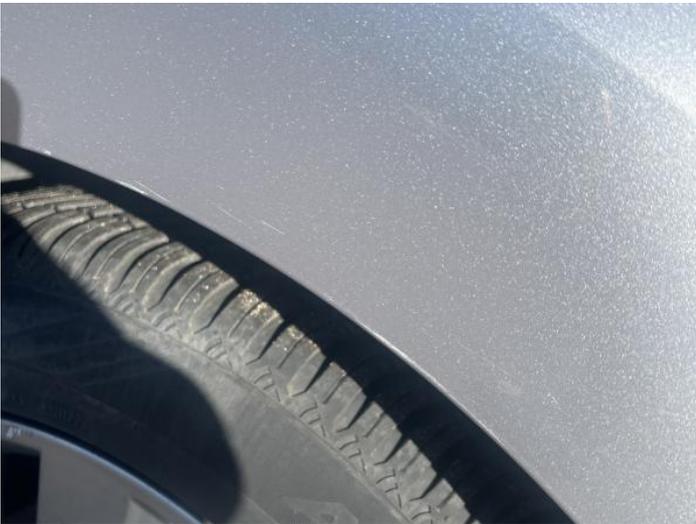
1: Wing ofsf
Scratched
Over 25mm Not Thru Paint

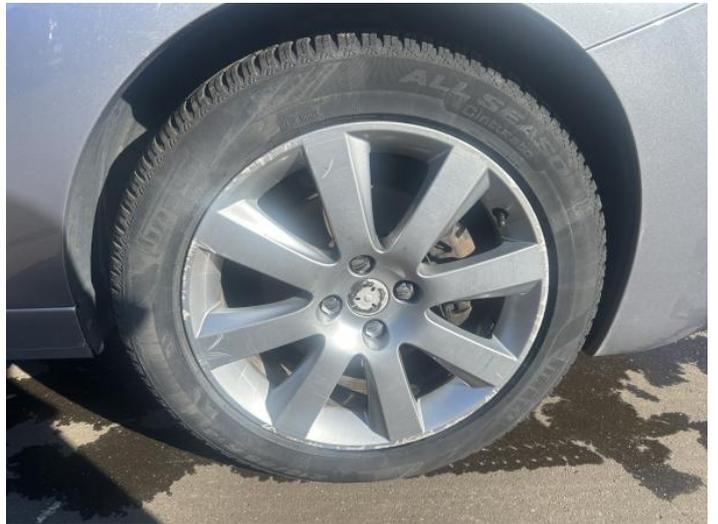
2: Wheel ofsf
Scratched
Over 50mm

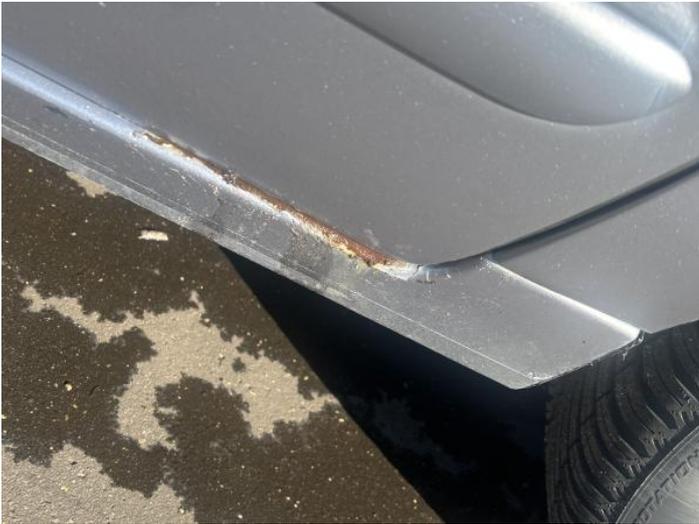
3: Sill os
Rusted
Over 5mm

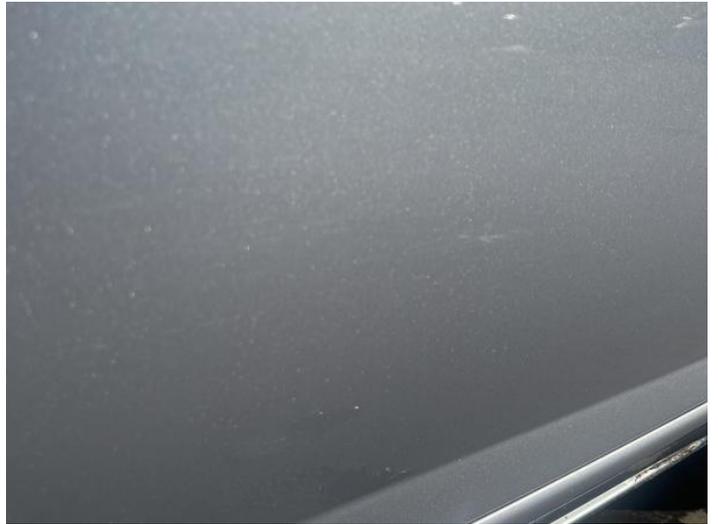
4: Door osf
Scratched
Over 25mm Not Thru Paint

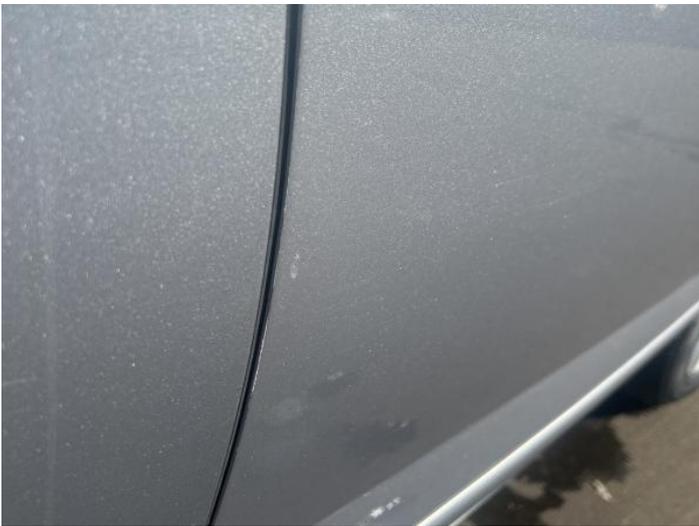
5: Door osf
Chipped
Edge Chip

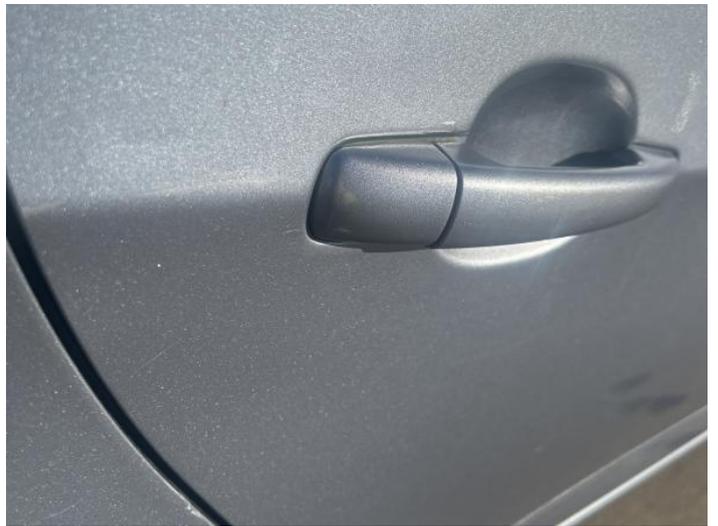
6: Door osr
Scratched
Over 25mm Not Thru Paint

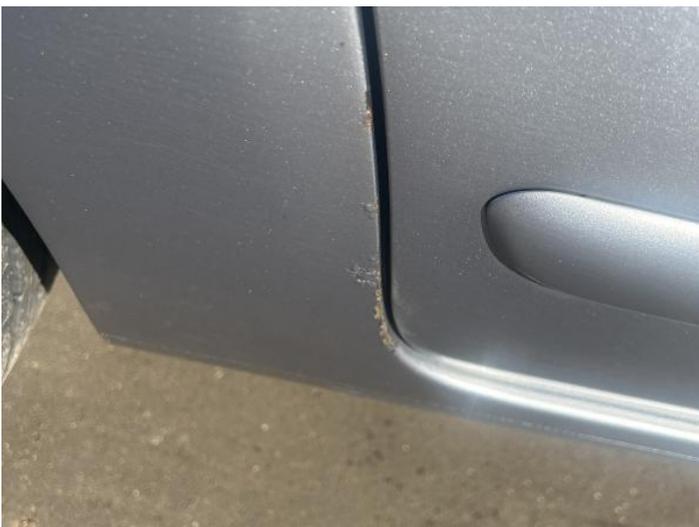
7: Qtr Panel osr
Rusted
Over 5mm

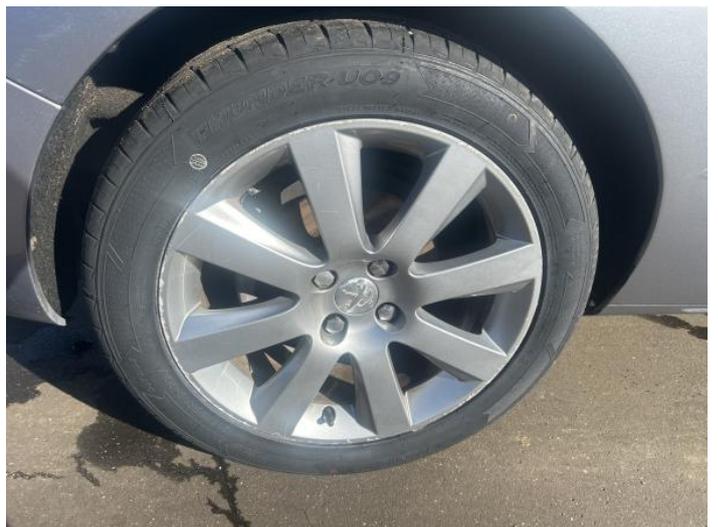
8: Wheel osr
Scratched
Over 50mm

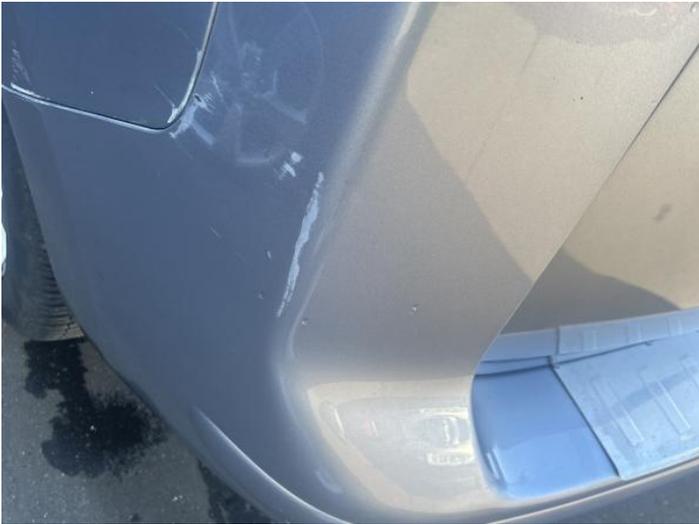
9: Bumper Rear
Scratched
Over 100mm Thru Paint

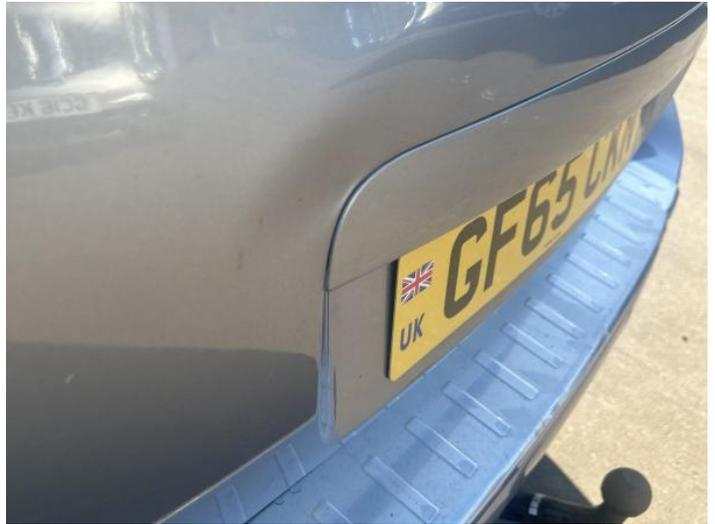
10: Tailgate
Dented
Over 30mm

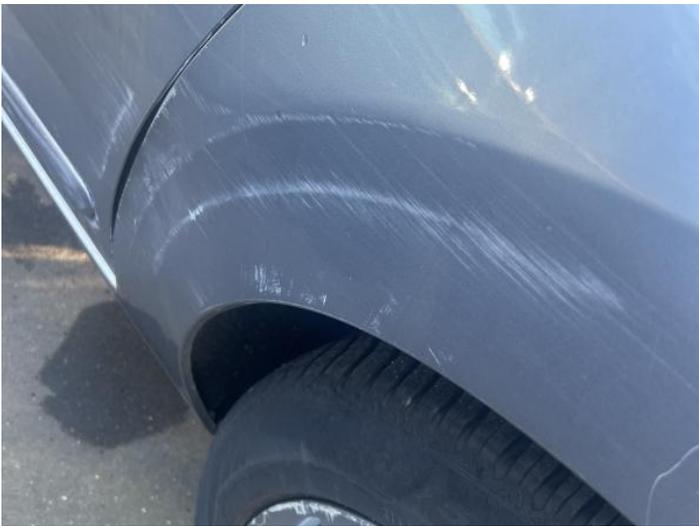
11: Qtr Panel nsr
Dented
With Paint Damage

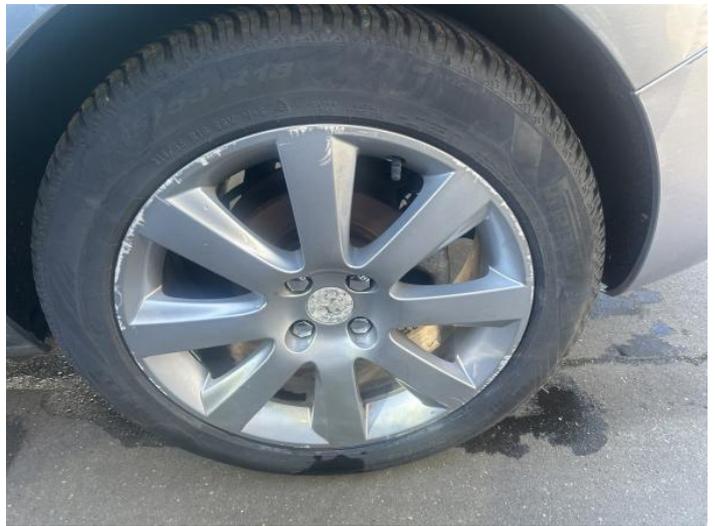
12: Wheel nsr
Scratched
Over 50mm

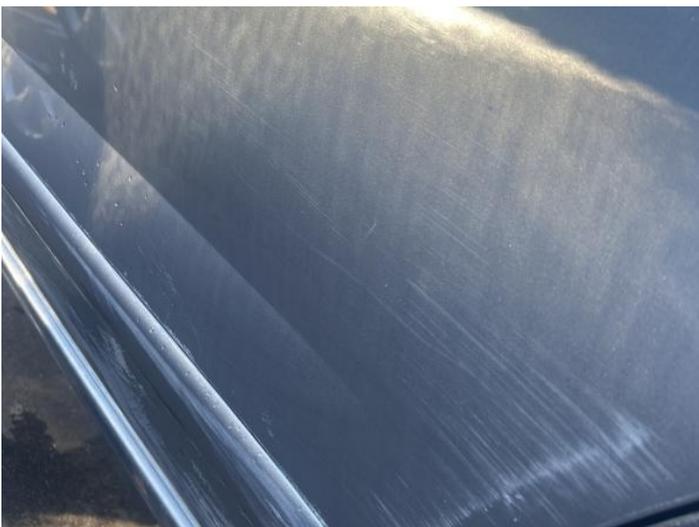
13: Door nsr
Scratched
Over 25mm Thru Paint

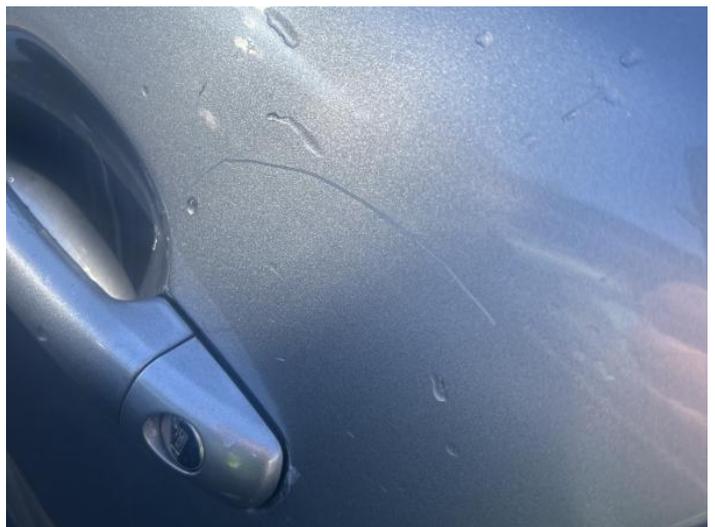
14: Door nsf
Scratched
Over 25mm Thru Paint

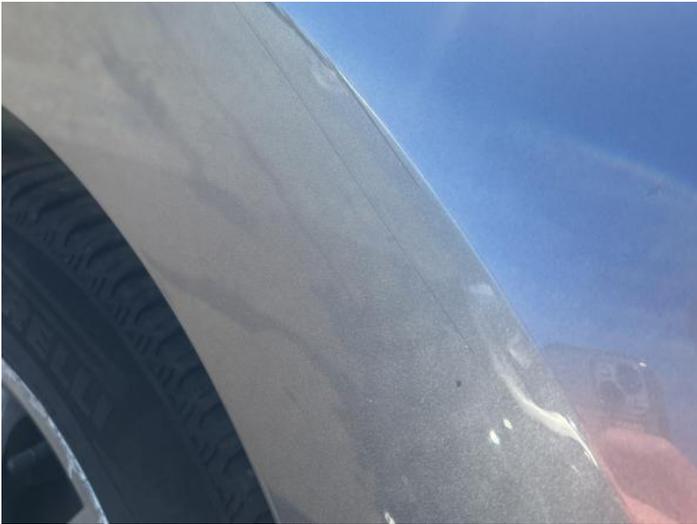
15: Wing nsf
Scratched
Over 25mm Thru Paint

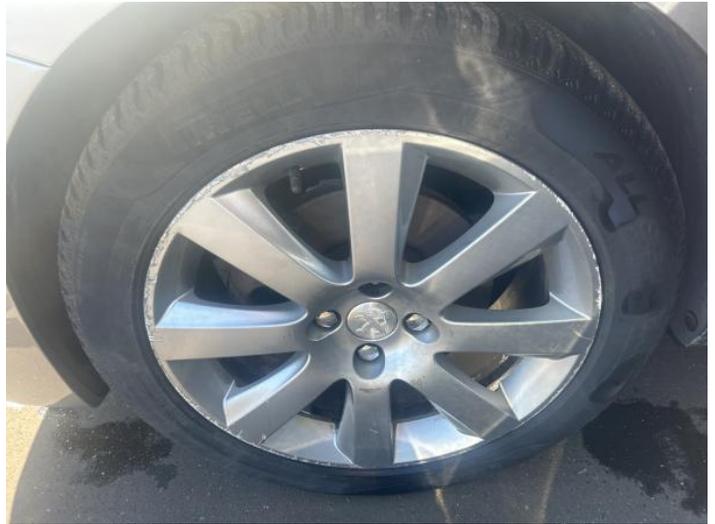
16: Wheel nsf
Scratched
Over 50mm

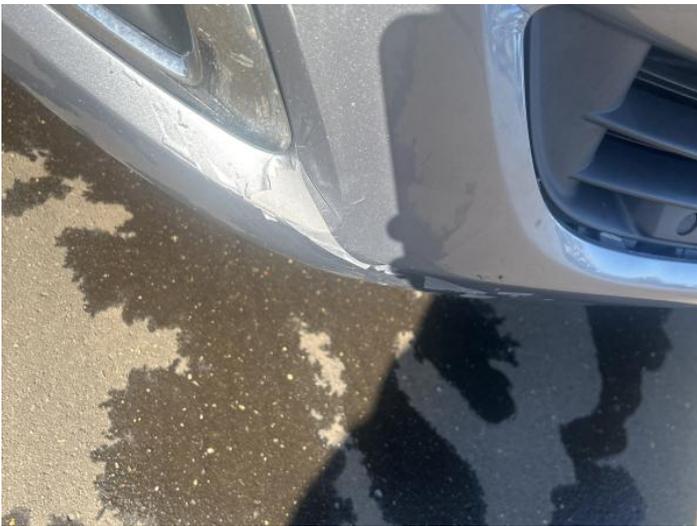
17: Bumper Front
Poor Previous Repair
Paint Flake
