VEHICLE INSPECTION REPORT

WO64OTV

Toyota Yaris 1.33 VVT-i Sport 5dr

nama
GRADE
4

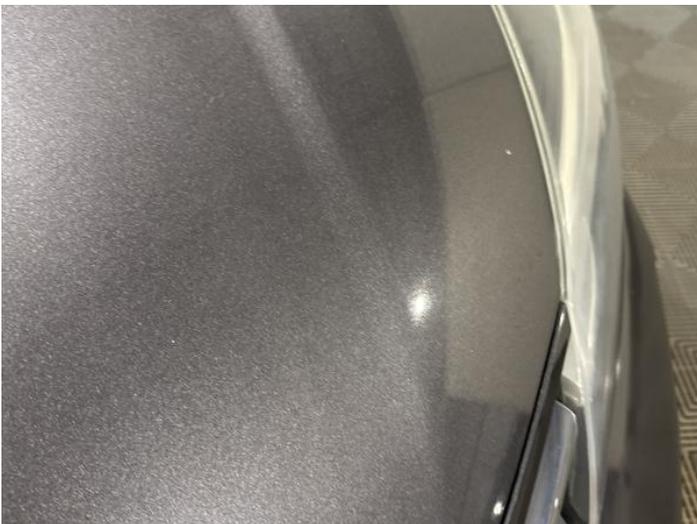
1: Bonnet
Chipped
Multiple Chips

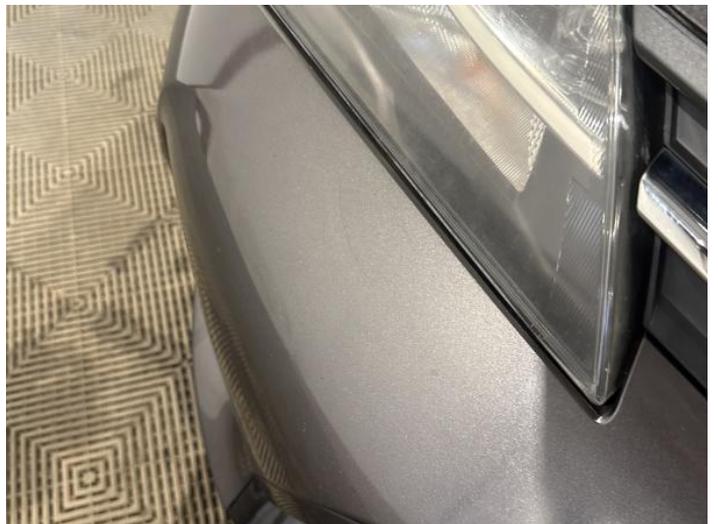
2: Bumper Front
Scratched
25 to 100mm Thru Paint

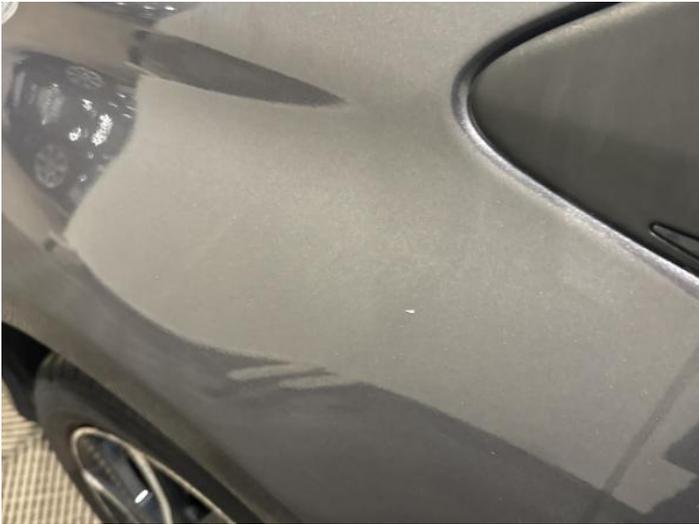
3: Wing nsf
Chipped
1 To 5

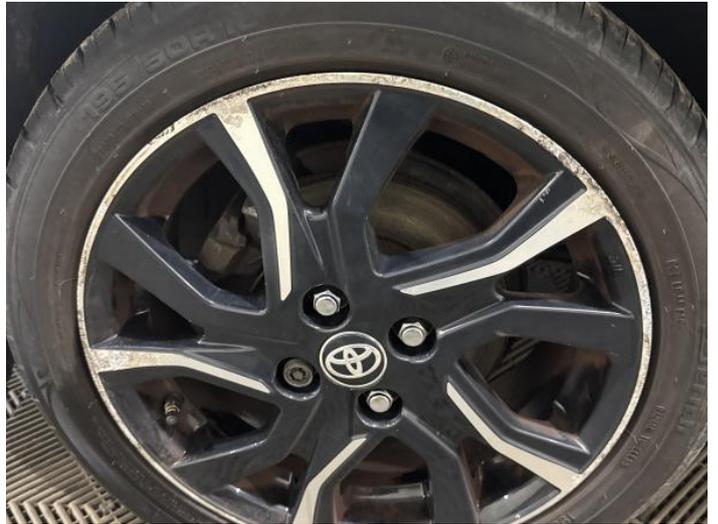
4: Wheel nsf
Scratched
Over 50mm

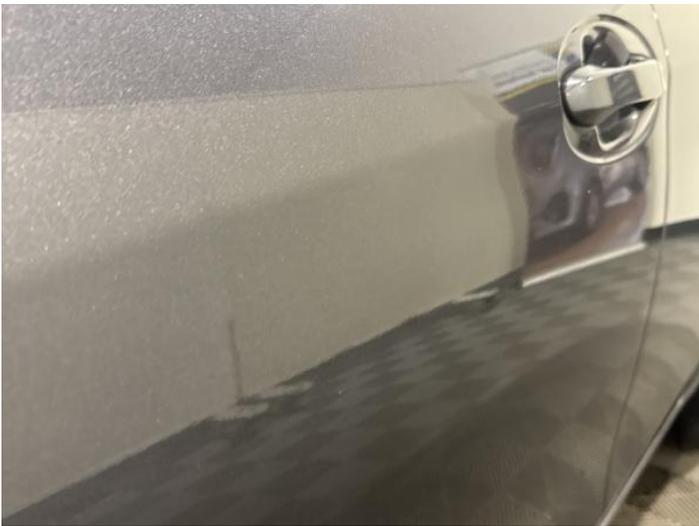
5: Door nsf
Dented
Between 10mm + 30mm

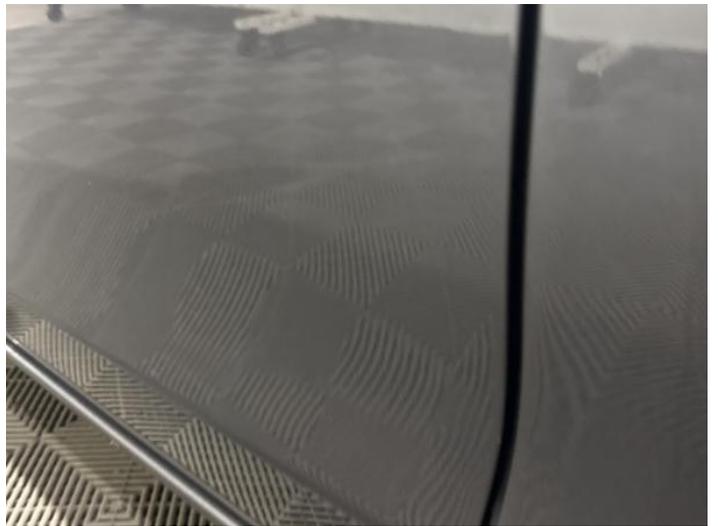
6: Door nsf
Scratched
Over 25mm Thru Paint

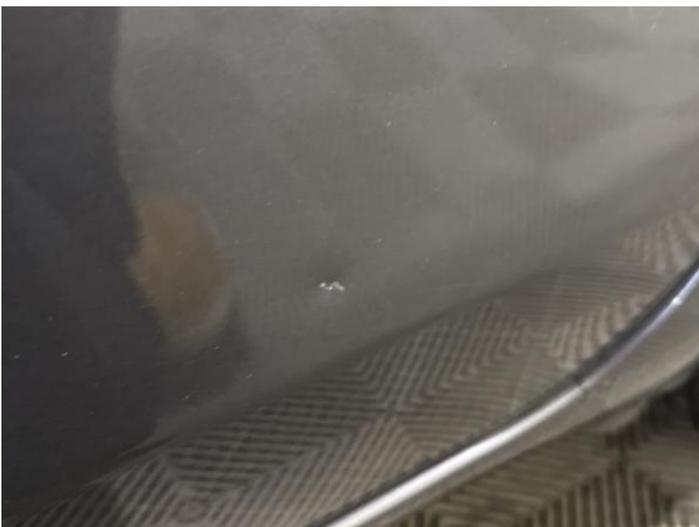
7: Door nsr
Dented
Between 10mm + 30mm

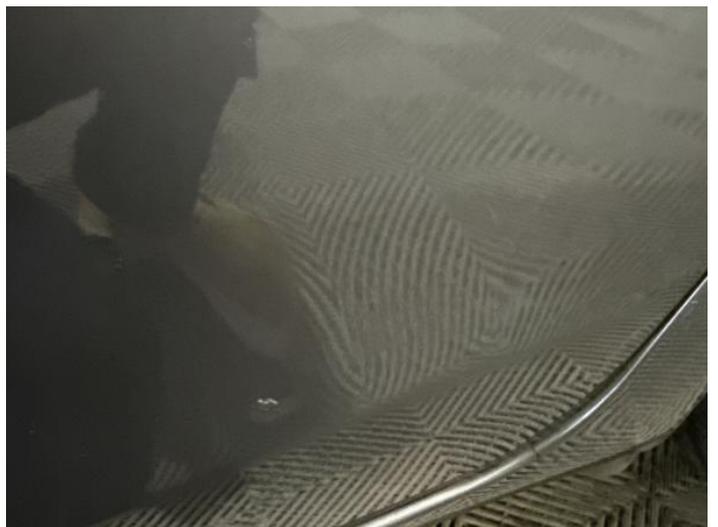
8: Door nsr
Scratched
Up To 25mm Thru Paint

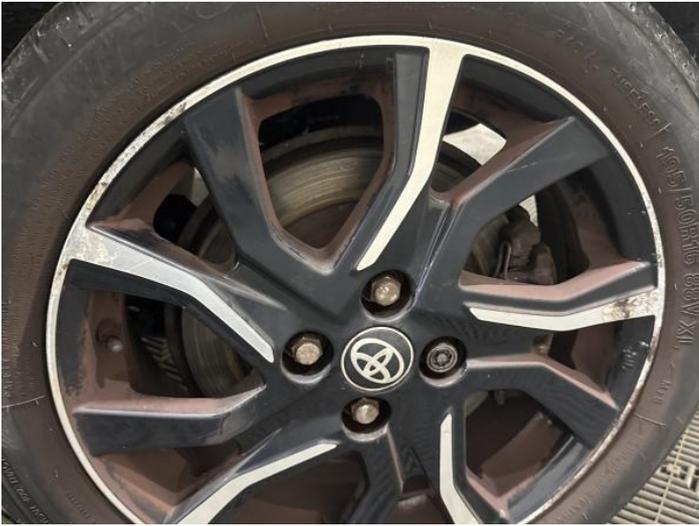
9: Wheel nsr
Scratched
Over 50mm

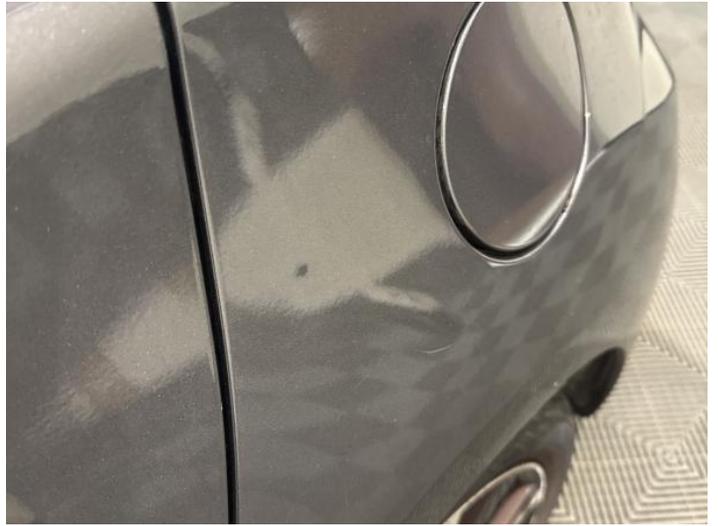
10: Qtr Panel nsr
Dented
Between 10mm + 30mm

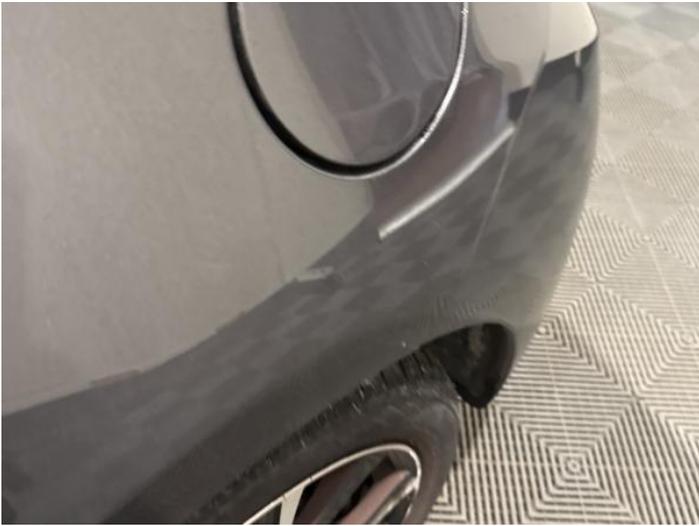
11: Qtr Panel nsr
Scratched
UpTo 25mm Thru Paint

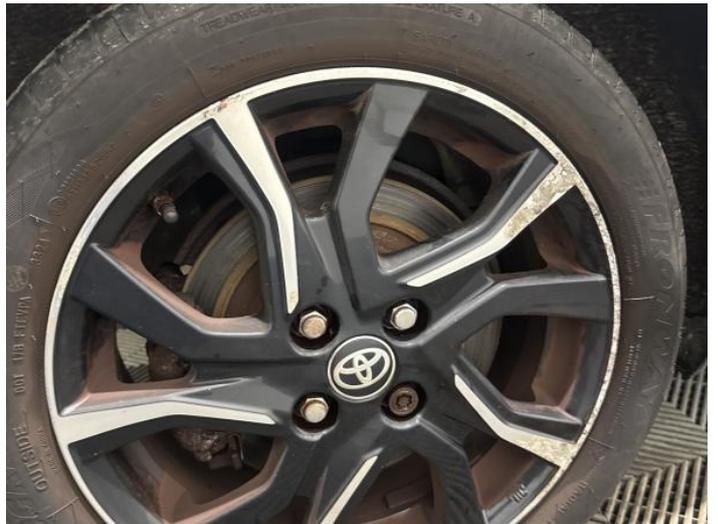
14: Wheel osr
Scratched
Over 50mm

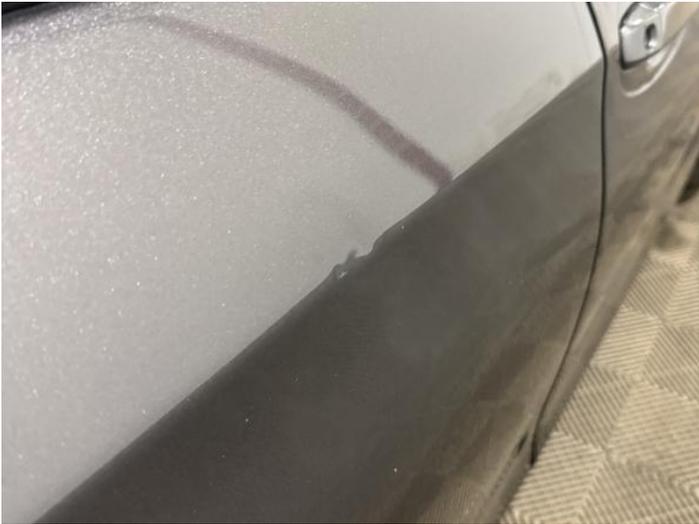
15: Door nsr
Dented
Over 30mm

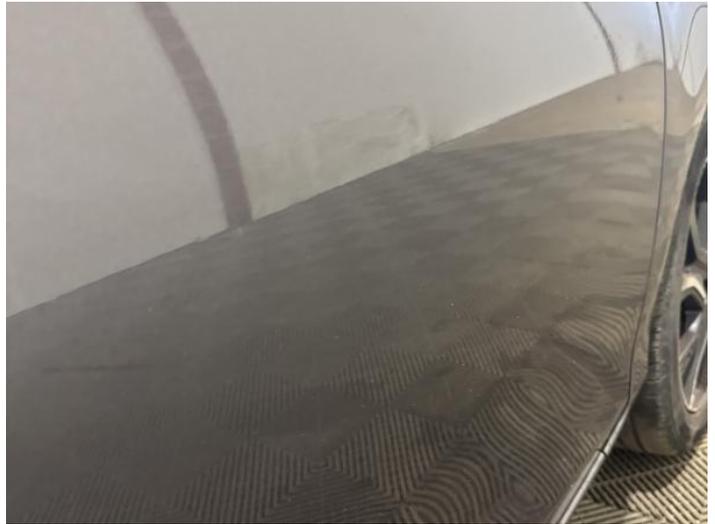
16: Door osf
Dented
Between 10mm + 30mm

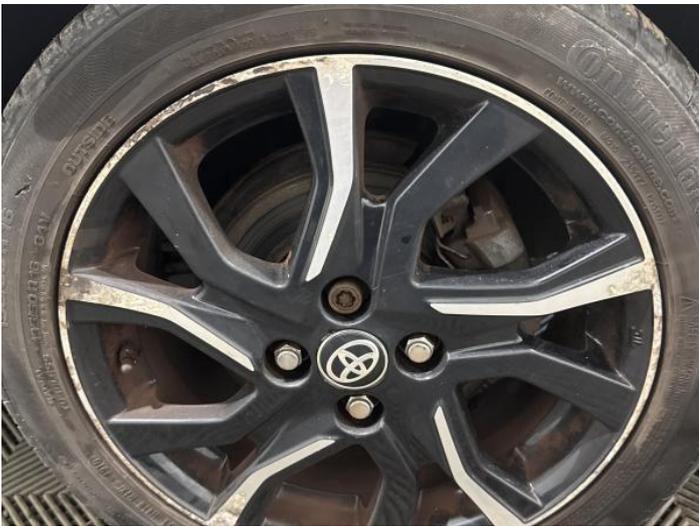
17: Wheel osf
Scratched
Over 50mm
