# VEHICLE INSPECTION REPORT

**LP72KCC**

## MG Mg 4 SE

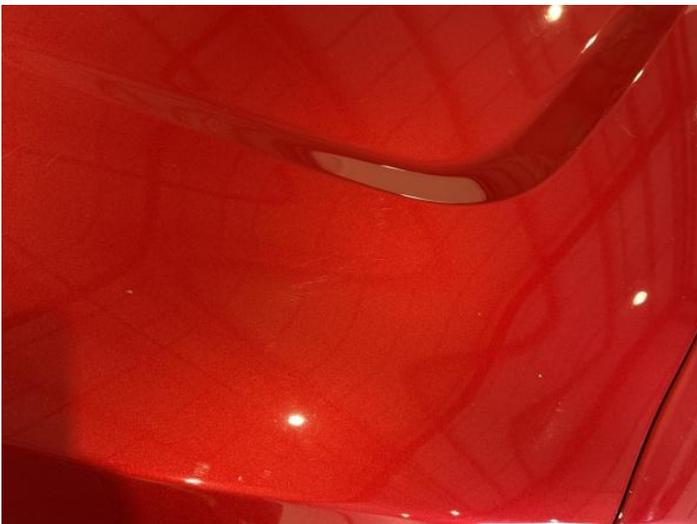
1: Bonnet  
Chipped  
1 To 5

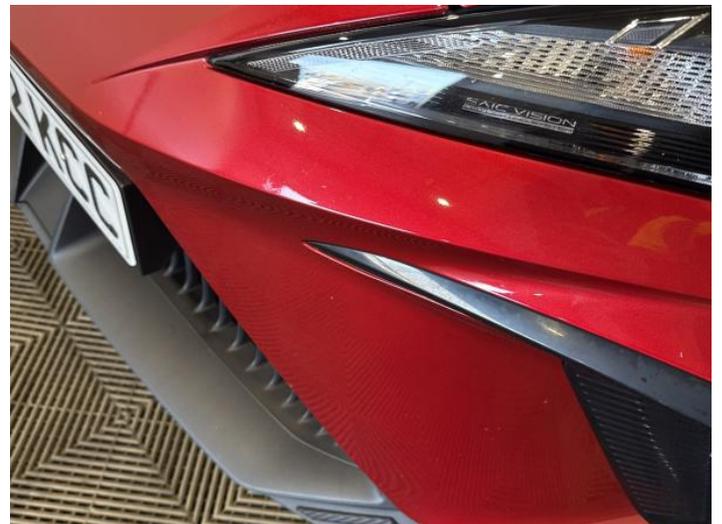
2: Bumper Front  
Chipped  
Multiple Chips

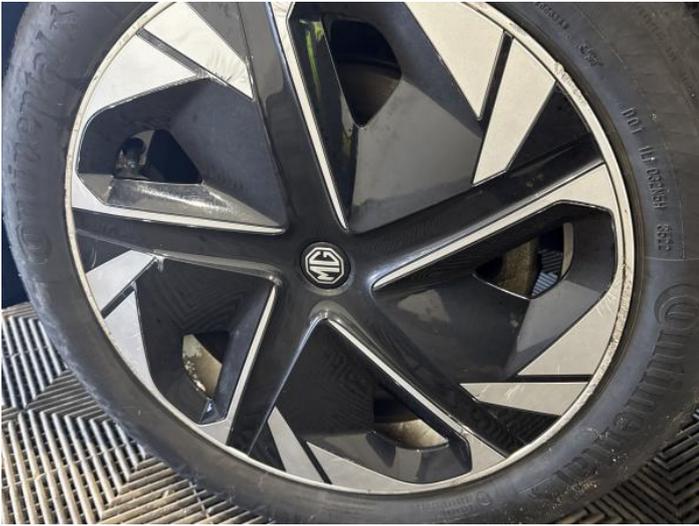
3: Wheel nsf  
Scratched  
Over 50mm

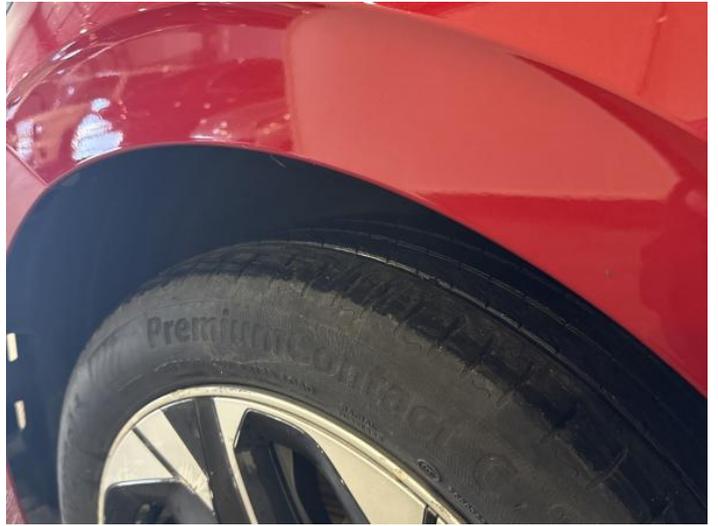
4: Wing nsf  
Scratched  
Over 25mm Thru Paint

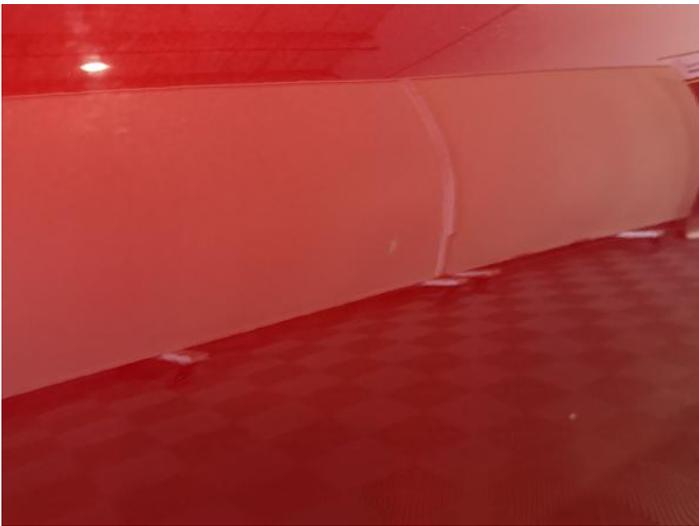
5: Door nsf  
Scratched  
UpTo 25mm Thru Paint

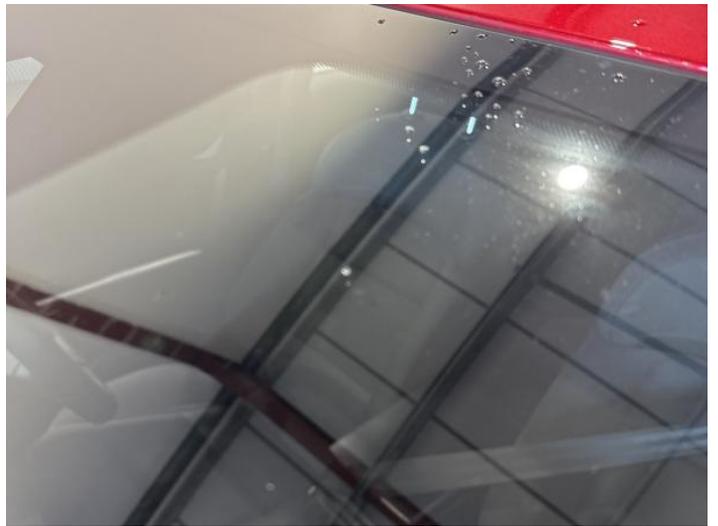
6: Screen Front  
Chipped  
UpTo 10mm

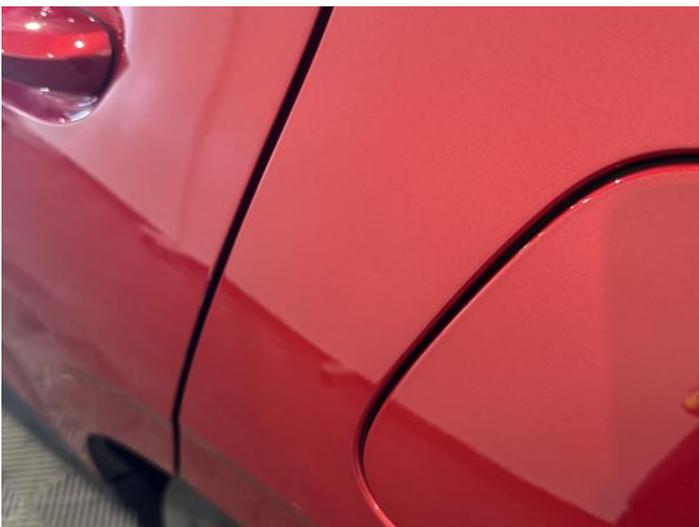
7: Qtr Panel nsr  
Dented  
Between 10mm + 30mm

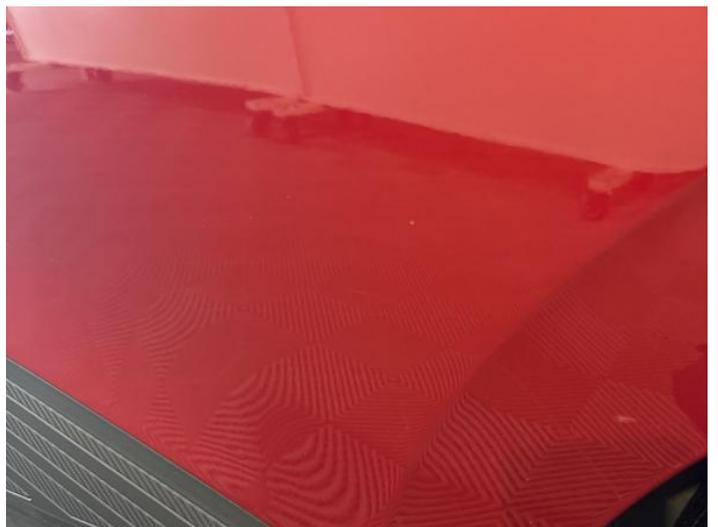
8: Door nsr  
Scratched  
UpTo 25mm Thru Paint

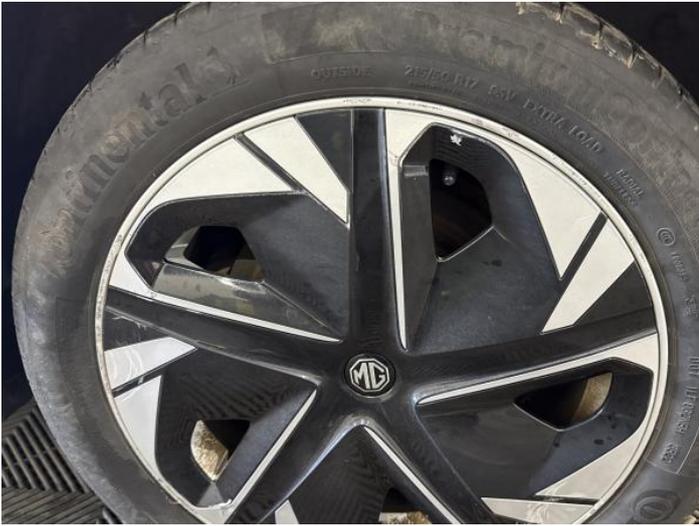
9: Wheel nsr  
Scratched  
Over 50mm

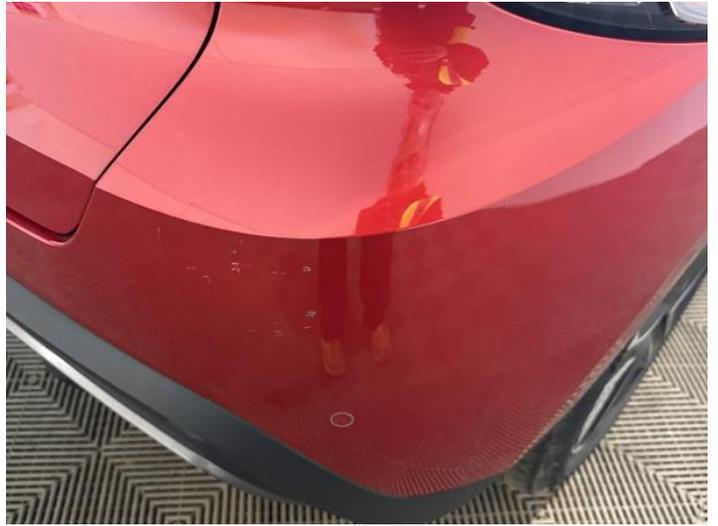
10: Bumper Rear  
Scratched  
Over 100mm Thru Paint

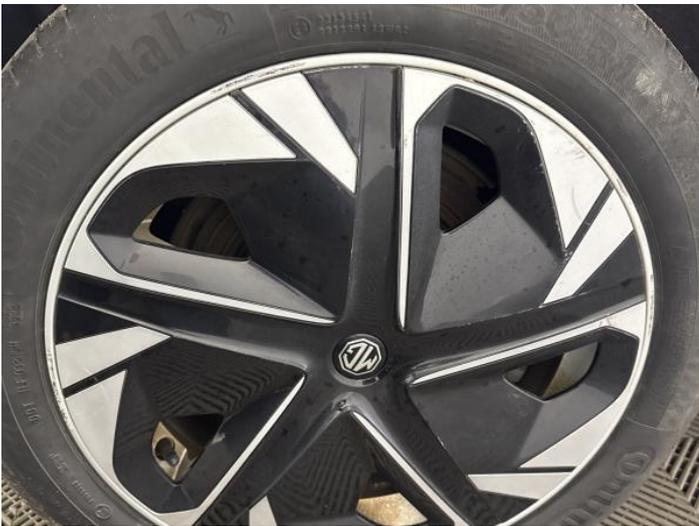
11: Wheel osr  
Scratched  
Over 50mm

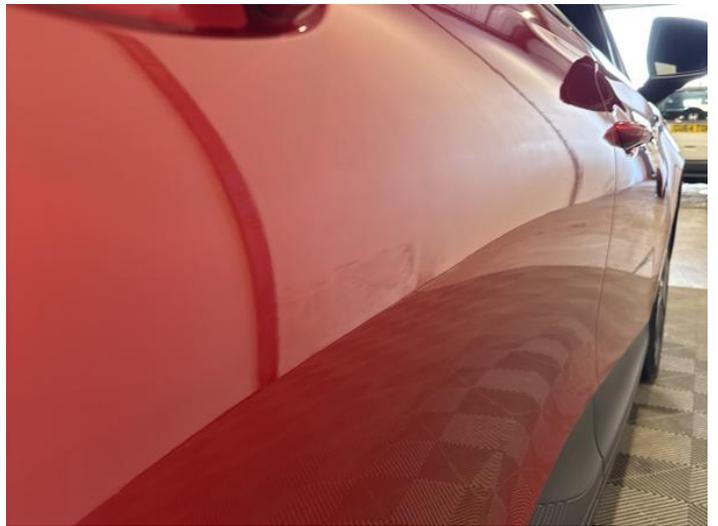
12: Door osr  
Poor Previous Repair  
Rippled Up To 30%

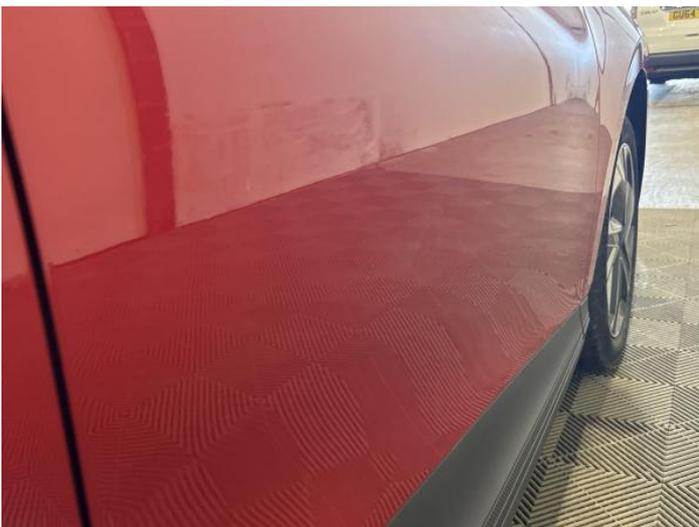
13: Door osf  
Poor Previous Repair  
Rippled Up To 30%

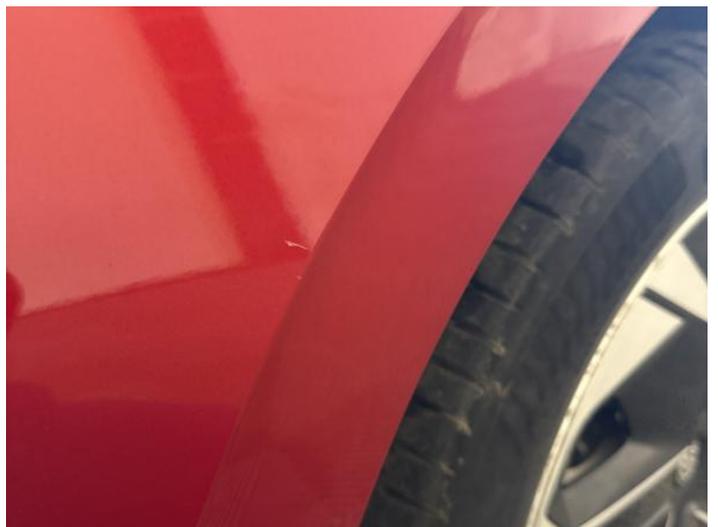
14: Wing osf  
Scratched  
Over 25mm Thru Paint

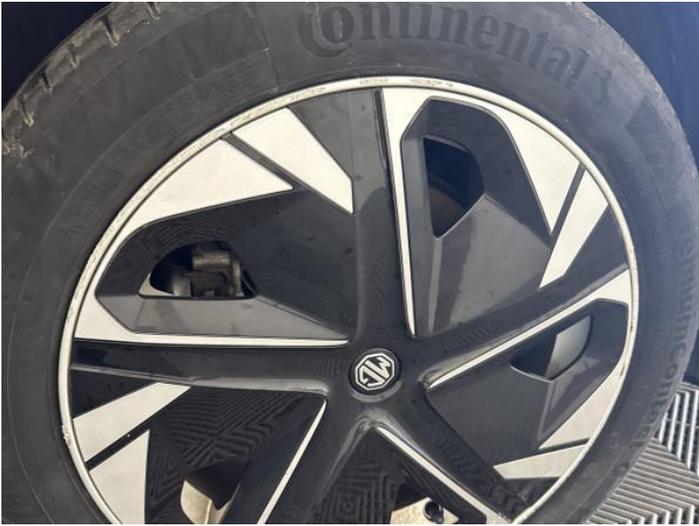
15: Wheel of  
Scratched  
Over 50mm
