VEHICLE INSPECTION REPORT

BC18ASO

Skoda Octavia 1.5 TSI SE L 5dr

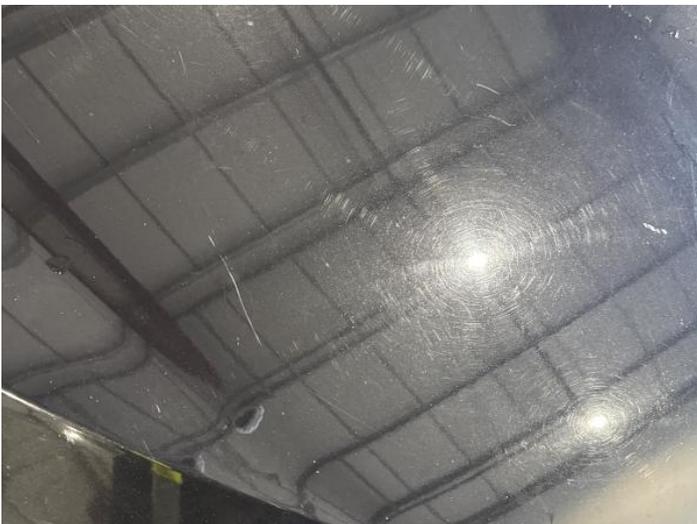
1: Bonnet
Scratched
Over 25mm Thru Paint

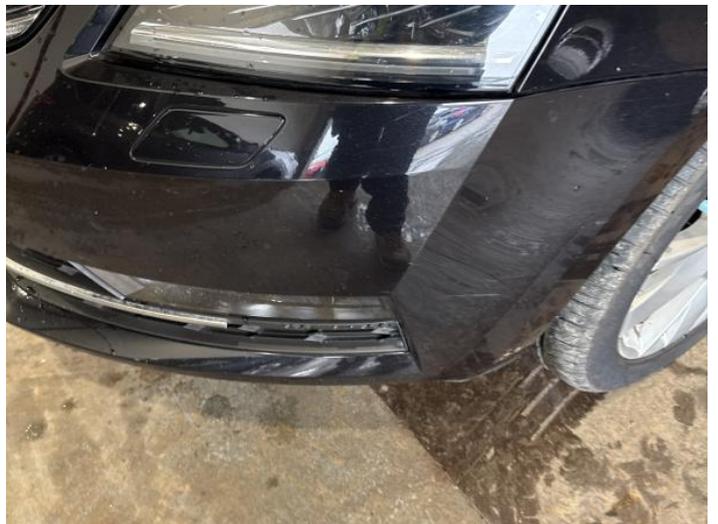
2: Bumper Front
Chipped
Multiple Chips

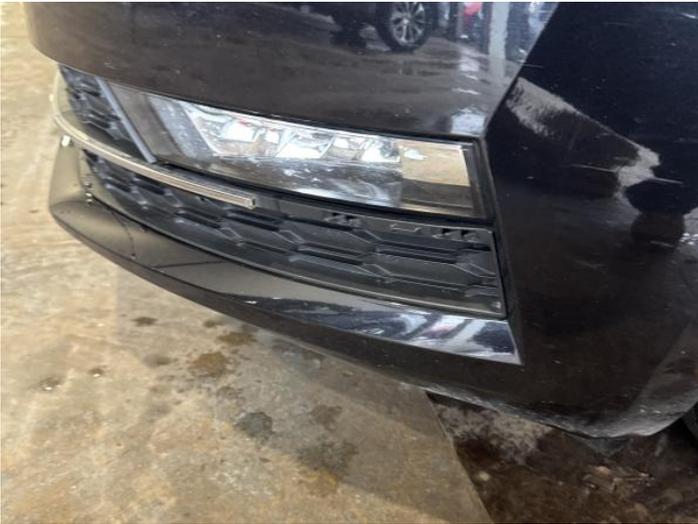
3: Bumper Front Moulding
Broken
Replace

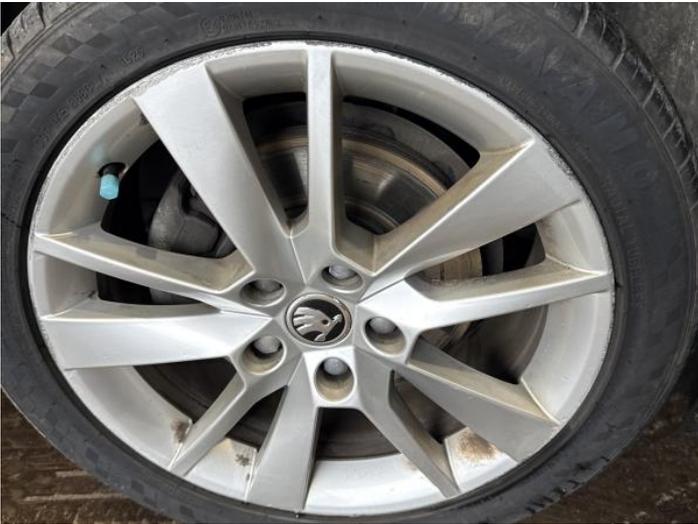
5: Wheel nsf
Scratched
Over 50mm

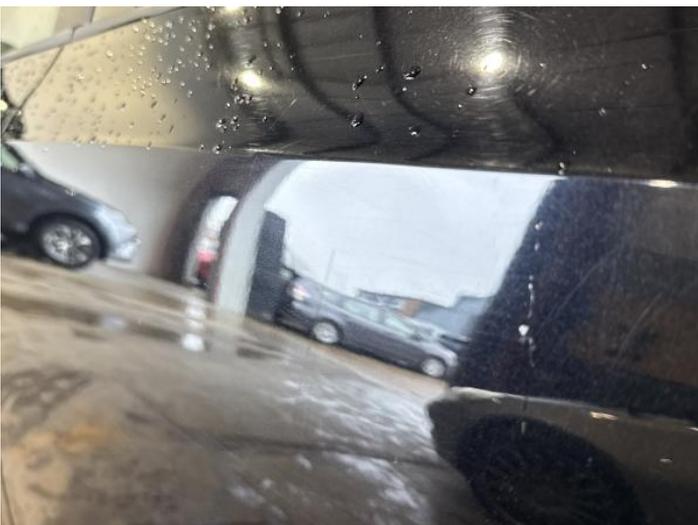
7: Door nsr
Dented
Over 30mm

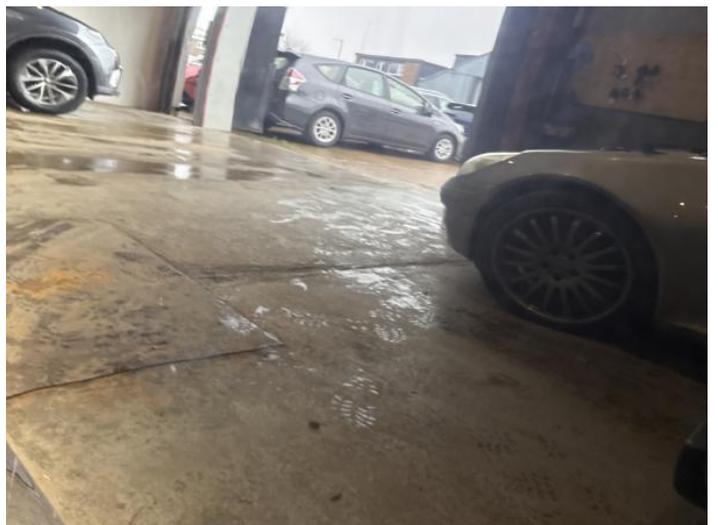
8: Door nsr
Scratched
Over 25mm Thru Paint

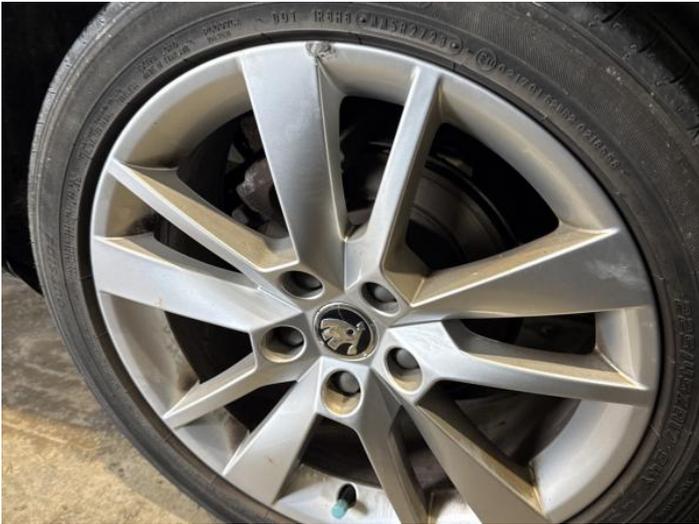
9: Wheel nsr
Dented
UpTo 30mm (Alloy)

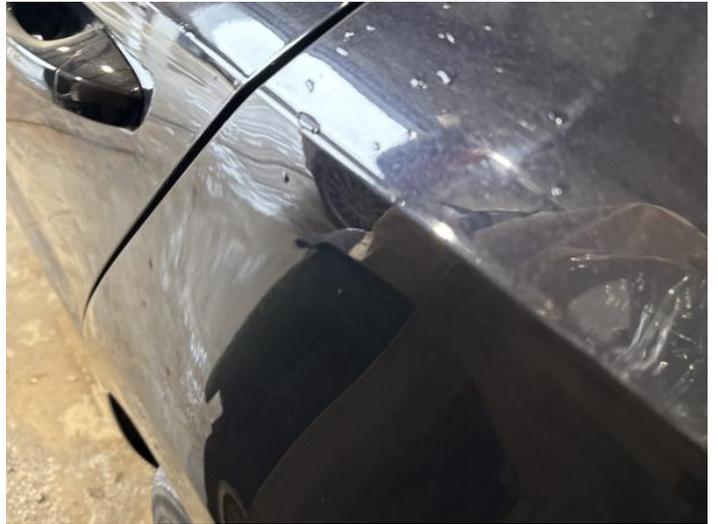
10: Qtr Panel nsr
Dented
Between 10mm + 30mm

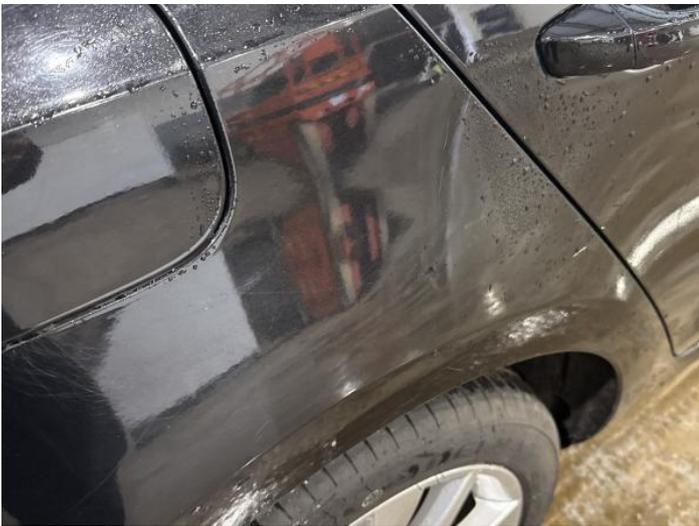
11: Qtr Panel osr
Scratched
Over 25mm Thru Paint

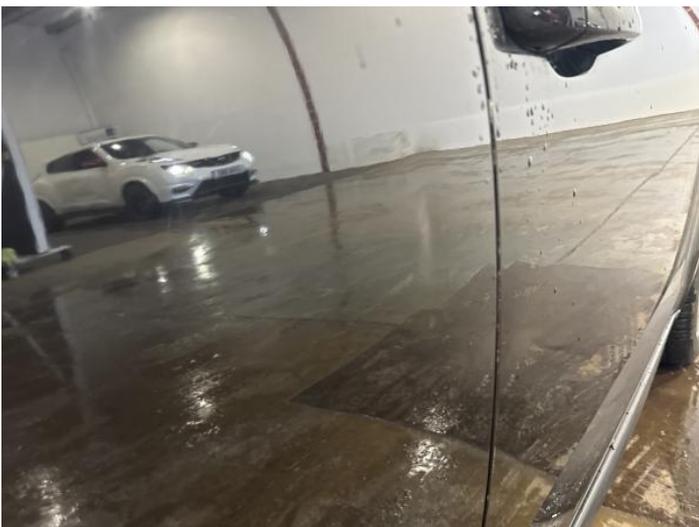
13: Door osr
Dented
Over 30mm

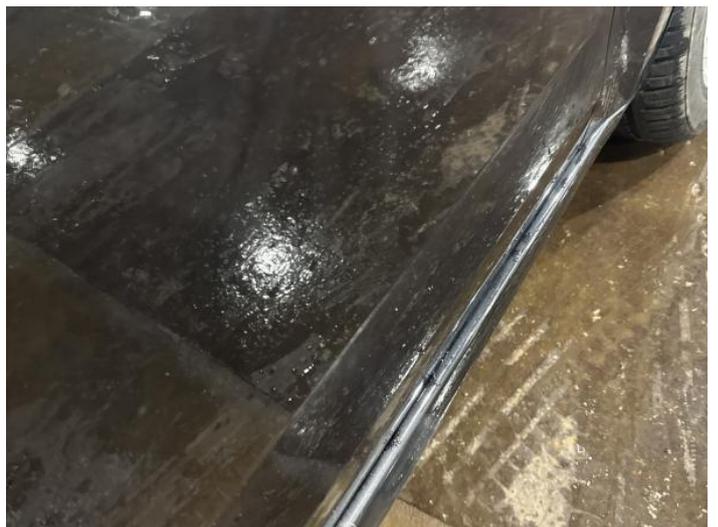
14: Door osf
Scratched
Over 25mm Thru Paint

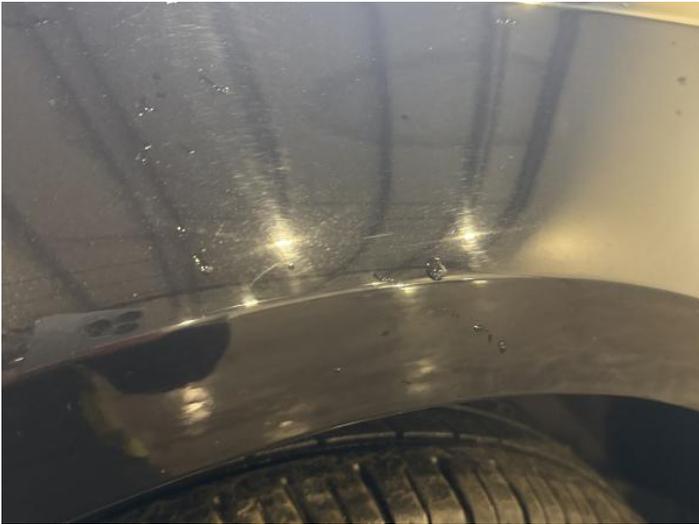
15: Wing osf
 Scratched
 UpTo 25mm Thru Paint

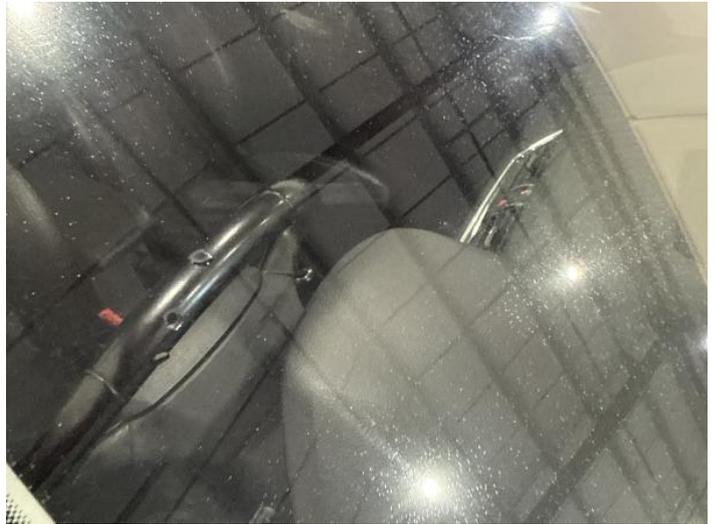
16: Screen Front
 Chipped
 UpTo 10mm

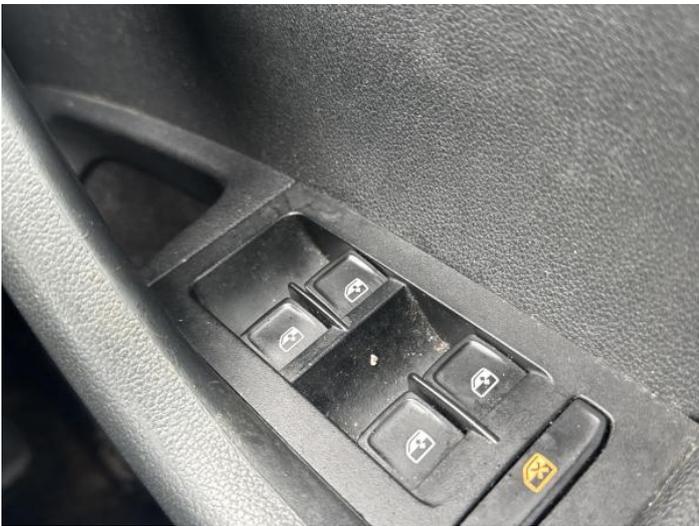
17: Switches And Controls
 Broken
 Replace
