# VEHICLE INSPECTION REPORT

**KY11KDN**

## Mazda 6 2.0 Takuya 5dr

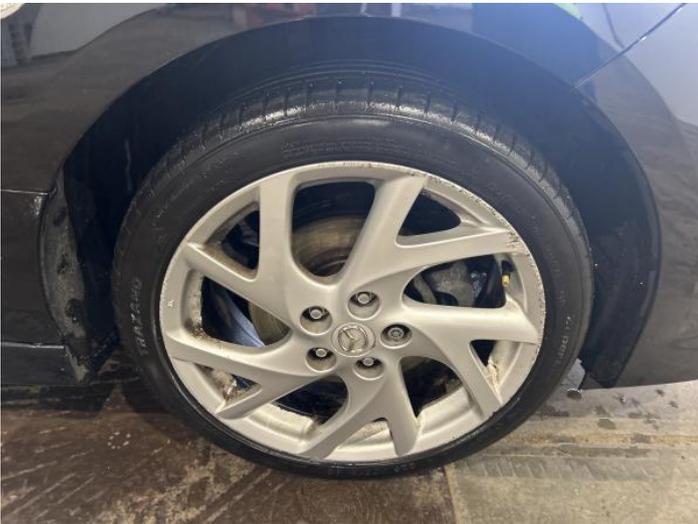
1: Wheel osf  
Scratched  
Over 50mm

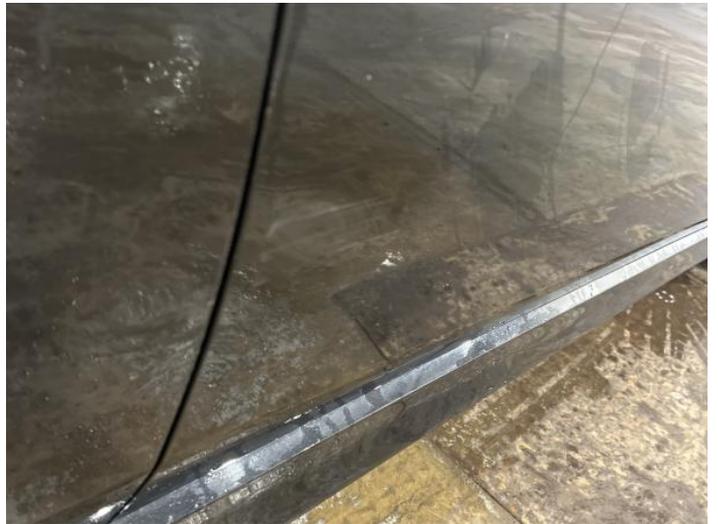
2: Door osf  
Dented  
Over 30mm

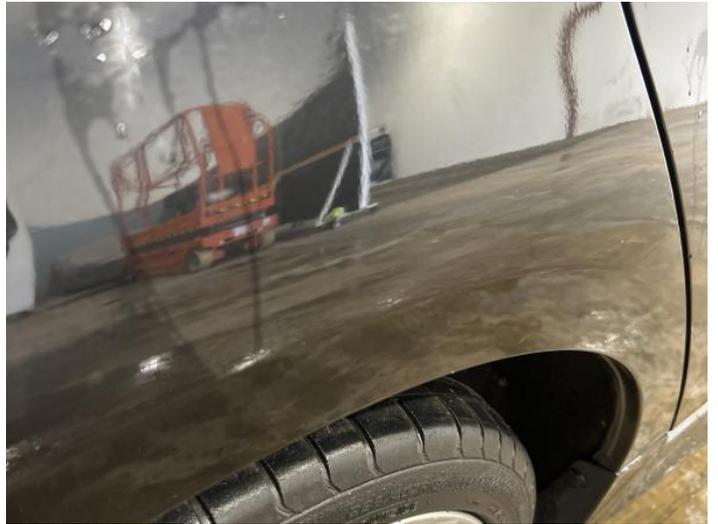
4: Qtr Panel osr  
Scratched  
Over 25mm Not Thru Paint

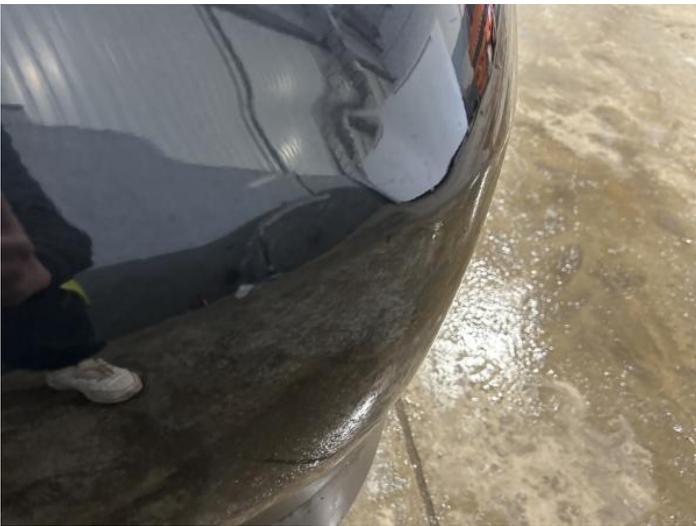
5: Bumper Rear  
Scratched  
25 to 100mm Thru Paint

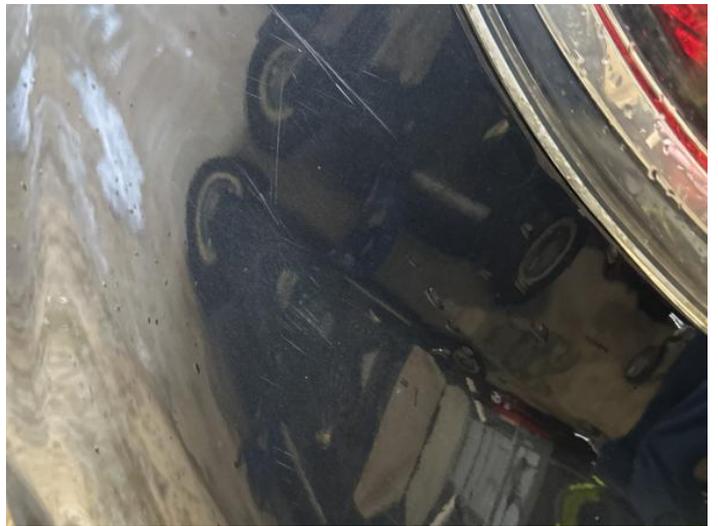
6: Bumper Rear  
Scratched  
Over 25mm Not Thru Paint

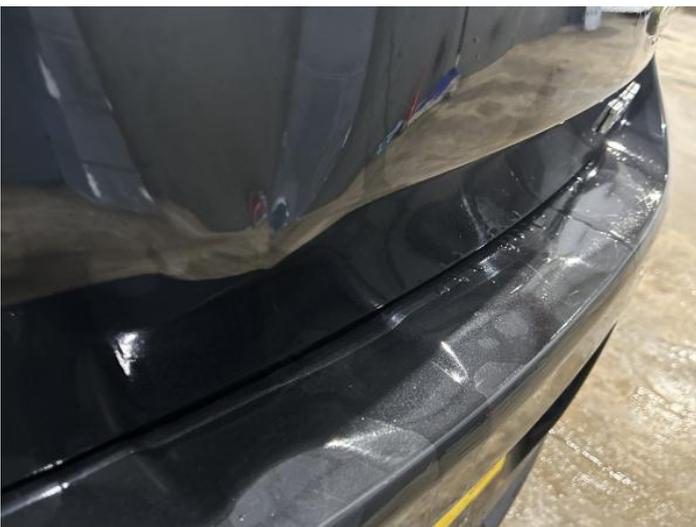
7: Tailgate  
Dented  
Over 30mm

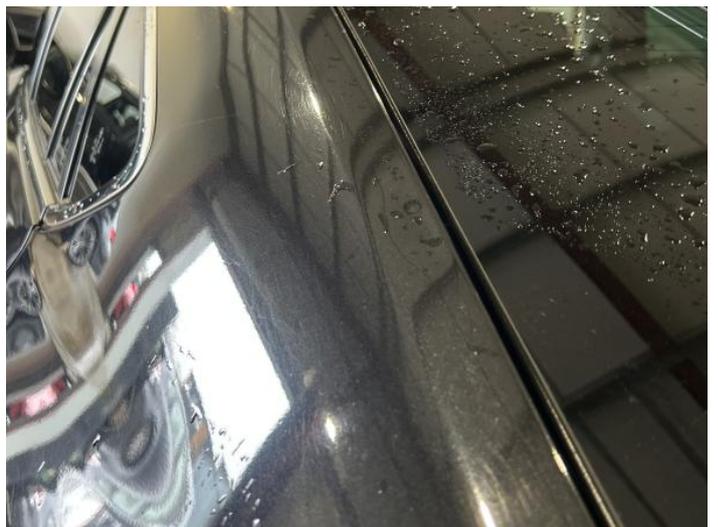
8: Qtr Panel nsr  
Dented  
Between 10mm + 30mm

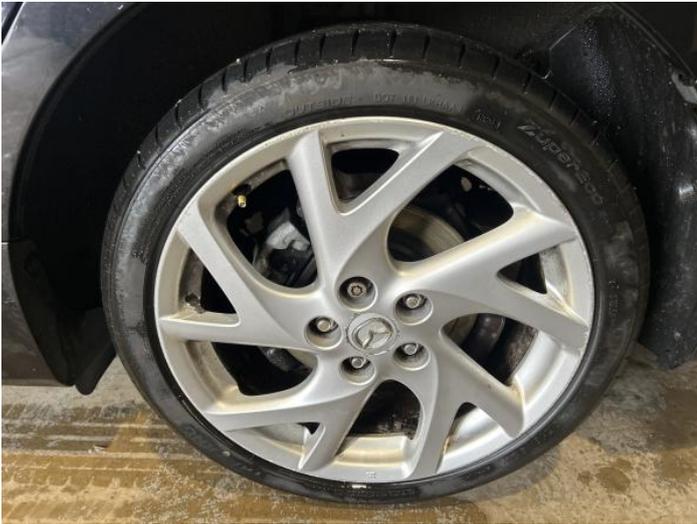
9: Wheel nsr  
Scratched  
Over 50mm

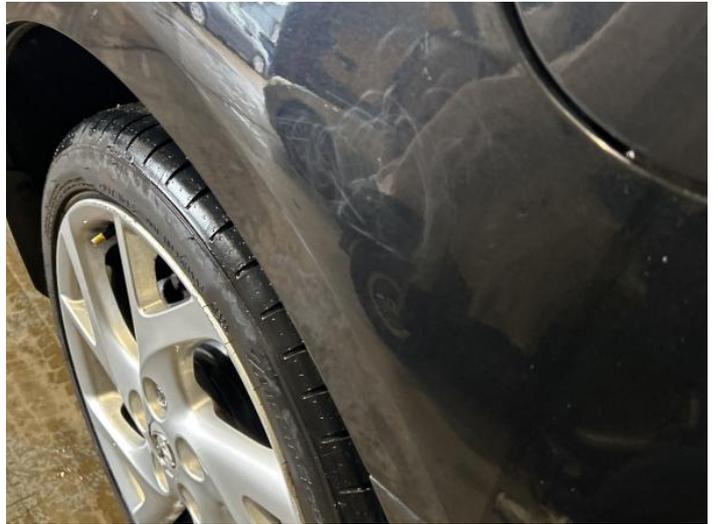
10: Qtr Panel nsr  
Scratched  
Over 25mm Not Thru Paint

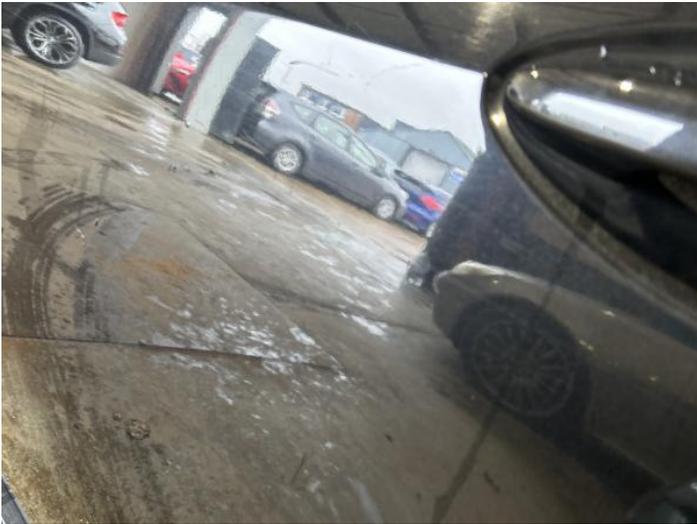
11: Door nsr  
Scratched  
Over 25mm Not Thru Paint

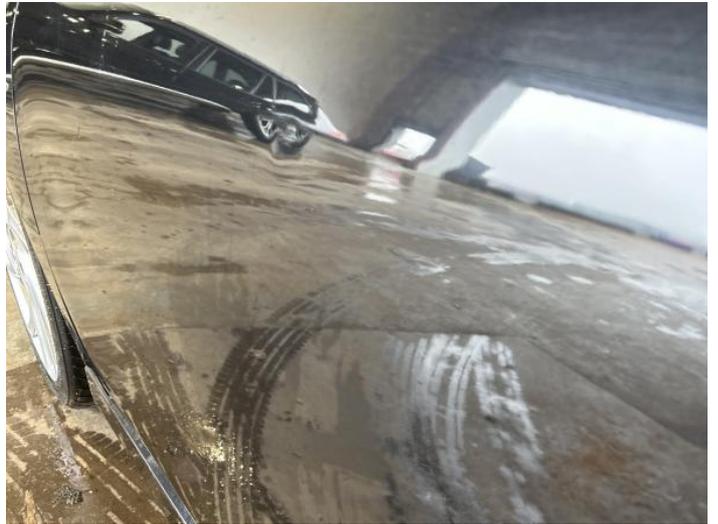
12: Door nsf  
Dented  
Between 10mm + 30mm

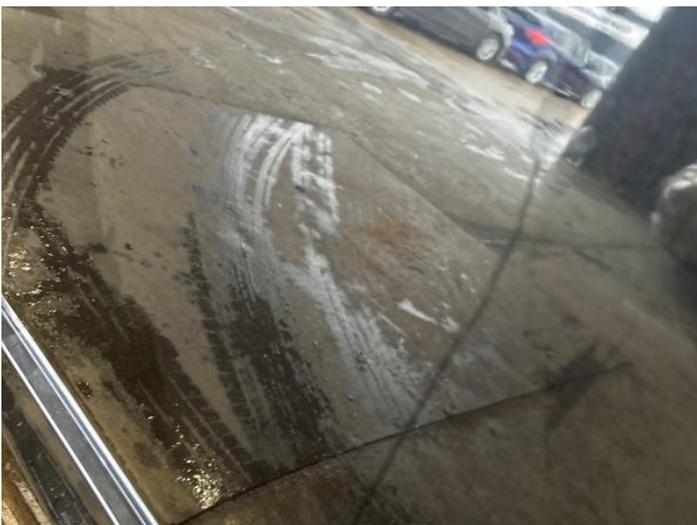
13: Door nsf  
Scratched  
Over 25mm Not Thru Paint

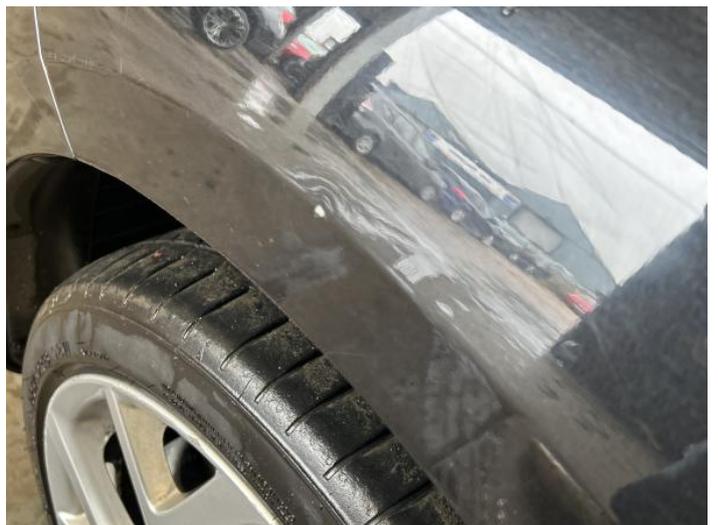
14: Wing nsf  
Dented  
With Paint Damage

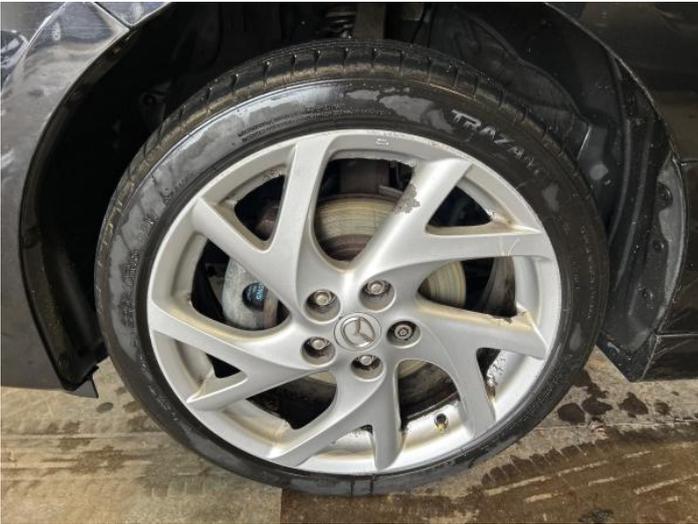
15: Wheel nsf  
Scratched  
Over 50mm

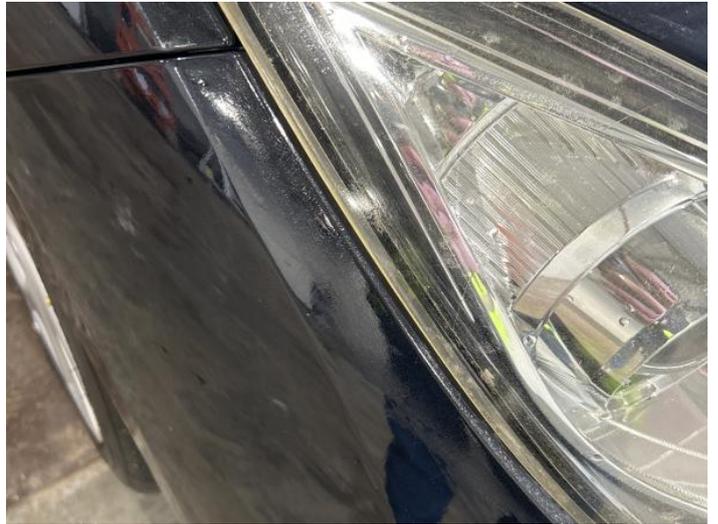
16: Bumper Front  
Poor Previous Repair  
Poor Paint

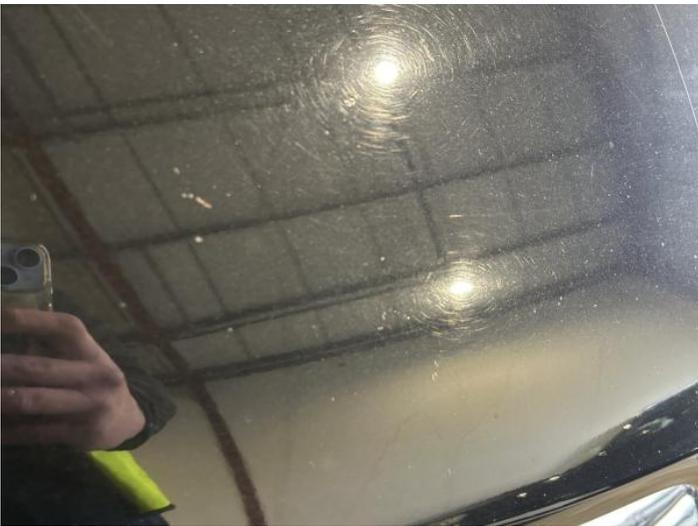
17: Bonnet  
Chipped  
Multiple Chips

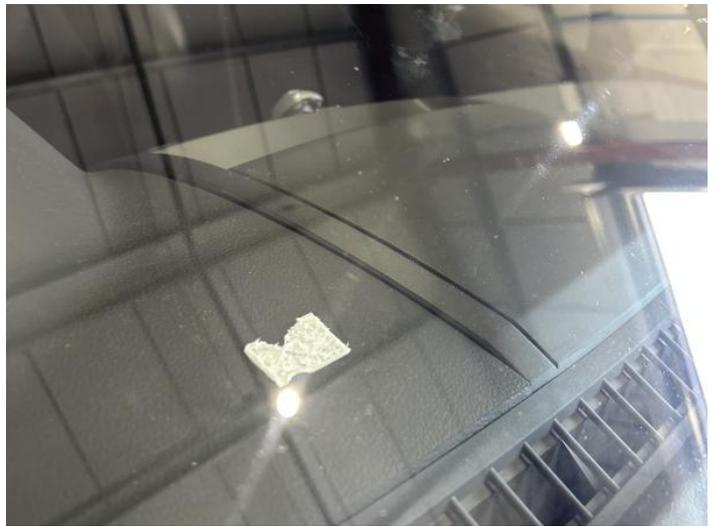
18: Screen Front  
Chipped  
UpTo 10mm

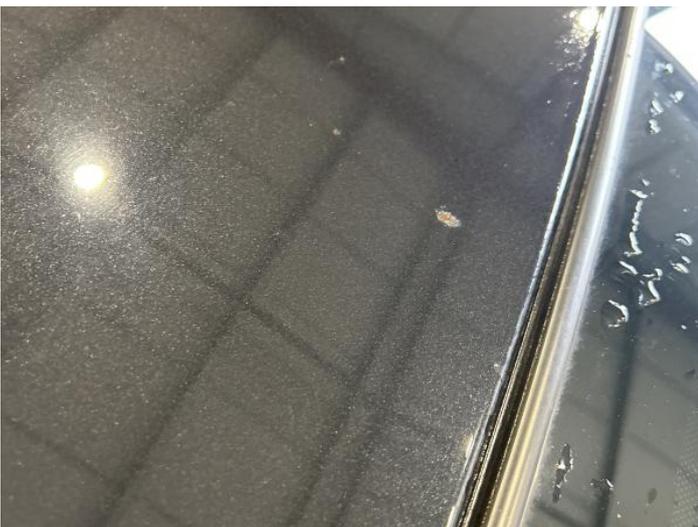
19: Roof  
Chipped  
1 To 5
