# VEHICLE INSPECTION REPORT

**CK63YNL**

## Peugeot 2008 1.6 e-HDi Allure 5dr EGC

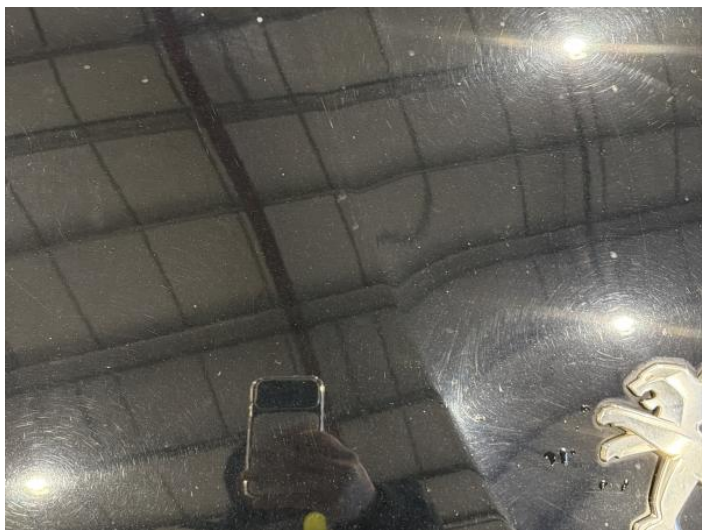
1: Bonnet  
Chipped  
Multiple Chips

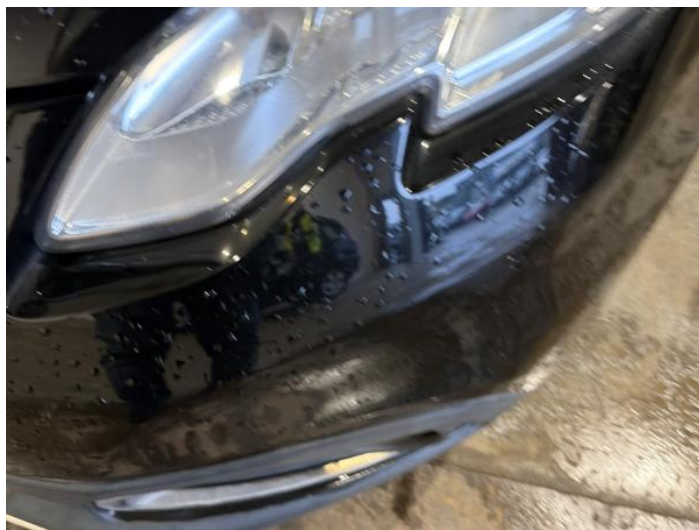
2: Bumper Front  
Poor Previous Repair  
Poor Paint

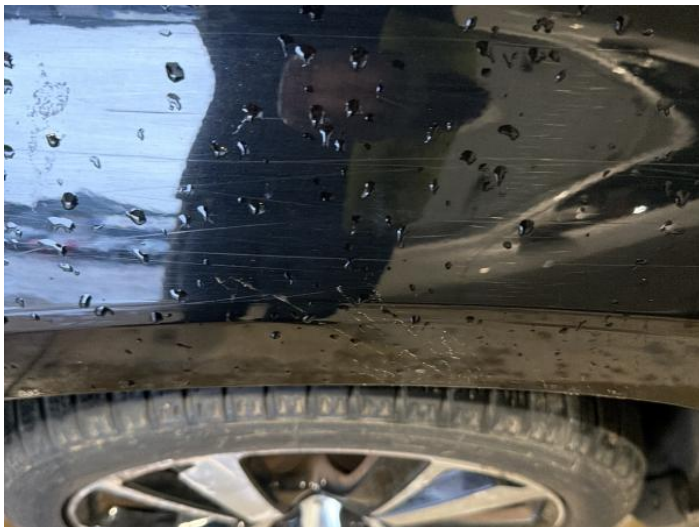
3: Wing nsf  
Dented  
Over 2 UpTo 10mm

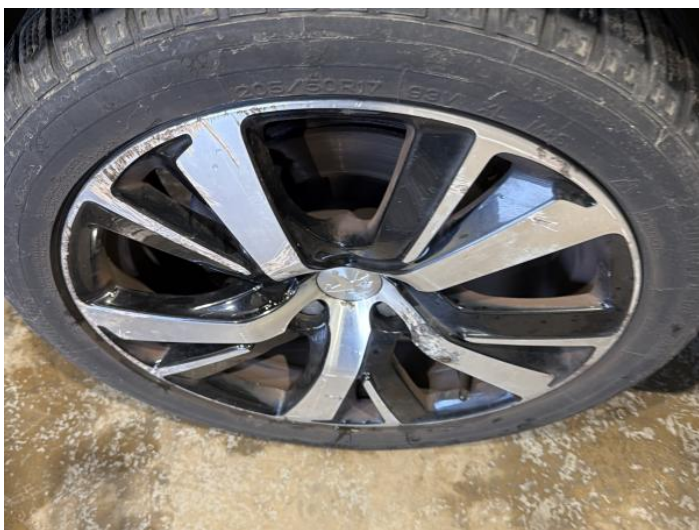
5: Wheel nsf  
Scratched  
Over 50mm

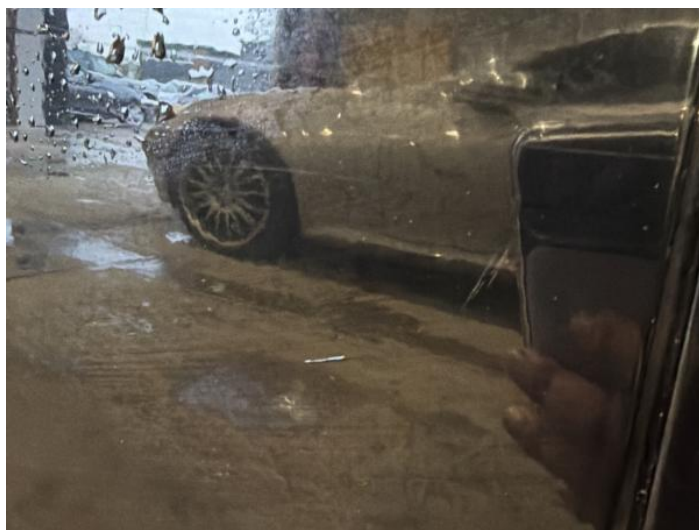
6: Door nsf  
Dented  
Over 2 UpTo 10mm

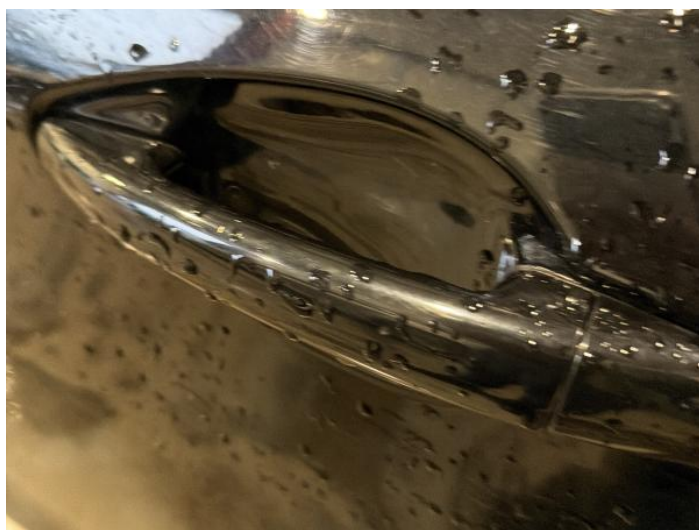
8: Door nsr  
Dented  
With Paint Damage

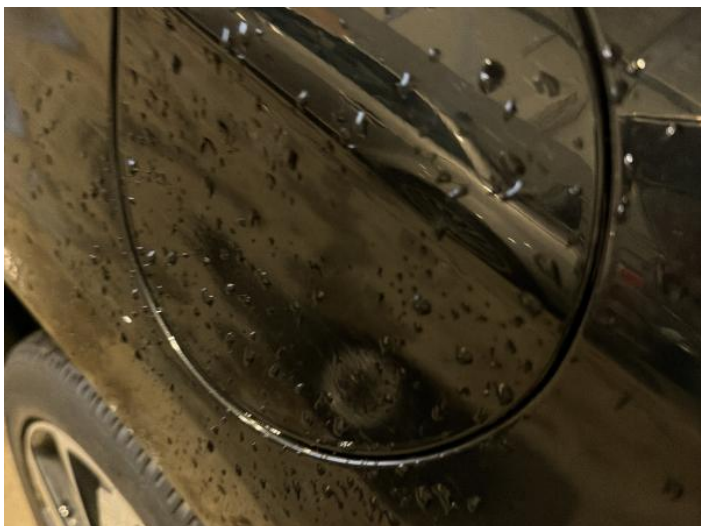
9: Qtr Panel nsr  
Dented  
Over 2 UpTo 10mm

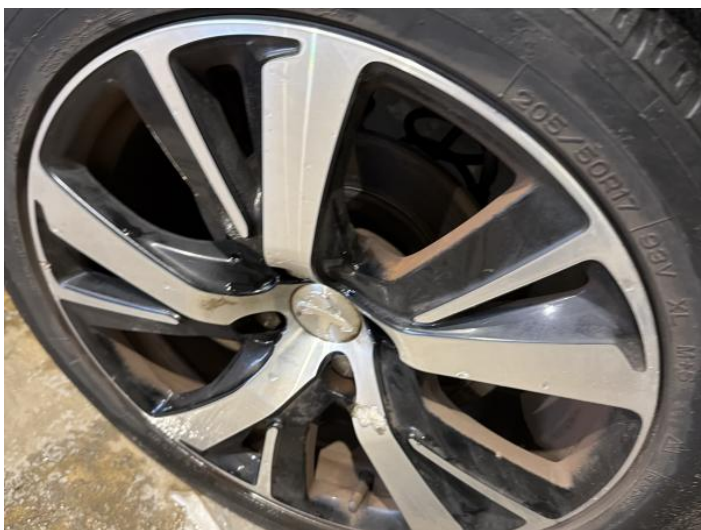
11: Wheel nsr  
Scratched  
Over 50mm

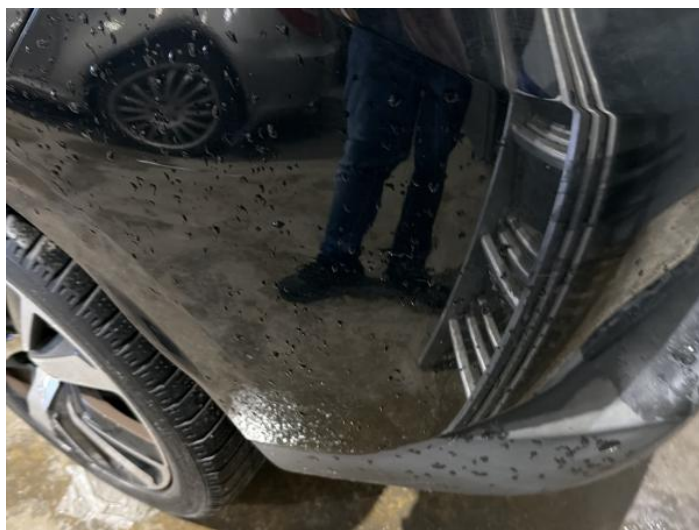
12: Bumper Rear  
Scratched  
25 to 100mm Thru Paint

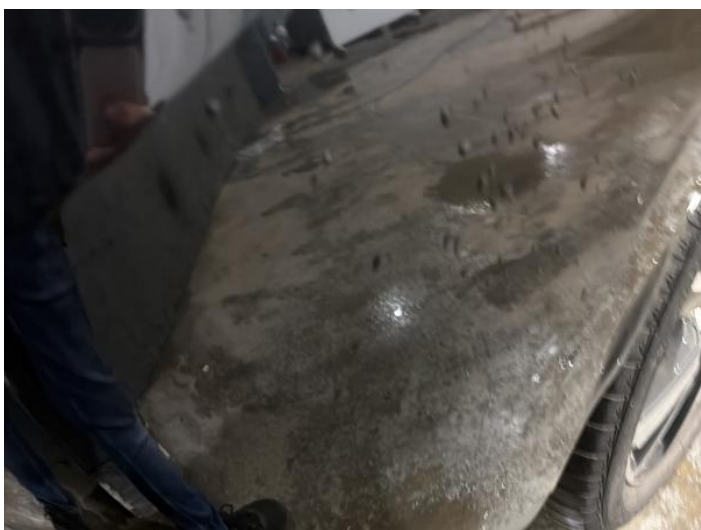
13: Bumper Rear  
Chipped  
Multiple Chips

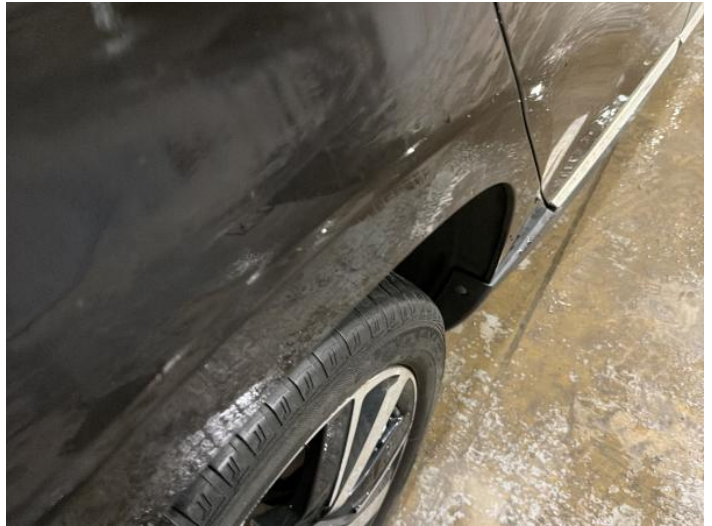
16: Qtr Panel osr  
Dented  
2 Or Less UpTo 10mm

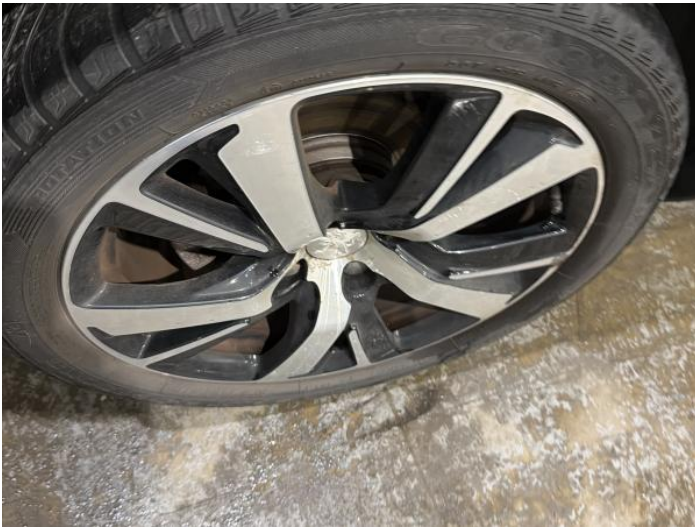
17: Wheel osr  
Scratched  
Over 50mm

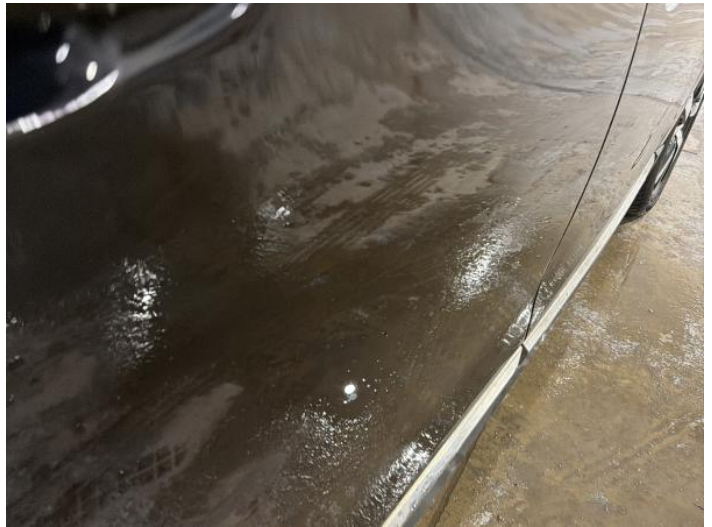
18: Door osr  
Dented  
Over 2 UpTo 10mm

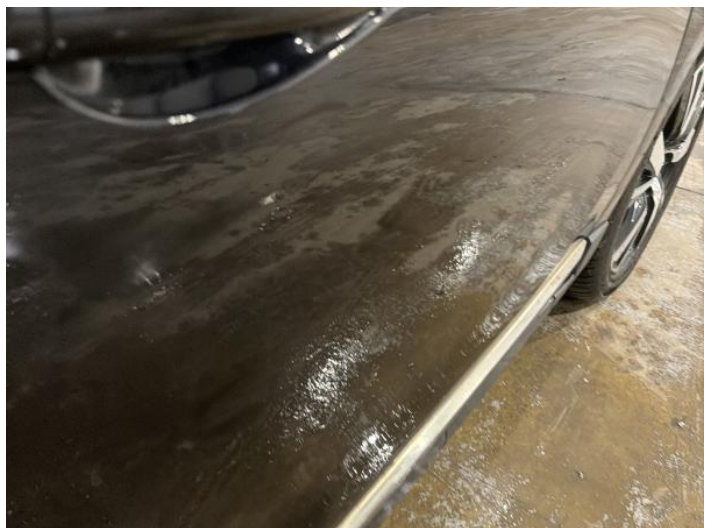
20: Door osf  
Dented  
Over 2 UpTo 10mm

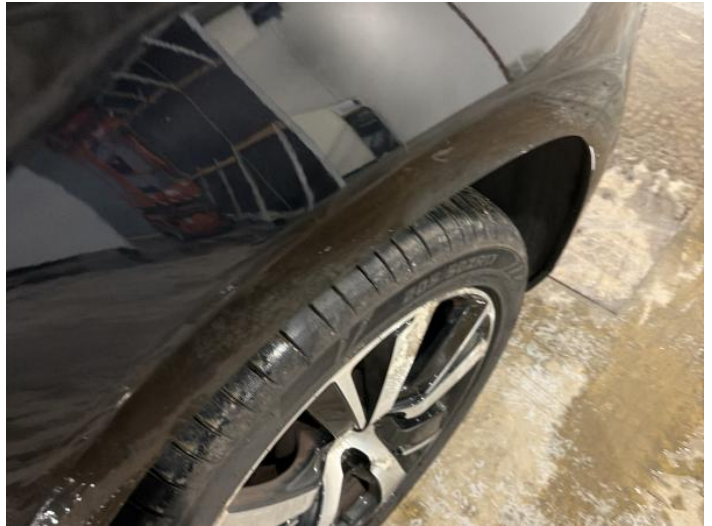
21: Door osf  
Scratched  
Over 25mm Not Thru Paint
