VEHICLE INSPECTION REPORT

LF19AJN

Ford Focus 1.5 EcoBlue 120 Zetec 5dr

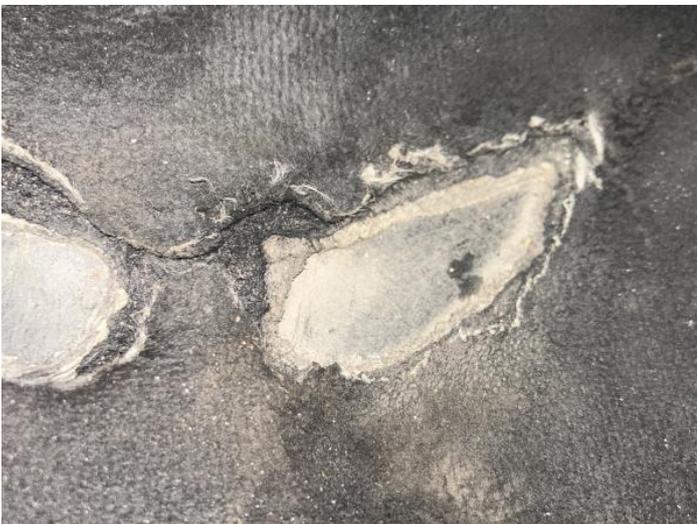
1: Carpets Front
Holed
Over 3mm

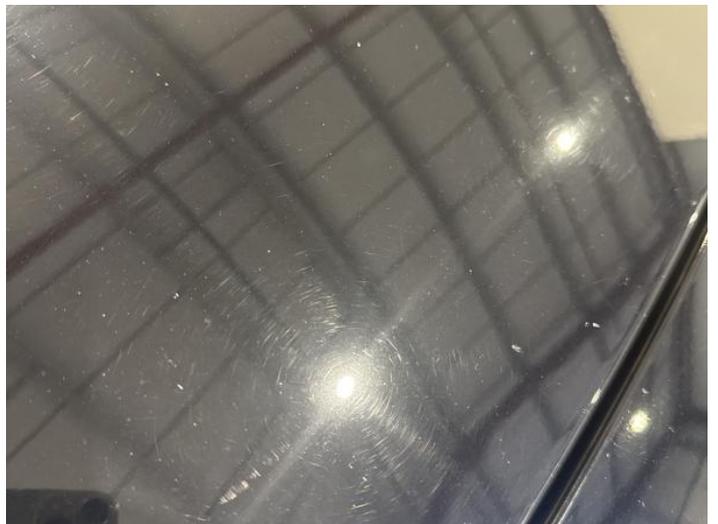
2: Bonnet
Chipped
Multiple Chips

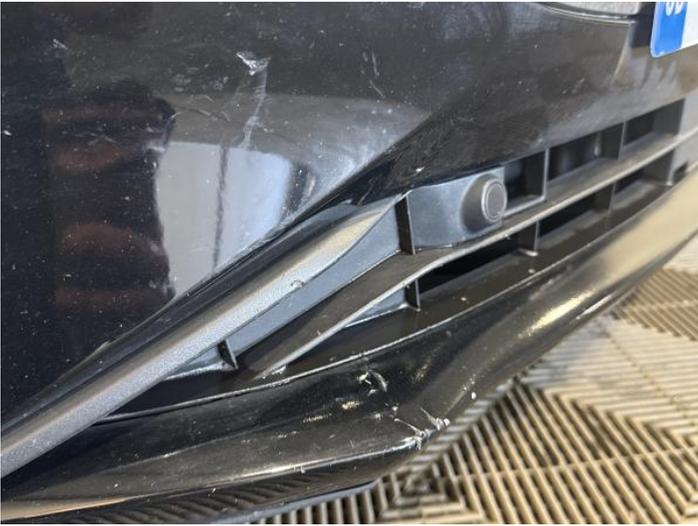
3: Bumper Front
Dented
With Paint Damage

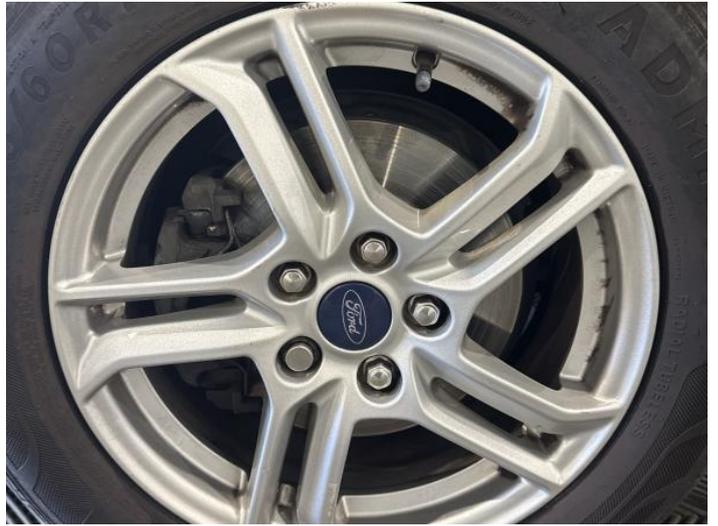
4: Wheel nsf
Scratched
Over 50mm

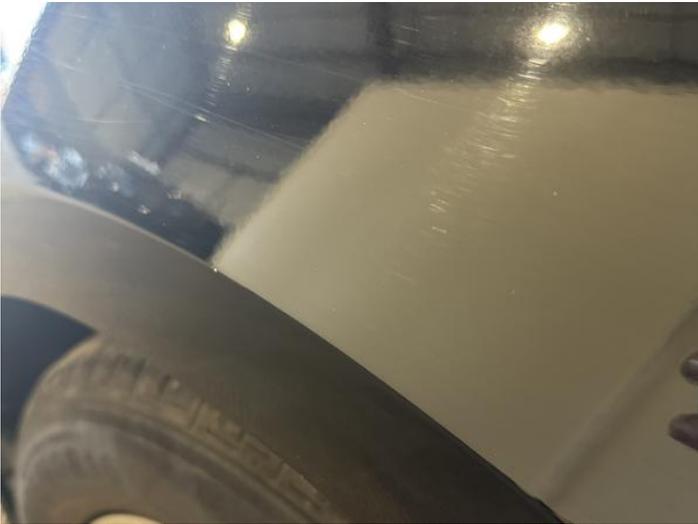
5: Wing nsf
Chipped
1 To 5

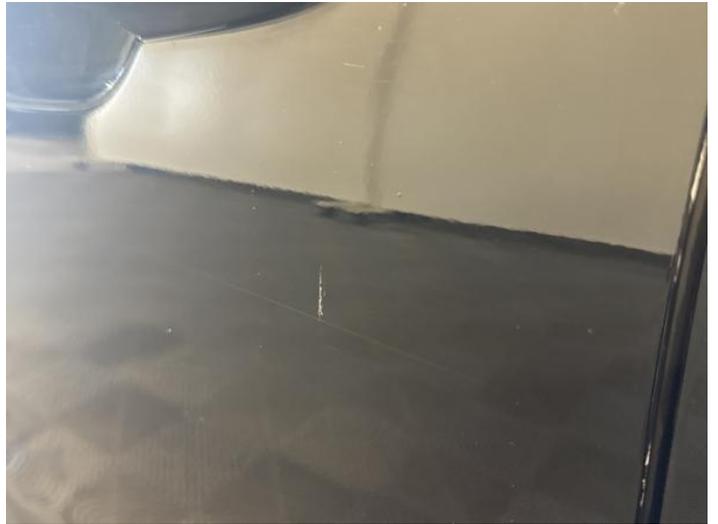
6: Door nsf
Scratched
Up To 25mm Thru Paint

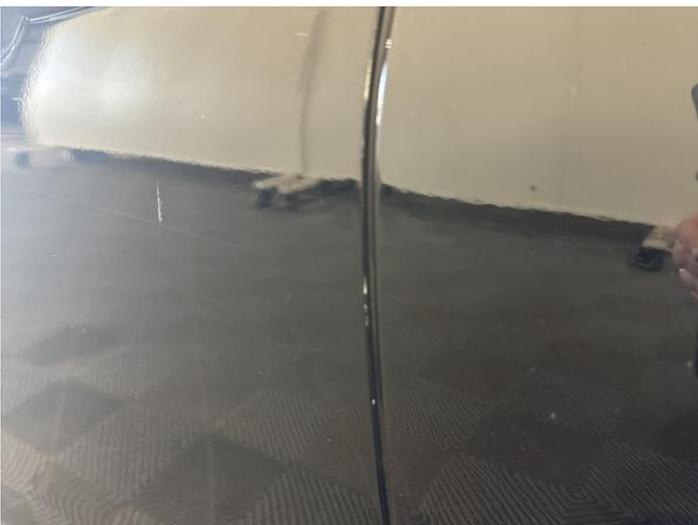
7: Door nsf
Chipped
Edge Chip

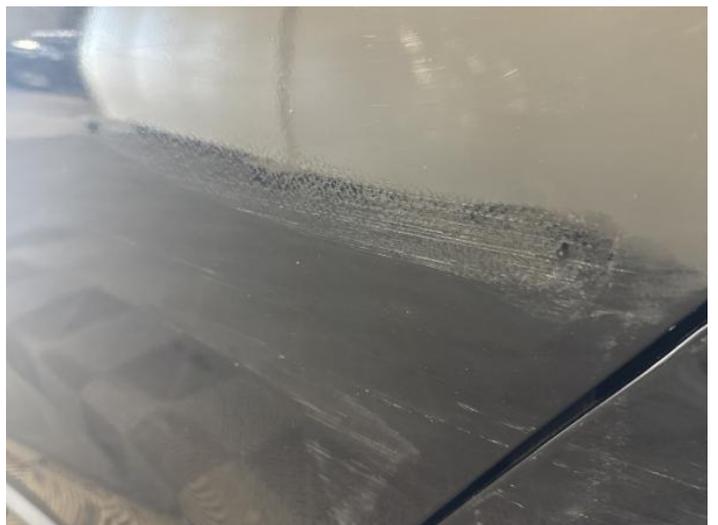
8: Door nsr
Dented
With Paint Damage

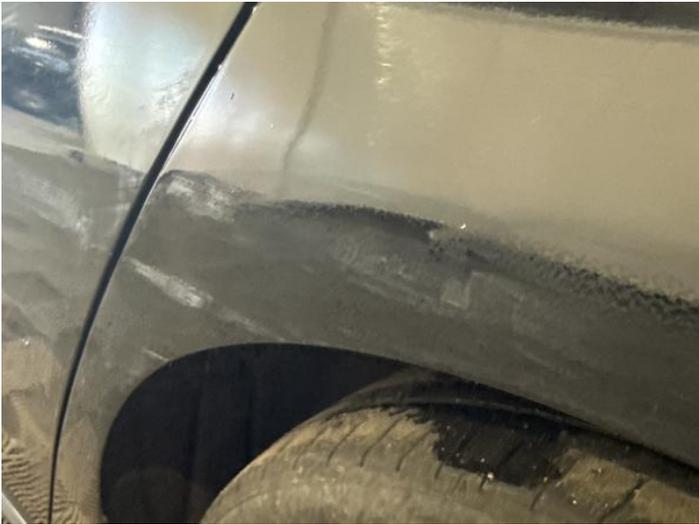
9: Qtr Panel nsr
Dented
With Paint Damage

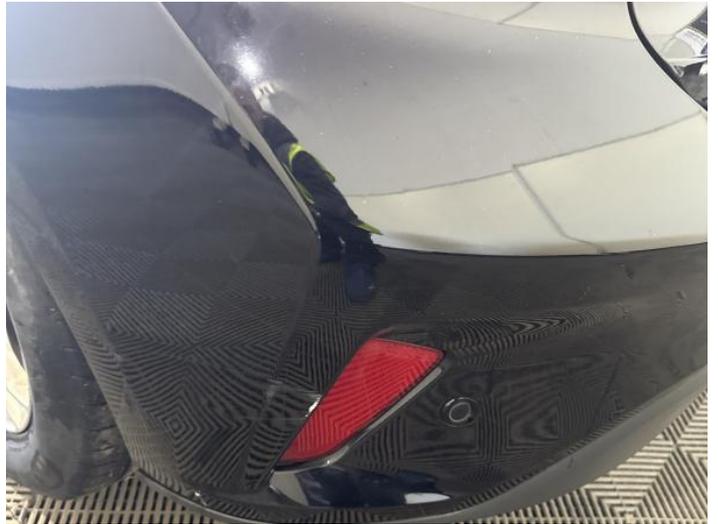
10: Bumper Rear
Scratched
25 to 100mm Thru Paint

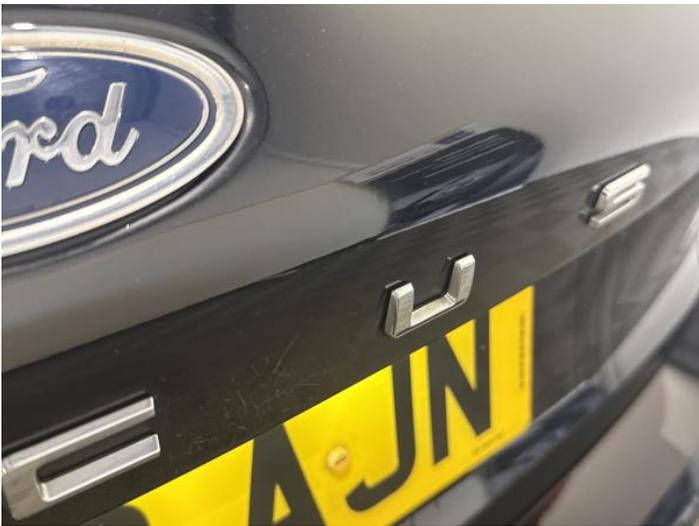
11: Tailgate
Scratched
UpTo 25mm Thru Paint

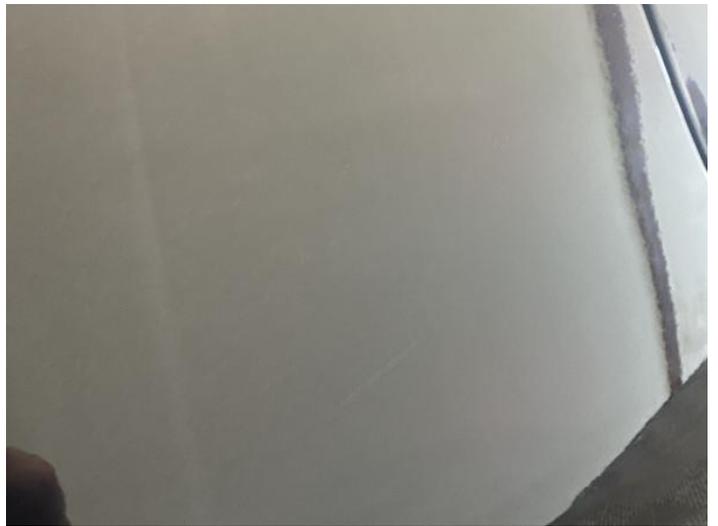
12: Qtr Panel osr
Scratched
UpTo 25mm Thru Paint

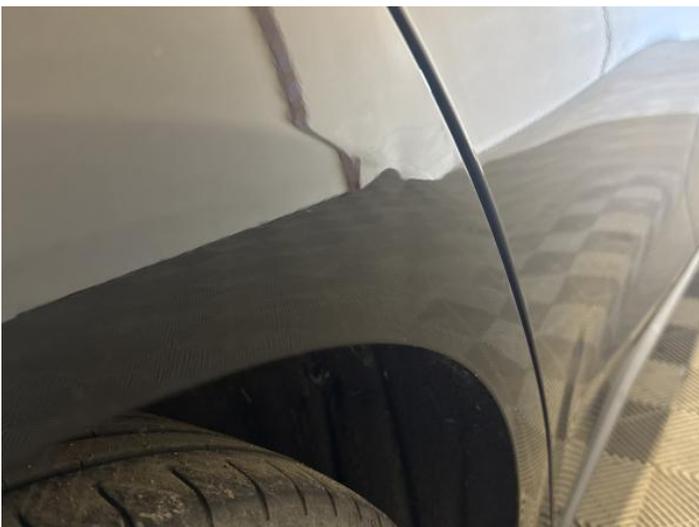
13: Qtr Panel osr
Dented
Over 30mm

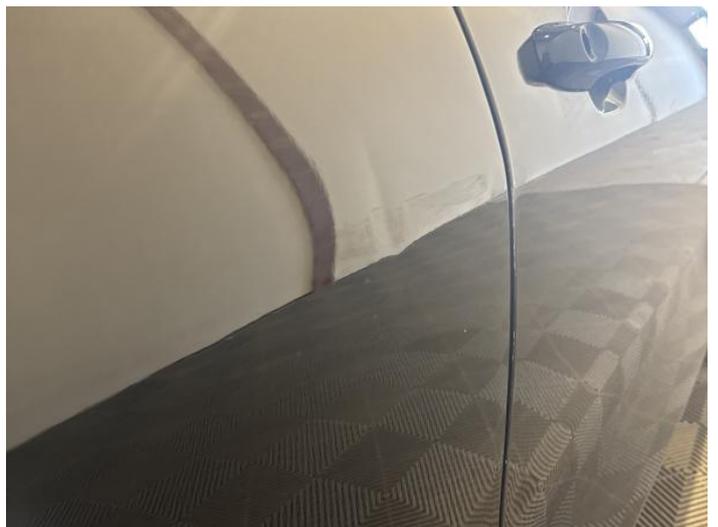
14: Door osr
Dented
Over 30mm

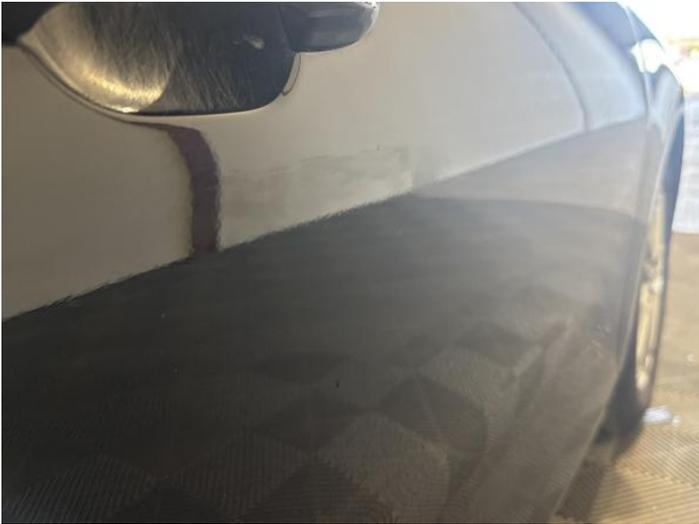
15: Door osf
Poor Previous Repair
Rippled UpTo 30%

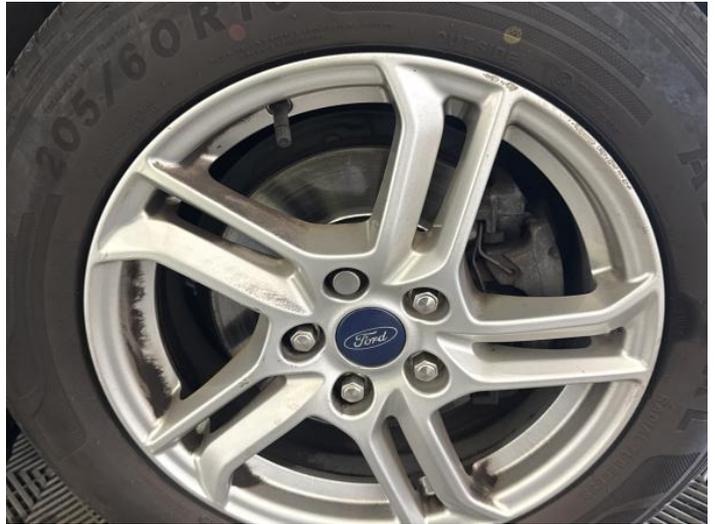
16: Wheel osf
Scratched
Over 50mm

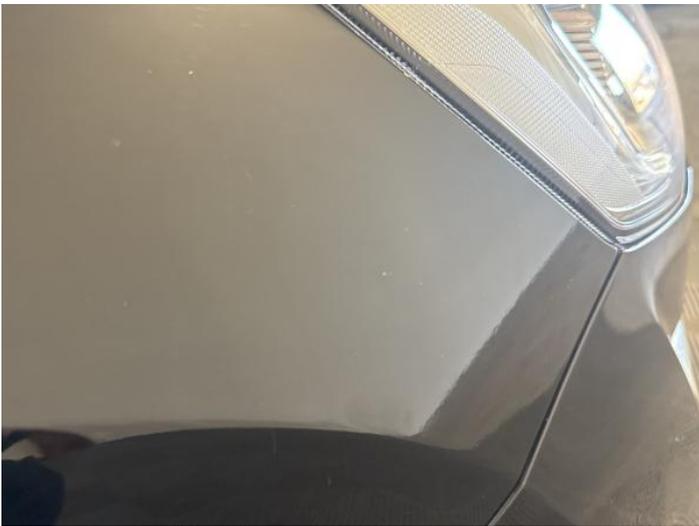
17: Wing osf
Chipped
1 To 5
