VEHICLE INSPECTION REPORT

GP16NZA

Kia Ceed 1.4 SR7 5dr

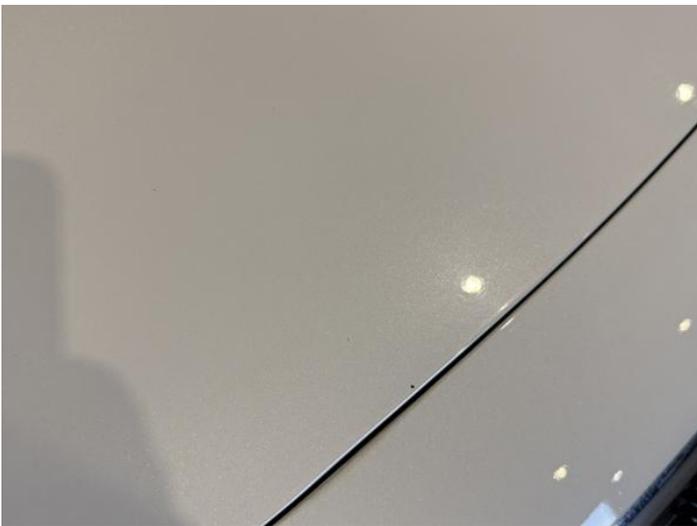
1: Bonnet
Chipped
1 To 5

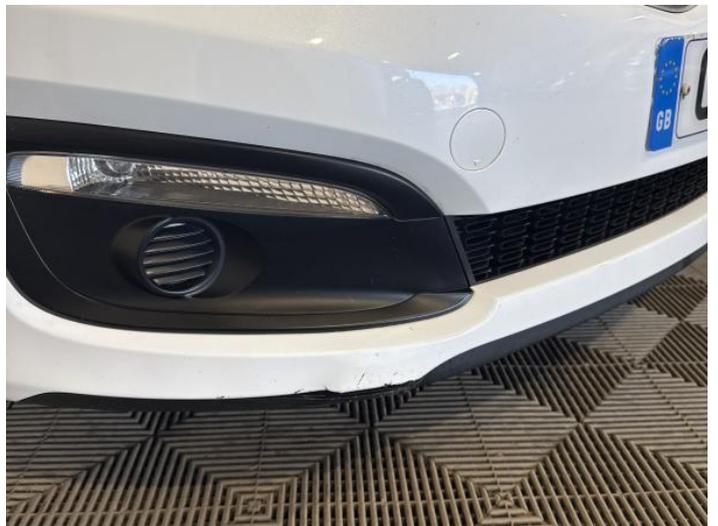
2: Bumper Front
Dented
With Paint Damage

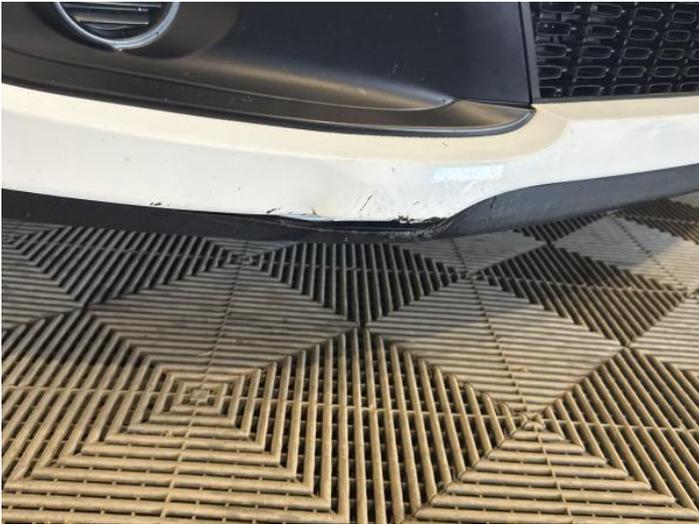
3: Bumper Front Moulding
Scuffed (Unpainted)
Over 100mm

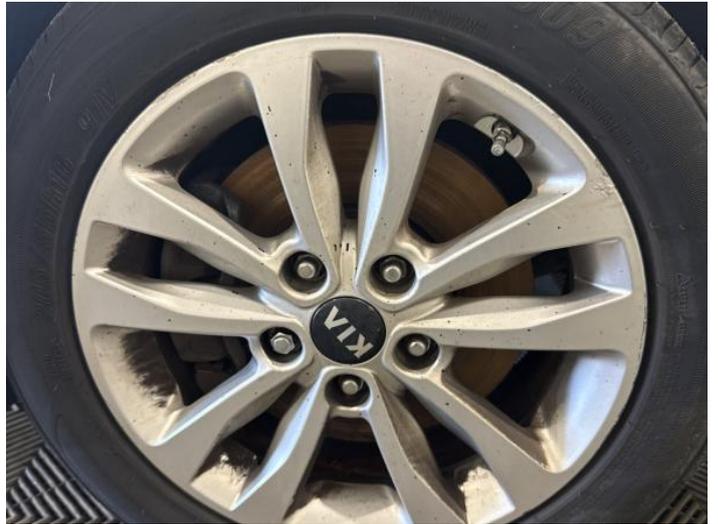
4: Wheel nsf
Scratched
Over 50mm

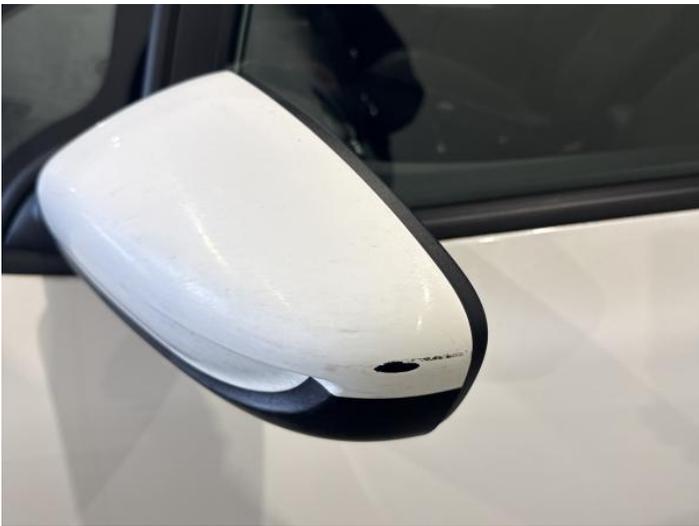
5: Door Mirror Assy nsf
Scratched (Painted)
UpTo 25mm Thru Paint

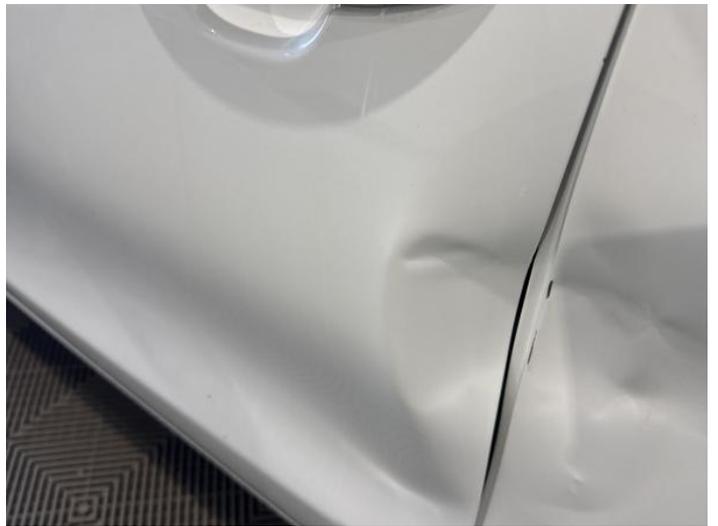
6: Door nsf
Dented
Over 30mm

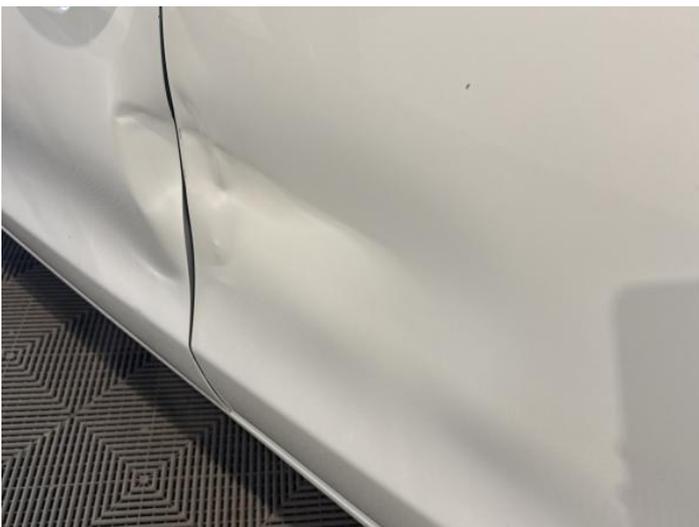
7: Door nsr
Dented
Over 30mm

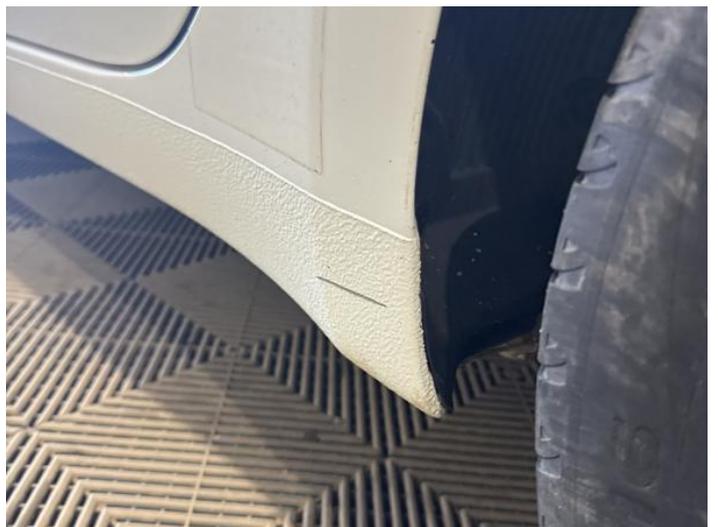
8: Sill ns
Scratched
Over 25mm Thru Paint

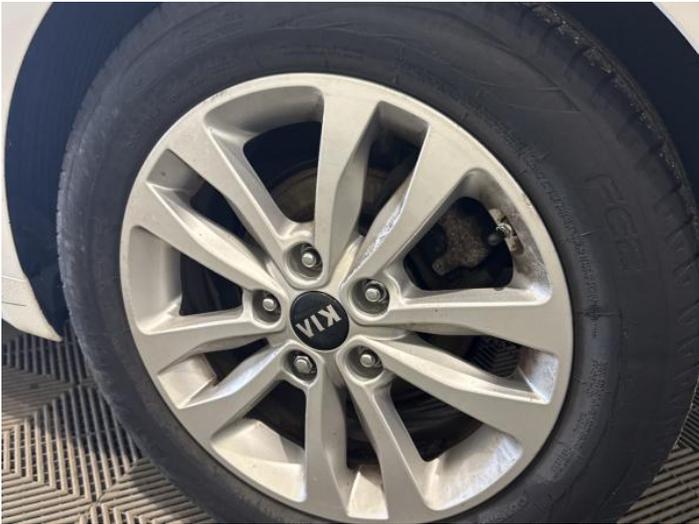
9: Wheel nsr
Scratched
Up To 50mm

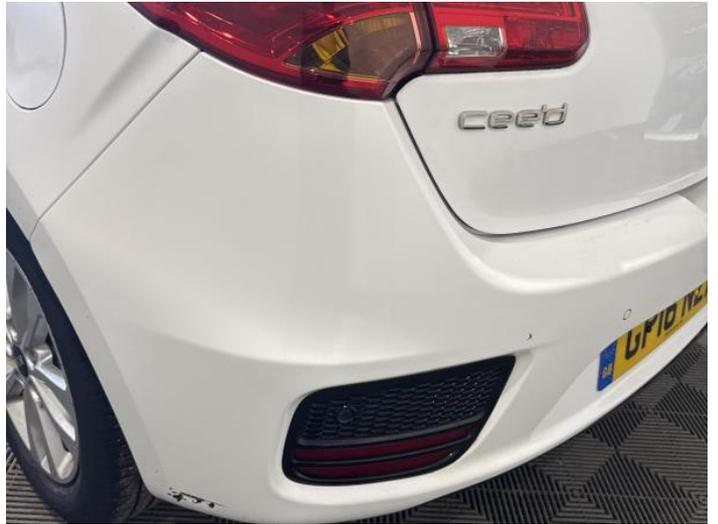
10: Bumper Rear
Scratched
Over 100mm Thru Paint

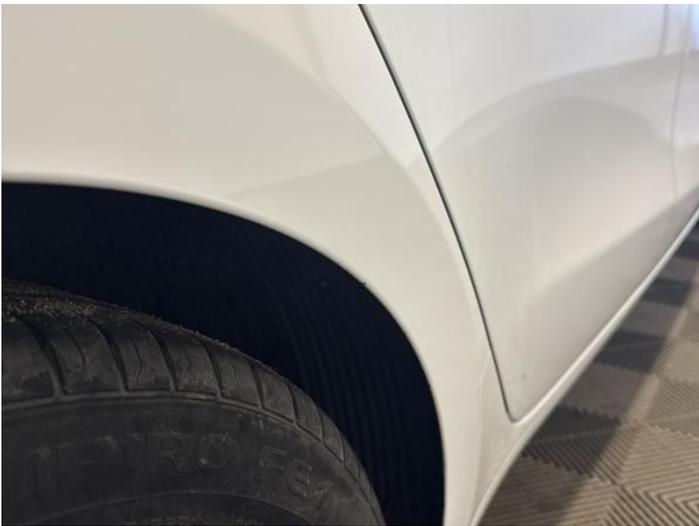
11: Qtr Panel osr
Chipped
Edge Chip

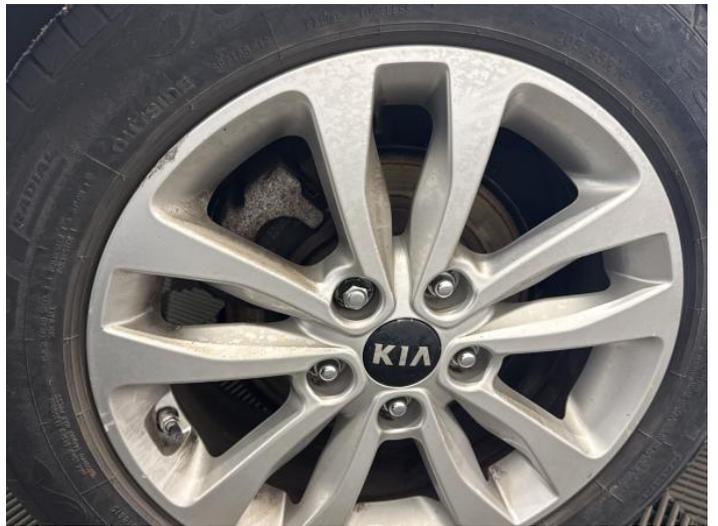
12: Wheel osr
Scratched
Over 50mm

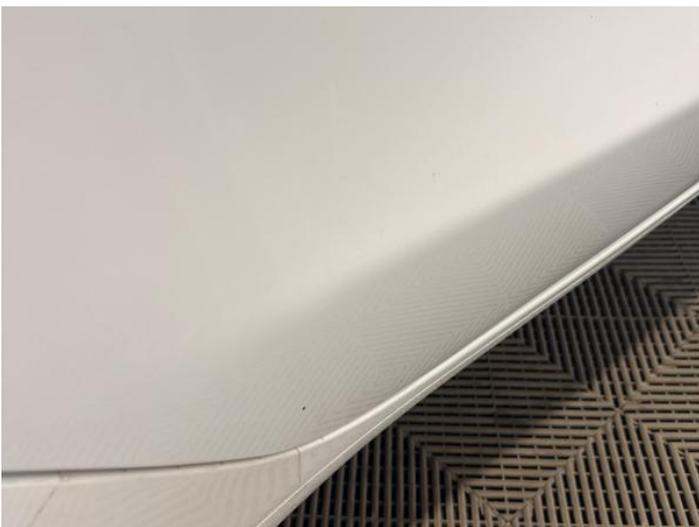
13: Door osr
Scratched
Up To 25mm Thru Paint

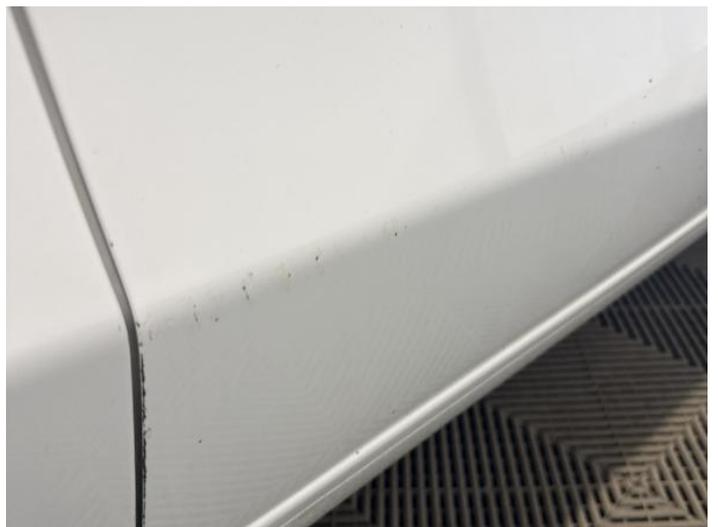
14: Door nsf
Scratched
Over 25mm Thru Paint

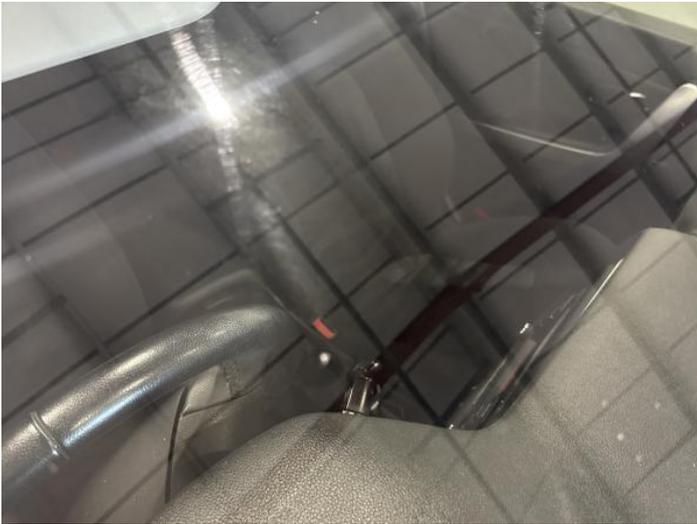
15: Screen Front
Chipped
UpTo 10mm

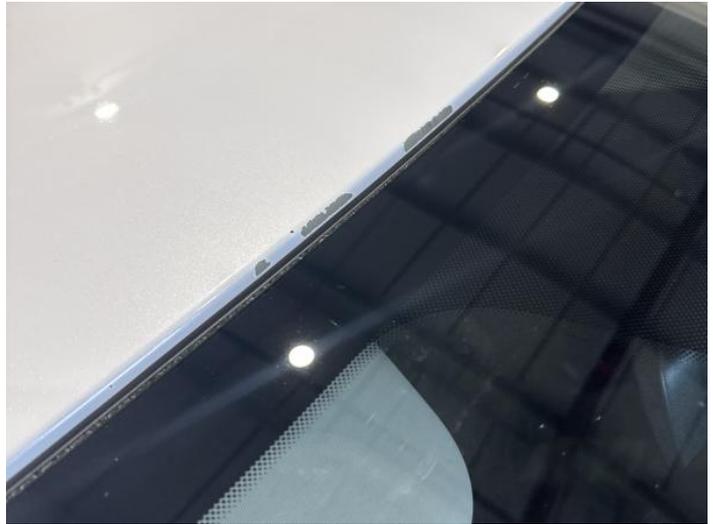
16: Roof
Scratched
Over 25mm Thru Paint
