VEHICLE INSPECTION REPORT

GY61VKW

Ford Focus 1.6 TDCi 115 Zetec 5dr

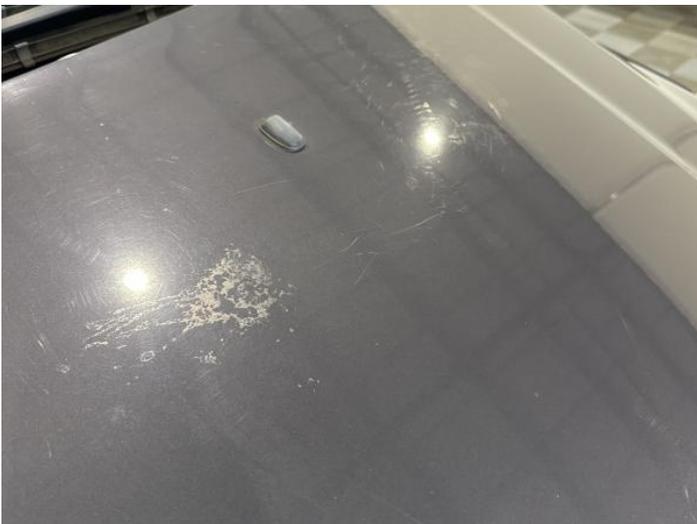
1: Bonnet
Scratched
Over 25mm Thru Paint

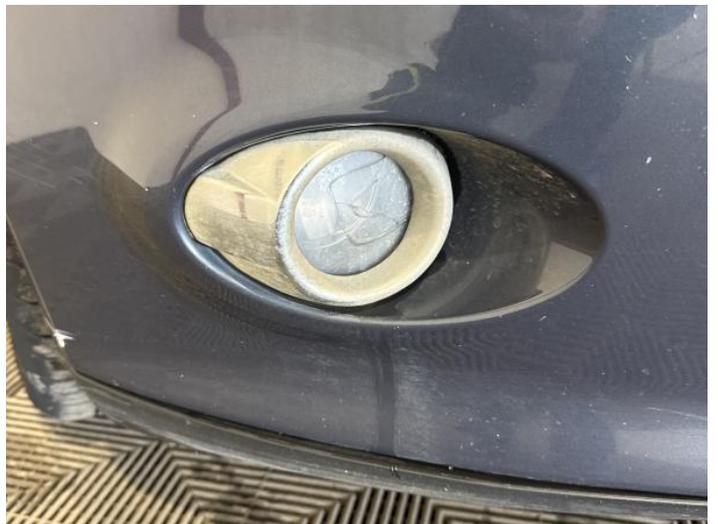
2: Fogdriving Lamp osf
Broken
Replace

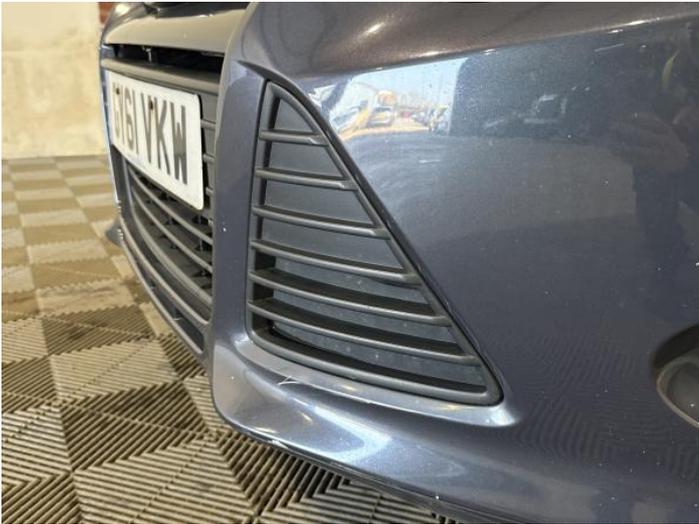
3: Bumper Front
Scratched
Over 100mm Thru Paint

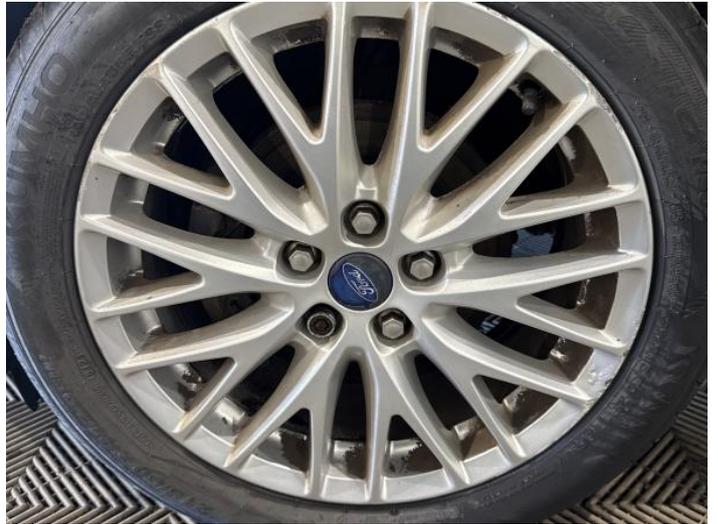
4: Wheel nsf
Scratched
Over 50mm

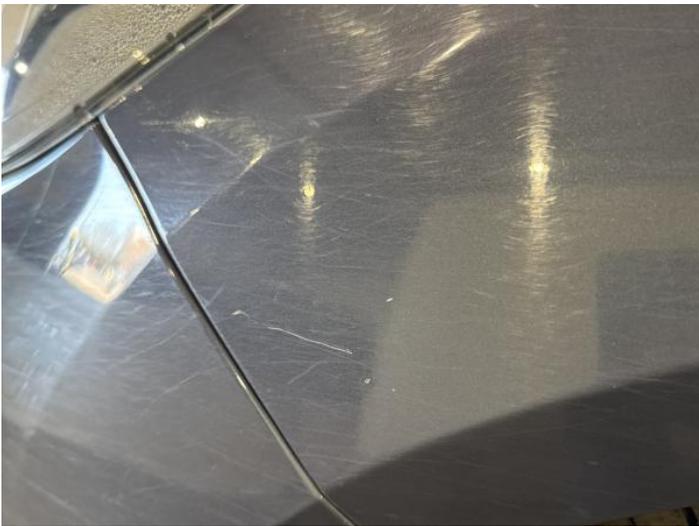
5: Wing nsf
Scratched
Over 25mm Thru Paint

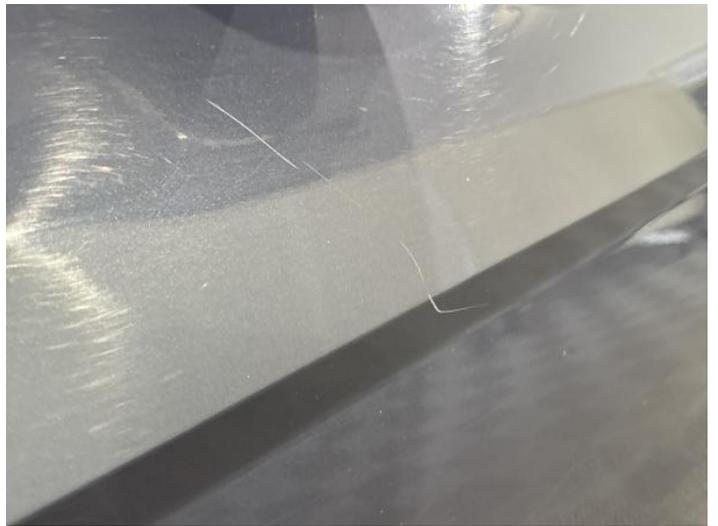
6: Door nsf
Scratched
Over 25mm Thru Paint

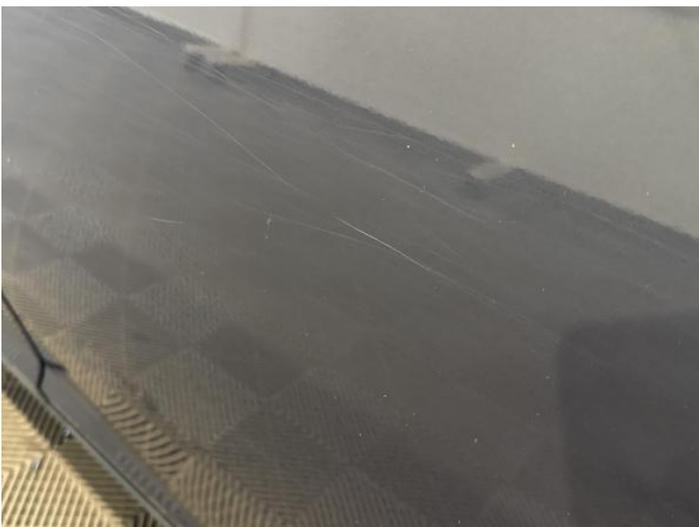
7: Door nsr
Scratched
Over 25mm Thru Paint

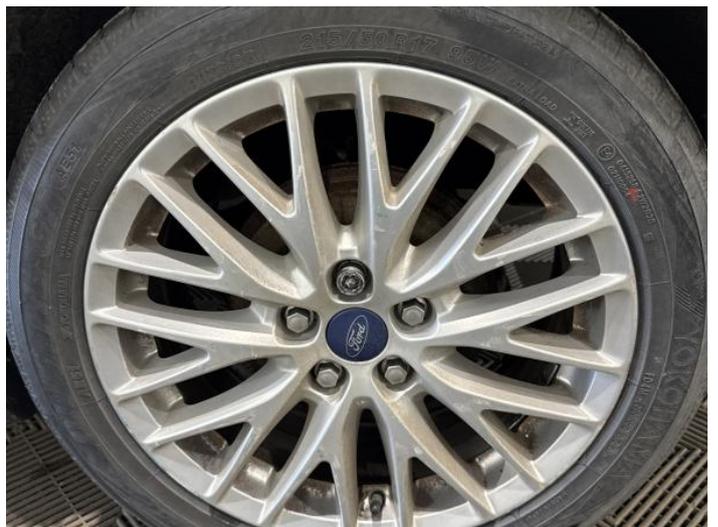
8: Wheel nsr
Scratched
Over 50mm

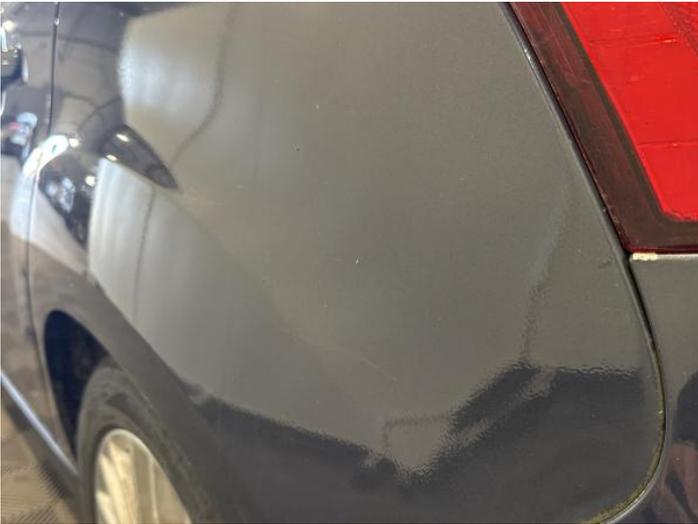
9: Qtr Panel nsr
Poor Previous Repair
Poor Paint

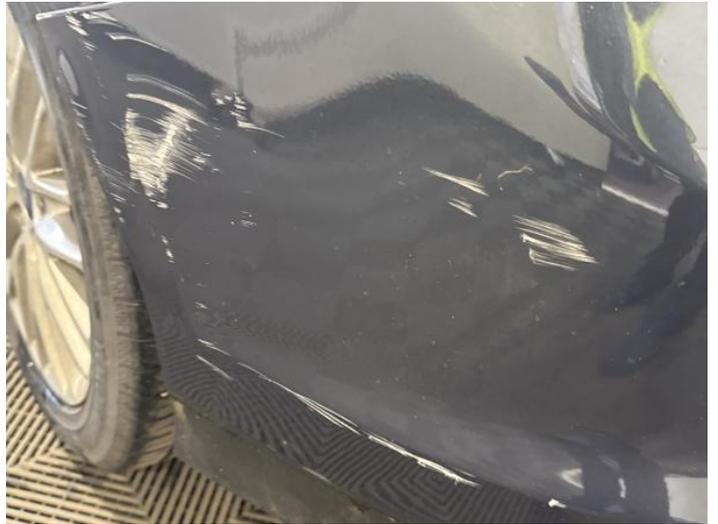
10: Bumper Rear
Dented
With Paint Damage

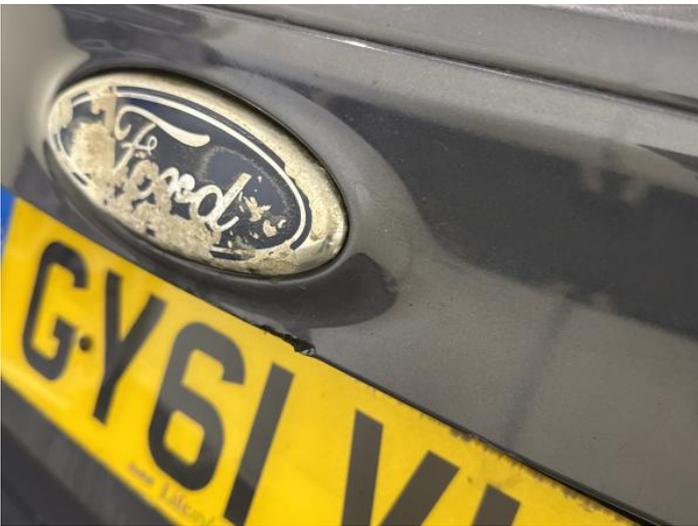
11: Tailgate
Dented
With Paint Damage

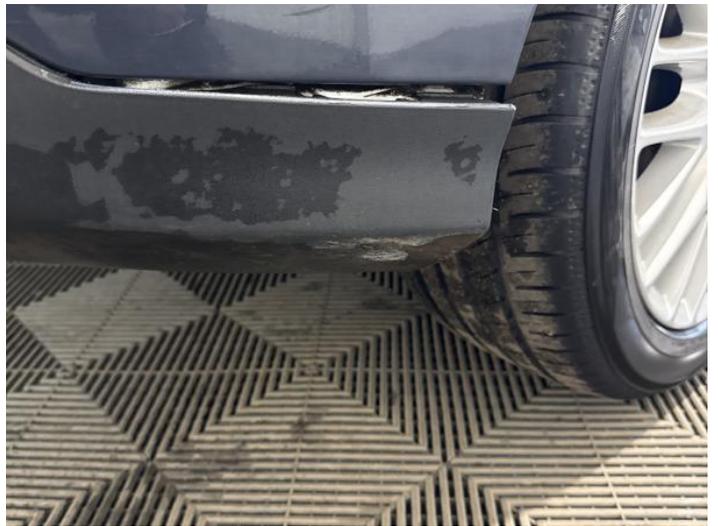
12: Bumper Rear Moulding
Broken
Replace

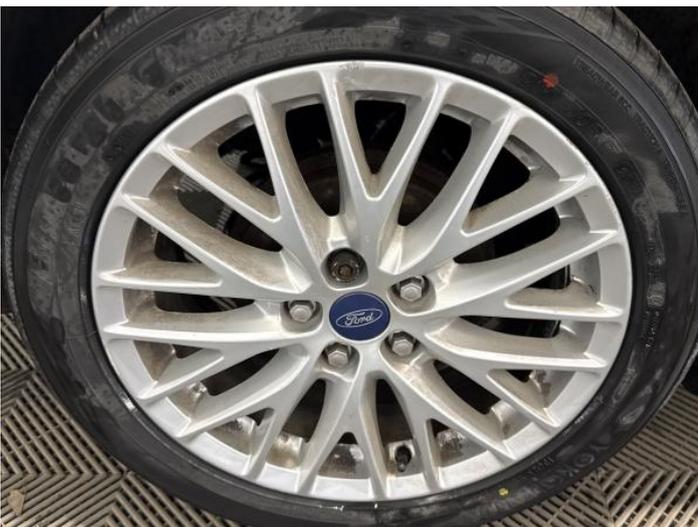
13: Wheel osr
Scratched
Over 50mm

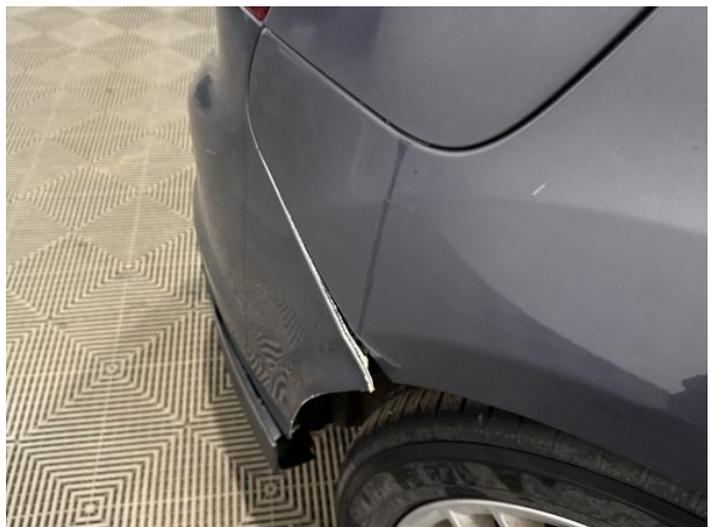
14: Bumper Rear
Insecure
Action Required

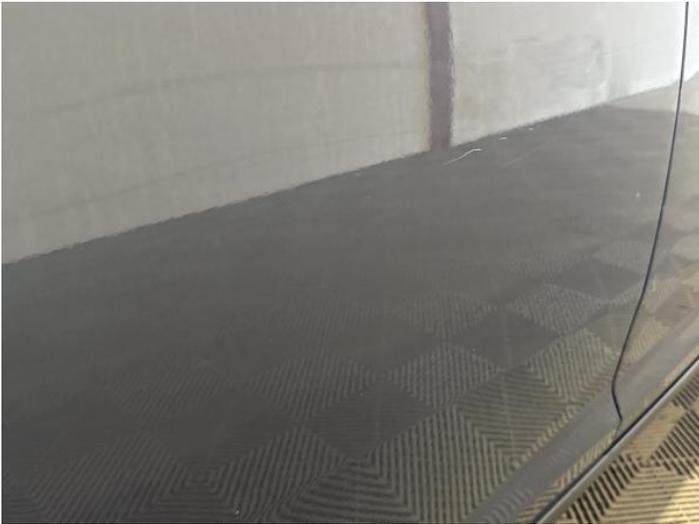
15: Door osr
Scratched
Over 25mm Thru Paint

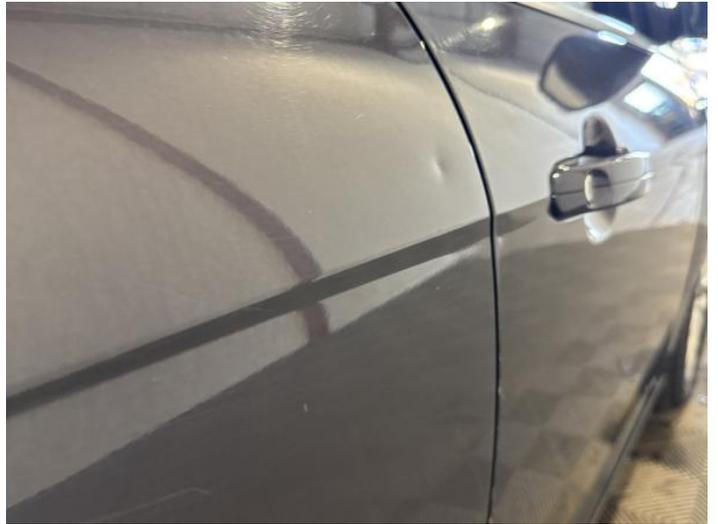
16: Door osr
Dented
Between 10mm + 30mm

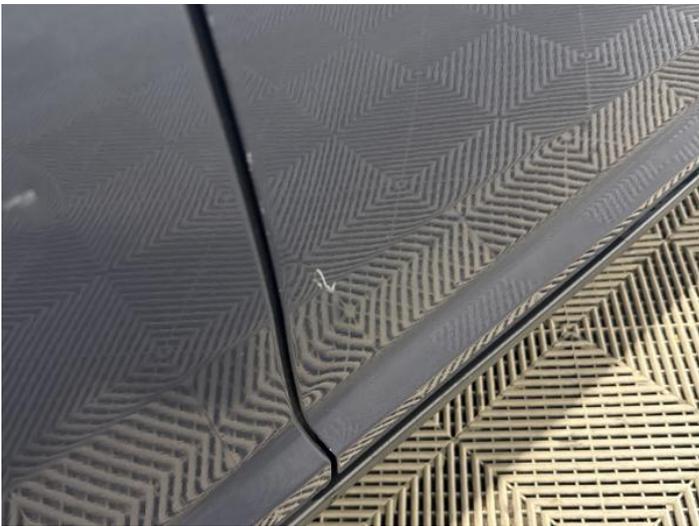
17: Door osf
Scratched
UpTo 25mm Thru Paint

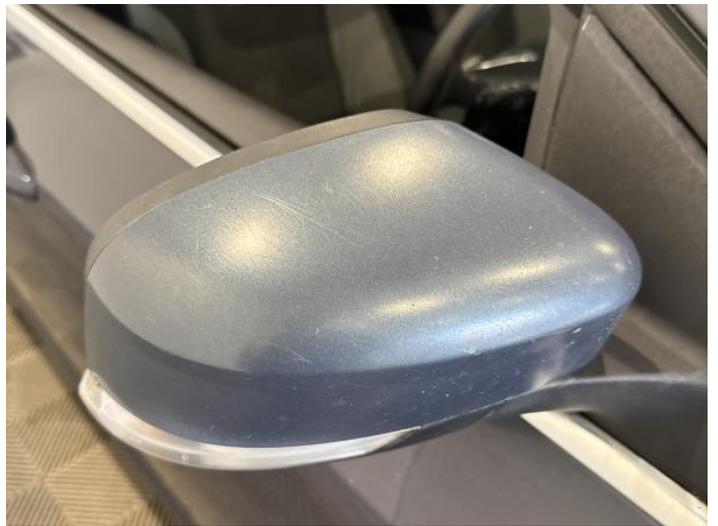
18: Door Mirror Assy osf
Scratched (Painted)
Over 25mm Thru Paint

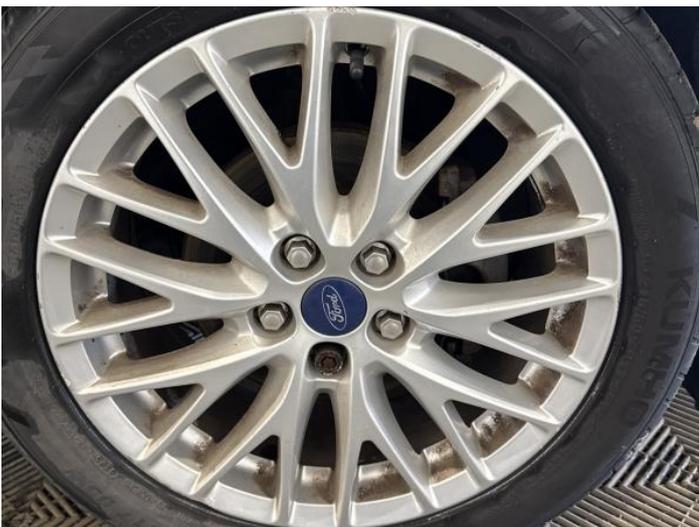
19: Wheel osf
Scratched
Over 50mm

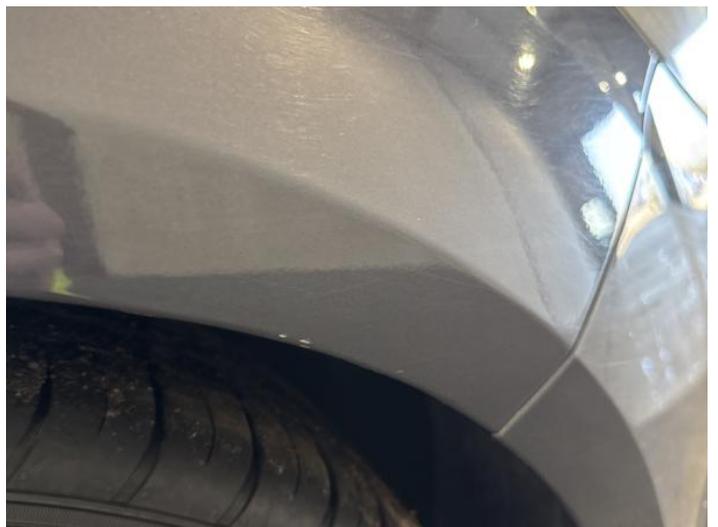
20: Wing osf
Chipped
1 To 5

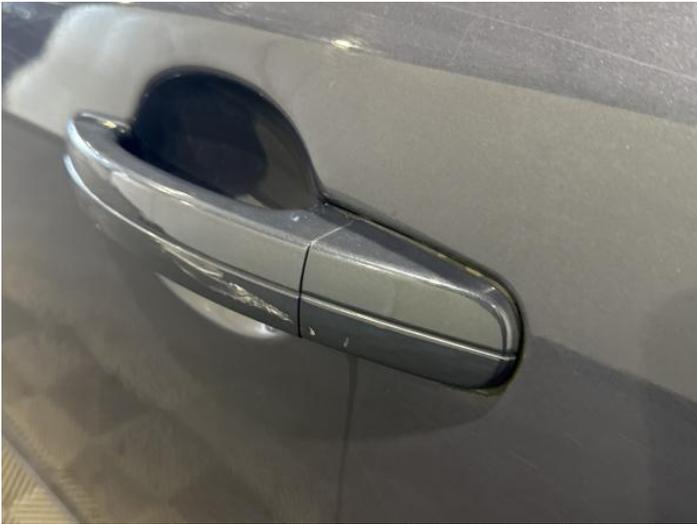
21: Handle Outer nsr
 Scratched (Painted)
 Over 25mm Thru Paint
