VEHICLE INSPECTION REPORT

GY70UAF

MG Mg 5 EXCLUSIVE

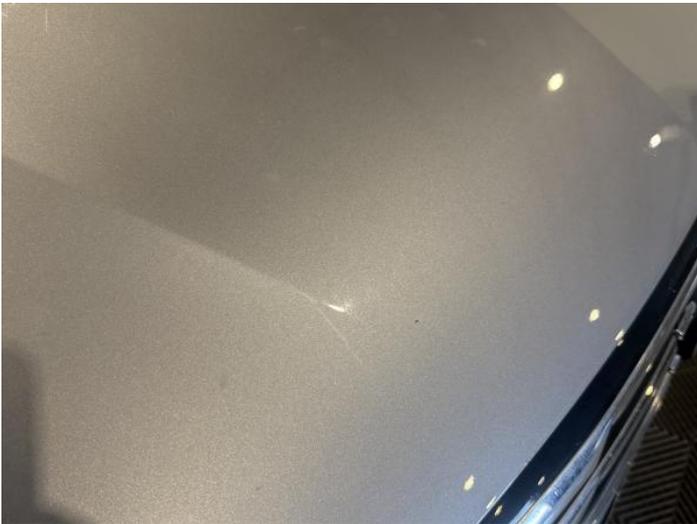
1: Bonnet
Chipped
1 To 5

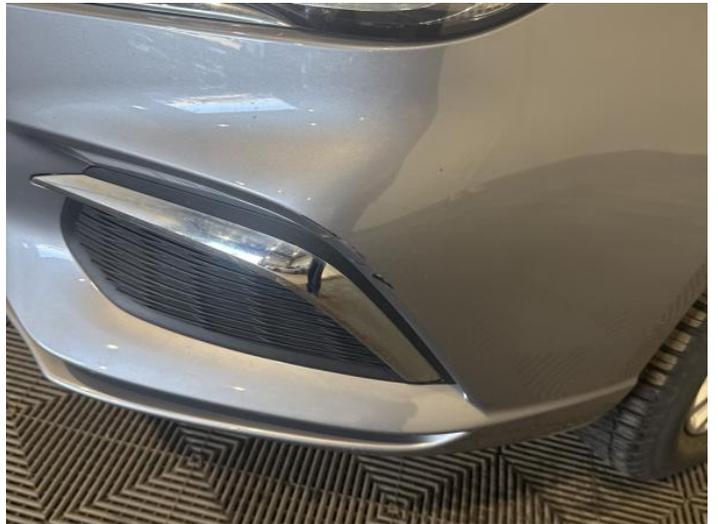
2: Bumper Front
Scratched
25 to 100mm Thru Paint

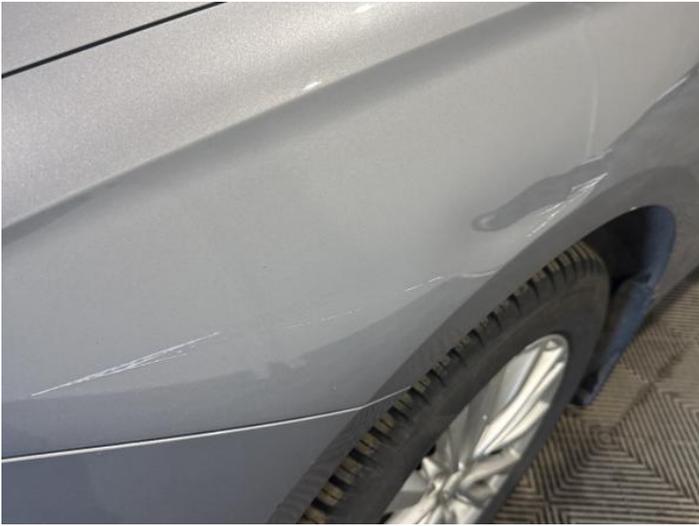
3: Wing nsf
Dented
With Paint Damage

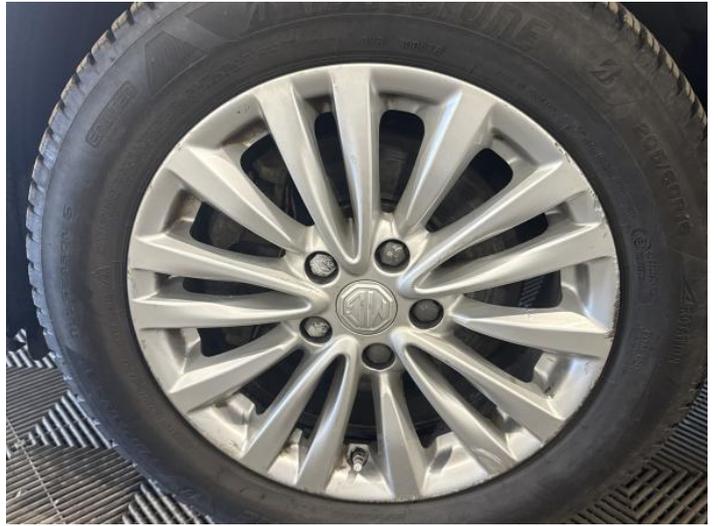
4: Wheel nsf
Scratched
Over 50mm

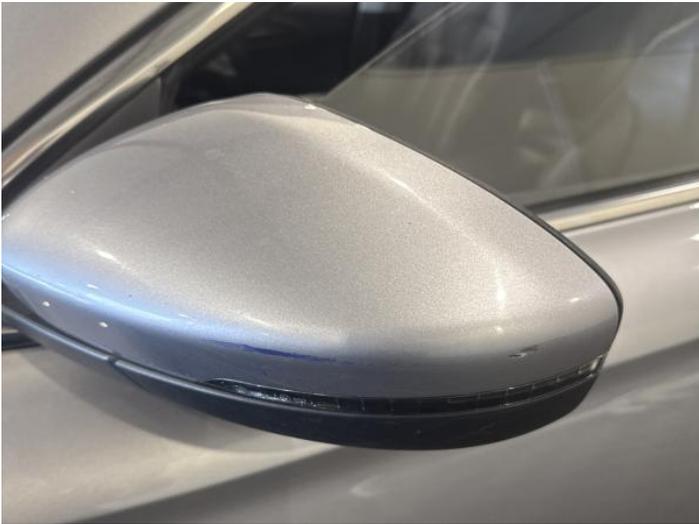
5: Door Mirror Assy nsf
Scratched (Painted)
UpTo 25mm Thru Paint

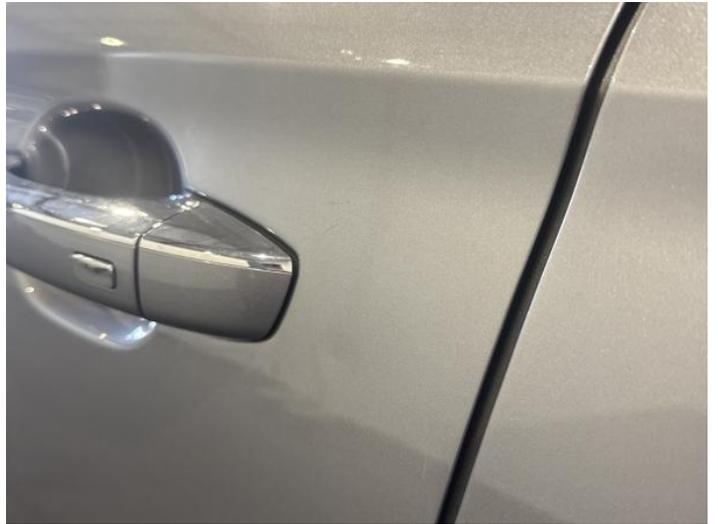
6: Door nsf
Dented
Between 10mm + 30mm

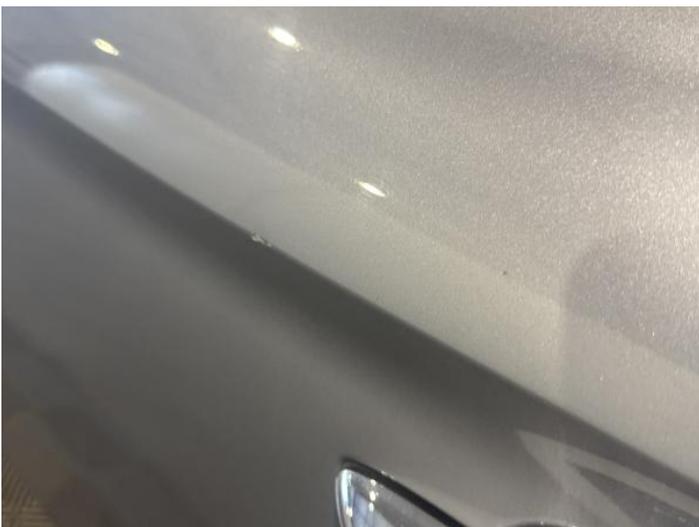
7: Door nsr
Dented
Between 10mm + 30mm

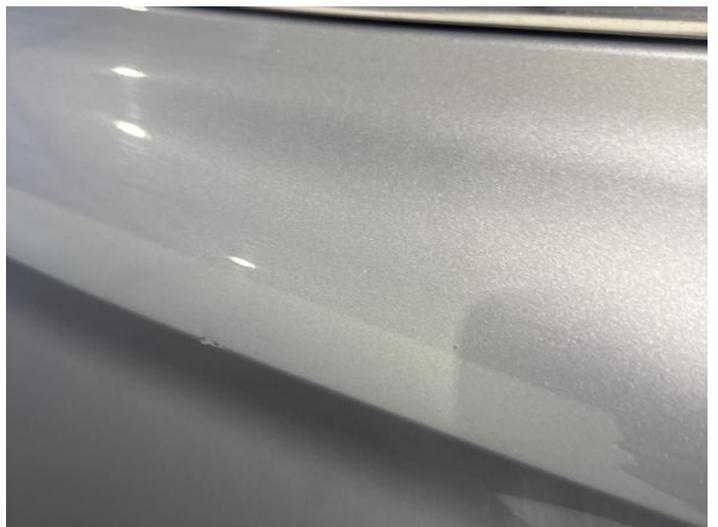
8: Door nsr
Scratched
UpTo 25mm Thru Paint

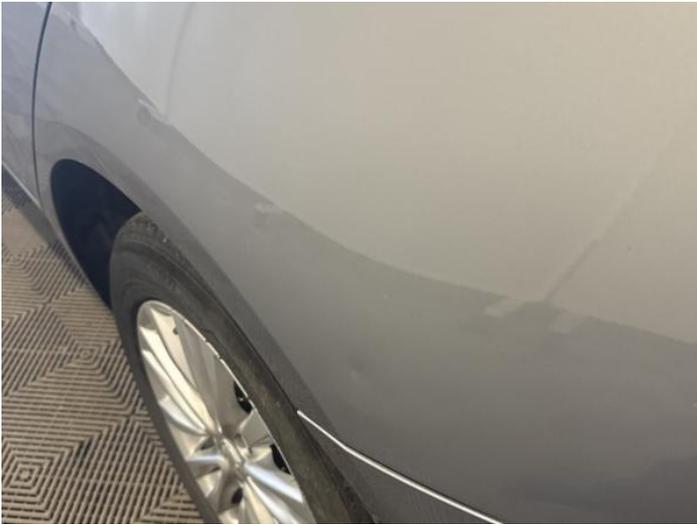
9: Qtr Panel nsr
Dented
Over 30mm

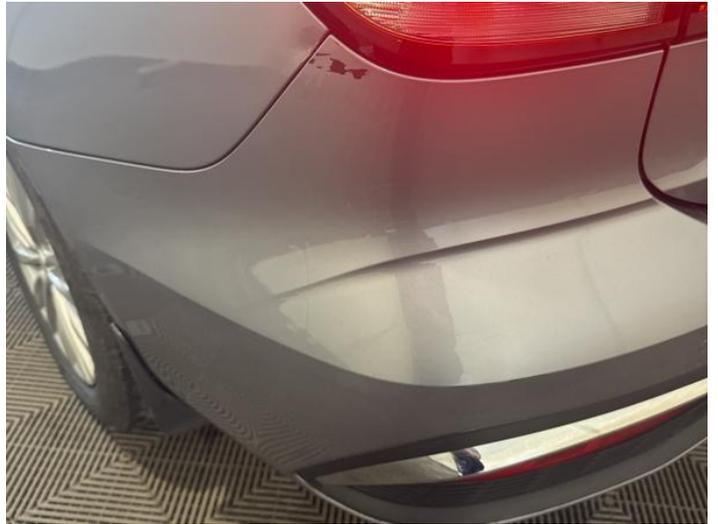
10: Bumper Rear
Scratched
25 to 100mm Thru Paint

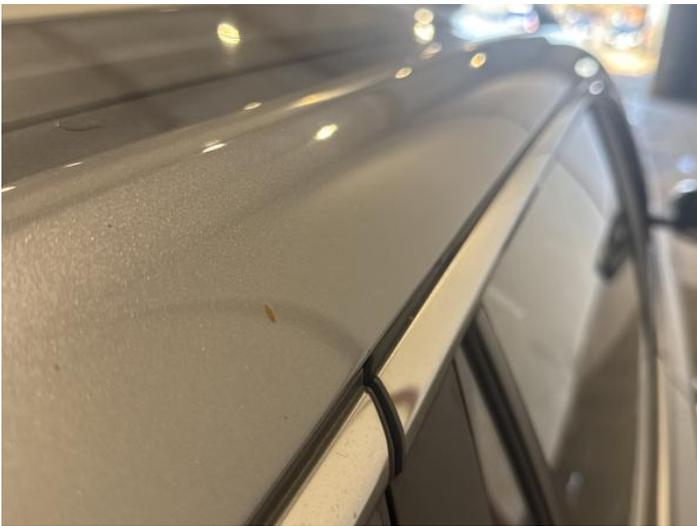
11: B Post os
Poor Previous Repair
Rippled UpTo 30%

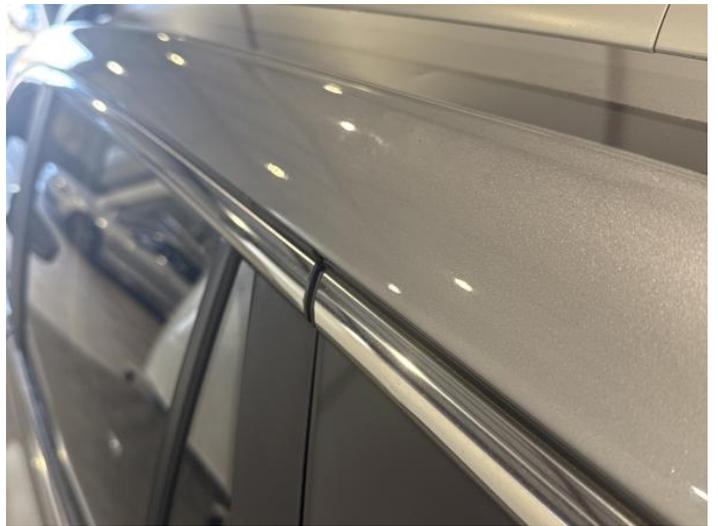
12: B Post ns
Dented
Over 30mm

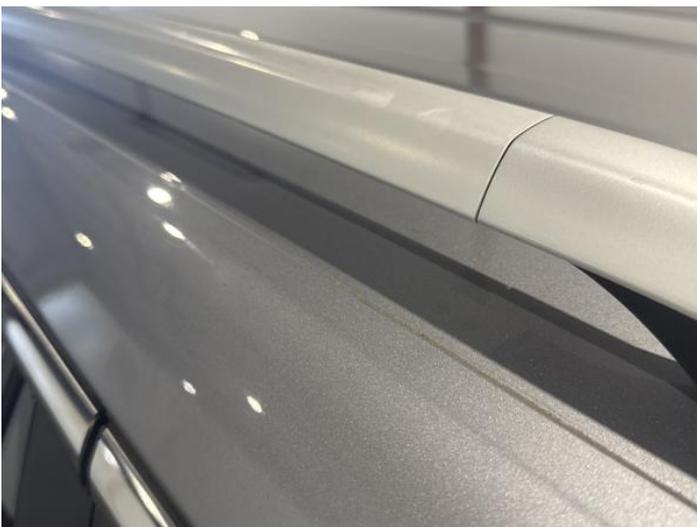
13: Roof
Dented
Over 30mm

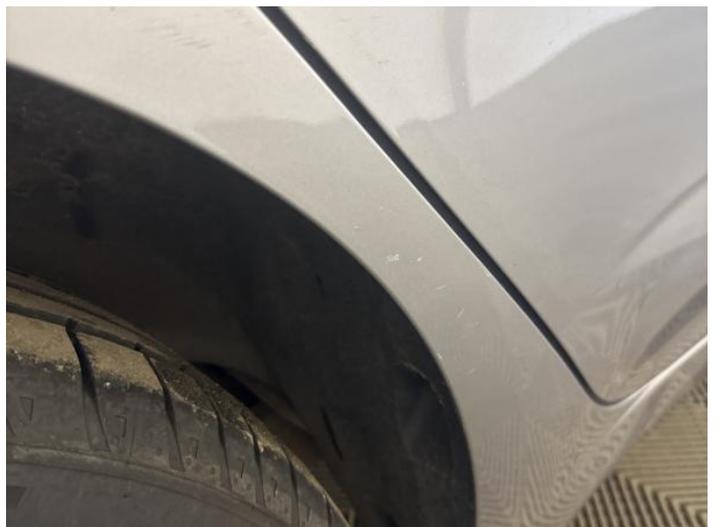
14: Qtr Panel osr
Scratched
UpTo 25mm Thru Paint

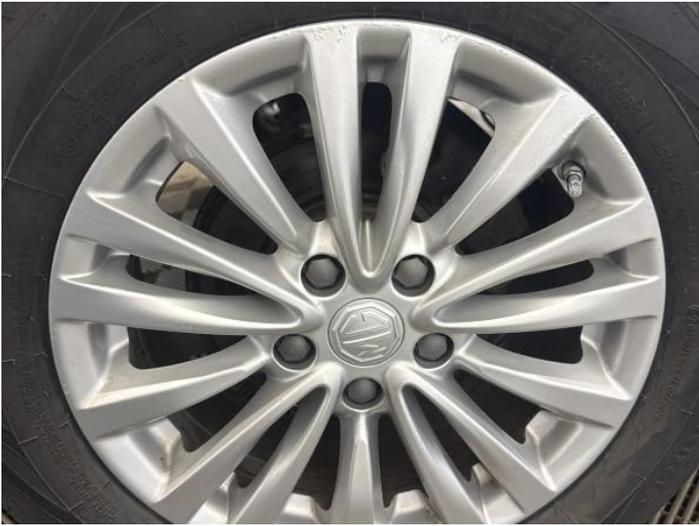
15: Wheel osr
Corroded
Light

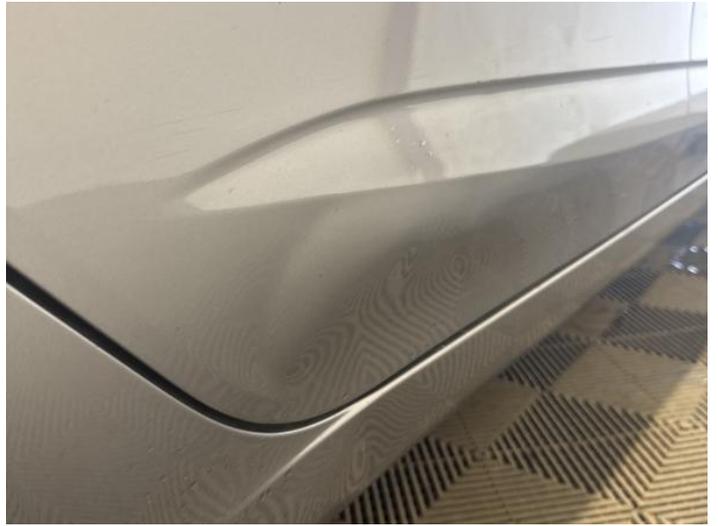
16: Door osr
Dented
Over 30mm

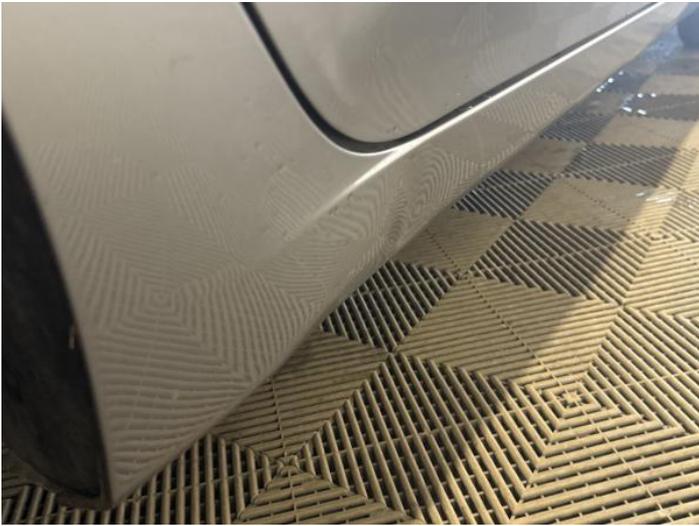
17: Sill os
Dented
Over 30mm

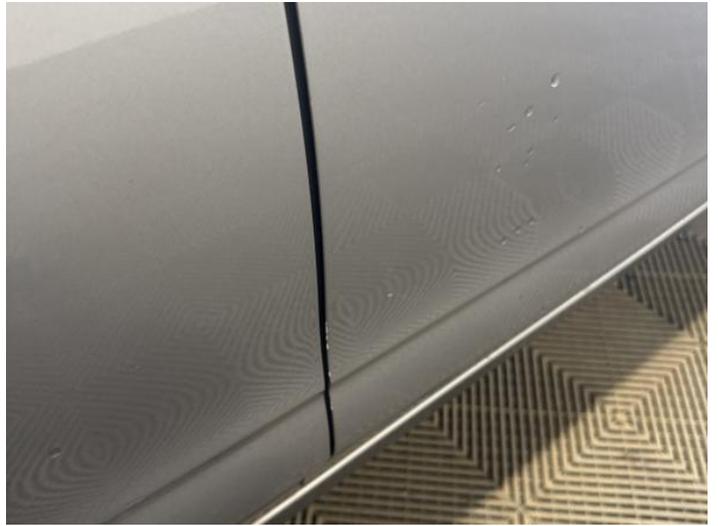
18: Door osf
Chipped
Edge Chip

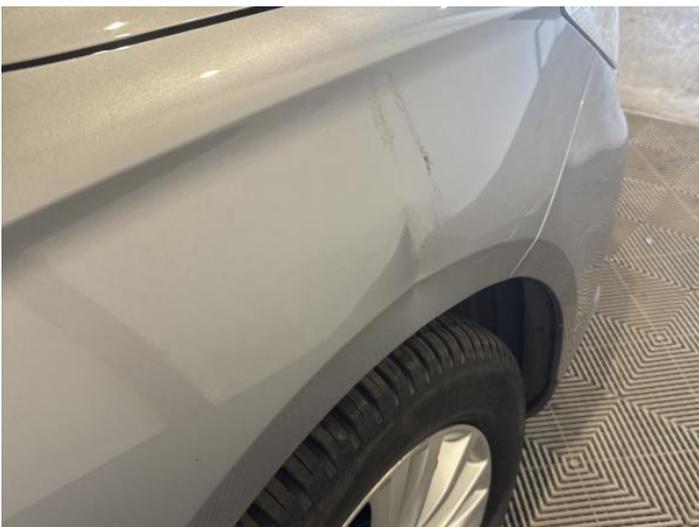
19: Wing osf
Dented
With Paint Damage

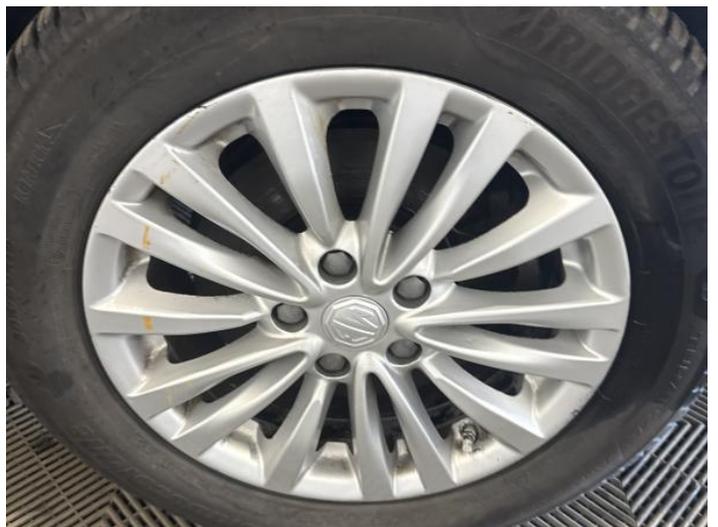
20: Wheel osf
Scratched
Over 50mm
