# VEHICLE INSPECTION REPORT

**GY71PXS**

## Seat Ibiza 1.0 TSI 95 Xcellence 5dr

nama  
GRADE  
**4**

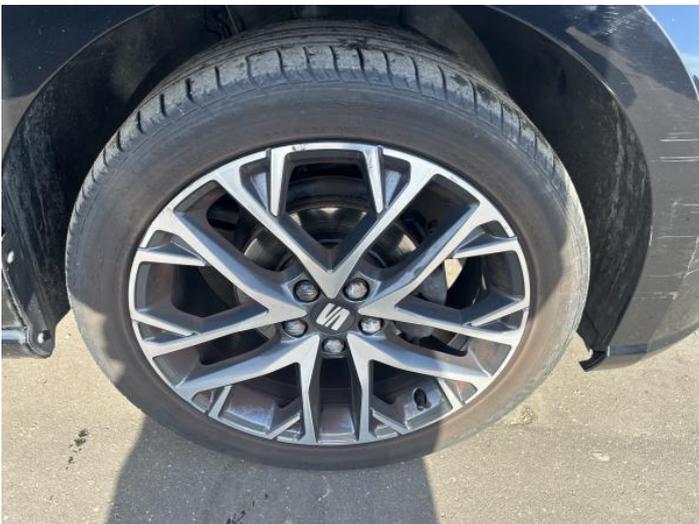
1: Wheel osf  
Scratched  
Over 50mm

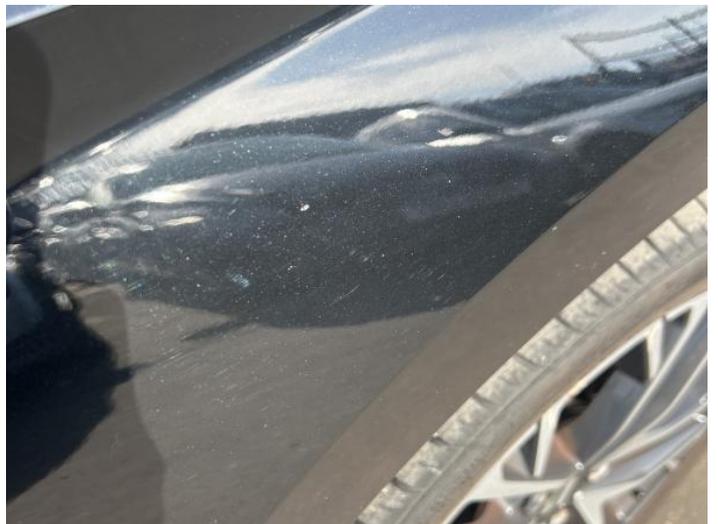
2: Wing osf  
Chipped  
1 To 5

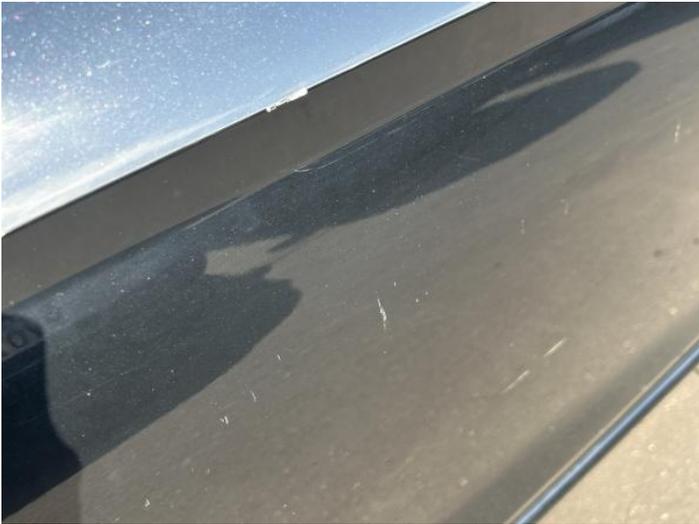
3: Door osf  
Scratched  
Over 25mm Thru Paint

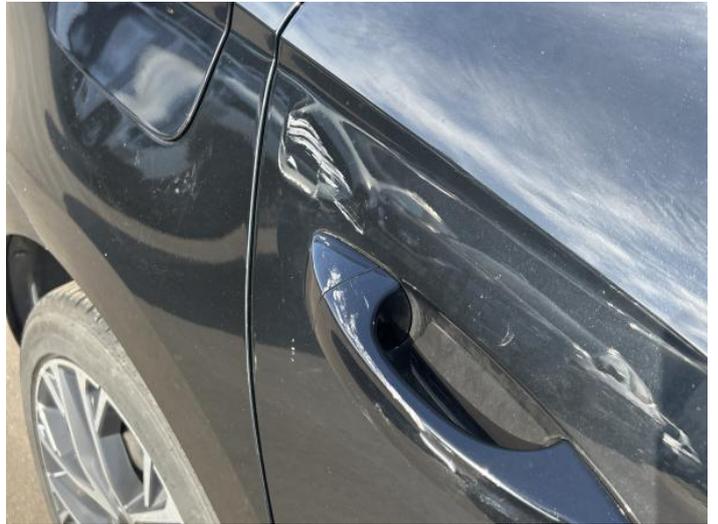
4: Door osr  
Dented  
With Paint Damage

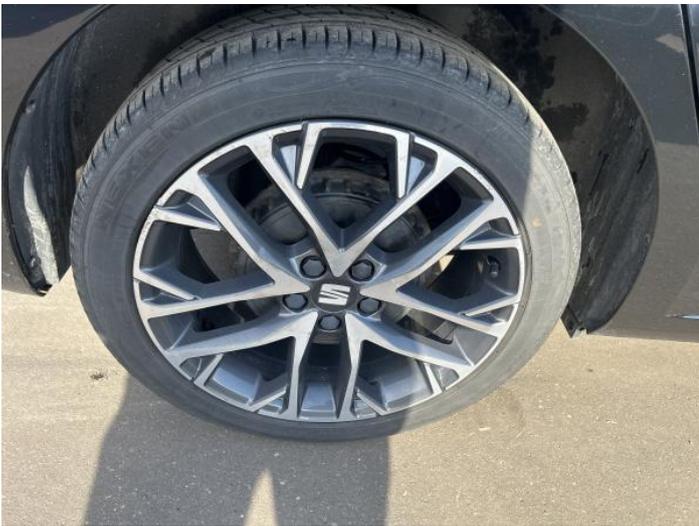
5: Wheel osr  
Scratched  
Over 50mm

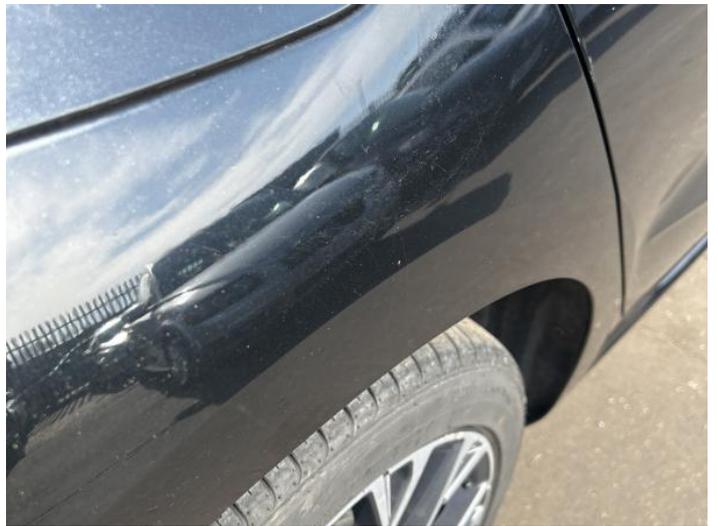
6: Qtr Panel osr  
Scratched  
Over 25mm Not Thru Paint

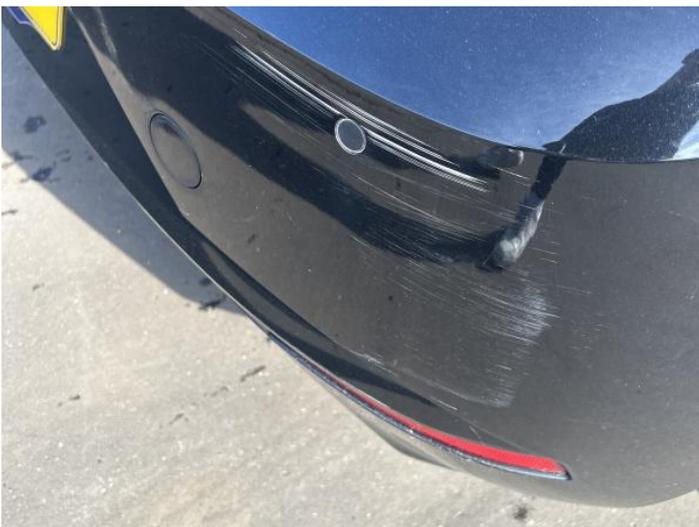
7: Bumper Rear  
Scratched  
Over 100mm Thru Paint

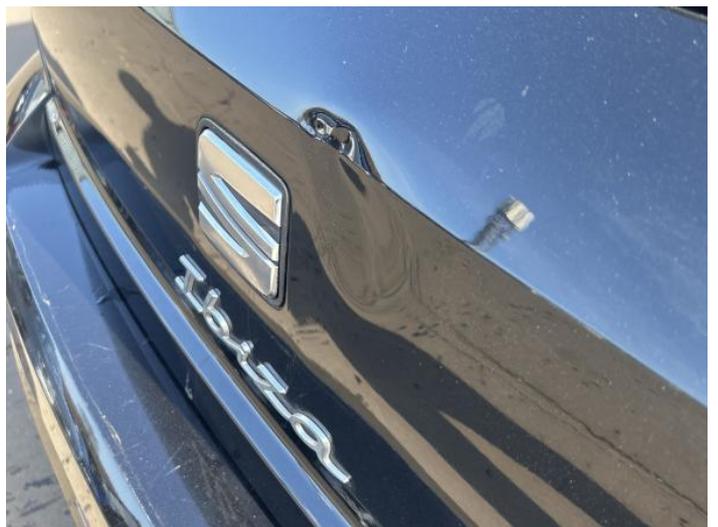
8: Tailgate  
Dented  
Over 30mm

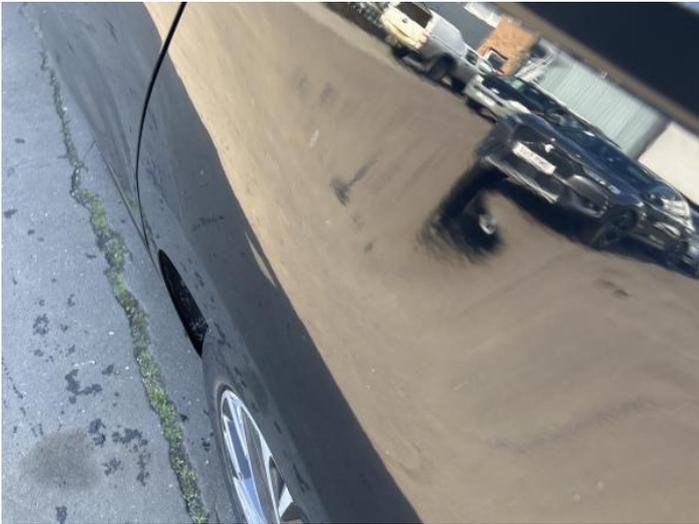
9: Qtr Panel nsr  
Dented  
Over 2 UpTo 10mm

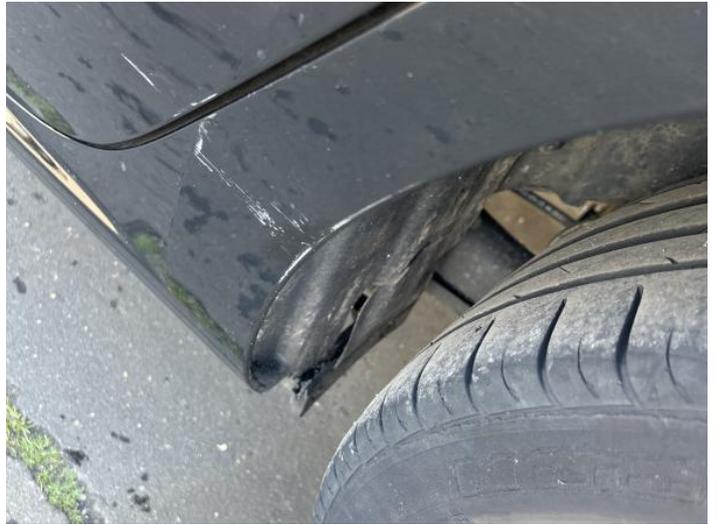
10: Qtr Panel nsr  
Scratched  
Over 25mm Not Thru Paint

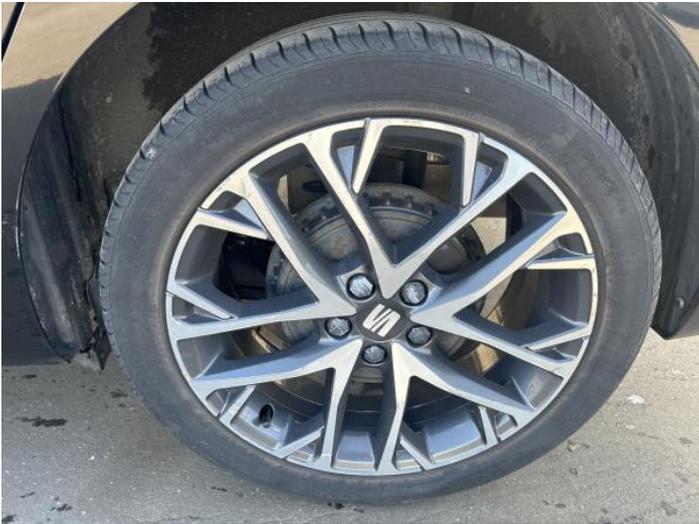
11: Wheel nsr  
Scratched  
Over 50mm

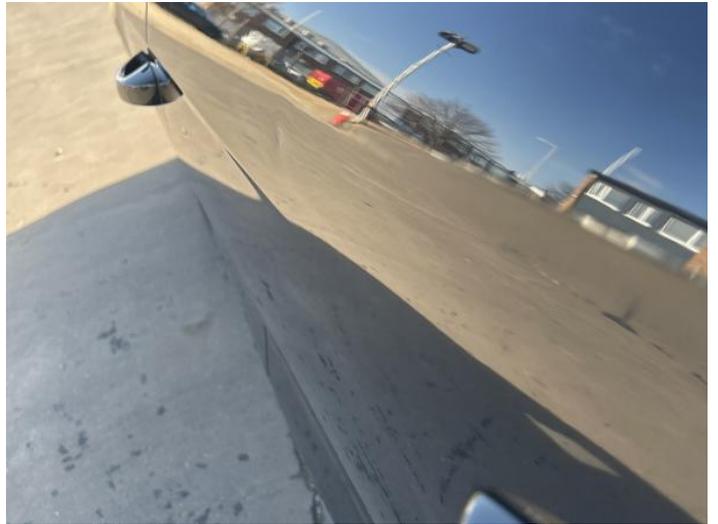
12: Door nsr  
Dented  
2 Or Less UpTo 10mm

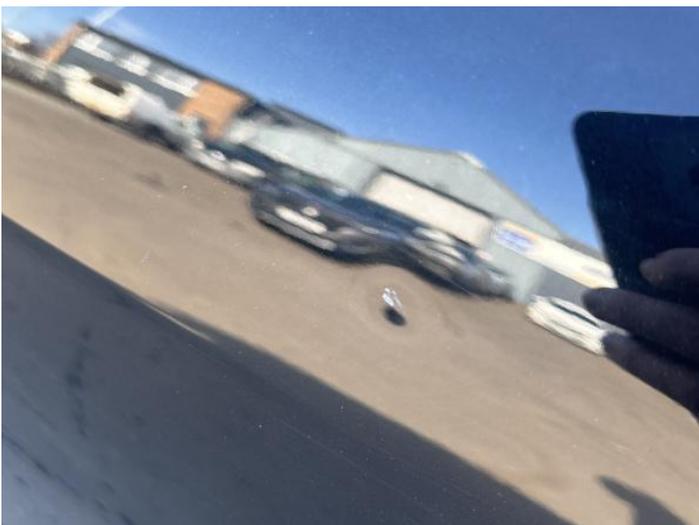
13: Door nsr  
Chipped  
1 To 5

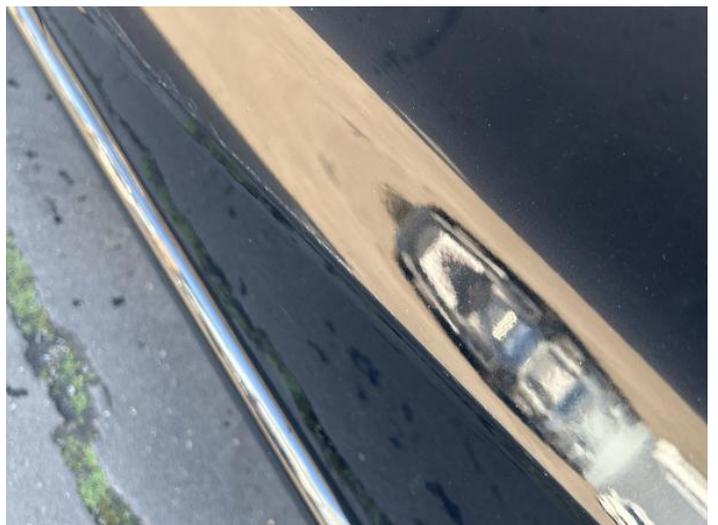
14: Door nsr  
Scratched  
Over 25mm Not Thru Paint

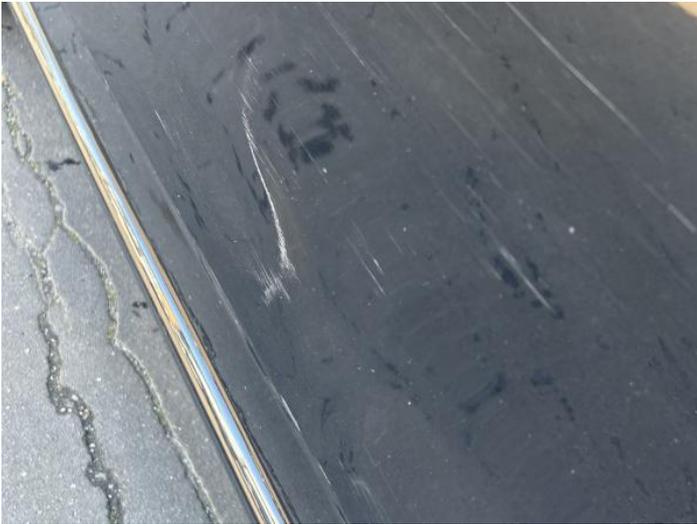
15: Door nsf  
Dented  
With Paint Damage

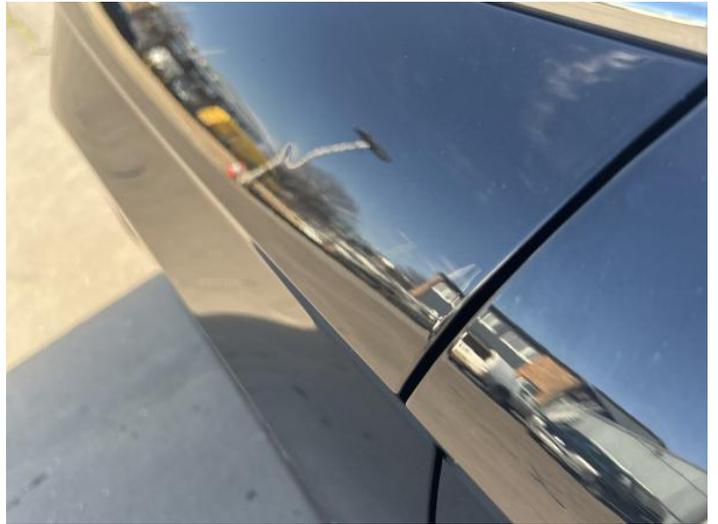
16: Wing nsf  
Dented  
2 Or Less Up To 10mm

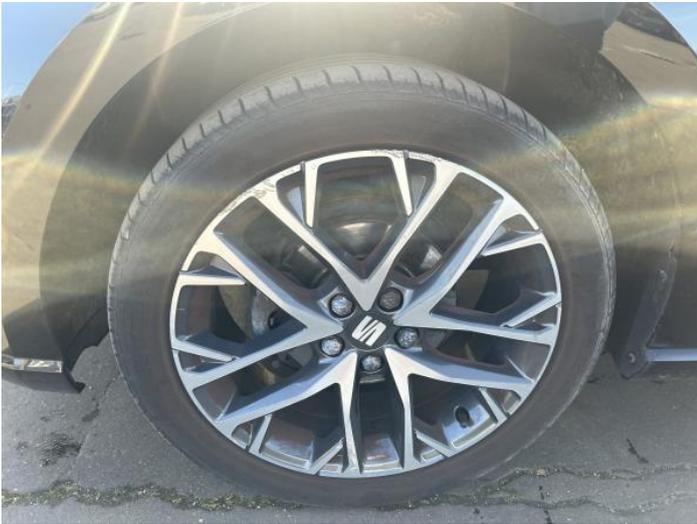
17: Wheel nsf  
Scratched  
Over 50mm

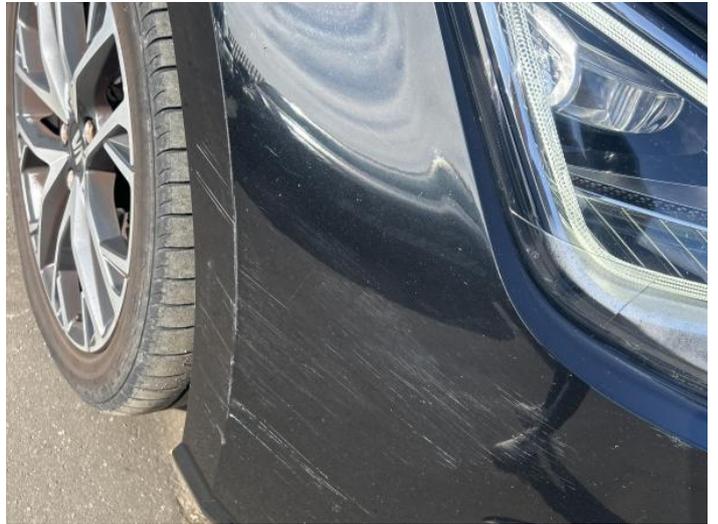
18: Bumper Front  
Scratched  
Over 100mm Thru Paint

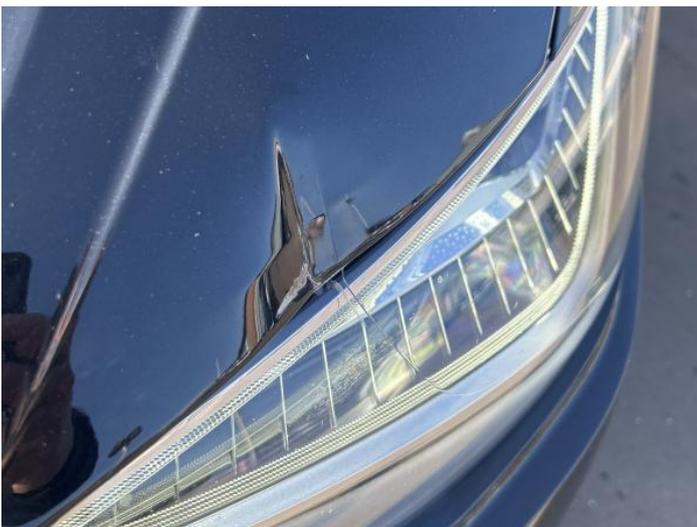
19: Bonnet  
Dented  
With Paint Damage
