VEHICLE INSPECTION REPORT

GU64XWG

Peugeot 3008 1.6 HDi Allure 5dr

nama
 GRADE
3

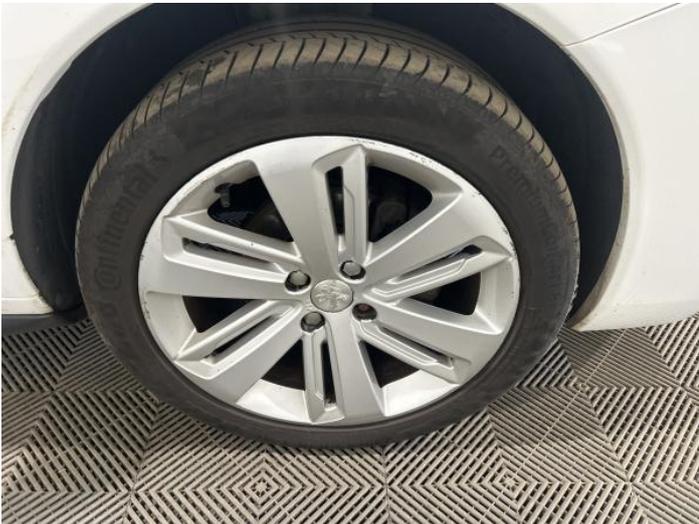
1: Wheel of
Scratched
Over 50mm

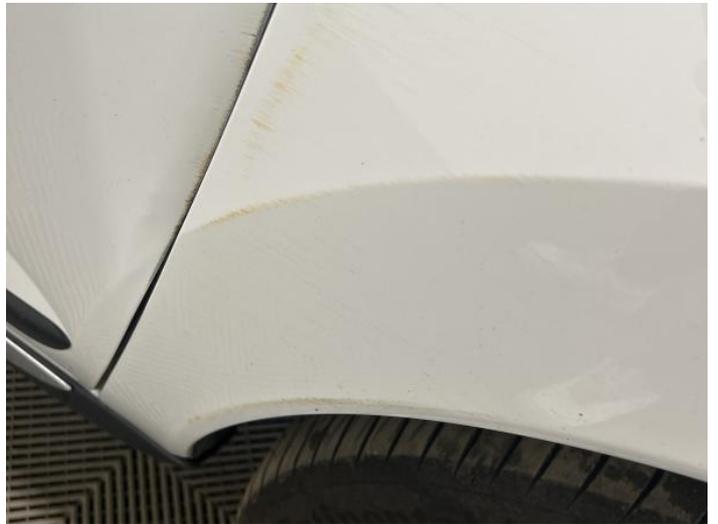
2: Wing of
Scratched
Over 25mm Not Thru Paint

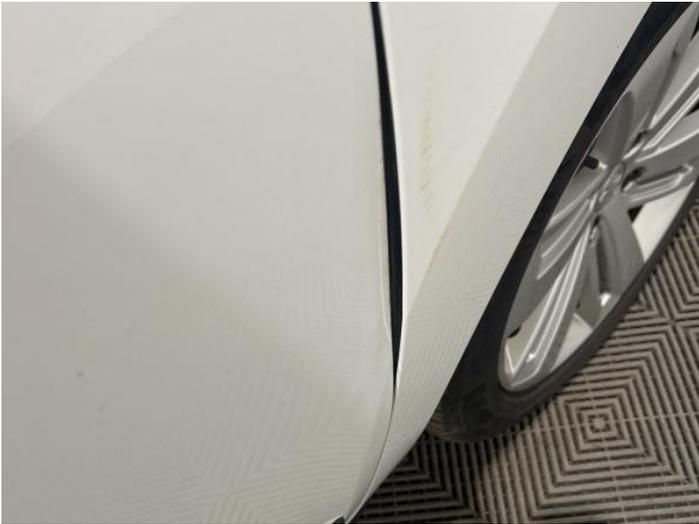
3: Door osf
Dented
Over 30mm

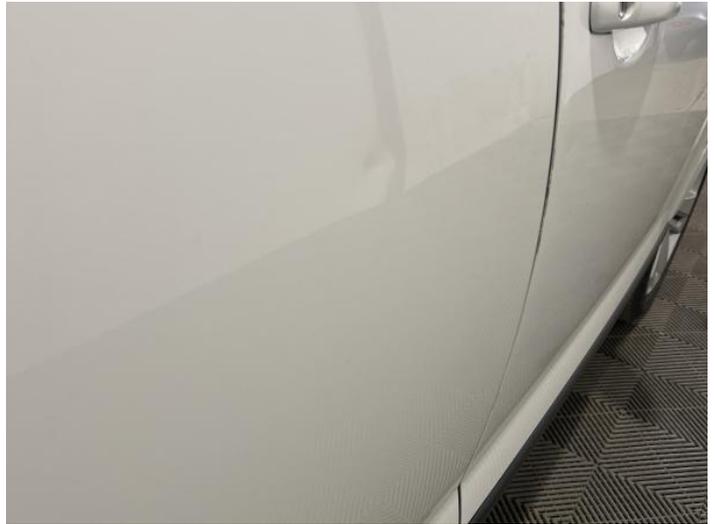
4: Door osr
Dented
Between 10mm + 30mm

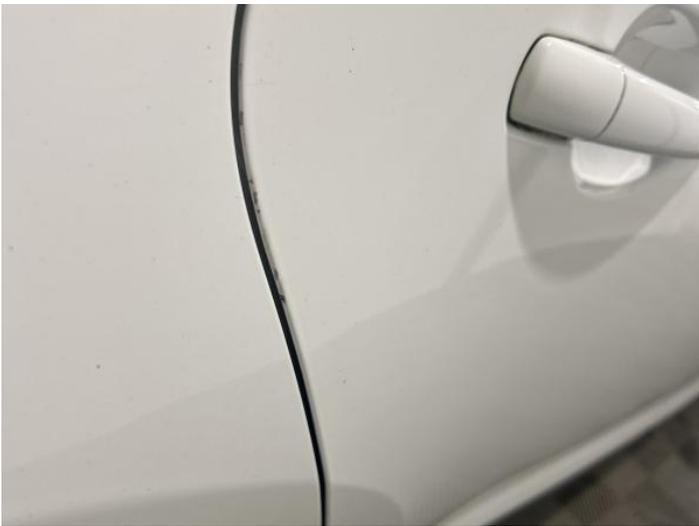
5: Door osr
Chipped
Edge Chip

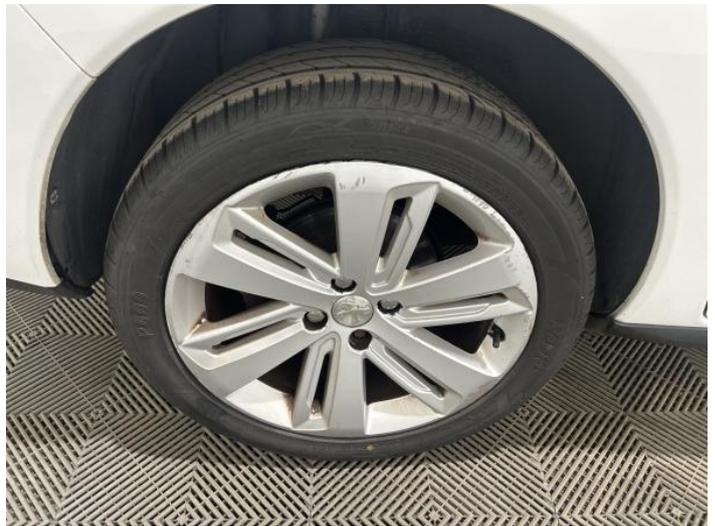
6: Wheel osr
Scratched
Over 50mm

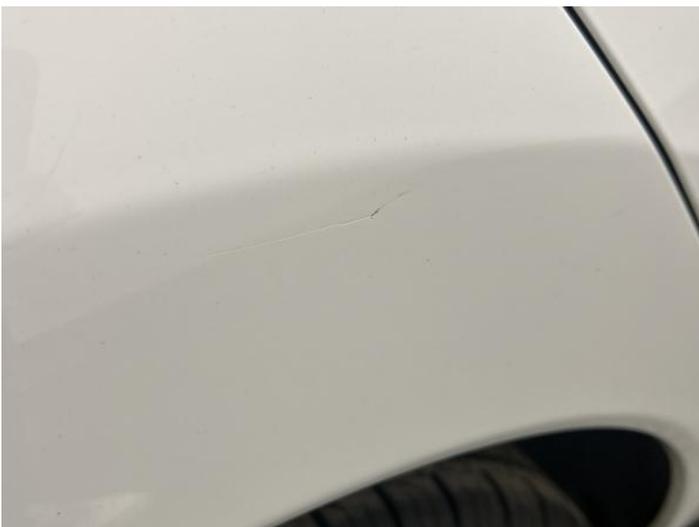
7: Qtr Panel osr
Scratched
Over 25mm Thru Paint

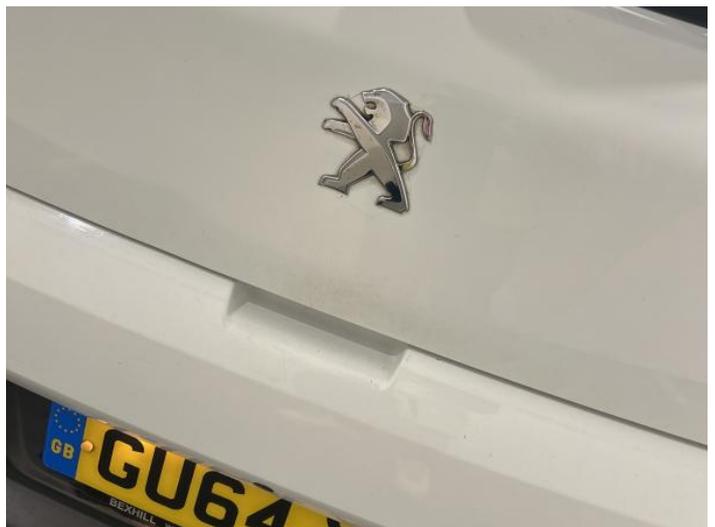
8: Tailgate
Scratched
Over 25mm Not Thru Paint

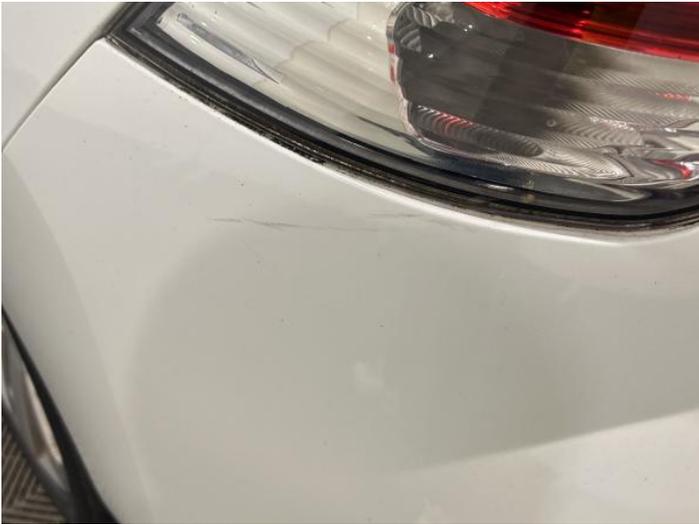
9: Bumper Rear
Scratched
Over 25mm Not Thru Paint

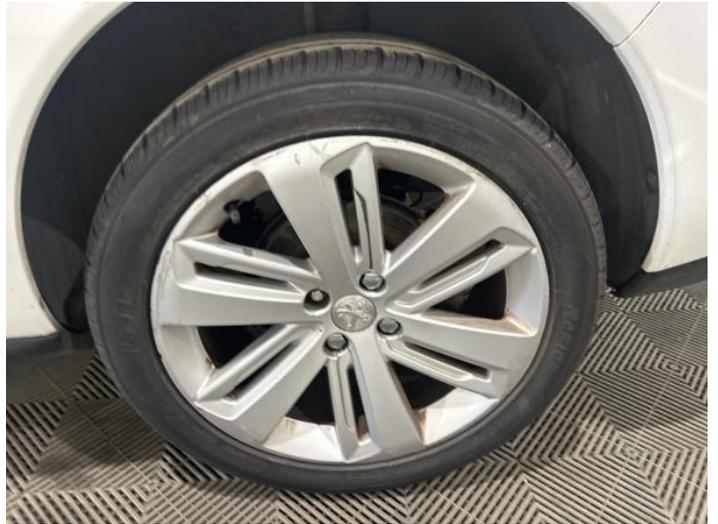
10: Wheel nsr
Scratched
Over 50mm

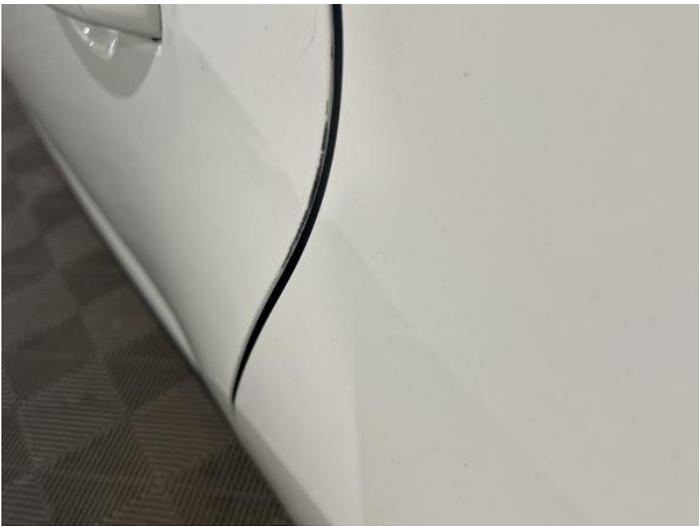
11: Door nsr
Chipped
Edge Chip

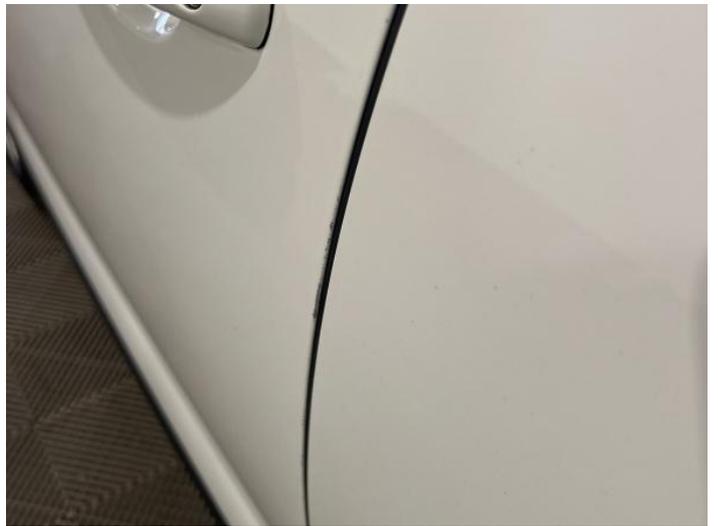
12: Door nsf
Chipped
Edge Chip

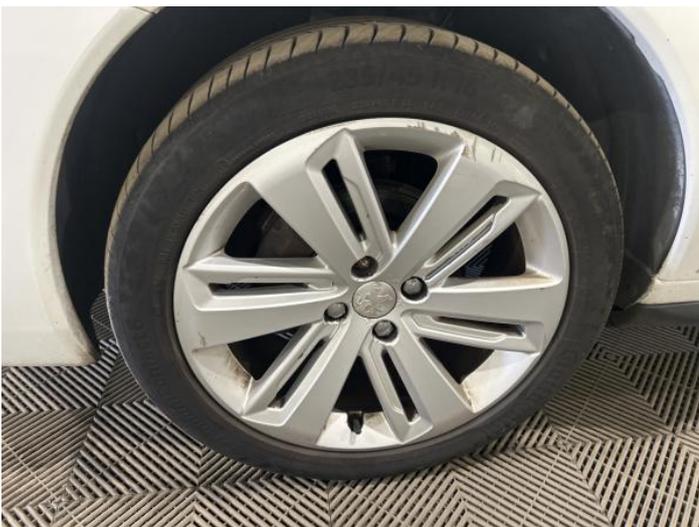
13: Wheel nsf
Scratched
Over 50mm

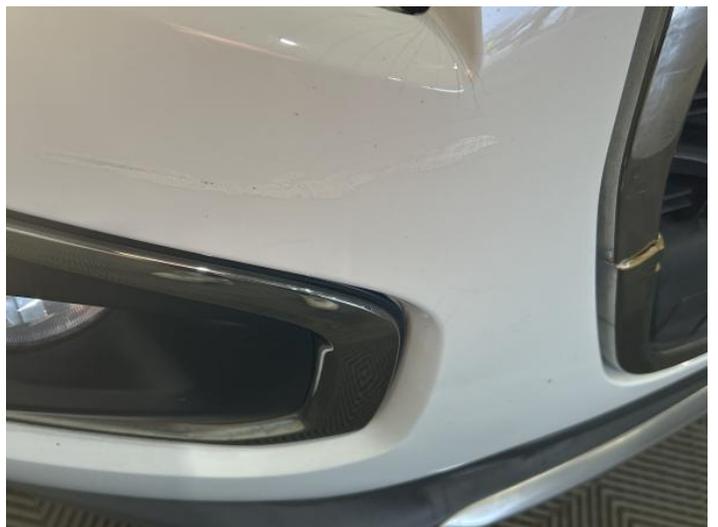
14: Bumper Front
Scratched
25 to 100mm Thru Paint
