VEHICLE INSPECTION REPORT

KM07GAU

Volkswagen Golf 1.9 Sport TDI 5dr

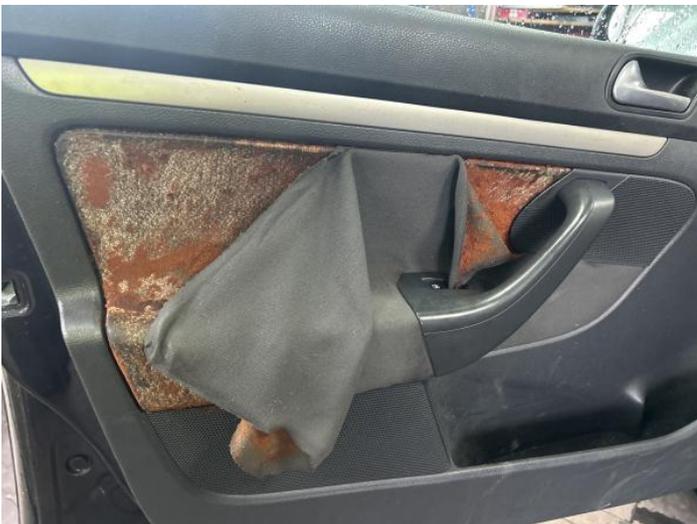
1: Door Pad nsf
Torn
Over 10mm

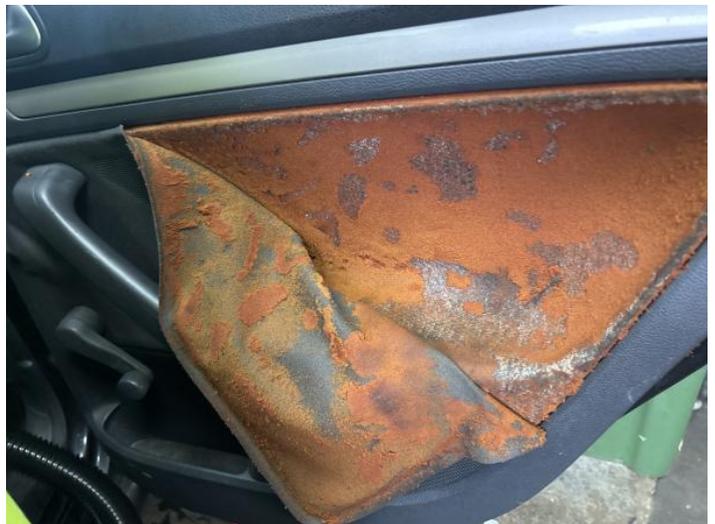
2: Door Pad osr
Torn
Over 10mm

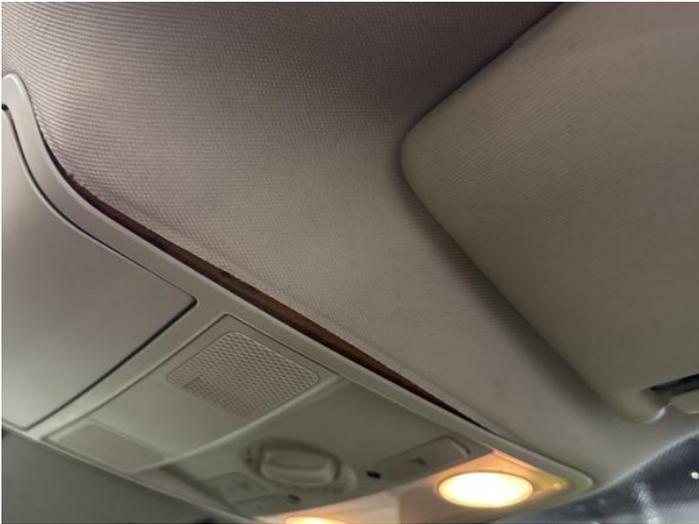
3: Roof Lining
Scuffed
Over 25mm

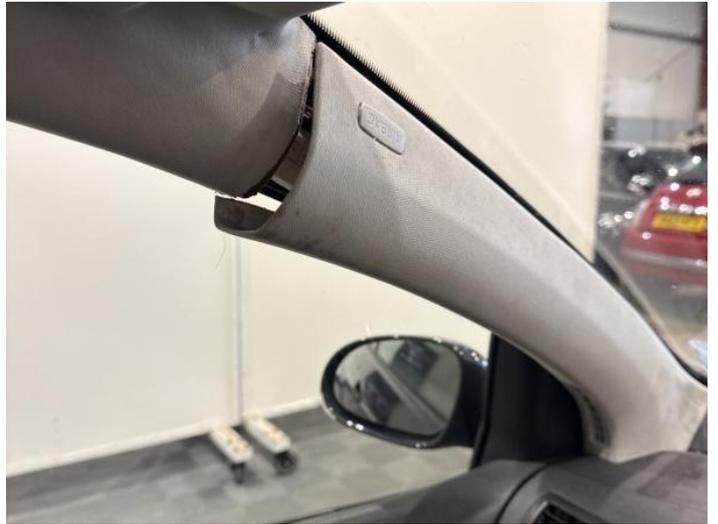
4: Fascia Trim
Damaged
Replace

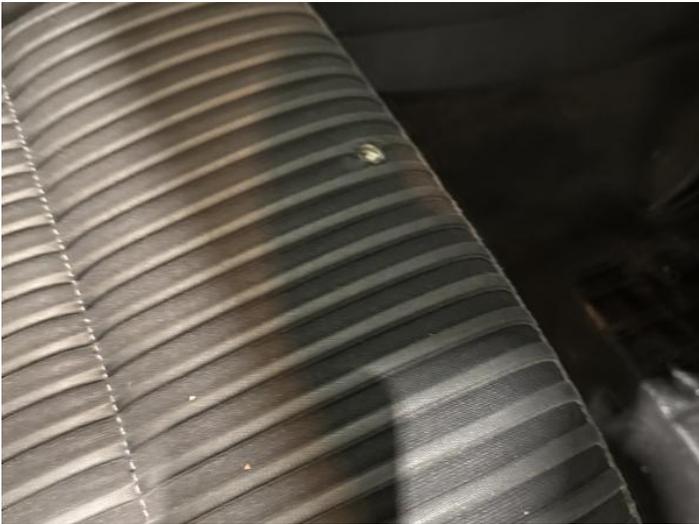
5: Seat Base Cover osf
Burn
Over 3mm

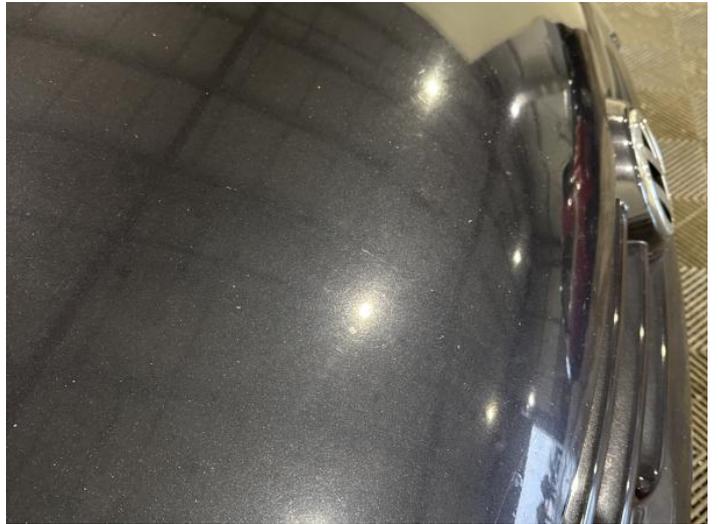
6: Bonnet
Chipped
Multiple Chips

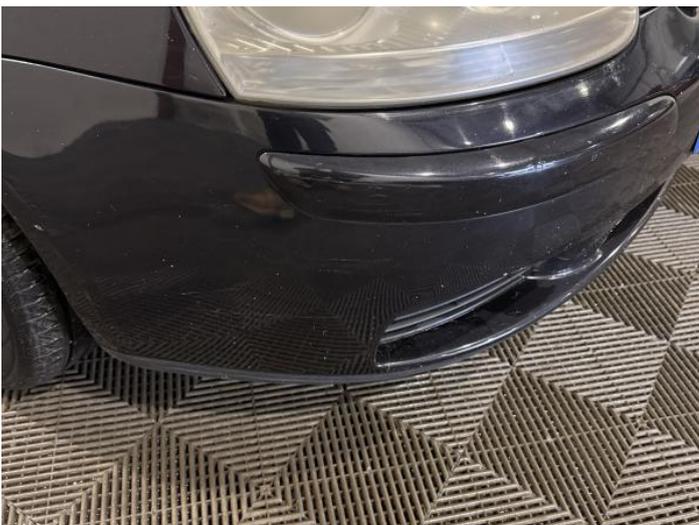
7: Bumper Front
Chipped
Multiple Chips

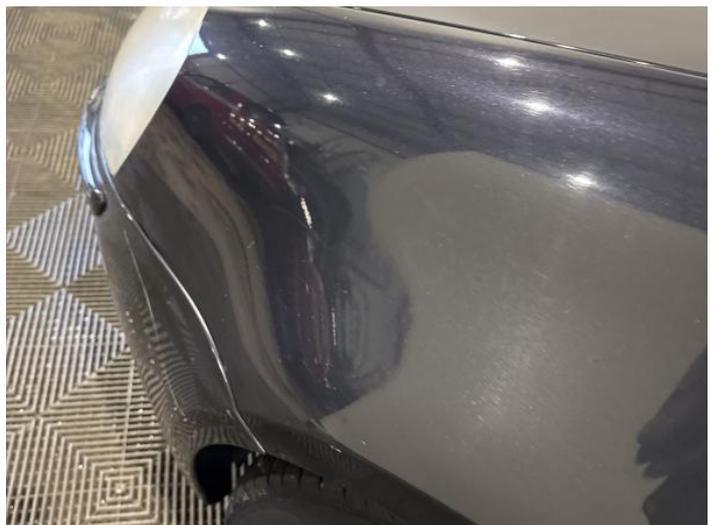
8: Wing nsf
Chipped
Multiple Chips

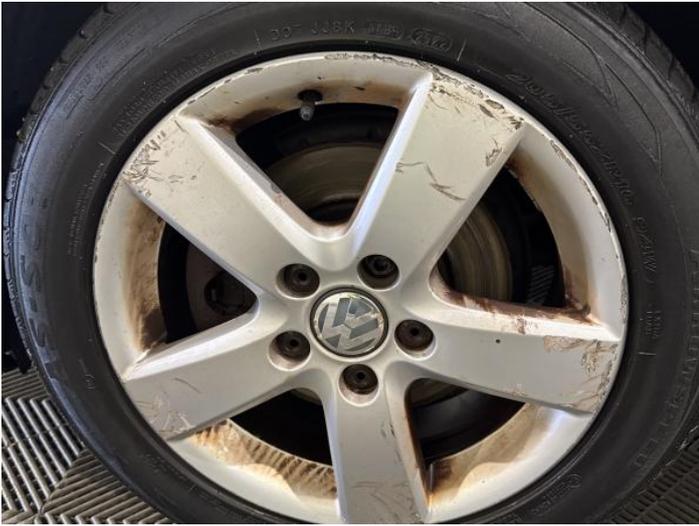
9: Wheel nsf
Scratched
Over 50mm

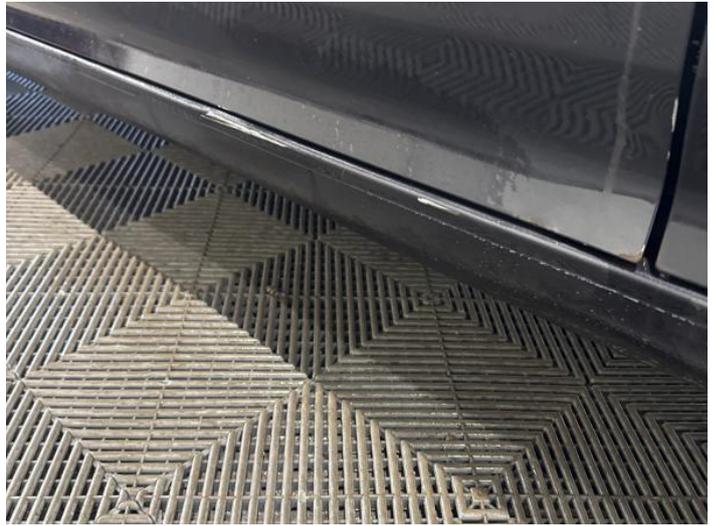
10: Sill ns
Scratched
Over 25mm Thru Paint

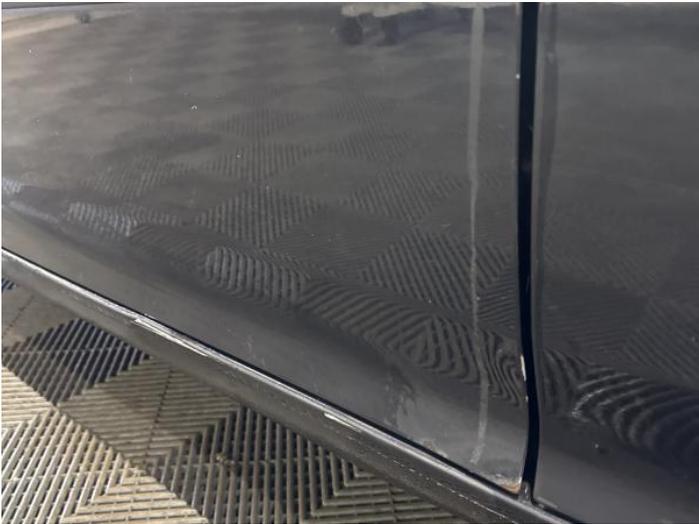
11: Door nsf
Dented
With Paint Damage

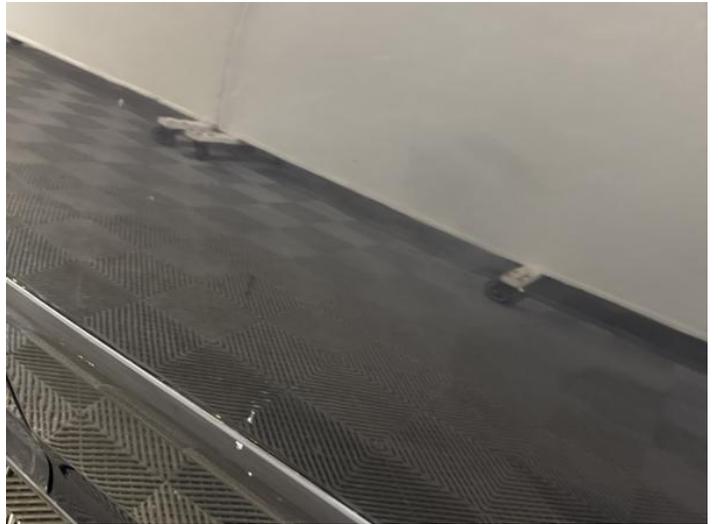
12: Door nsr
Scratched
Over 25mm Thru Paint

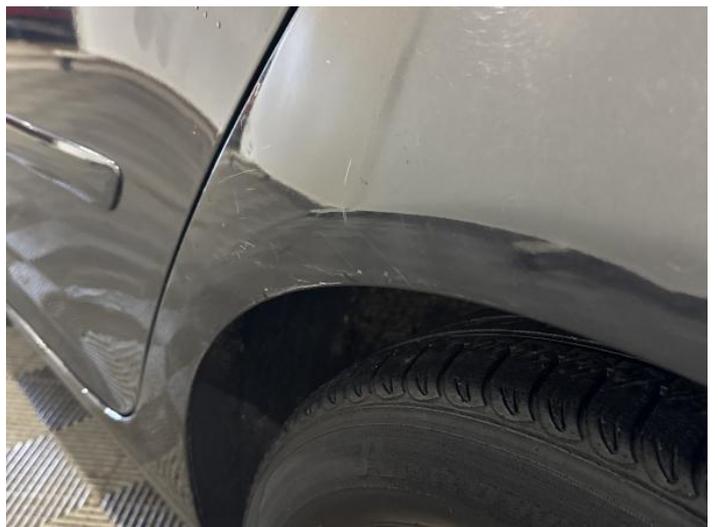
14: Qtr Panel nsr
Scratched
Over 25mm Thru Paint

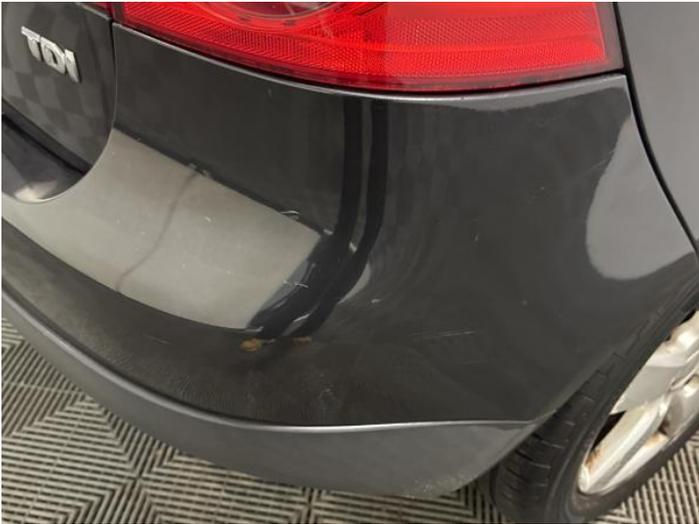
15: Bumper Rear
Scratched
Over 100mm Thru Paint

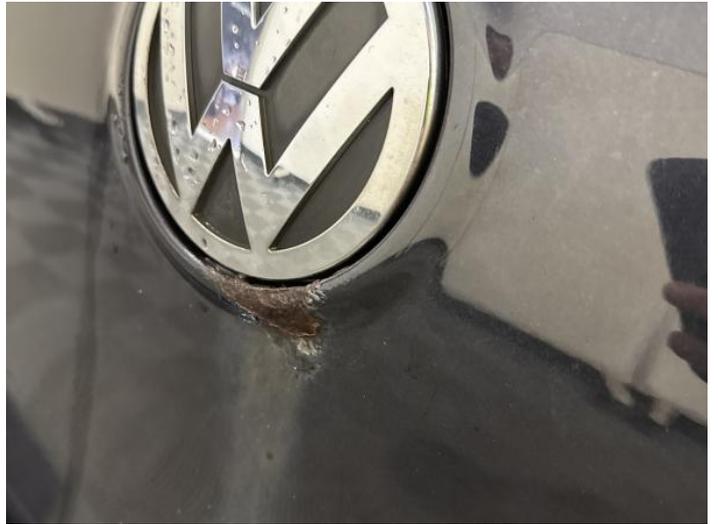
16: Tailgate
Rusted
Over 5mm

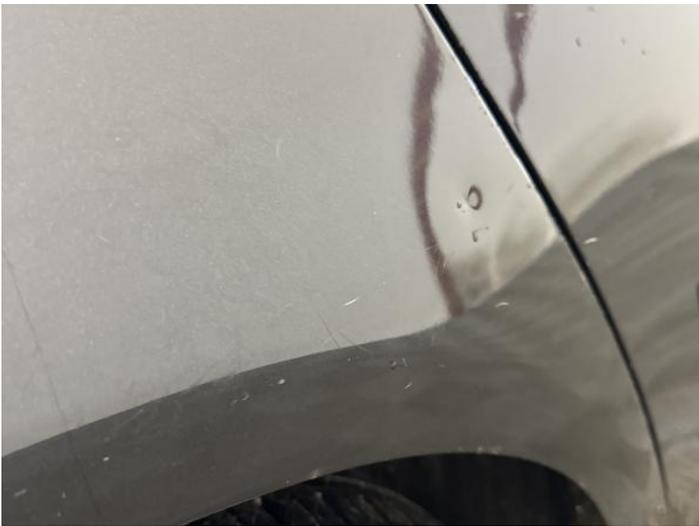
17: Qtr Panel osr
Dented
Between 10mm + 30mm

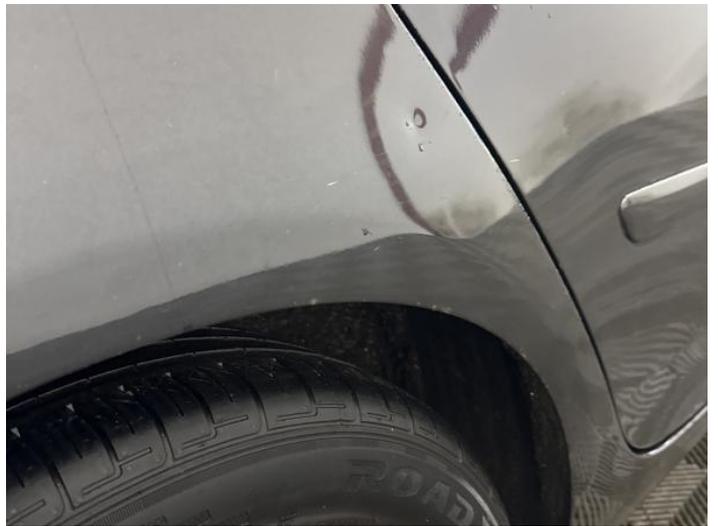
18: Qtr Panel osr
Scratched
Rusted

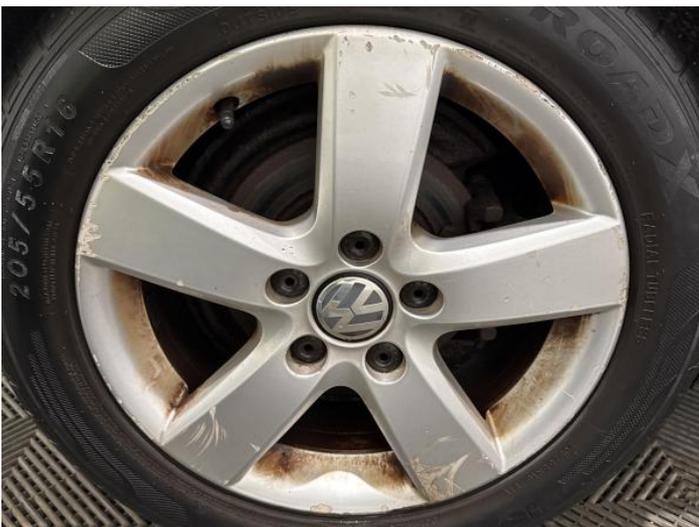
19: Wheel osr
Scratched
Over 50mm

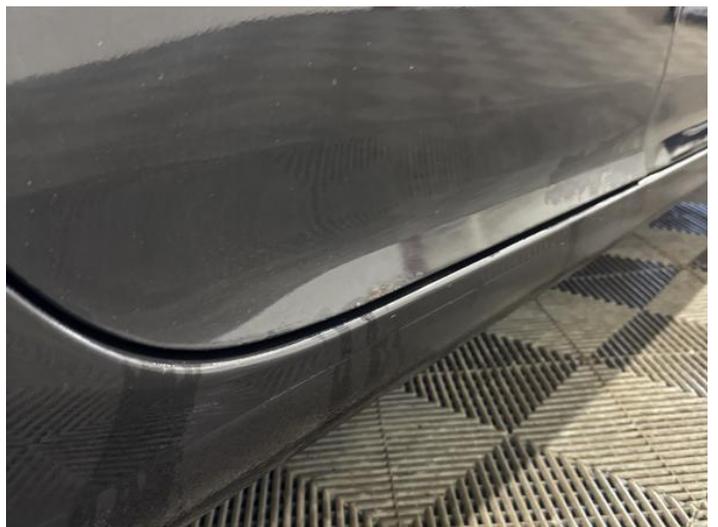
20: Door osr
Scratched
Rusted

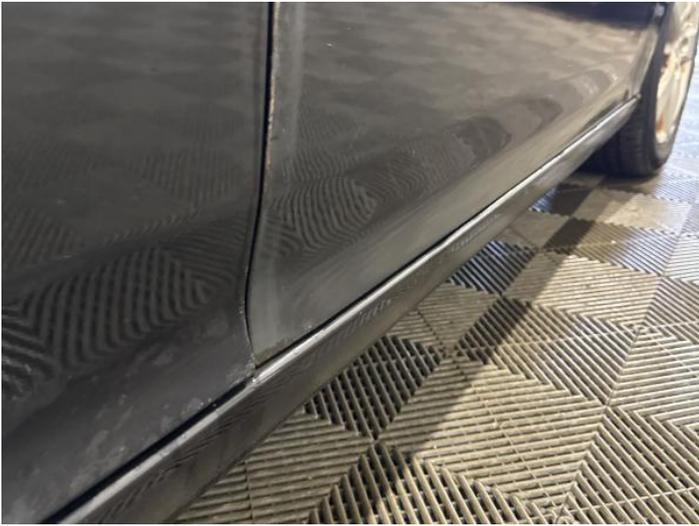
21: Door osf
Dented
Over 30mm

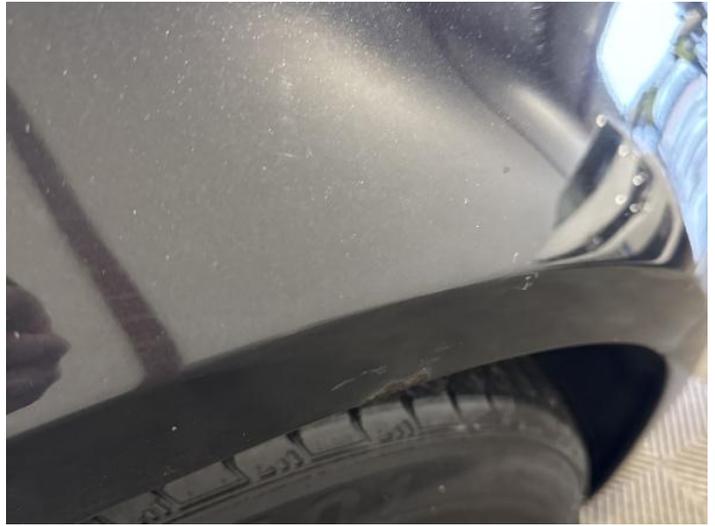
22: Wing osf
Scratched
Rusted

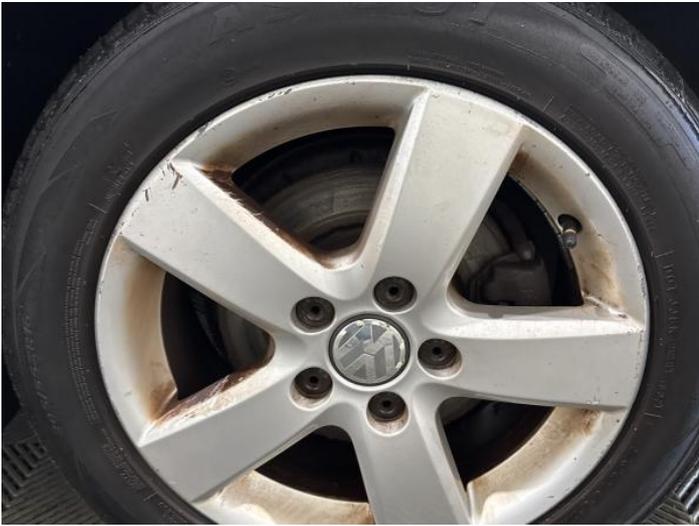
23: Wheel osf
Scratched
Over 50mm

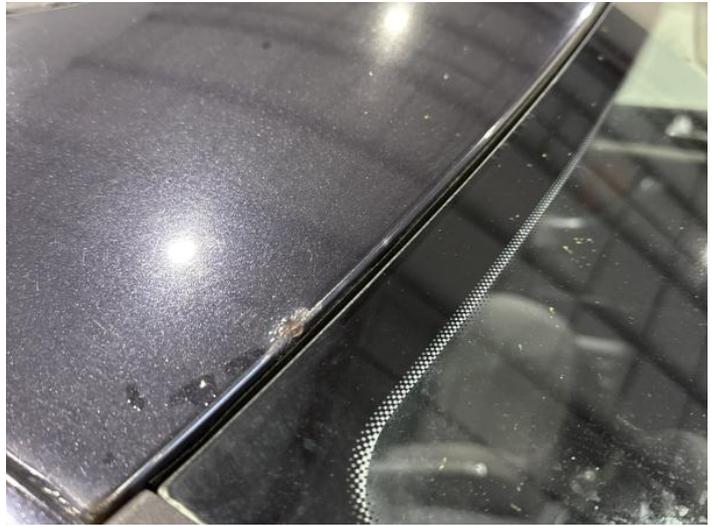
24: Roof
Chipped
Edge Chip
