# VEHICLE INSPECTION REPORT

**OE11ERX**

## BMW 3 Series 330d M Sport 2dr

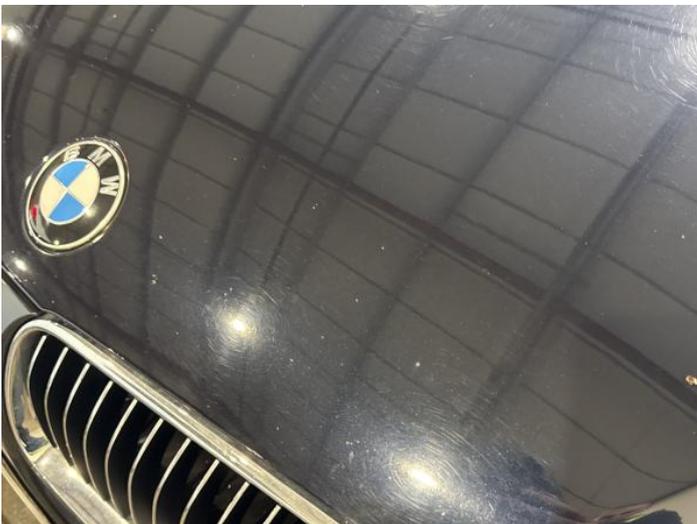
1: Bonnet  
Chipped  
Multiple Chips

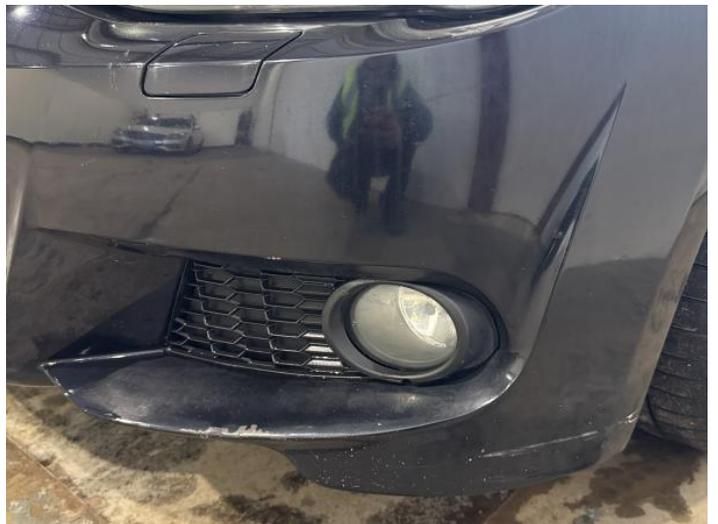
2: Bumper Front  
Scratched  
Over 100mm Thru Paint

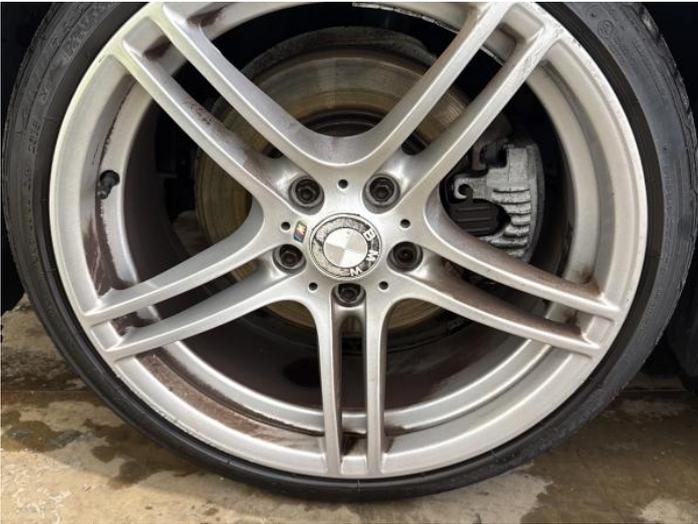
3: Wheel nsf  
Scratched  
Over 50mm

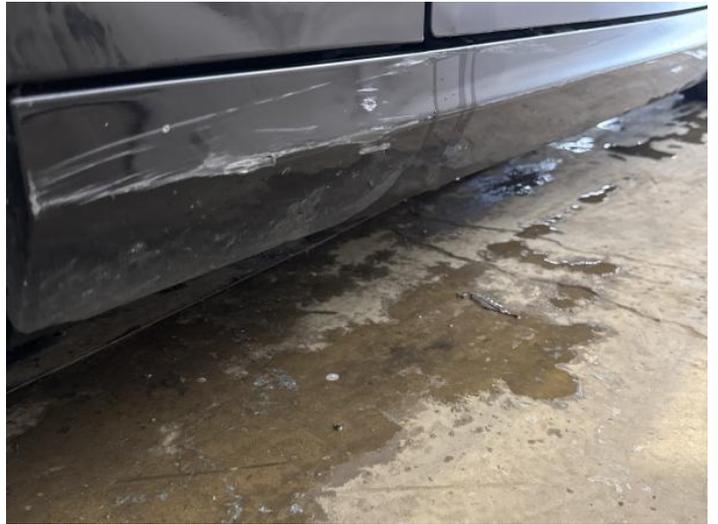
4: Sill Panel Trim ns  
Scratched (Painted)  
Over 25mm Thru Paint

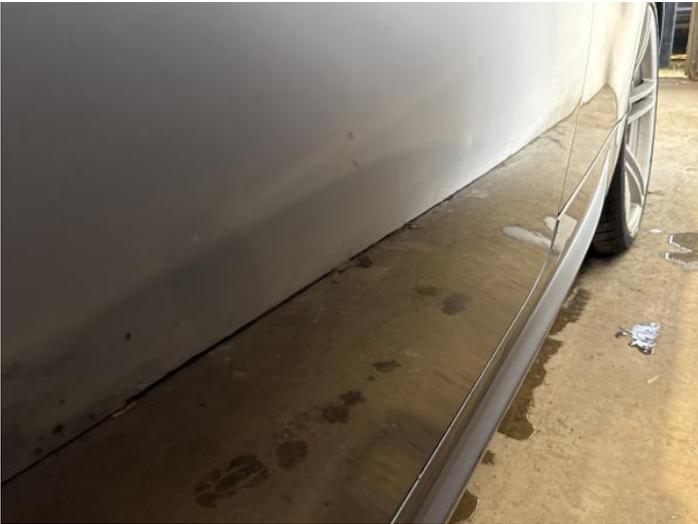
5: Door nsf  
Dented  
Over 30mm

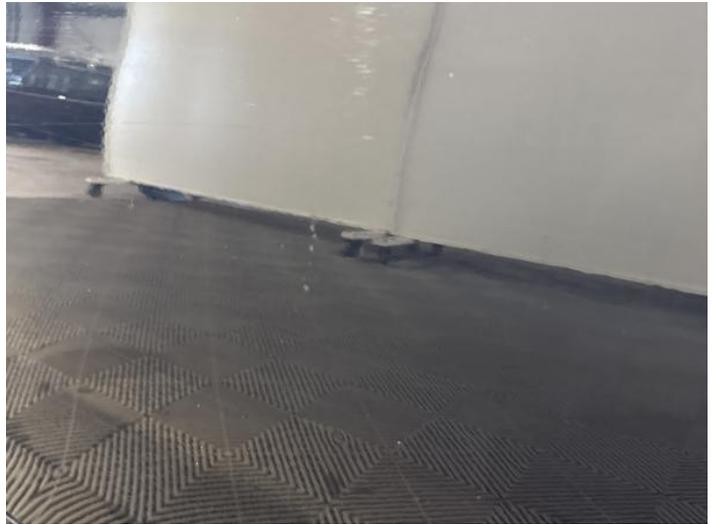
6: Door nsf  
Scratched  
UpTo 25mm Thru Paint

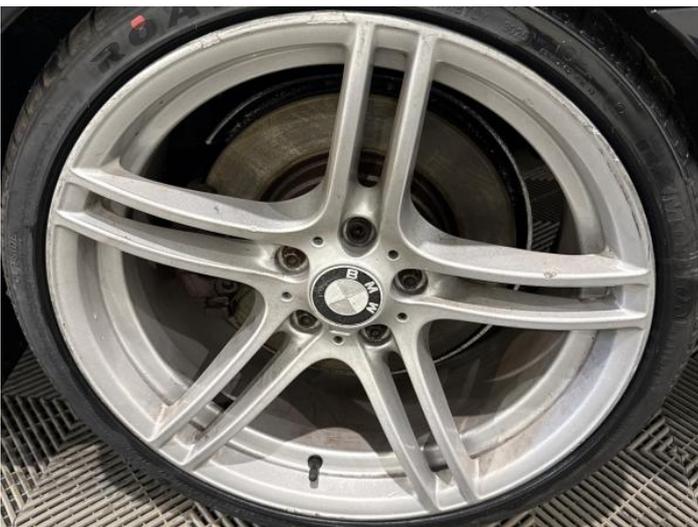
7: Wheel nsr  
Scratched  
Over 50mm

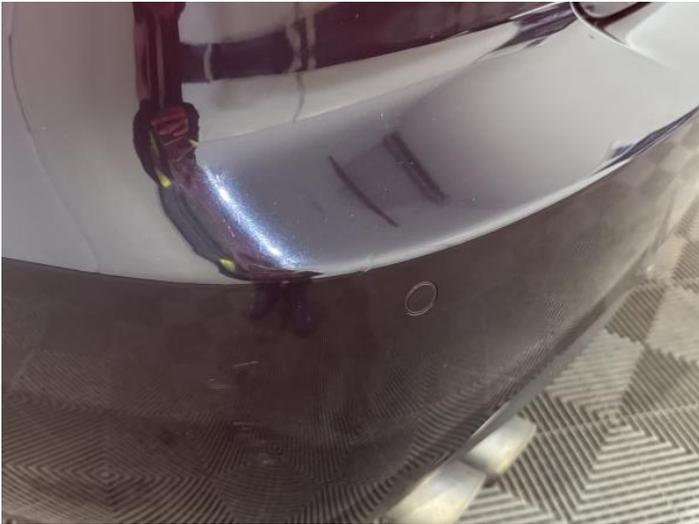
9: Bumper Rear  
Dented  
With Paint Damage

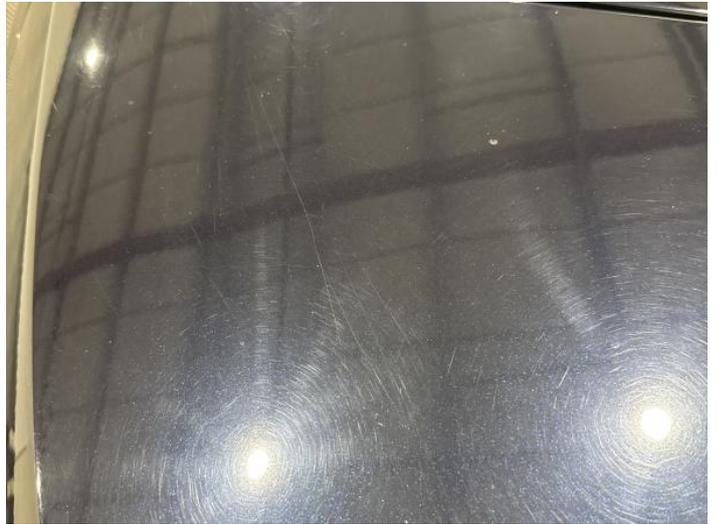
10: Boot Lid  
Scratched  
Over 25mm Thru Paint

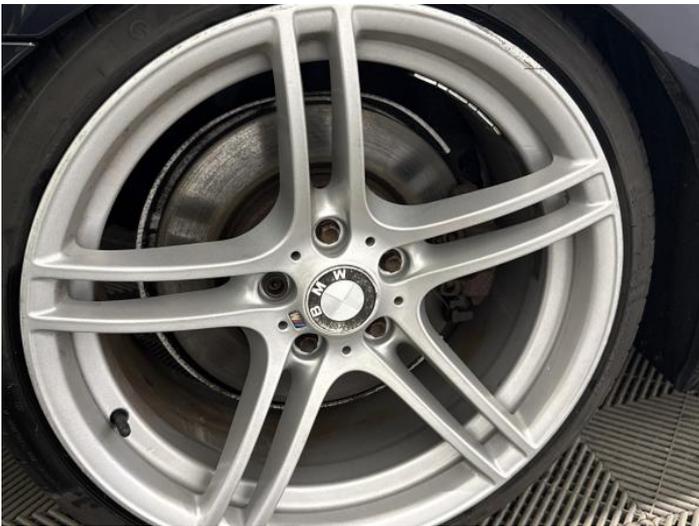
11: Wheel osr  
Scratched  
Over 50mm

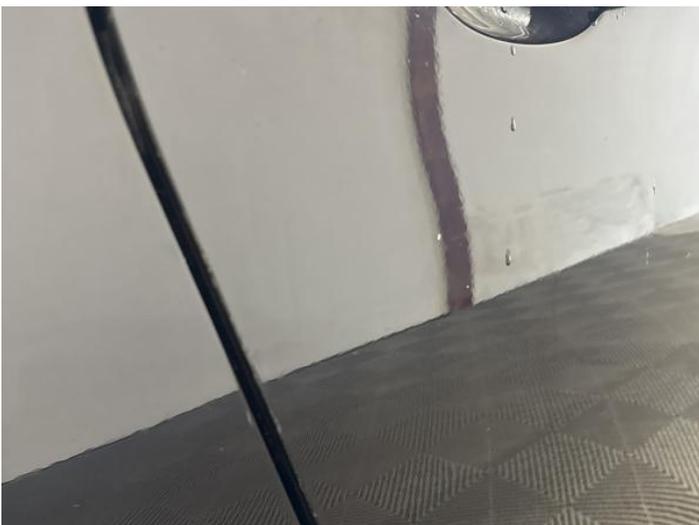
13: Door osf  
Scratched  
UpTo 25mm Thru Paint

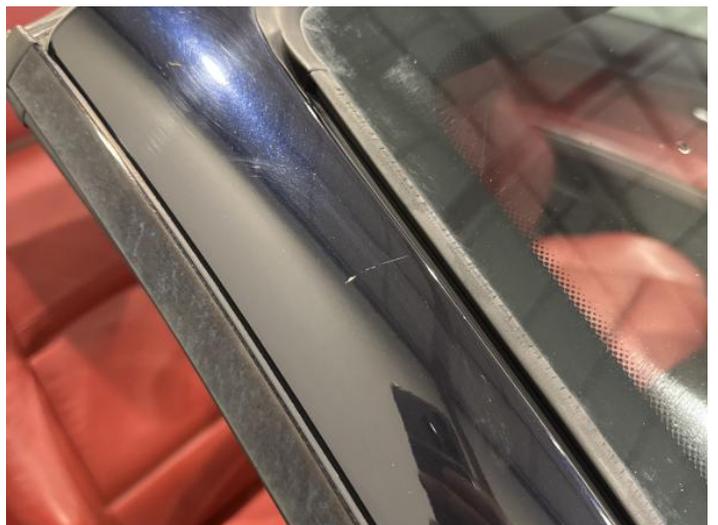
14: A Post os  
Scratched  
UpTo 25mm Thru Paint

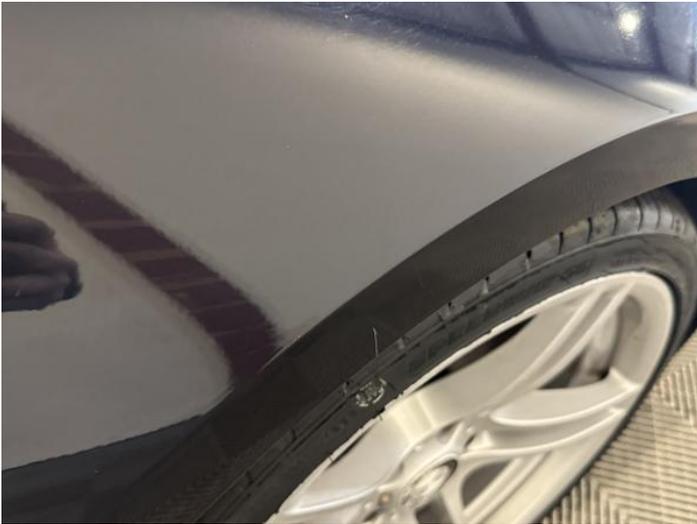
15: Wing osf  
Scratched  
UpTo 25mm Thru Paint

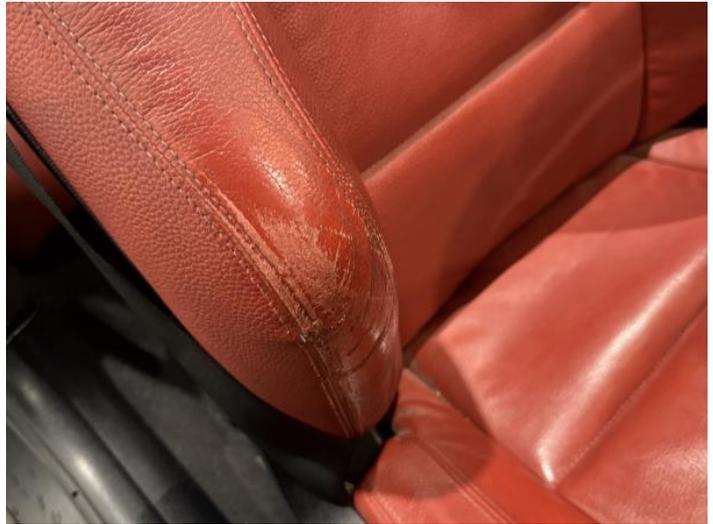
16: Seat Back Cover osf  
Scuffed  
Over 25mm
