VEHICLE INSPECTION REPORT

SJ14LTA

Nissan Qashqai 1.2 DiG-T Acenta Premium 5dr

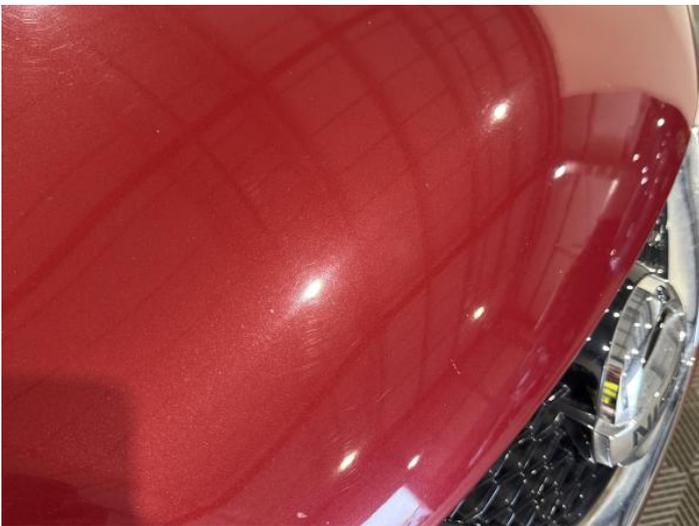
1: Bonnet
Chipped
Multiple Chips

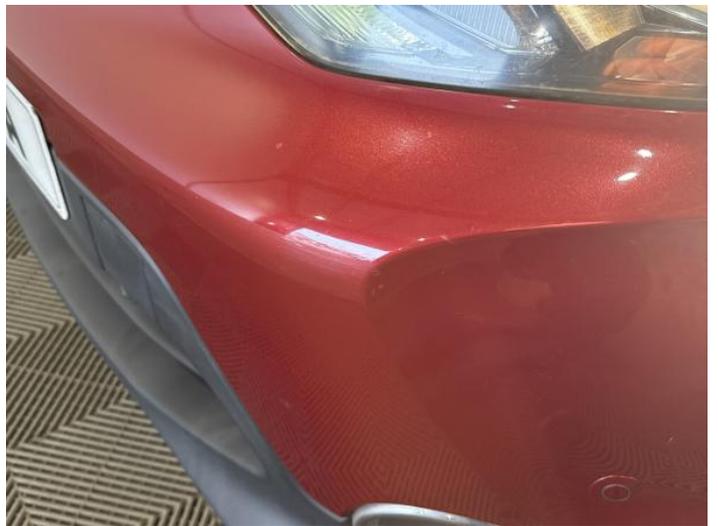
2: Bumper Front
Chipped
Multiple Chips

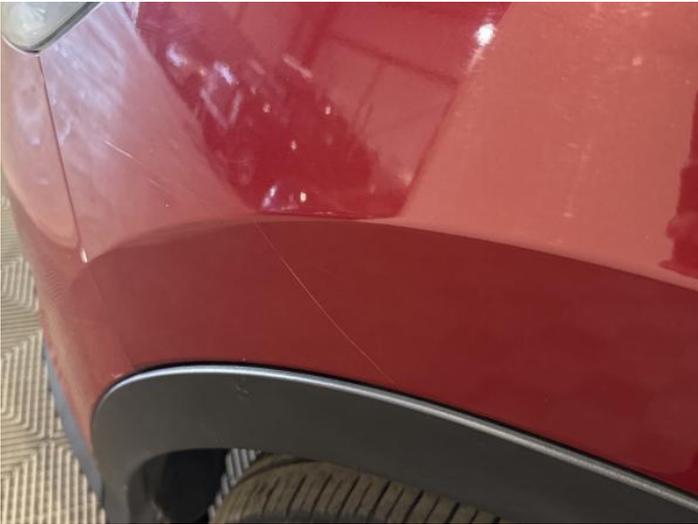
3: Wing nsf
Scratched
Over 25mm Thru Paint

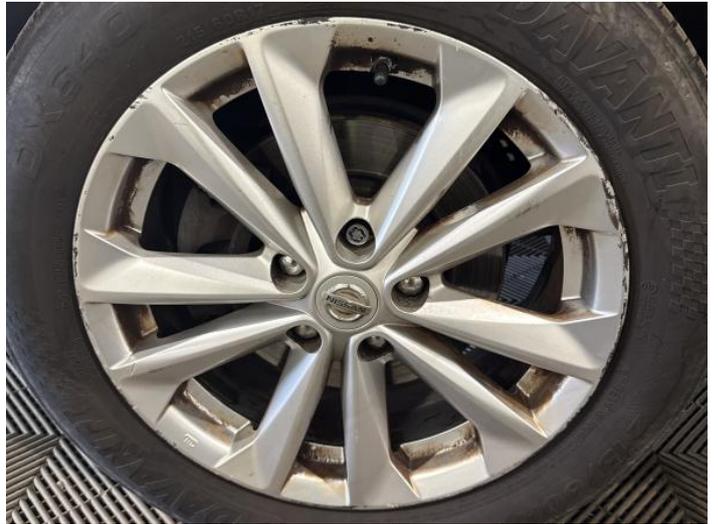
4: Wheel nsf
Scratched
Over 50mm

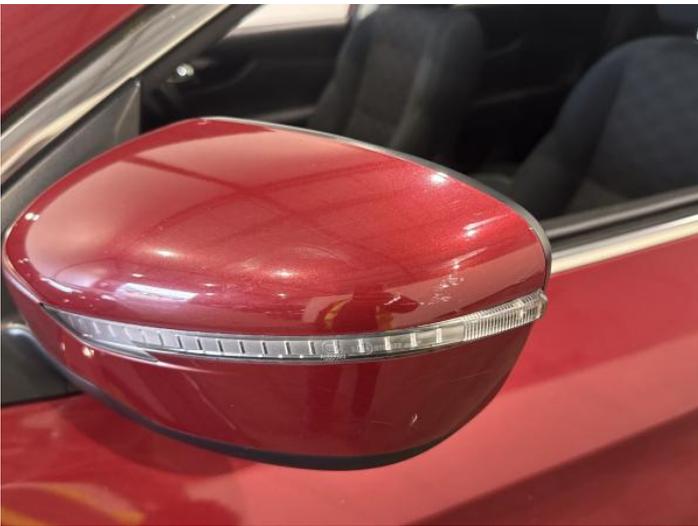
5: Door Mirror Assy nsf
Scratched (Painted)
UpTo 25mm Thru Paint

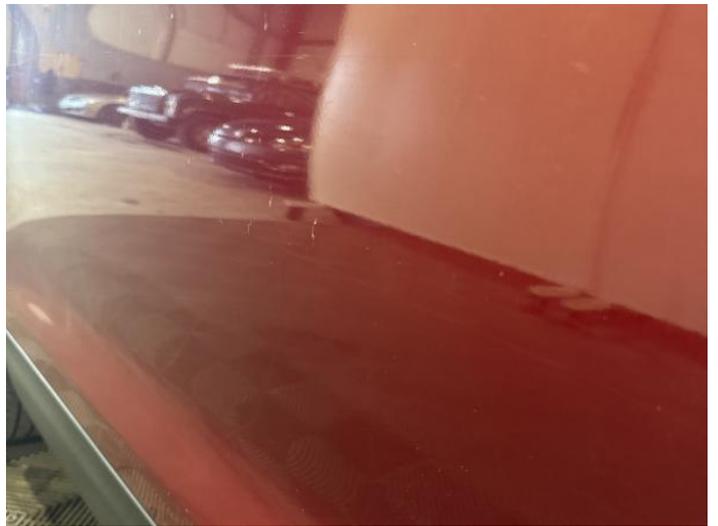
6: Door nsf
Scratched
Over 25mm Thru Paint

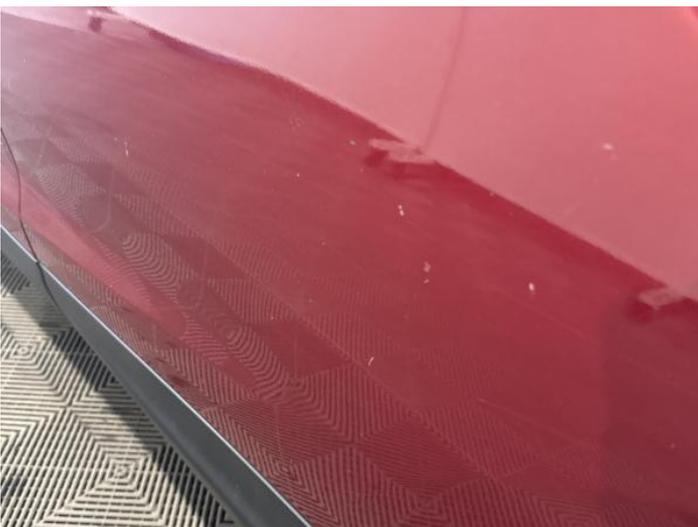
7: Door nsr
Scratched
Over 25mm Thru Paint

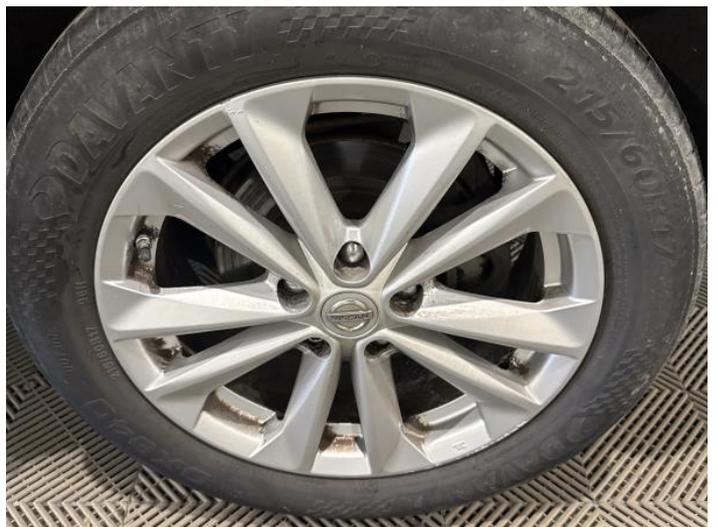
8: Wheel nsr
Corroded
Light

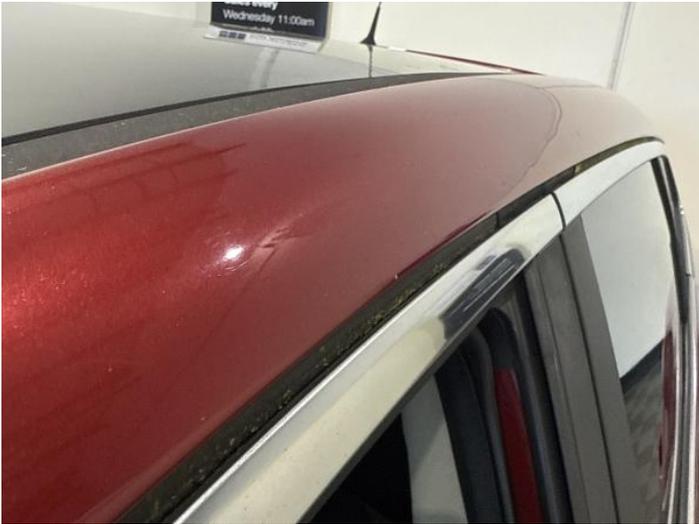
9: A Post ns
Dented
2 Or Less UpTo 10mm

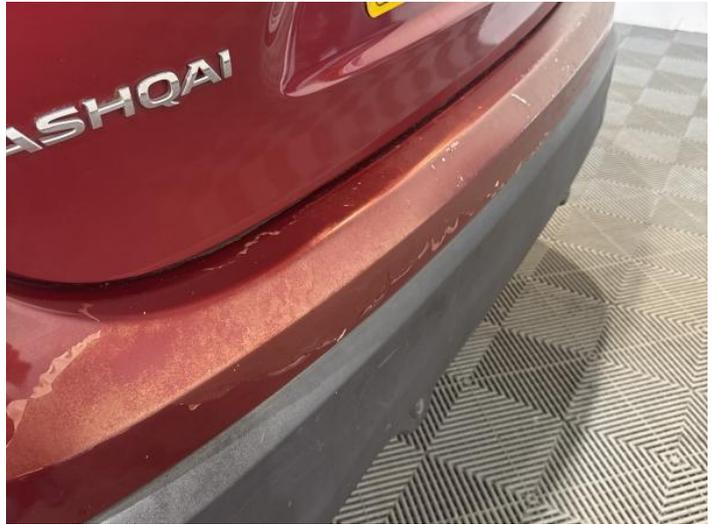
10: Bumper Rear
Poor Previous Repair
Paint Flake

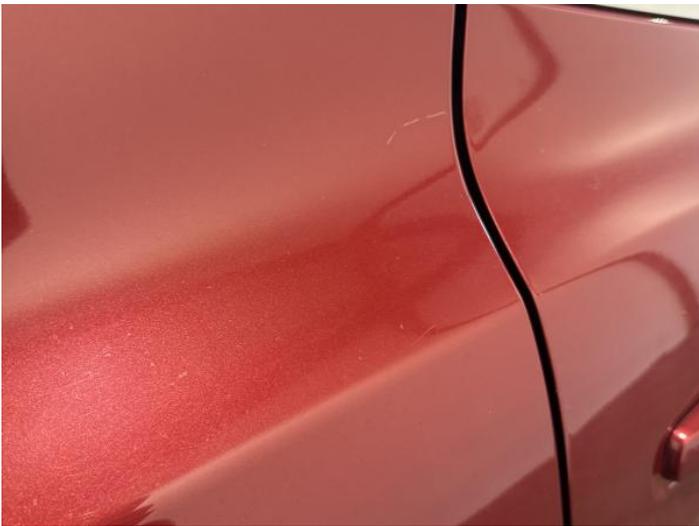
11: Qtr Panel osr
Scratched
Over 25mm Thru Paint

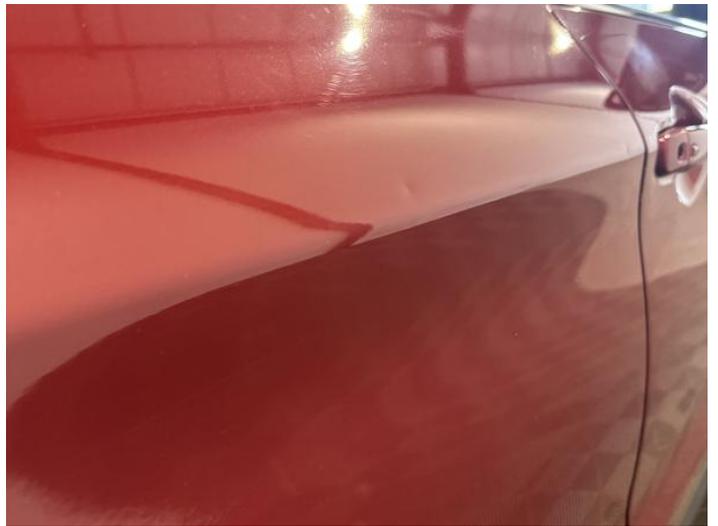
12: Door osr
Dented
Between 10mm + 30mm

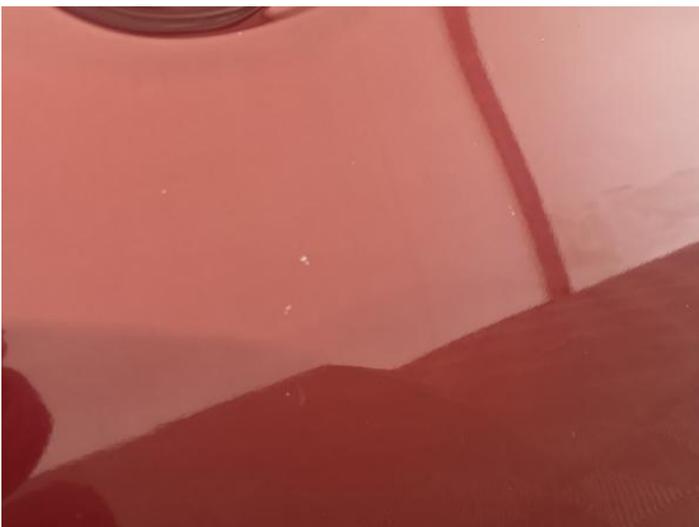
13: Door osr
Chipped
1 To 5

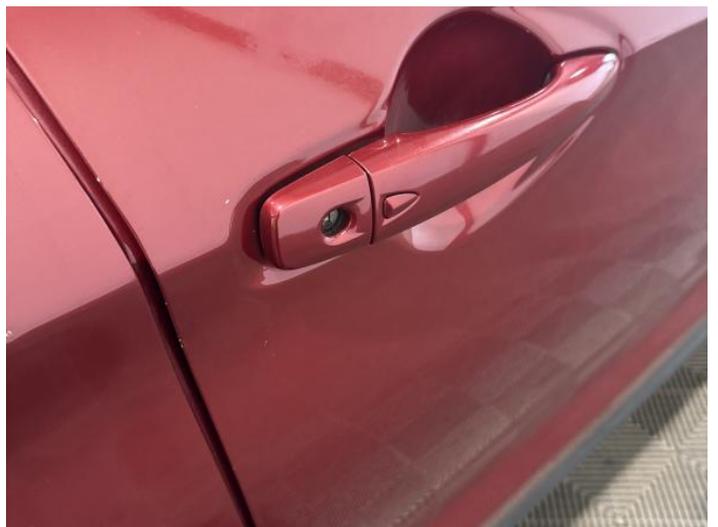
14: Door osf
Chipped
1 To 5

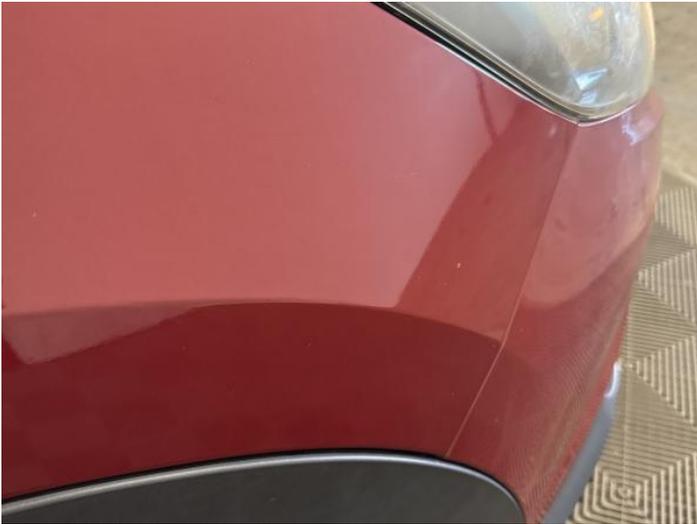
15: Wing osf
 Scratched
 UpTo 25mm Thru Paint

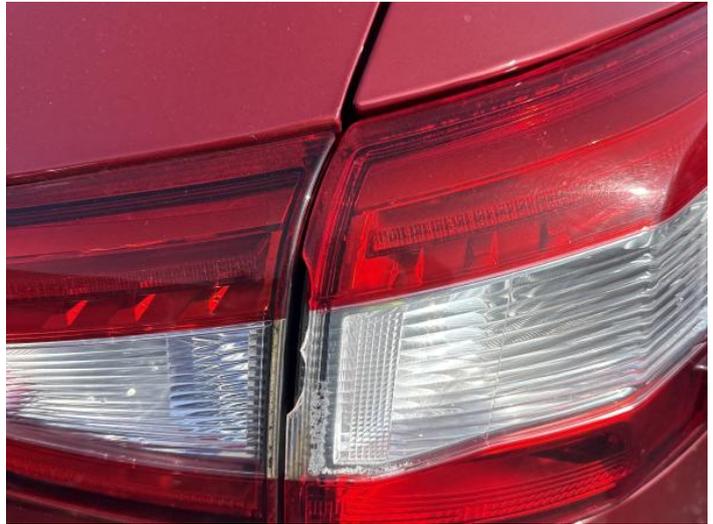
16: Lamp osr
 Broken
 Replace
