VEHICLE INSPECTION REPORT

GN16OFH

Ford Fiesta 1.0 EcoBoost Zetec 5dr

Cat: N
Inspection

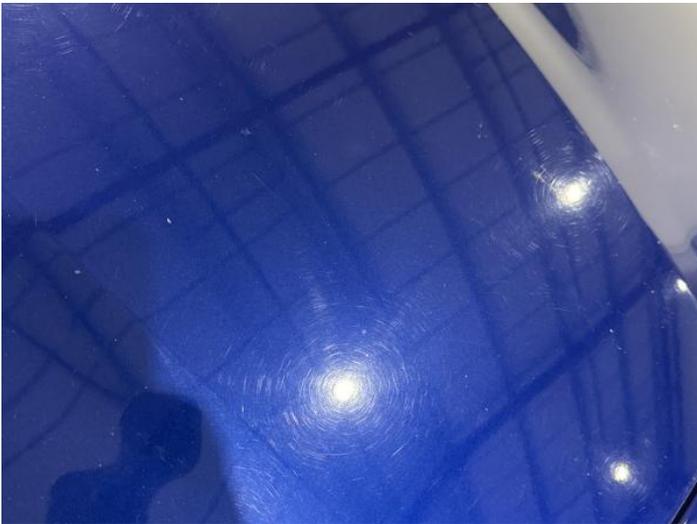
1: Bonnet
Chipped
Multiple Chips

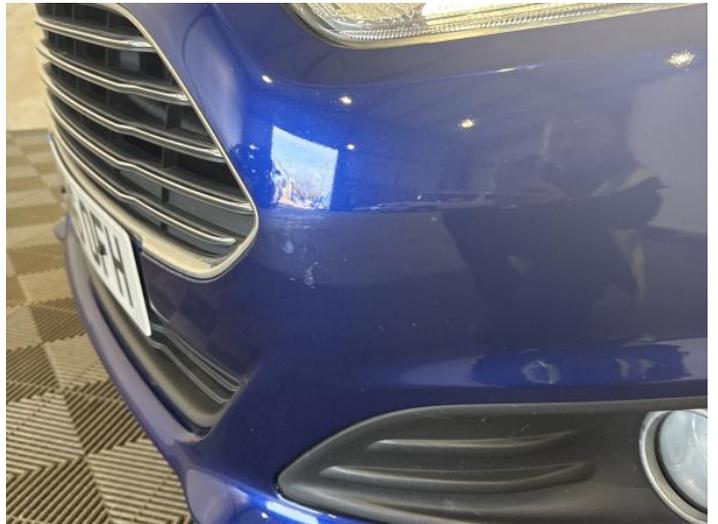
2: Bumper Front
Poor Previous Repair
Poor Paint

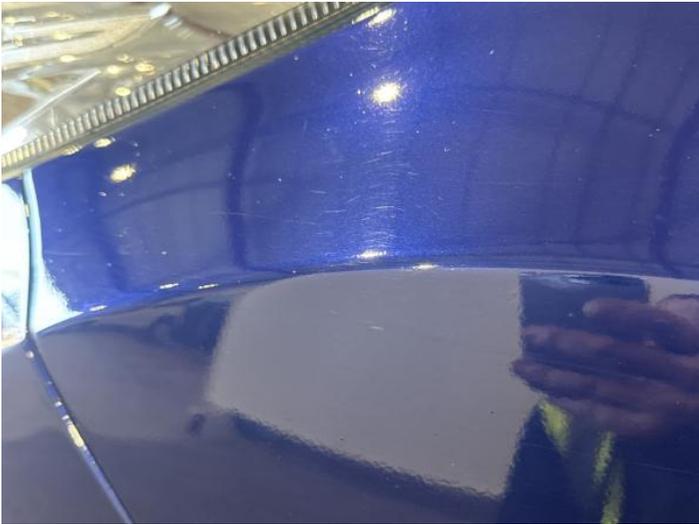
3: Wing nsf
Poor Previous Repair
Poor Paint

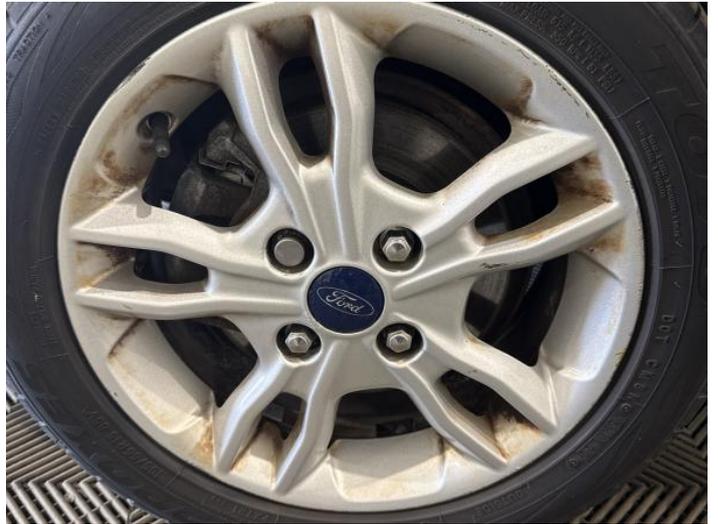
4: Wheel nsf
Scratched
Over 50mm

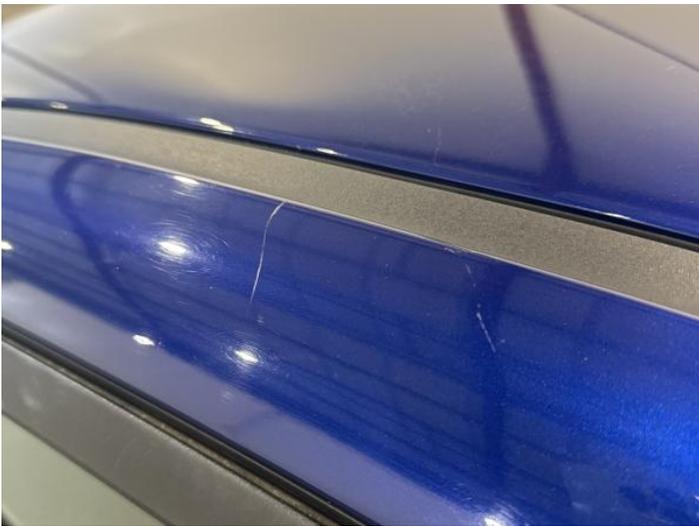
5: A Post ns
Scratched
Over 25mm Thru Paint

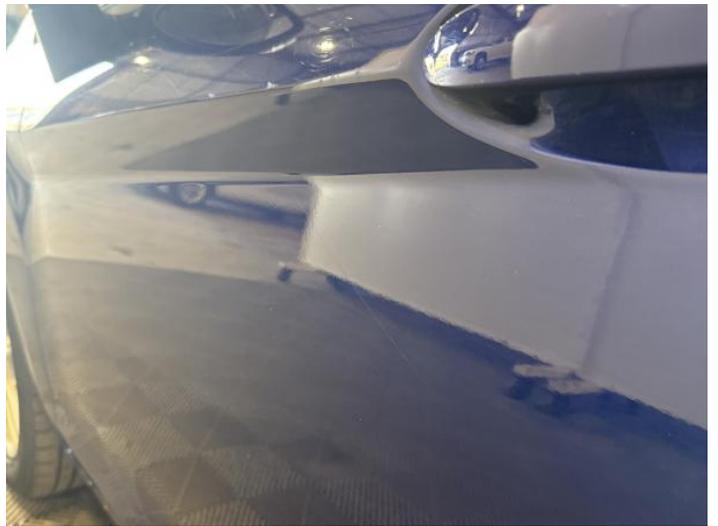
6: Door nsf
Scratched
Over 25mm Thru Paint

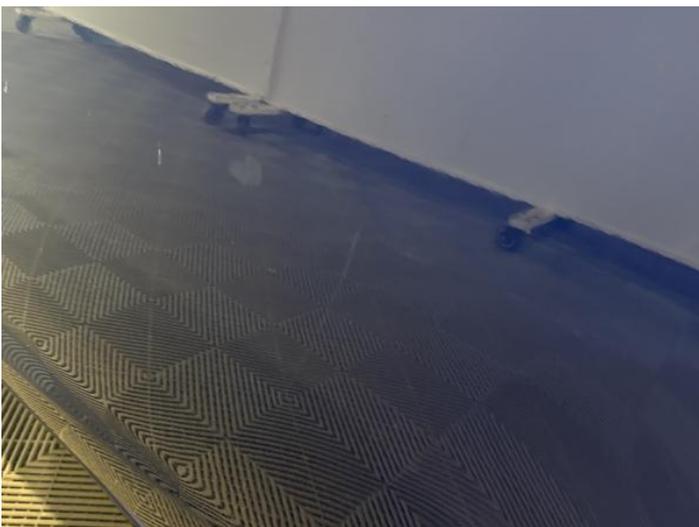
7: Door nsr
Scratched
Over 25mm Thru Paint

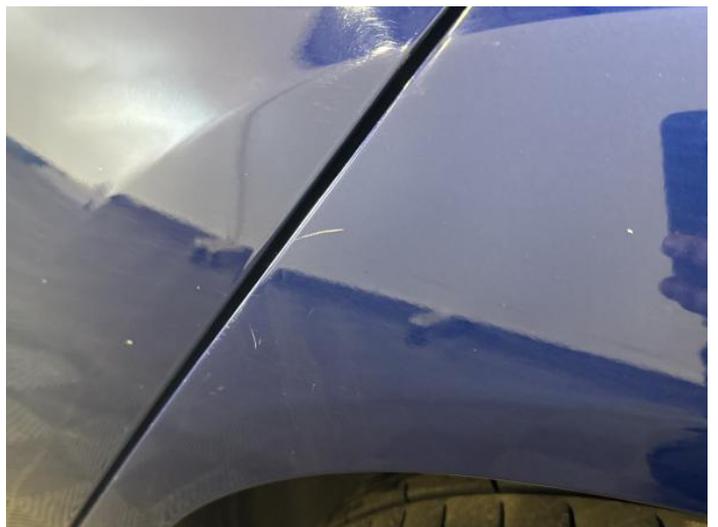
8: Qtr Panel nsr
Scratched
UpTo 25mm Thru Paint

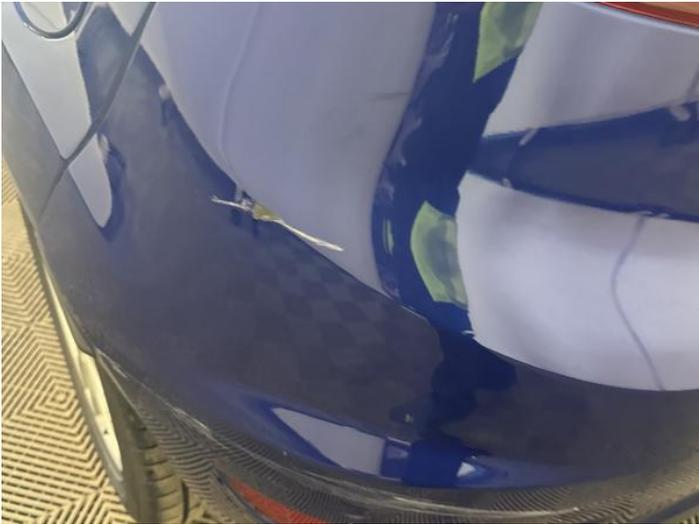
9: Bumper Rear
Scratched
Over 100mm Thru Paint

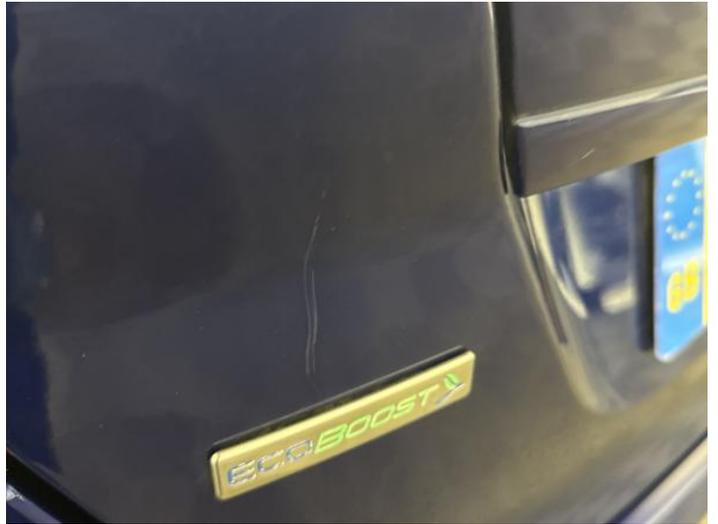
10: Tailgate
Scratched
Over 25mm Thru Paint

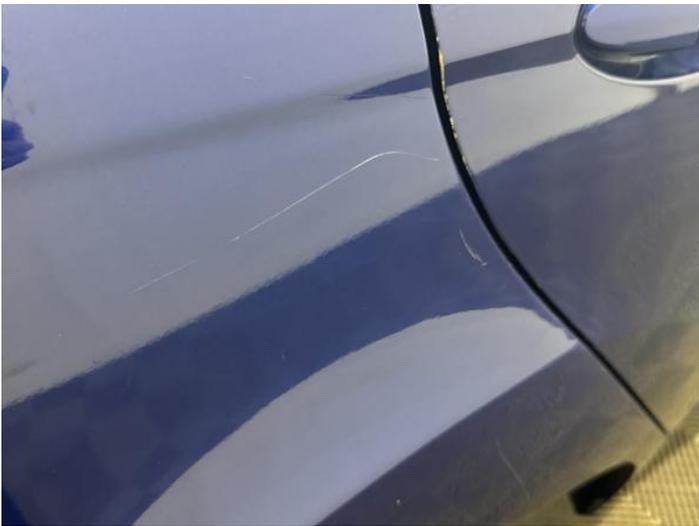
11: Qtr Panel osr
Scratched
Over 25mm Thru Paint

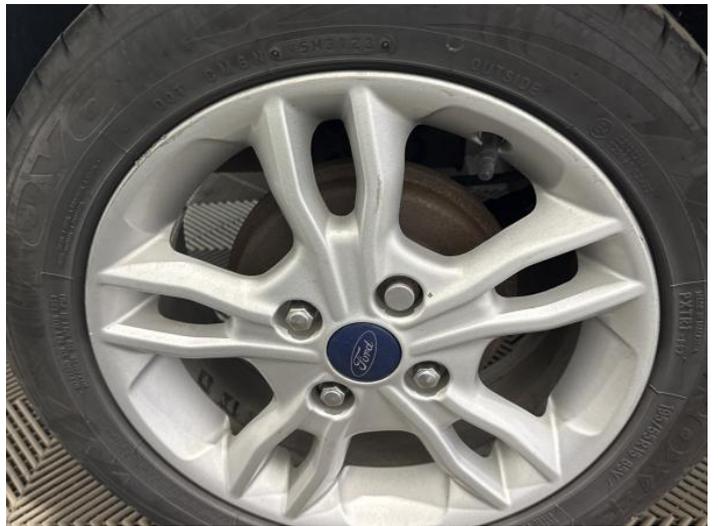
12: Wheel osr
Scratched
Over 50mm

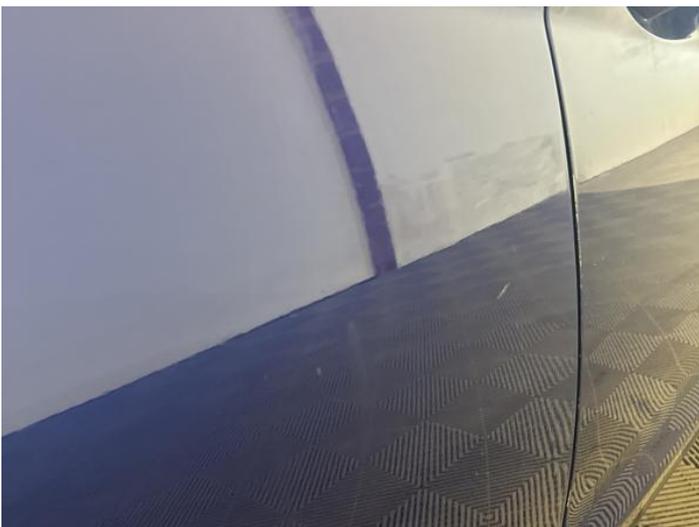
13: Door osr
Scratched
Over 25mm Thru Paint

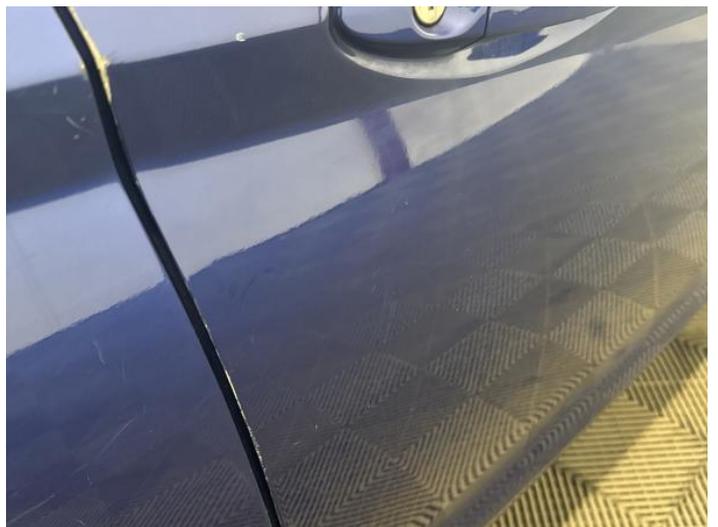
14: Door osf
Scratched
Over 25mm Thru Paint

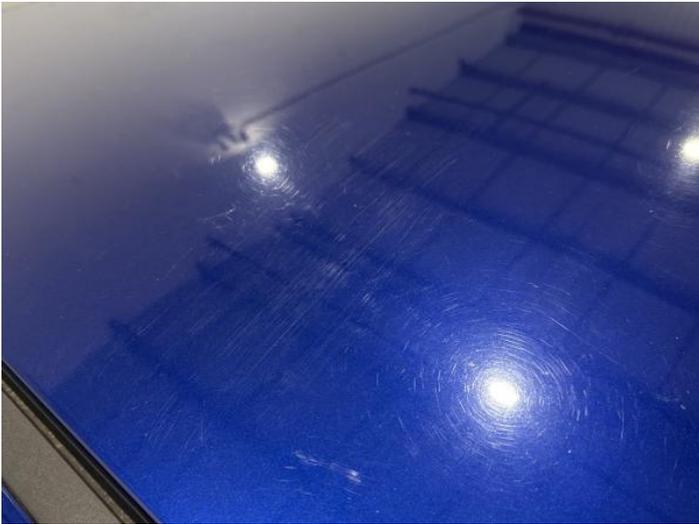
15: Roof
Scratched
Over 25mm Thru Paint

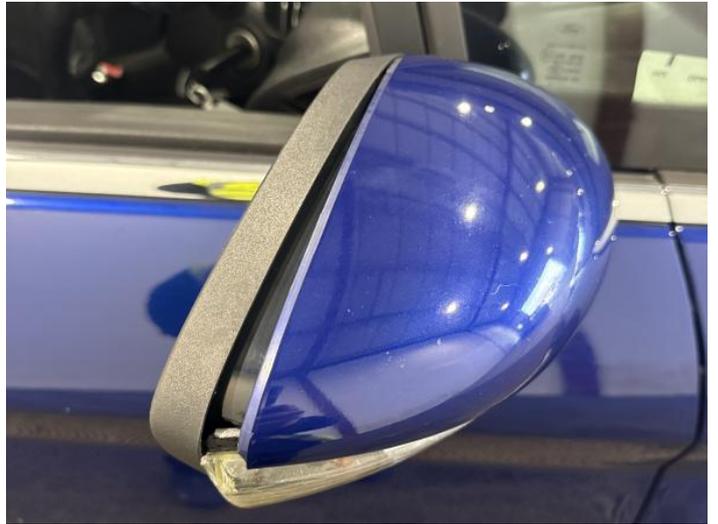
16: Door Mirror Assy osf
Broken
Replace

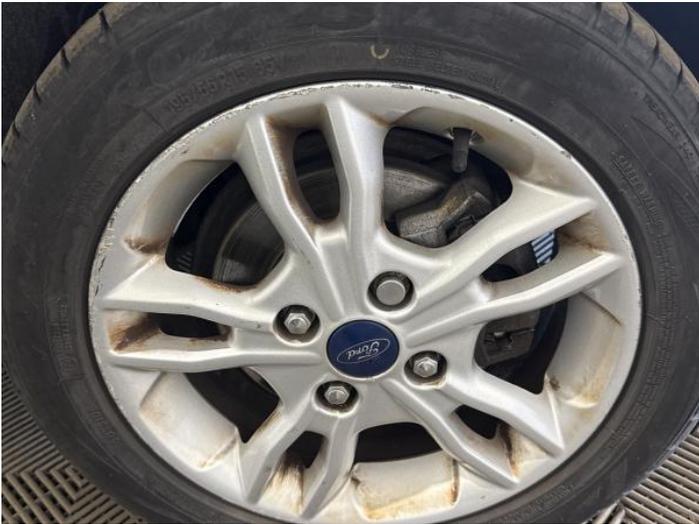
17: Wheel osf
Scratched
Over 50mm

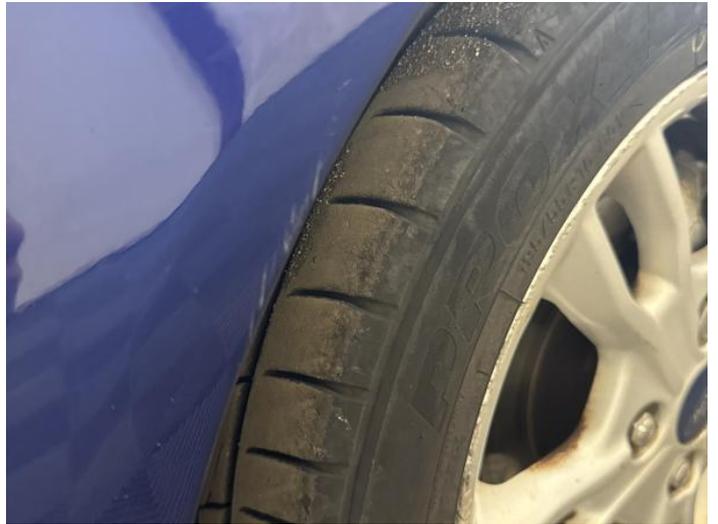
18: Wing osf
Scratched
Over 25mm Thru Paint

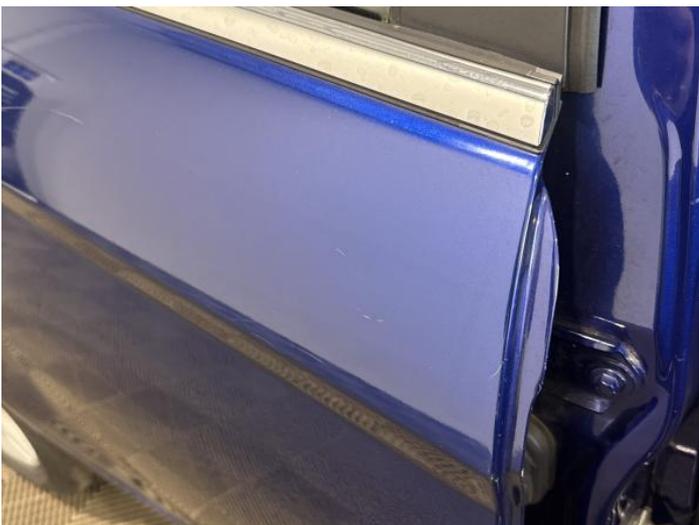
19: Door osr
Dented
2 Or Less UpTo 10mm
