VEHICLE INSPECTION REPORT

GV190KX

Mazda CX-5 2.2d Sport Nav+ 5dr Auto

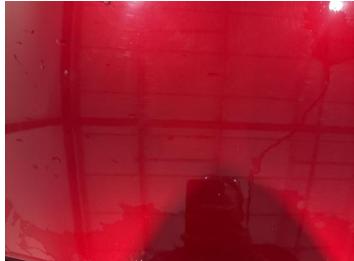
1: Bonnet Chipped 1 To 5

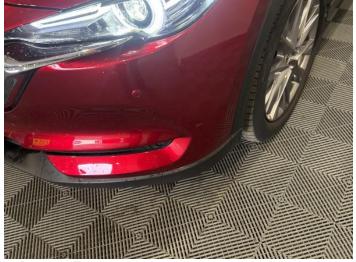
2: Bumper Front Scratched 25 to 100mm Thru Paint

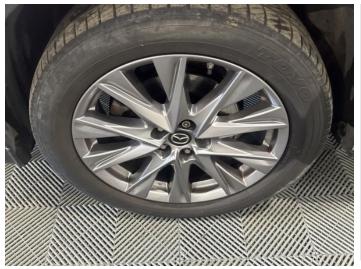
3: Wheel nsf Scratched Up To 50mm

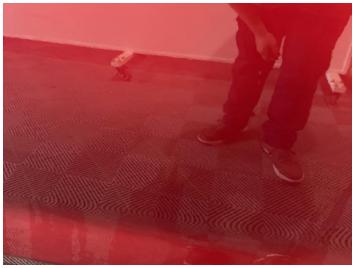
5: Door nsf Chipped 1 To 5

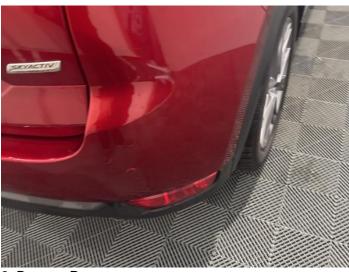
8: Bumper Rear Chipped Multiple Chips

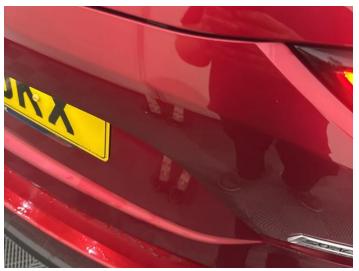
9: Boot Lid Chipped 1 To 5

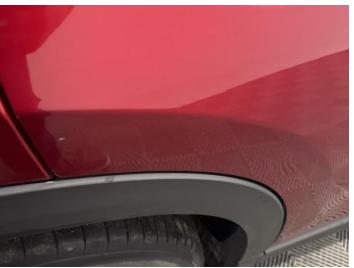
10: Door osrChipped1 To 5

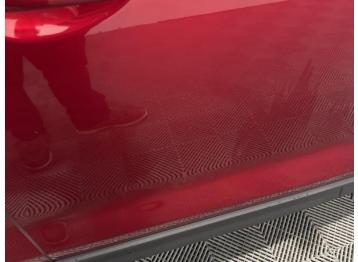
11: Door osfChipped1 To 5

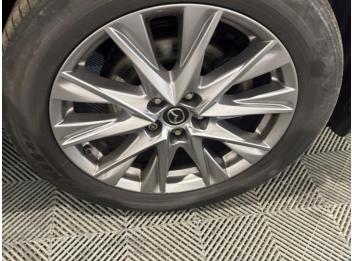
12: Wheel osf Scratched Over 50mm
