VEHICLE INSPECTION REPORT

BF12RBX

Audi A3 1.6 TDI Sport 5dr S Tronic

nama
GRADE
4

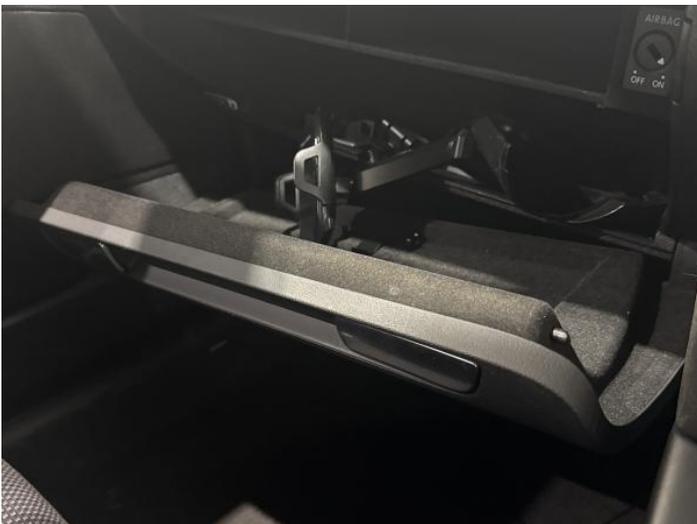
1: Glove Box Lid
Broken
Replace

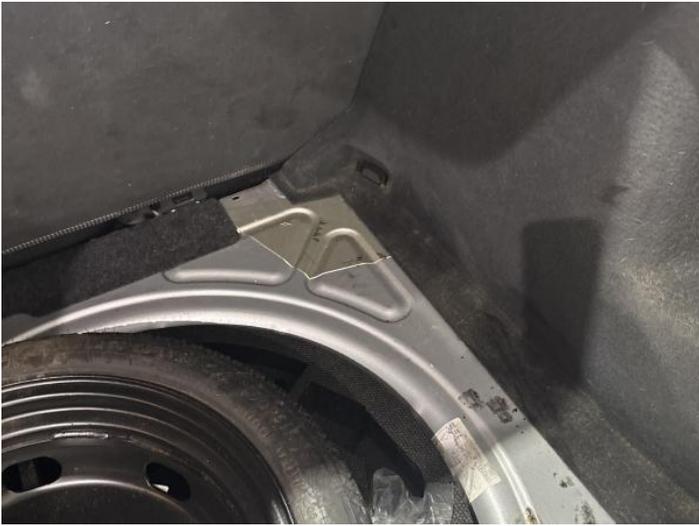
3: Carpets Rear
Missing
Replace

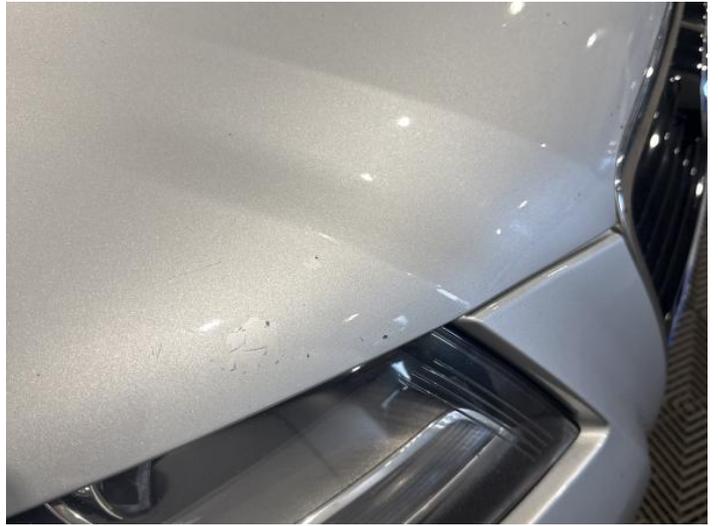
4: Bonnet
Poor Previous Repair
Paint Flake

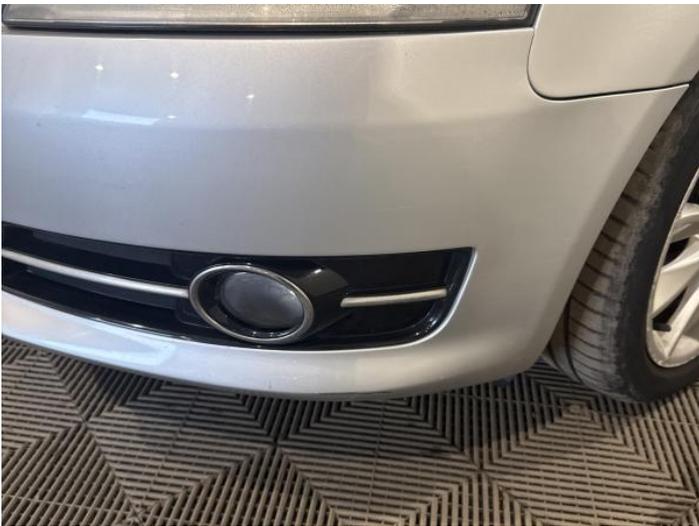
5: Bumper Front
Scratched
25 to 100mm Thru Paint

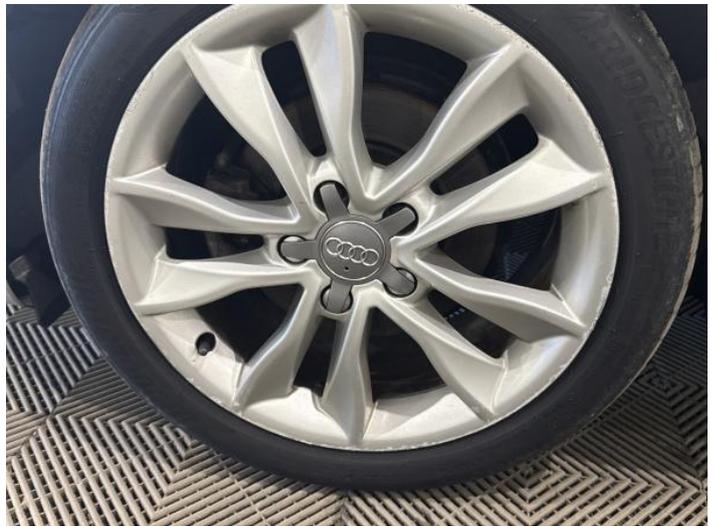
6: Wheel nsf
Scratched
Over 50mm

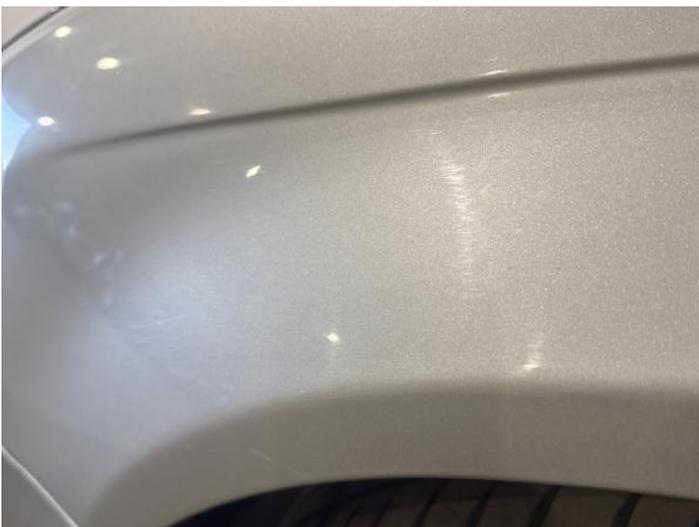
7: Wing nsf
Poor Previous Repair
Poor Paint

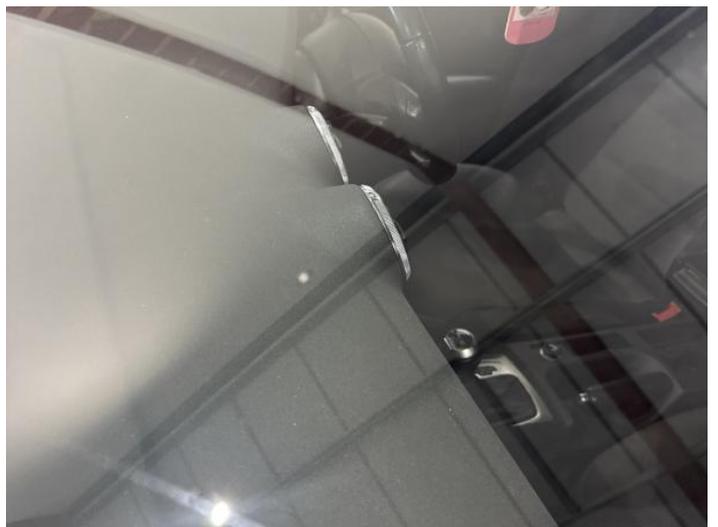
8: Screen Front
Chipped
UpTo 10mm

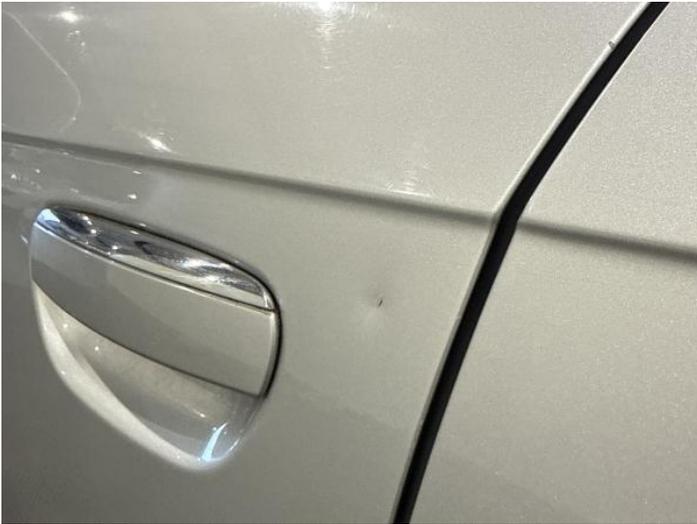
9: Door nsf
Dented
Between 10mm + 30mm

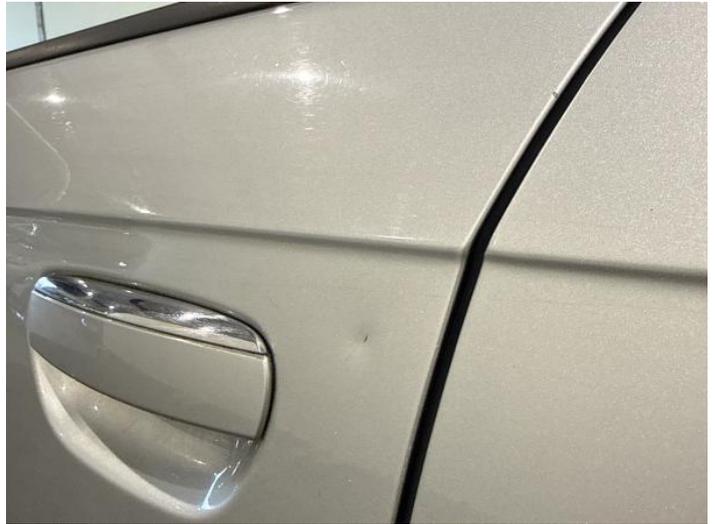
10: Door nsf
Scratched
Over 25mm Thru Paint

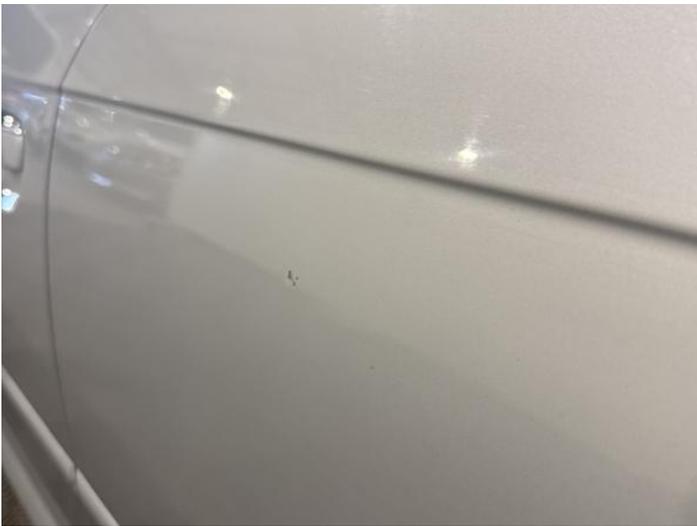
11: Door nsr
Chipped
1 To 5

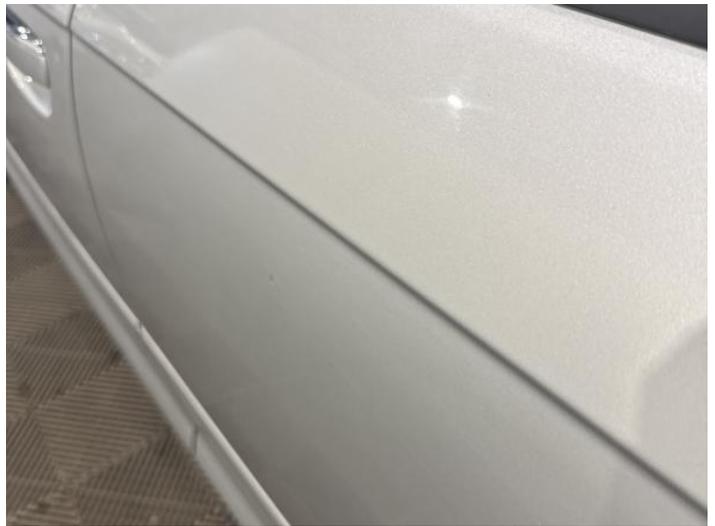
12: Door nsr
Dented
2 Or Less Up To 10mm

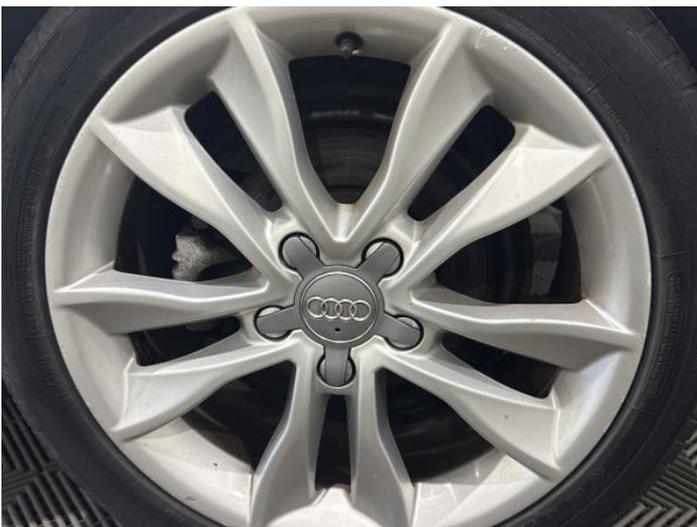
13: Wheel nsr
Scratched
Over 50mm

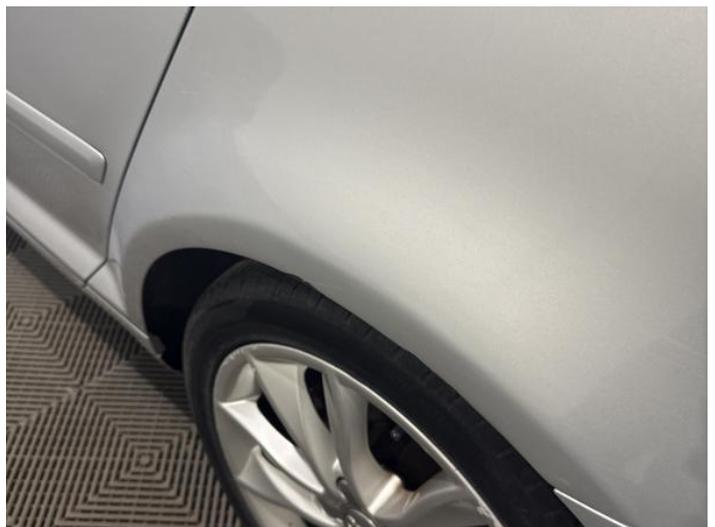
14: Qtr Panel nsr
Scratched
Over 25mm Thru Paint

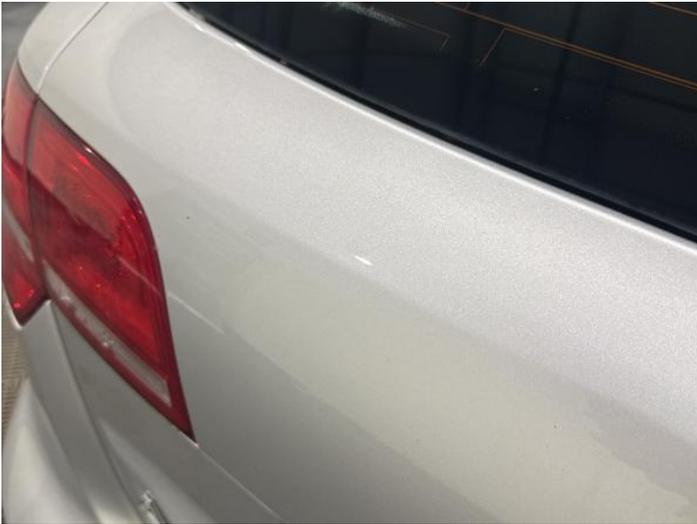
15: Tailgate
Chipped
1 To 5

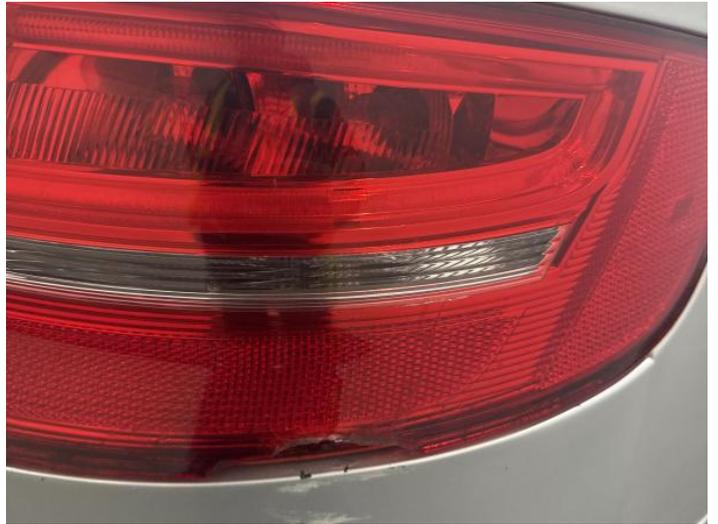
16: Lamp osr
Broken
Replace

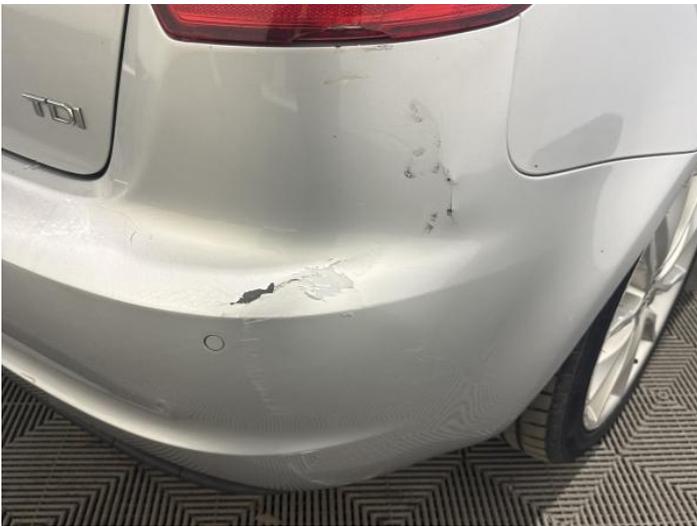
17: Bumper Rear
Dented
With Paint Damage

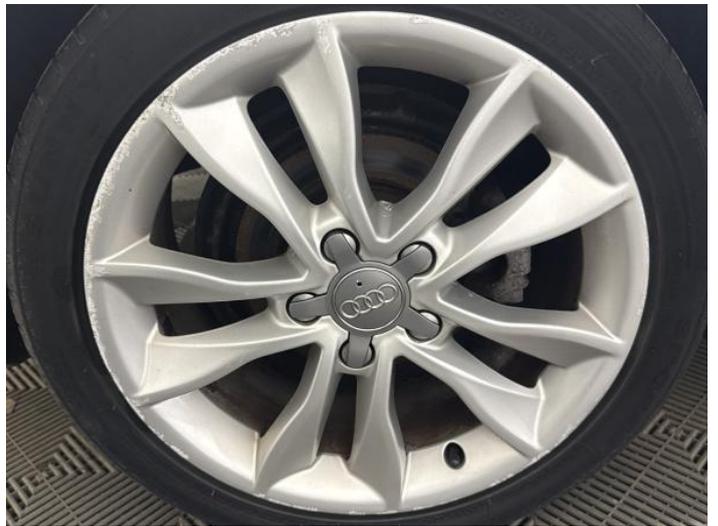
18: Wheel osr
Scratched
Over 50mm

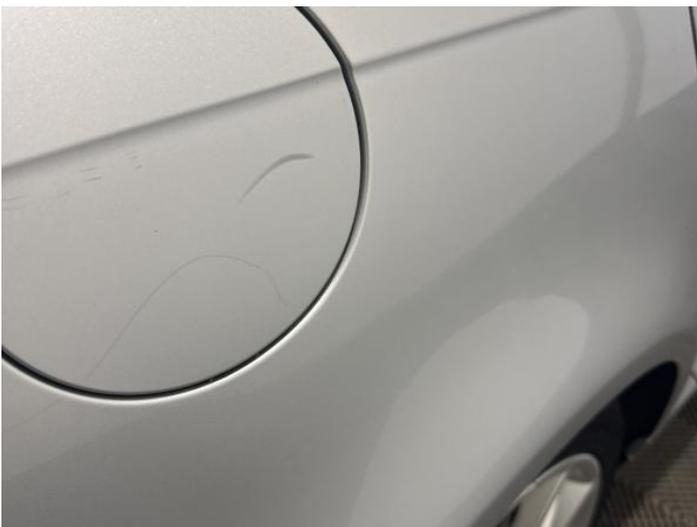
19: Qtr Panel osr
Scratched
Over 25mm Thru Paint

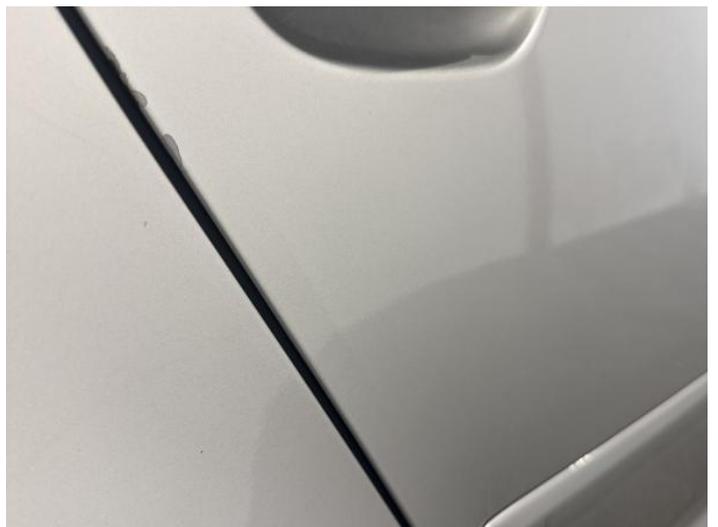
20: Door osr
Dented
With Paint Damage

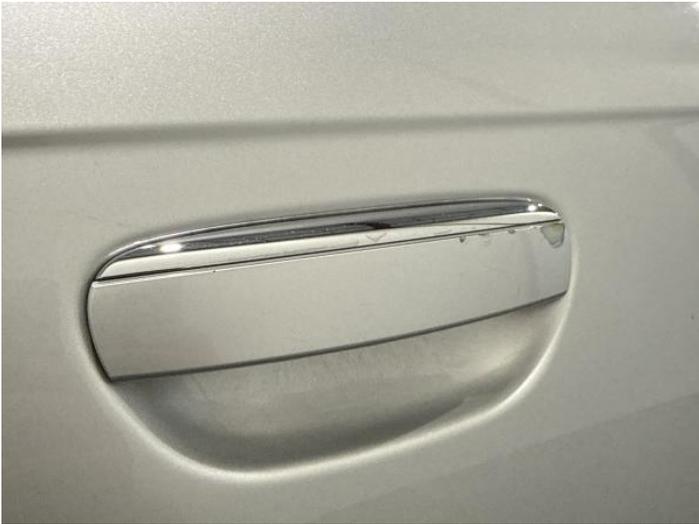
21: Handle Outer osr
Scratched (Painted)
Over 25mm Thru Paint

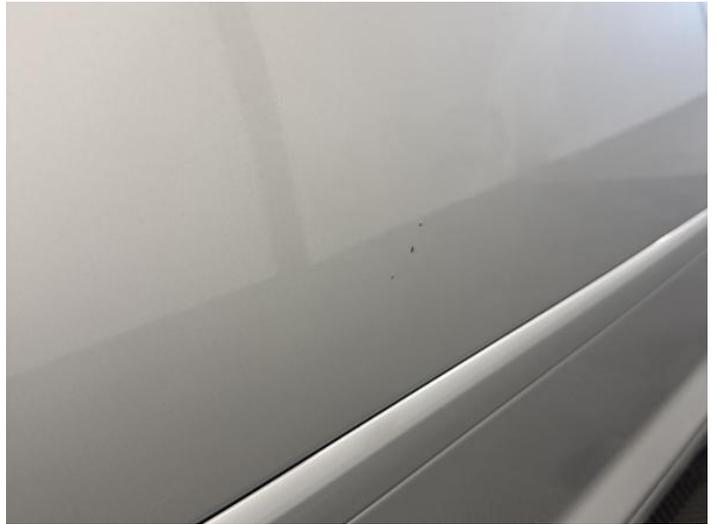
22: Door osf
Chipped
1 To 5

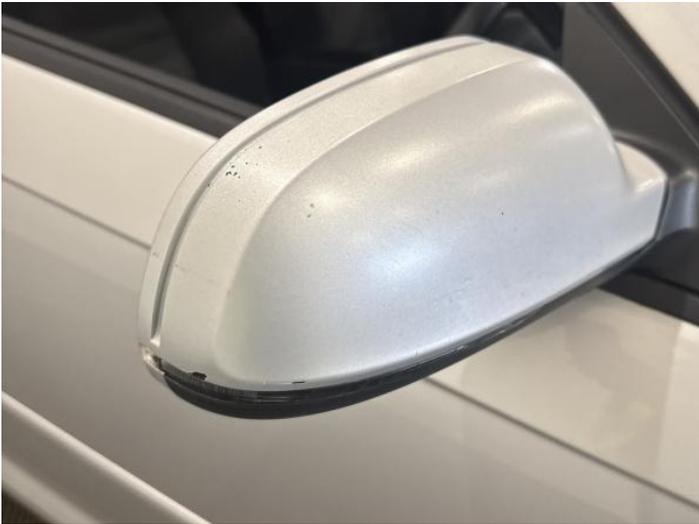
23: Door Mirror Assy osf
Scratched (Painted)
UpTo 25mm Thru Paint

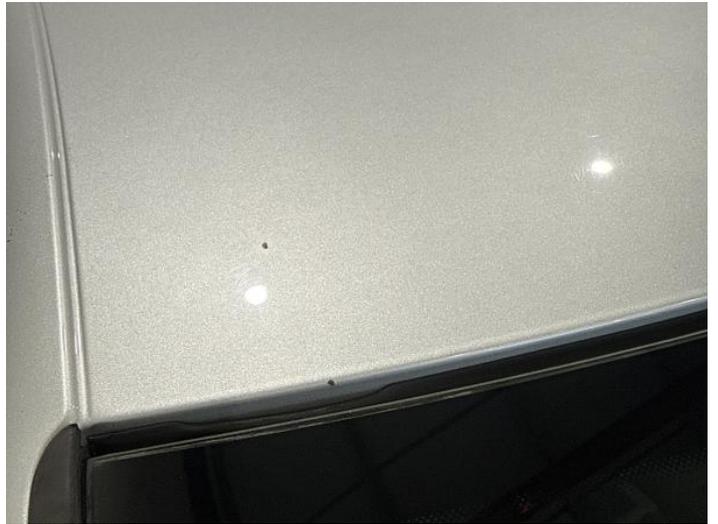
24: Roof
Chipped
1 To 5

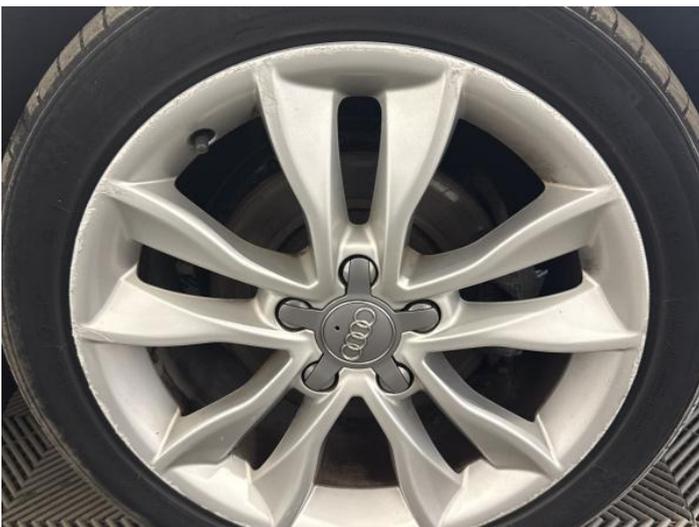
25: Wheel osf
Scratched
Over 50mm
